GP160F/160DF/160

SERVICE HANDBOOK

FY8-23B3-000

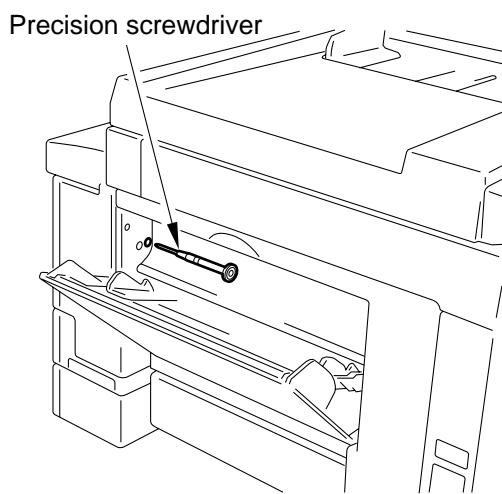
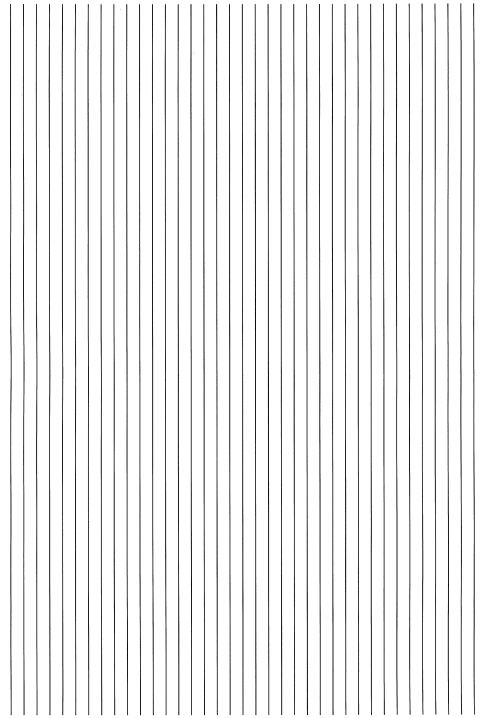
Figure 4-19

When the test print switch (SW401) on the sensor PCB is pressed, the print patterns shown below are output.

By outputting these test prints, you can conduct a print check with the scanning assembly Operation panel assembly installed.

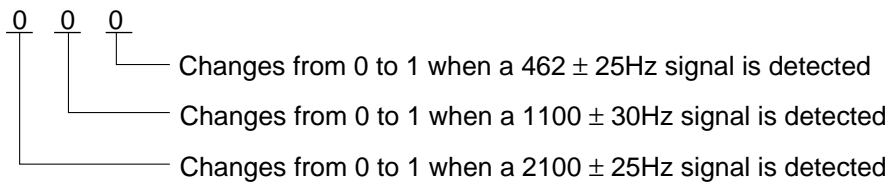
Tonal signal reception test

4-6 : TONE Rx 000
1 2 3 4 5 6 7 8 9 0

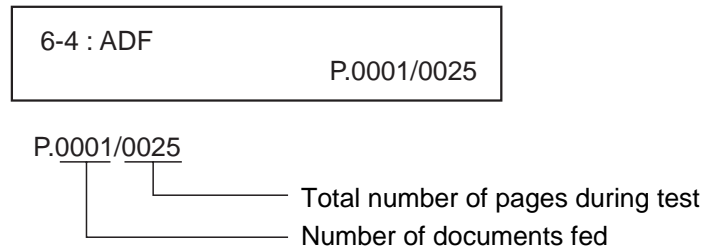
Figure 4-27

When the document is set in the document inlet guide and the start key is pressed, the document is fed at a speed matching the selected resolution. The number on the display counter advances with each page.

It is possible to set up to 50 sheets of A4 paper, 20 sheets of A3/B4 paper.

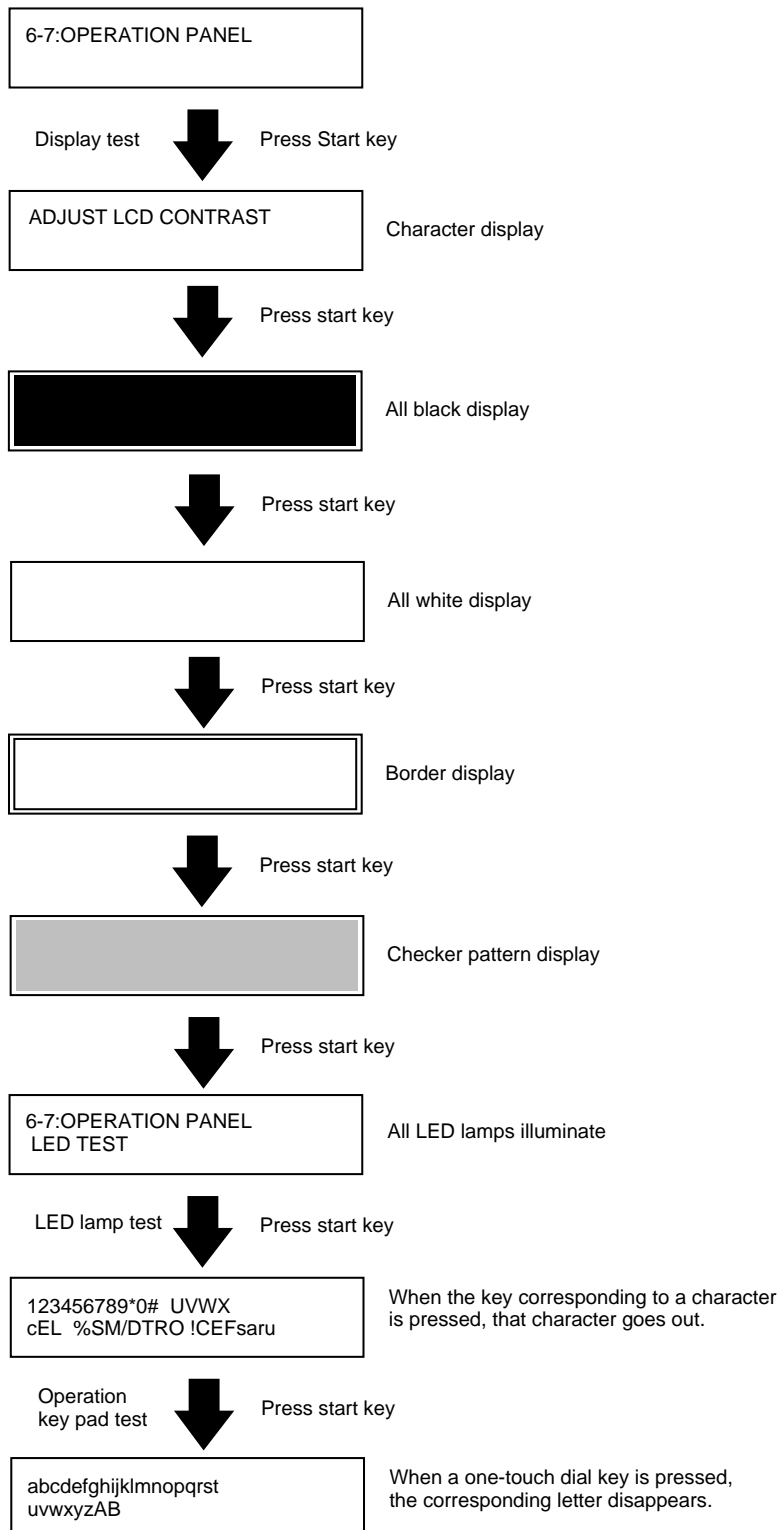
Figure 4-30

When all the characters displayed have disappeared, then the one-touch dial key test starts. Characters from a-z and A-Z are displayed. The display from characters a-B corresponds to the one-touch dial keys 01-28. When the one-touch dial keys are pressed, the characters corresponding to them disappear from the display.

The test ends when the stop key is pressed.
