Troubleshooting

Guide to Troubleshooting the Printer

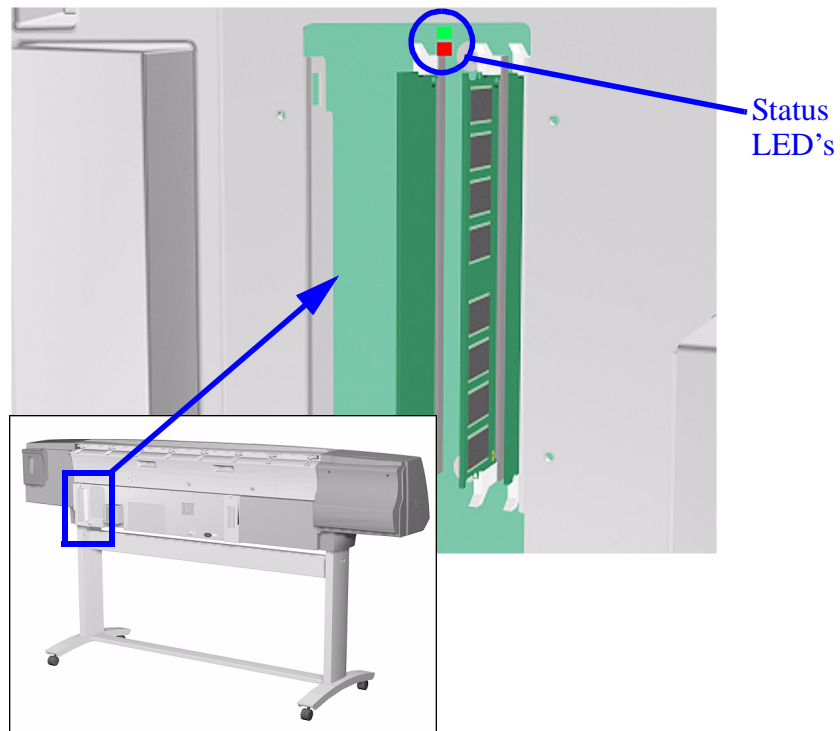
1. Check that the Power Cord is connected correctly to the Printer and to the Power Socket.
2. Check that the Power Switch on the BACK of the Printer is in the ON position.
3. Remove the DIMM's Cover (See ⇒ Page 8-75) and check the green and red Status LED's on the Main PCA. If they are both NOT lit, replace the Power Supply Unit ⇒ Page 8-83.

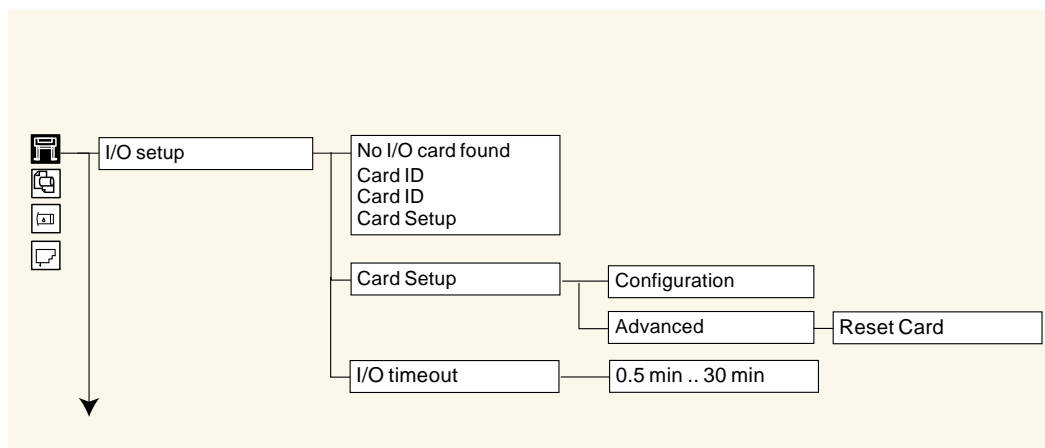
I/O Setup Menu

Only Appear in
Full Menu Mode

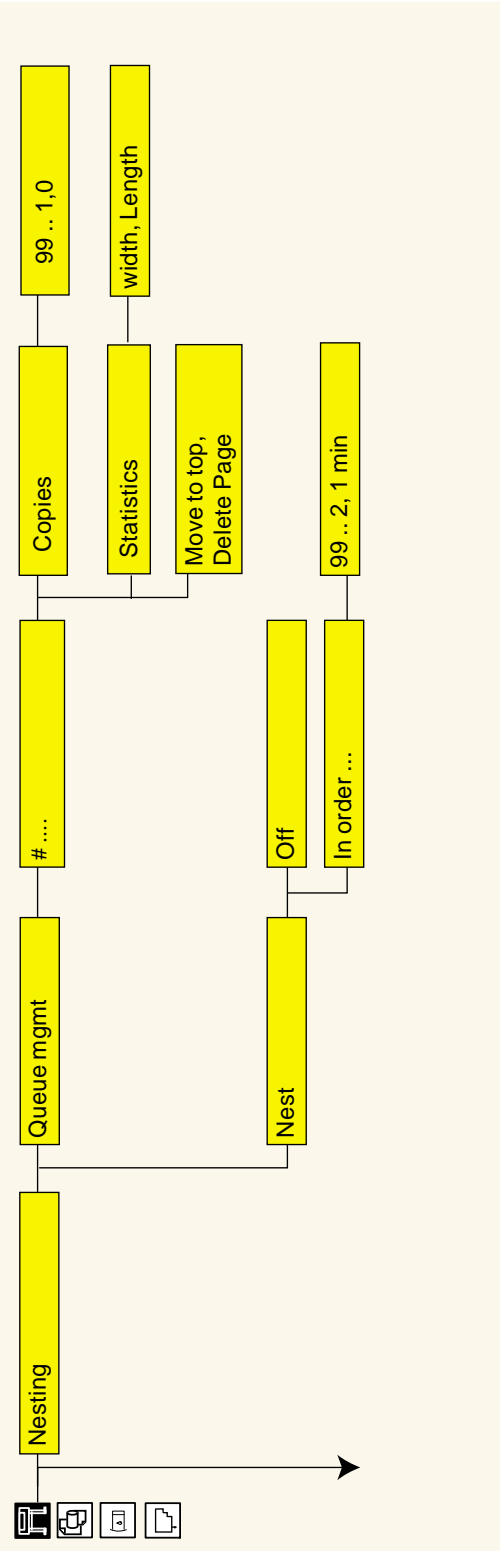
Queuing and Nesting Menu

@	
Only Appear in Full Menu Mode	Always Appear	PostScript Only

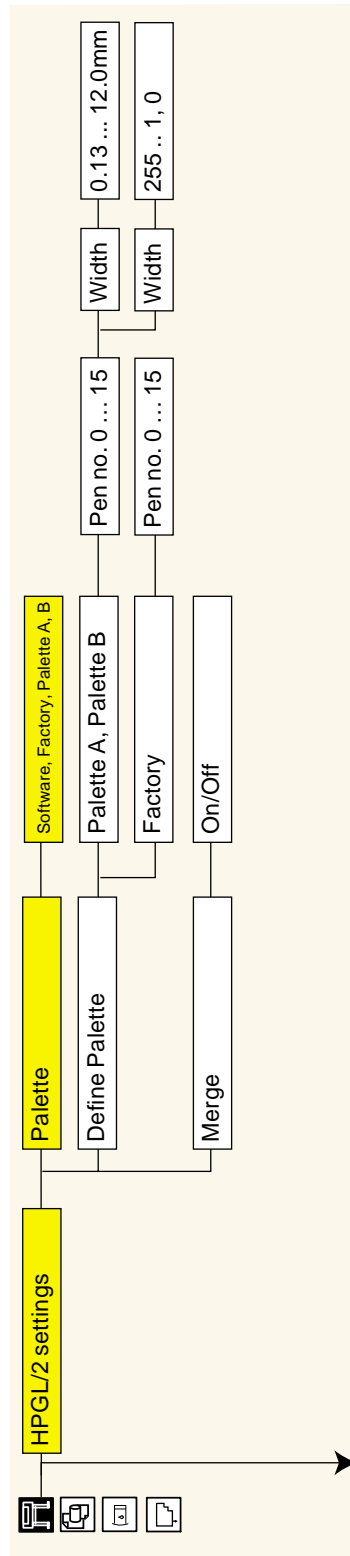
HP-GL/2 Settings Menu

Only Appear in Full Menu Mode
 Always Appear
@
PostScript Only

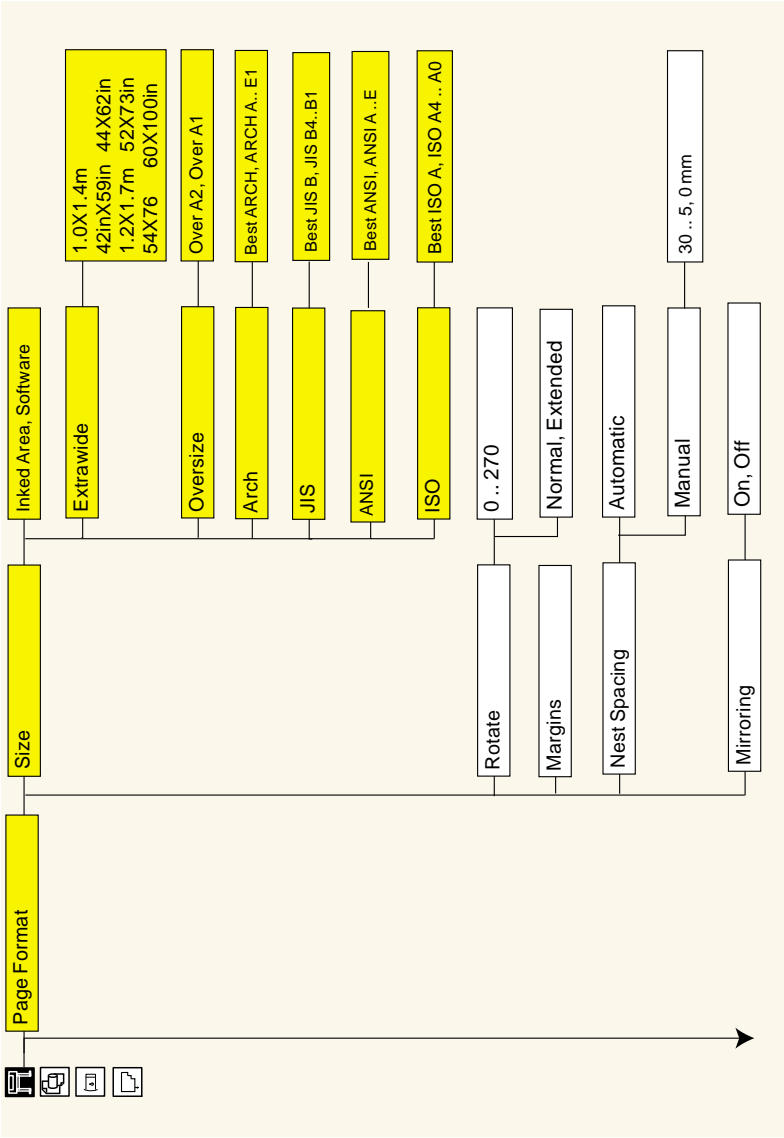
Page Format Menu

Only Appear in Full Menu Mode

Always Appear

@ PostScript Only

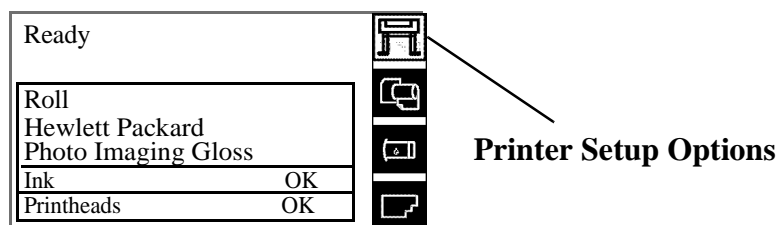
1. Load media (Roll media or at least an A0 Sheet) into the Printer.
2. Once the message “Ready” is displayed on the front-panel, scroll to the “Printer Setup Options” icon and press the **Enter** key.

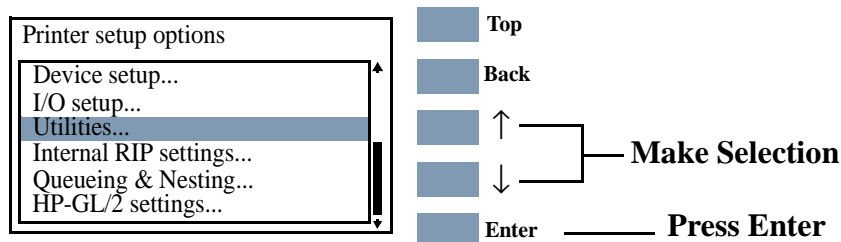
3. Once inside the “Printer Setup Options” menu, use the **Arrow** keys to scroll to the “Utilities” menu display and press the **Enter** key.

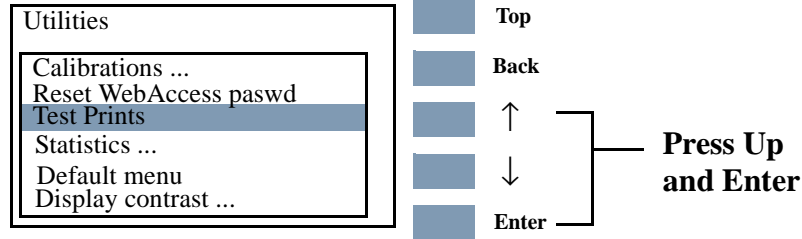
4. Once inside the “Utilities” menu, use the **Arrow** keys to scroll to the “Test prints” menu display and press the **Enter** key.
