# Effect of Composite Fabrication Method on Structural Response and Impact Damage

Experimentally determined axial compressive failure loads, strains, and failure modes of composite flat panels and cylinders are presented. A comparison of two types of filament-wound flat graphite-epoxy panels indicates that the winding pattern can influence structural response. A comparison of hand laid-up tape and filament-wound composite cylinders indicates that fabrication method may not significantly influence the failure mode or average failure strain of thick-walled (radius-to-thickness ratio less than 15) graphite-epoxy cylinders. The interaction of manufacturing-induced features (fiber crossovers) and low-speed impact damage for graphite-epoxy specimens is also presented. Filament-wound flat panels with many fiber crossovers exhibited lower failure strains than did filament-wound panels without fiber crossovers for all impact speeds examined. Graphite-thermoplastic cylinders exhibited a significantly different failure mode from graphite-epoxy cylinders.

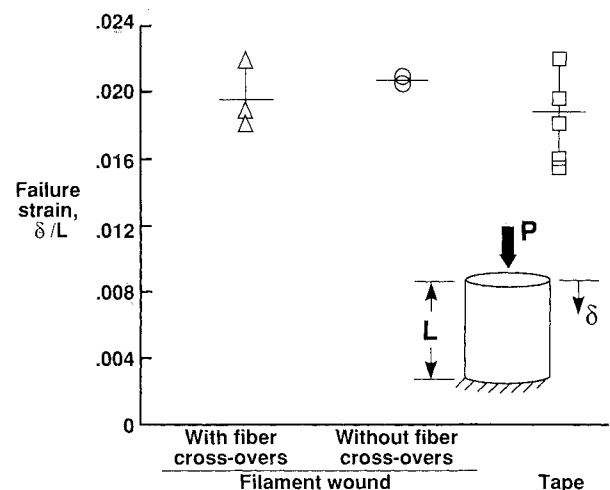
Fig. 7 Average failure strain of graphite-epoxy control cylinders with a  $[\pm 45/90]_{3s}$  stacking sequence.

Five graphite-epoxy filament-wound control cylinders, as described in Tables 1 and 3, were loaded in axial compression to failure. The failure strain ( $\delta/L$  at failure) of each specimen is shown in Fig. 7 and given in Table 3. The horizontal bars in the figure represent the average failure strain of cylinders of each type, and the symbols represent the failure strain of each cylinder. Average failure strains of the two types of filament-wound control cylinders differ by less than 10%, which is within the scatter range of the results, indicating that the presence of fiber crossovers has little effect on failure strain.

inder is shown in Fig. 7 and given in Table 3. The horizontal bar in the figure represents the average failure strain of the tape cylinders, and the symbols represent the failure strain of each cylinder. A larger scatter range is evident for the tape cylinders than for the filament-wound cylinders. The average failure strain of the tape cylinders is approximately 10% lower than the average failure strain of the filament-wound cylinders (including those with and without fiber crossovers). However, with such a large scatter range, for a larger population of specimens, it is expected that there may be no significant difference in failure strains between tape and filament-wound cylinders. Fiber weight fractions for pieces cut from failed cylinders were determined via an acid digestion technique. The variation in fiber weight fraction among tape cylinders, filament-wound cylinders away from fiber crossovers, and filament-wound cylinders at fiber crossovers was less than 2%.

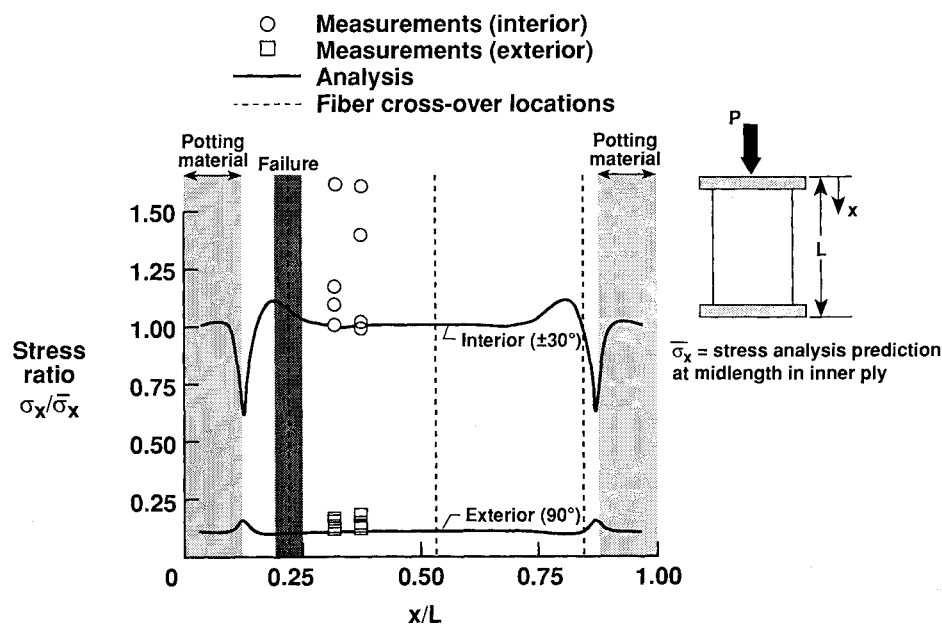
Fig. 12b Normalized stress distribution in outermost and innermost layers of graphite-thermoplastic control cylinder with a  $[\pm 30/90]_s$  stacking sequence based on analysis and strain gauges.

A linear finite element analysis of the thicker control cylinder using the computer code STAGS<sup>6</sup> and the graphite-thermoplastic properties presented in Table 4 is used to examine the stress state in the inner and outer plies of the cylinder. The normalized axial stress distribution along the length of the cylinder predicted by the analysis, represented by solid lines, is shown in Fig. 12b. Analysis indicates that boundary effects are limited to within about 2.54 cm from the clamped edge. Experimental results of calculated stress based on strain gauge measurements recorded at four points around the circumference of the cylinder 2.5 cm away from midlength and four points 3.5 cm away from midlength, represented by open symbols, are also shown in Fig. 12b. These gauges were 2.0 and 3.2 cm from the nearest fiber crossovers. In a perfect cylinder subjected to purely axisymmetric load, the circumferential position would be irrelevant and all strain gauge data points from one axial location on a given surface would lie one on top the other. No variation around the circumference is seen in the analytical results. In the test data shown in the figure, significant variation is seen in data recorded at the same axial but different circumferential locations. Two factors contribute to the difference between the strain recorded at different points around the circumference and the difference between interior and exterior recorded strains. First, the strain gauges were located near the fiber crossovers. The proximity of the strain gauges to the fiber crossovers probably caused variation in measurements among the interior gauges. Fiber crossovers were not included in the analysis. Second, the interior ply is a wound  $\pm 30$ -deg layer and the exterior ply is a 90-deg layer. The measured strains (and calculated stresses shown in Fig. 12b) are therefore not the same on the interior and the exterior of the cylinder. The stress analysis also indicates this difference, as shown by the two solid lines in Fig. 12b. Little difference between interior and exterior measurements would be seen in a symmetrically laminated specimen
