Effects of Longitudinal and Hoop Stiffeners on Damage Propagation in Pressurized Composite Cylinders

Haryanto T. Budiman,*Kerry F. Henault,[†] and Paul A. Lagace[‡]
Massachusetts Institute of Technology, Cambridge, Massachusetts 02139

An experimental study was conducted on the combined effects of longitudinal and hoop stiffening bands on the damage propagation in pressurized composite cylindrical shells. Damage was simulated as through-thickness longitudinal slits. Two different stiffener configurations were studied: 1) alternating continuous and broken hoop and longitudinal stiffeners (type A) and 2) continuous longitudinal and hoop fabric stiffeners (type B). In all but one cylinder, damage turned 90 deg near the edge of the hoop stiffening bands. In cases in which damage turned, it continued its propagation in the hoop direction, breaking the first set of longitudinal reinforcement layers, inducing secondary damage modes (such as stiffener debonding and delamination) along the way, and generally being arrested at the second set of longitudinal stiffeners. Damage redirection by the first set of longitudinal stiffeners was seen in one cylinder that had significant reinforcement

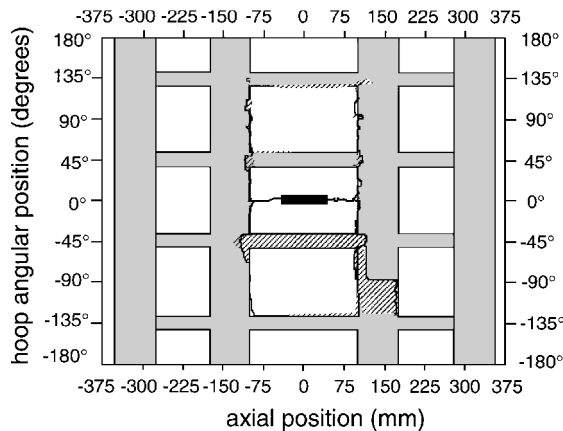
Fig. 8 Fracture path of cylinder 3 stiffened with four layers of continuous (type B) 0-deg fabric layers.

In cylinder 3, which was stiffened with four layers of 0-deg continuous fabric layers, damage was turned as it reached the edge of the hoop stiffeners. It then continued its propagation in the hoop direction, fracturing and delaminating one set of the longitudinal stiffening bands during its progression. Some further debonding was also observed in the hoop stiffener far from the slit region as depicted in Fig. 8. A similar fracture path was observed in cylinder 4, which was stiffened with four continuous layers of 45-deg fabric layers as shown in Fig. 9. Some fracture of the longitudinal stiffeners was also observed while damage propagated across the region. As in cylinder 1, damage was arrested by the next set of longitudinal stiffeners.

the hoop direction, generally cleanly breaking the longitudinal stiffening bands along the way. These can be seen clearly in the fracture paths of cylinders 1, 3, and 4 shown in Figs. 6, 8, and 9, respectively. Cylinder 1, which was reinforced with the type A stiffener, suffered significant secondary damage in the form of delamination and stiffener debonding near the locations where the longitudinal and hoop reinforcements meet. Thus, although damage may appear to have been diverted/turned in this case, it is more likely that it just found an easier path (via matrix cracking and associated delamination) along which to propagate.

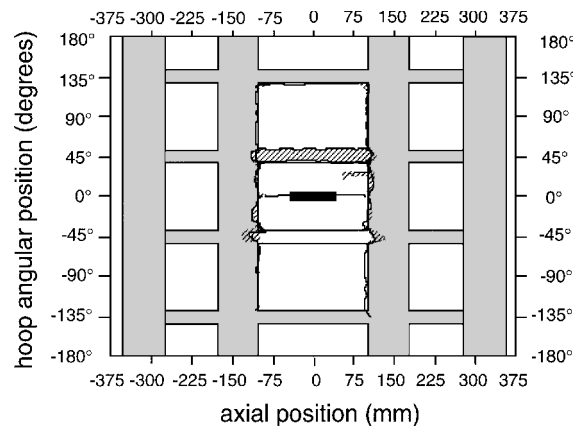
Fig. 9 Fracture path of cylinder 4 stiffened with four layers of continuous (type B) 45-deg fabric layers.
