Hypervelocity Impacts on Thin Metallic and Composite Space Debris Bumper Shields

The mechanism of hypervelocity impact crater formation in metallic and composite space debris shields has been investigated. Both normal and oblique impact crater formations have been investigated using 2.2-mm-thick aluminum (Al 2017), carbon fiber reinforced plastic (CFRP) and aramid fiber reinforced plastic (AFRP) space debris shields in a two-stage light gas gun. A cylindrical projectile made of high-density polyethylene (14 mm in diameter and length) at a muzzle speed of 5.0 ± 0.2 km/s is used to create the craters in the debris bumper shields. The microscopic study reveals the formation of adiabatic shear bands near the crater zone, from where the secondary cracks emerge, ultimately resulting in the formation of the craters in thin aluminium plates at impact angles of 90, 51, and 64 deg. On the other hand, surface delamination zones caused by the peeling of surface piles surrounding the impact and exit craters are observed in the case of CFRP and AFRP debris shields at normal impact. To estimate the temperature near the craters, time-integrated spectrum of the light emission during the crater for

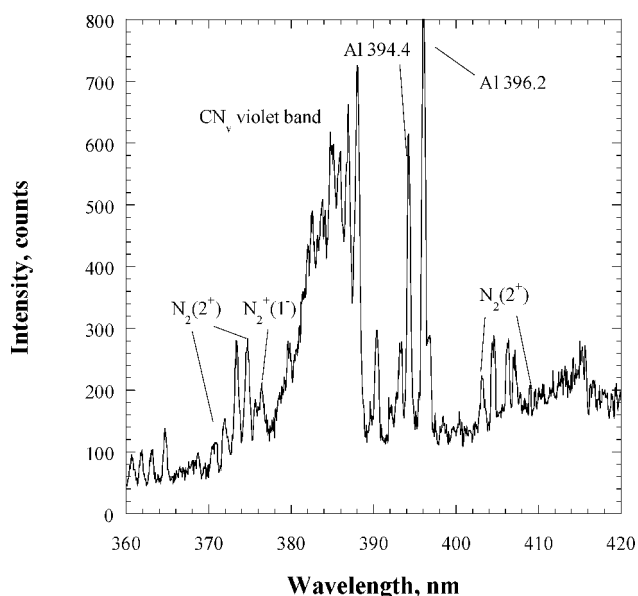
Fig. 11 Time-integrated spectroscopy of debris cloud during normal impact of polyethylene projectile on aluminum bumper; projectile velocity equal to 5.1 km/s in N_2 gas at 600 Pa.

Figure 11 shows an example of the emission spectrum of the impact flash measured during a normal impact on aluminum. Tests using magnesium projectiles on aluminum bumpers yielded no CN bands, thus, confirming that these bands do not originate from contamination of the experimental chamber. Strong emission of the 394.4- and 396.2-nm Al lines, as well as some magnesium lines when using projectiles of this metal, could also be detected.

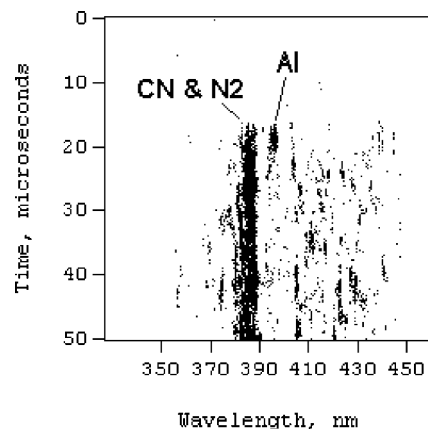
Fig. 13 Time-resolved spectroscopy, normal impact on Al; projectile velocity equal to 5 km/s in N_2 at 600 Pa.

diation from shock-heated material near to the impact zone and the second, frames 6–8, to molecular radiation as the debris cloud interacts with the surrounding gas. Spectroscopic verification of these emissions was done by time-resolved spectroscopy, using a streak unit, and is shown in Fig. 13a. Because of the technical limitations of the present streak setup, this measurement was done only in very low spectral resolution. Time evolutions of the emission from Al and CN/ N_2^+ bands could be distinguished and are, thus, plotted in Fig. 13b. Within the present temporal resolution of the system, which is of the order of $1 \mu s$ the onset of these bands coincides with the corresponding emission on the sequential photographic results. That is, line emission from aluminum is emitted as soon as it is being heated on impact and vaporized in the debris jet. Probably, the aluminum vapor cools down as it expands in the surrounding gas, which explains the brief nature of its emission. Debris from the polyethylene projectile vaporizes very quickly, but takes a longer time to be heated in the surrounding gas through localized shock waves. Eventually, the material undergoes successive dissociation and recombination reactions, which lead to formation of radicals such as CN and N_2^+ , responsible for the strong band emissions observed in Fig. 13b, lasting for more than $20 \mu s$. It is essentially the second flash that is being measured and analyzed by spectroscopy in the present study.

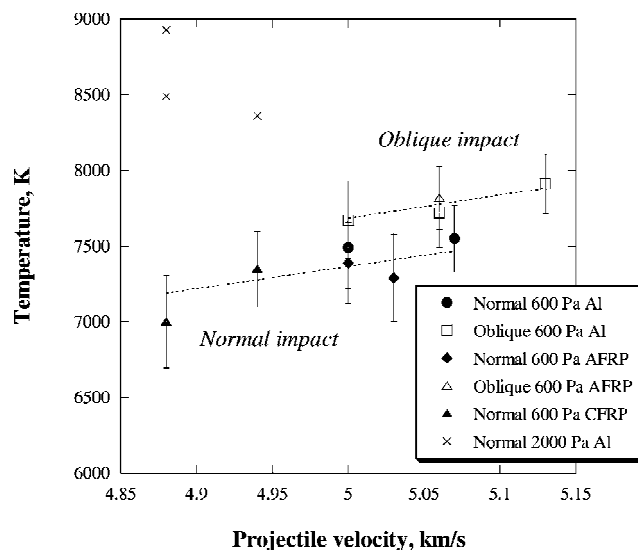
Fig. 15 Summary of estimated impact temperature of debris cloud in different experimental conditions.

When the method described in the preceding section is used, the average temperatures of the different impact tests are calculated (example in Fig. 14) and summarized in Fig. 15. The error bars are determined from the uncertainty in matching the experimental spectrum data with calculation. In the case of oblique angle impacts,

because no clear distinction could be made between the two different angles tested, data from these two sets are analyzed together. The mean value of the temperature during normal impacts of polyethylene projectiles on an aluminum bumper in N_2 gas under the present experimental conditions is estimated to be slightly lower than in oblique conditions, about 300 K for impacts at 5 km/s. This discrepancy seems to be larger in the case of impacts on AFRP, where the temperature difference between normal and oblique impacts is of the order of 500 K. For CFRP, this trend could not be verified. However, note that the different tendencies exhibited by the estimated debris cloud temperatures are within the experimental error range. Therefore, before confirming these tendencies, more experiments are mandatory.
