# Bonded Composite Patch Design for Aircraft Structures Exhibiting Cracking and Corrosion

Madhukar Singh\* and William P. Schonberg†  
*University of Missouri–Rolla, Rolla, Missouri 65409*

Many military and civilian aircraft are expected to operate beyond their designed life expectancy. As a result, the development of reliable and cost-effective repair techniques for deteriorating components in aging aircraft is of great interest. The application of bonded composite material patches to restore cracked and corroded metallic airframes has been shown to be an effective repair technique for increasing the durability and damage tolerance of the repaired structure. Composite Repair of Aircraft Structures (CRAS) is a computer program that is currently being used to design bonded patches for damaged metallic structures. The results are presented for a study whose objective was to extend the applicability of the CRAS program to include bonded patch design for aircraft structures that have sustained adjacent cracking and corrosion damage. Patch designs were developed for three different cracking and corrosion configurations. Composite patches were manufactured according to the designs deve

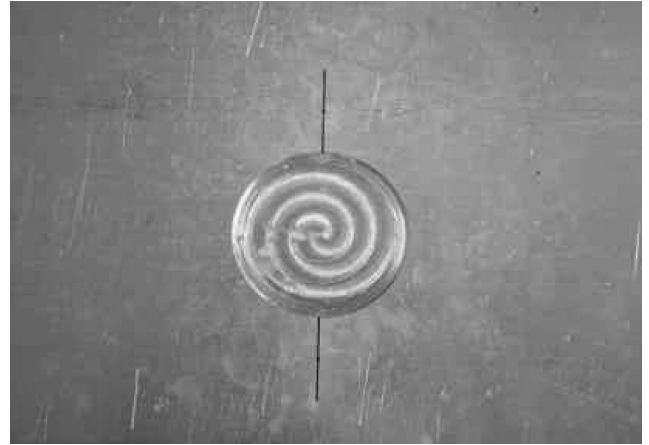
**a) Damaged panel without putty**

**b) Damaged panel with putty****Fig. 5 Application of putty to damaged panel.**

After the precracking and grinding was completed, the grind-out areas were filled with Devcon WR-2 wear-resistant putty. The putty was prepared by mixing hardener and resin in the ratio of 1:4 by volume. Before applying the putty, the grind-out area was cleaned with acetone. After the putty hardened, its surface was smoothened with a fine sandpaper in preparation for patch application. Figure 5 shows the damage area before and after application of the putty had been applied to the grind-out area of the panel.

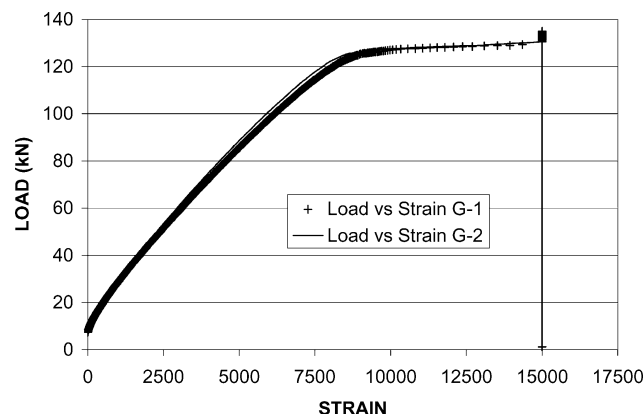
Fig. 10 Load vs strain plot for unpatched panel SCC1-1 (strain gauge locations G-1 and G-2).

Figures 10 and 11 show typical load-vs-strain graphs for corresponding pairs of patched and unpatched panels, respectively. The units of load are pounds and the units of strain are microstrain. In Fig. 10 we see that the load-vs-strain curve for the unpatched specimen is smooth until the failure point. In contrast, the load-vs-strain

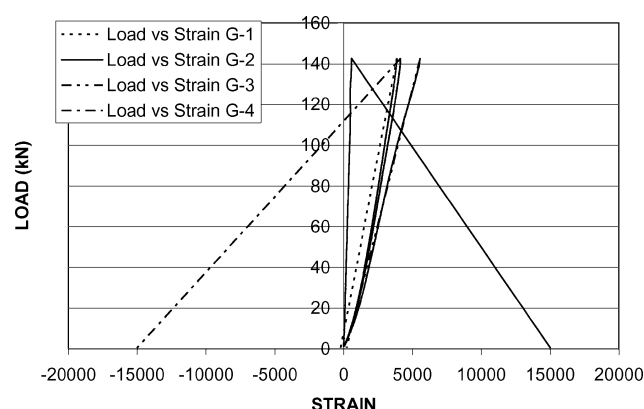
Fig. 11 Load vs strain plot for patched panel SCC1-1 (strain gauge locations G-1, G-2, G-3, G-4).

curve for the patch specimens in Fig. 11 is erratic. These curves are typical of those in tests of the unpatched (and patched) specimens that failed by crack extension and the patched specimens that showed bolt bearing failures, respectively. A possible explanation for this is that the unpatched specimen failed suddenly at the middle of the specimen due to crack elongation. However, the patched specimen produced an irregular curve, because there were numerous bolt slippages occurring throughout the test resulting ultimately in a bolt bearing failure.
