In-Flight GPS-Signal-Reception Anomalies of Helicopters

Naoki Matayoshi* and Yoshinori Okuno[†]

Japan Aerospace Exploration Agency,
Mitaka, Tokyo 181-0015, Japan

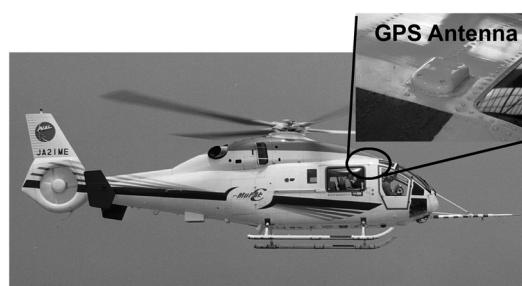
Fig. 1 JAXA's research helicopter and its GPS antenna installation.

JAXA's Mitsubishi Heavy Industries MH2000A-based research helicopter [5] (Fig. 1) is equipped with two GPS receivers: a Thales Navigation Z-Eurocard dual-frequency GPS receiver and a Furuno Electric GW-10II GPS/SBAS receiver. The GW-10II has equivalent capabilities to a Class Beta-3 GPS/SBAS receiver defined in the WAAS MOPS. Both GPS receivers use the same GPS antenna installed on the roof of the cockpit on the right-hand side (Fig. 1), which may be representative of a typical helicopter GPS antenna

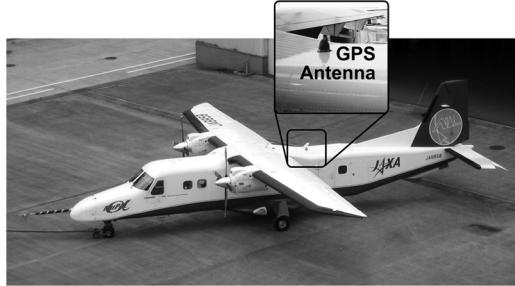
Fig. 3 JAXA's research airplane and its GPS antenna installation.

The results for JAXA's Dornier-228-based fixed-wing research airplane (Fig. 3) are also shown for comparison. Its GPS antenna is installed on the top of the center fuselage section, with no significant obstructions around it. A Trimble 4000 SSI GPS receiver was used for data collection.
