Damage of Ti-6Al-4V Alloy Induced by Hypervelocity Impact

S. L. Dong,* Z. Y. Ye,[†] H. B. Geng,[‡] H. Zhang,[§] Y. Zou,[§] D. Z. Yang,[¶] and S. Y. He[¶]
Harbin Institute of Technology, 150001 Harbin, People's Republic of China

DOI: 10.2514/1.49458

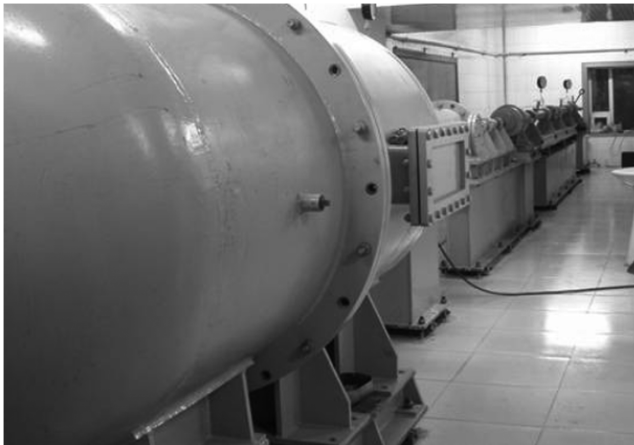
Fig. 2 The two-stage light gas gun for impact experiment.

In the impact experiments, the 4-mm-diam bearing-steel sphere were used as projectiles to impact the Ti-6Al-4V alloy target specimens at the normal impact model (the projectile direction is normal to the surface of target), in the two-stage light gas gun as shown in Fig. 2. The projectile velocity was measured in the tip of the launch tube using an oscilloscope in a “time of flight” mode. In current study, the impacting velocity is within the range from about 1 to 4 km/s, and the error in measurement of project velocity is about ±0.15 km/s. One group of single targets were impacted by steel projectiles at a certain velocity of about 2 km/s, and another group of single targets were tested for comparison at nominal velocities of 1, 2, or 3 km/s, respectively. For the multilayer targets, four impacting velocities were selected, namely, 1, 2, 3, and 4 km/s. The actual recorded velocity value during the impact experiment is generally not an integer as proposed, because of the variability in the two-stage light gas gun operation. Figure 3 gives an example of velocity

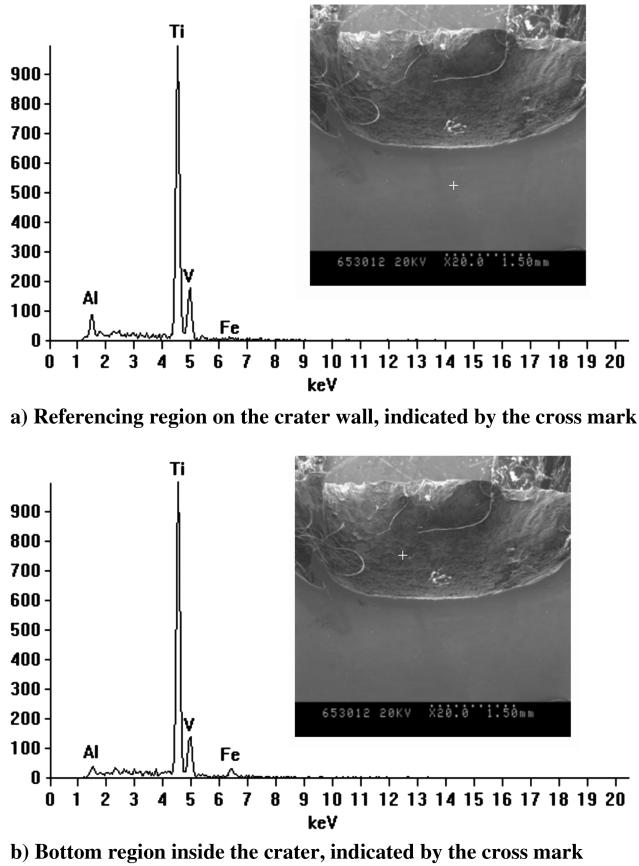
Fig. 12 Spectra of energy dispersive spectrometer microanalysis of the crater formed in the 20 mm target (4 mm spherical steel projectile, impacting at a nominal velocity of 2 km/s).

Another interesting microdamage phenomenon during the steel projectile impacting the Ti-6Al-4V target is the possible melting of the projectile, as shown in Fig. 12. For the crater formed in the 20 mm-thick target impacted at 2 km/s, much amount of Fe element was detected inside the bottom of the crater (as seen in Fig. 12b). The content of Fe is above 5 wt % and much higher than that in the target alloy, implying partly melting of the spherical steel projectile occurred during the impacting process. It was reported recently [17] that using of a three-stage light gas gun, the impact shock could induce vaporization of metals such as zinc, indium and aluminum with a titanium (Ti-6Al-4V) projectile traveling at 10.4 km/s. As the impacting velocity applied in this study is too low, it is reasonable to deduce the partly melting mechanism.
