Ground vehicle blunt impact damage formation to composite aircraft structures

Hyonny Kim^a, Gabriela K. DeFrancisci^a & Zhi M. Chen^a

^a Department of Structural Engineering, University of California San Diego, 9500 Gilman Drive #0085, La Jolla, CA 92093-0085, USA
Published online: 23 Dec 2013.

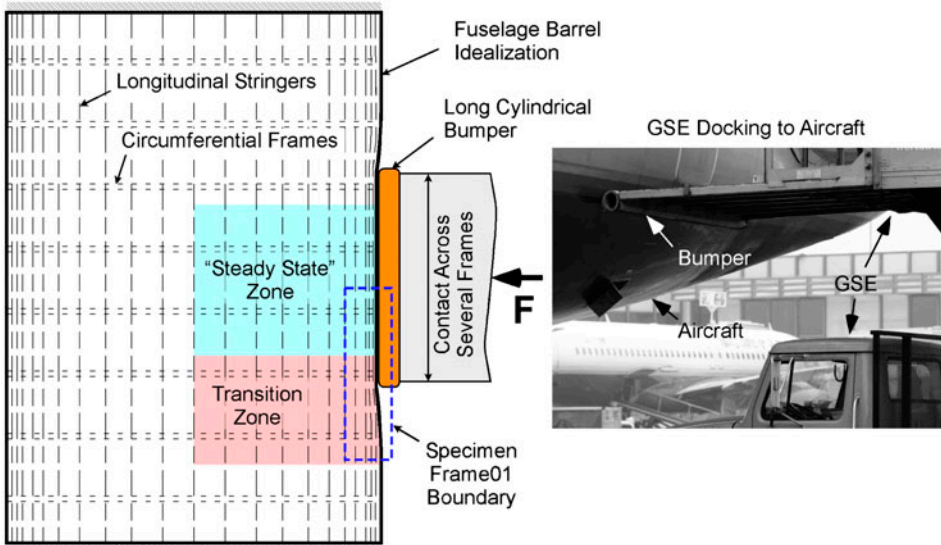
Figure 1. Conceptual view of fuselage impacted by GSE having long bumper.

Test specimens were designed at the University of California, San Diego (UCSD) with direct input provided by two major aircraft industry partners participating in this research program. The concept for the test specimens, shown in Figure 1, depicts the scenario of interest, where a GSE with a long cylindrical bumper makes contact against the side of an aircraft fuselage. The fuselage structure, generically composed of longitudinal stringers and circumferential frames, would have some number of frames ‘uniformly’ depressed by the interior portion of the long bumper, referred to in Figure 1 as ‘Steady State Zone,’ while the near-end portions of the bumper would involve biaxial bending response and is referred to as the ‘Transition Zone.’ Both zones were of interest, particularly the Transition Zone, due to the transverse shear developing in the stringers and the end-effect of the bumper where large bending stresses and interlaminar shear can result in visible skin cracking. The first-stage quasi-static specimen involved a 3-frame curved test panel, while the second-stage dynamic test specimen involved a larger 5-frame panel.

It should be noted that the specimen described here is the first of a series of these large panels and is identified as specimen Frame01. Having four co-cured stringers, as depicted in Figure 2, loading was applied over a distributed zone across a portion of the center of the specimen (on the skin between the two stringers), spanning from Frame #1 to Frame #2 (see Figure 3 for frame IDs). This loading area was chosen to create deformations representing a half-symmetry (like) condition, e.g. of a six frame panel being loaded, where two of the frames (#2 and #3) are in the ‘Transition Zone’ as depicted in Figure 1 (see dashed line indicating specimen Frame01 boundary). Note

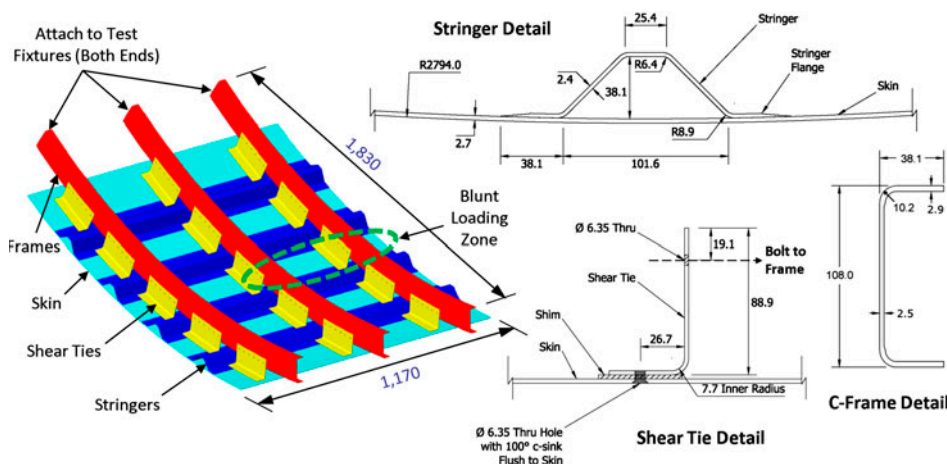
(a) Specimen detail: C-shaped frames (shown only in left drawing) are overall 108 x 32 mm with 2.9 and 2.5 mm thick flanges and web, respectively. All dimensions are mm

Figure 2. Stage 1 quasi-static test specimen Frame01 with four stringers and three frames.

The skin layup was $[0/45/90/-45]_{2S}$ tape with a single layer of 3 k fabric on each outer surface. The stringers had a layup of $[0/45/-45/90/45/-45/0]_S$ tape with the 0° direction oriented along the stringer main axis direction. The dimensions of the stringers, shear ties, and frames, and details of the connection to the skin are shown in Figure 2(a). The shear ties had a layup of $[45/0]_{3S}$ with 6 k woven plain weave fabric and were bolted to the skin using six 6.35 mm Hi-Lok HL19 PB8-5 alloy countersunk ‘shear head’ bolts and HL70-8 aluminum collars (see details in Figure 2). The frames were 6 k plain weave fabric composite of $[45/0]_{3S}$ layup having C-shaped cross-section of height 108 mm in the main bending axis direction and width 38.1 mm. Two additional 0° fabric plies were added to each frame flange to increase the overall bending rigidity. The frames were mechanically fastened to the shear ties via six 6.35 mm (shank diameter) Hi-Lok non-countersunk fasteners, as indicated in Figure 2(a). A gap of 6.35 mm existed between the stringer and frames. The close-up photo of the assembled structure in Figure 2(b) shows the details of the shear ties mechanically fastened to the skin and frames.

The dynamically-loaded test specimens are larger-sized and composed of an identical stringer-stiffened skin attached to frames via shear ties. The key difference is the length of the panel in the stringer direction, shown in Figure 5 to be 2030 mm to accommodate the mounting of five frames (two more than Stage 1 panel). The length of the frames in the curved direction remained identical, and all other aspects including stringer and shear tie geometry, and fastened assembly are identical to the details, as shown in Figure 2.

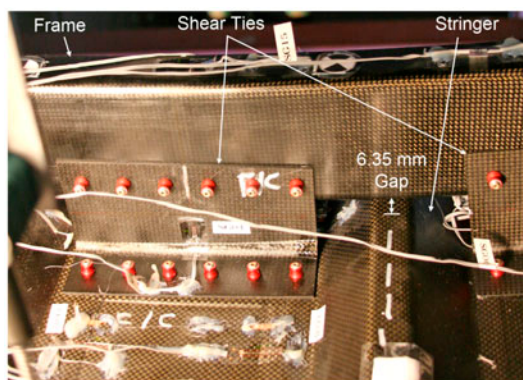
(b) View of assembled components

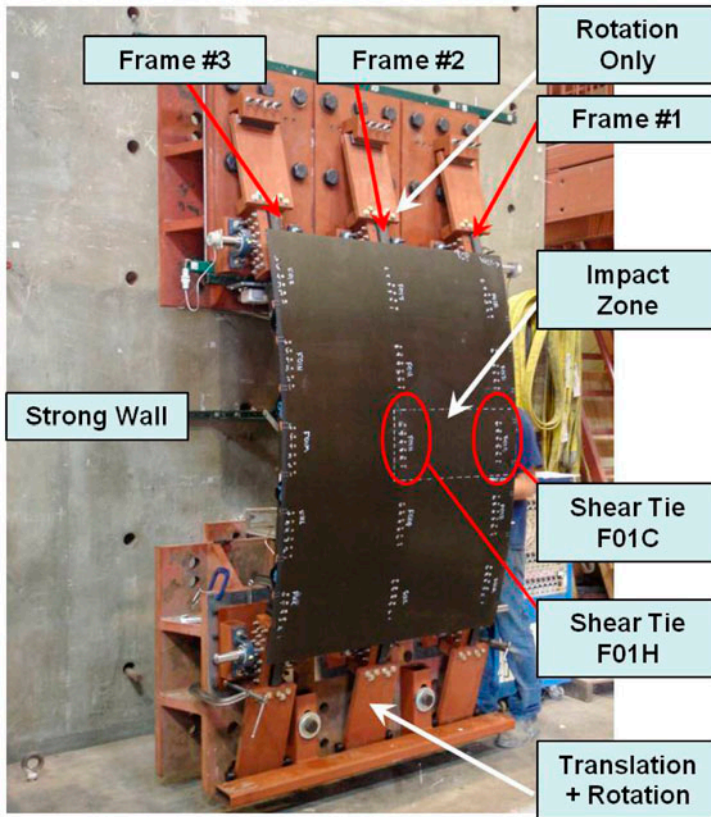
Figure 3. Quasi-static loading test set-up of specimen Frame01.

The specimen was tested in the Powell Structural Research Lab at UCSD using a single degree of freedom shake table base as the loading/actuator system. The specimen was secured to a strong wall (see Figure 3) via a bolted connection at the frame ends to the pivoting boundary condition fixtures shown in Figure 4(a). These fixtures provide controlled rotational stiffness of 445 MN/rad at each frame end via flexure plates. The lower set of frame ends had the same rotational stiffness, but was free to translate in the hoop direction (vertical in Figure 3) via rollers. The rotational stiffness at the frame ends was determined using a series of finite element analysis (FEA) models [17] comparing the behavior of a full aircraft barrel to the smaller panel test specimen, and adding rotational stiffness to the latter to achieve an equivalent response (matching stiffness, peak bending stress) as the full barrel. On the free edges of the panel where the stringers terminate, no boundary condition fixtures were applied. This decision was based on the results of the FEA models [17] showing approximately equivalent

Specimen Frame01 was quasi-statically indented directly on the skin between two stringers over the area indicated in Figures 2 and 3. The indenter was moved very slowly into the panel over four separate loading sessions. The measured force (normalized by number of frames) vs. skin displacement (measured directly by displacement pot) plotted in Figure 7 shows the panel lost overall stiffness with increasing level of damage. The occurrence of damage events were detected by listening for audible cracking sounds and by observation of drops in the measured load. At significant damage events, the actuator was stopped, the panel unloaded, and careful observations were made and photo-documented. As can be seen in Figure 7, each re-loading was found to intercept where the last loading ended, and thus the successive loading events are composited into one single loading event. The load axis was normalized by the number of frames (two frames) so as to compare the results with the dynamically-loaded specimen over which three frames were loaded.

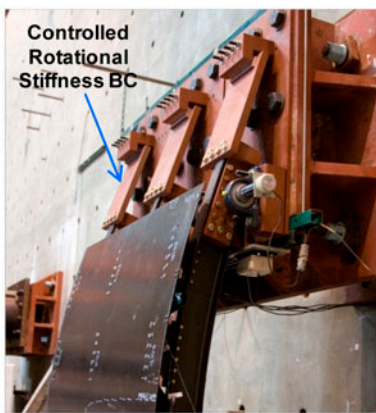
(a) Boundary condition detailed view

Figure 4. Quasi-static test boundary conditions and loading detail.

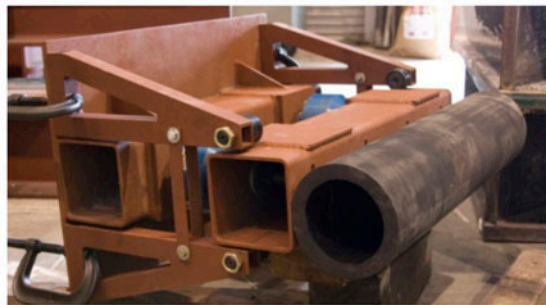
(b) Uncompressed cylindrical bumper

The specimen was quasi-statically loaded under displacement control using an original equipment manufacturer rubber cylindrical bumper mounted to the fixture shown in Figure 4(b) having two load cells. The bumper had 178 mm outer diameter \times 127 mm inner diameter \times 590 mm length and was mounted to a 152 \times 152 mm hollow steel box beam.

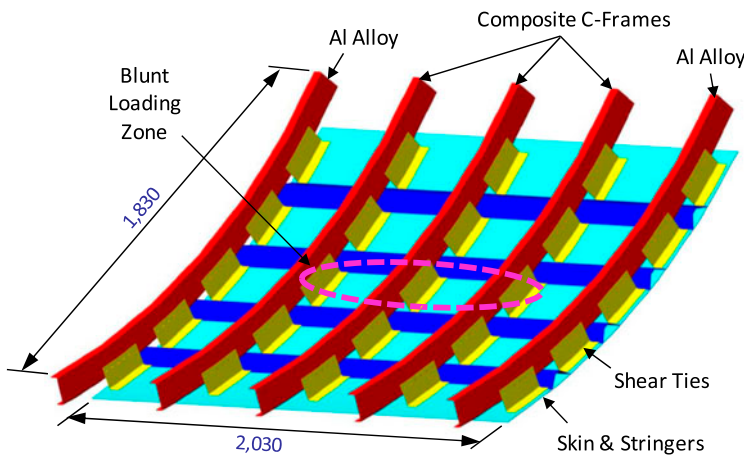
Figure 5. Stage 2 dynamic test specimen Frame03 with four stringers and five frames. Stringers, frames, and shear ties are identical to stage 1 specimen. All dimensions are in mm.

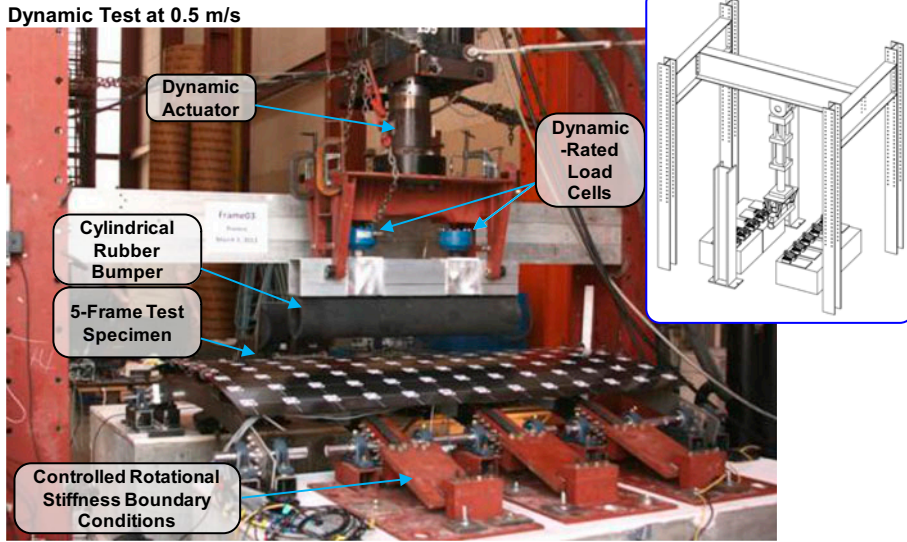
Figure 6. Stage 2 dynamic test set-up for specimen Frame03.

The dynamically-tested specimen reported on here is identified as Frame03 and is shown in Figure 6. The 1.0 m-long cylindrical rubber bumper (same 178 mm outer diameter \times 127 mm inner diameter as previous test) shown in the figure was centered over the middle three composite C-frames, as shown in Figure 6 which also gives an overview of the general test set-up. Boundary conditions, as visible in Figure 6, include rotating end supports for each frame end, with controlled rotational stiffness achieved via flexure plates for the middle three composite frames (same as shown in Figure 4(a)). The two outer frames, made of flat 6.35 mm thick Al 2024 alloy plate stock, were simply-supported at each end without any rotational stiffness constraint. Loading was applied under displacement control at a speed of 0.5 m/s by a dynamic servo-hydraulic

actuator, shown in Figure 6, onto which the 1.0 m long bumper was mounted. It is noted here that the 152×152 mm hollow box beam supporting the cylindrical rubber bumper was changed to aluminum alloy to reduce the mass of the indenter head components located between the load cells and test panel face.

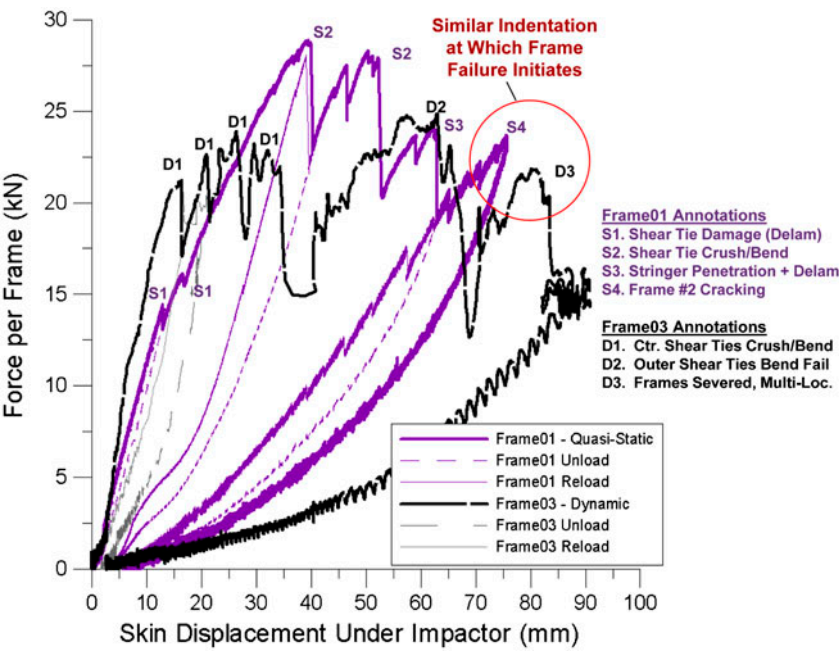
Figure 7. Force per frame comparison vs. skin displacement for quasi-static indentation (Frame01) and dynamic impact (Frame03) tests.

- Initial damage occurred at a load of 14.5 kN/frame, accompanied by a load drop of 0.55 kN/frame. This is indicated by the first event labeled S1 in Figure 7. No visible signs of damage was observed, however, and it was determined that the center shear tie (ID: F01H) on Frame #2 (see Figure 3 and damage location map in Figure 8) experienced delamination in the radius region near where the shear tie contacts the skin (see Figure 2 Shear Tie Detail where 7.7 mm inner radius is

- At loads above 20 kN/frame, both Frames #1 and #2 started to rotate (due to shear-center offset effect of an open C-shaped cross-section), thereby causing a reduction in overall stiffness. At 40.0 mm indentation (28.9 kN/frame), shear tie F01H completely fractured (first event S2 in Figure 7) and the center frame

- These directly-loaded shear ties, having been damaged first, allowed the stringers to make contact with Frames #1 and #2, creating a direct load path to the frames. Increasing rotation of the frames occurred at loading beyond 40 mm indentation, thereby reducing the overall bending stiffness. At 53.3 mm indentation (27.8 kN/frame), complete full-width fracture of shear tie F01C (second event S2 in Figure 7 and mapped in Figure 8) occurred with an accompanying load drop of 7.6 kN/frame.

- Frame #2 next penetrated into the upper stringer (located above the loading area) as a result of high-contact stresses and the accompanying interlaminar shear and bending stresses developing at these stringer-frame contact points. This event, labeled S3 in Figure 7, occurred at 62.2 mm indentation (22.2 kN/frame, with a load drop of 0.7 kN/frame), resulting in a full severing of the stringer, as shown in Figure 9(a). The location of this damage is mapped by the label S3 in Figure 8. The stringer cracking quickly propagated through the stringer walls to the flange, then transitioning into large delamination growth of the top stringer flange as it was separated from the skin (see upper portion of Figure 9(a)), resulting in a load drop of 4.7 kN/frame.

- Finally, cracking in Frame #2 occurred, indicated as event S4 in Figure 7, where the stringer contacted the frame below the indenter (see Figure 9(b) and location S4 in Figure 8). The test was stopped at an indentation of 70.6 mm (23.7 kN/frame) in order to prevent damage to Frame #3, which was reused in the construction of a subsequent panel specimen. It is hypothesized that if loading had continued, further damage to Frame #2 or to the lower stringer would have occurred. The resulting ~38 mm length crack in the frame web, shown in Figure 9(b), was visible from both sides of the frame, thereby indicating that it existed through the web thickness.

A comparison of the quasi-static indentation and dynamic impact (Frame01 vs. Frame03) responses can now be made via the plots in Figure 7. It should be noted that

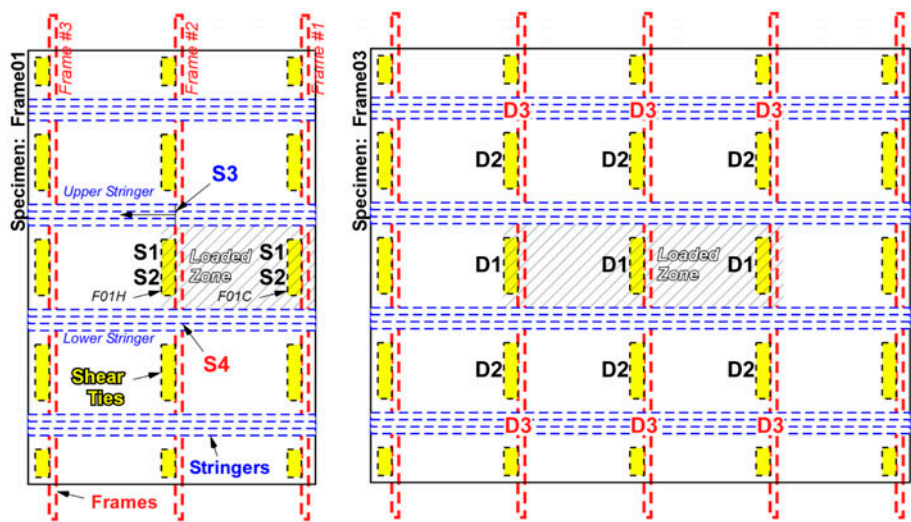
Figure 8. Failure locations map on specimens Frame01 (left) and Frame03 (right) viewed from exterior side.

rebounded (less rotation of the frame), followed by a load drop of 5.6 kN/frame. This damage location is shown in Figure 8, and a photograph of the failed shear tie is shown in Figure 9(a). Also, partial fracture damage occurred in shear tie F01C (see Figure 8, not visible in the Figure 9(a)) which is attached to Frame #1.

- Final failure occurred at 83 mm skin displacement in the C-frames, fracturing near the boundary fixture joints under a combination of torsion, bending, and shear (see image 4 of Figure 12 – note failure locations are not within field of view). This is classified as a non-local failure since the failure locations were relatively far away from the impact contact region (see locations D3 in Figure 8).

The final internal damage state is shown in Figures 13 and 14. All three frames fractured at location D3 in Figure 8, and all nine shear ties (three per frame) were fractured as depicted in these figures. A view of the outside surface of the specimen after impact is shown in Figure 15. No obvious damage was visible (i.e. no surface cracks), and the permanent dent-deformation was measured to be only 4.5 mm (relaxed state measured over 24 h following test). The visual detectability of a 4.5 mm indentation existing over a ‘dent span’ of ~1 m has been found to be very difficult to perceive by visual observation.

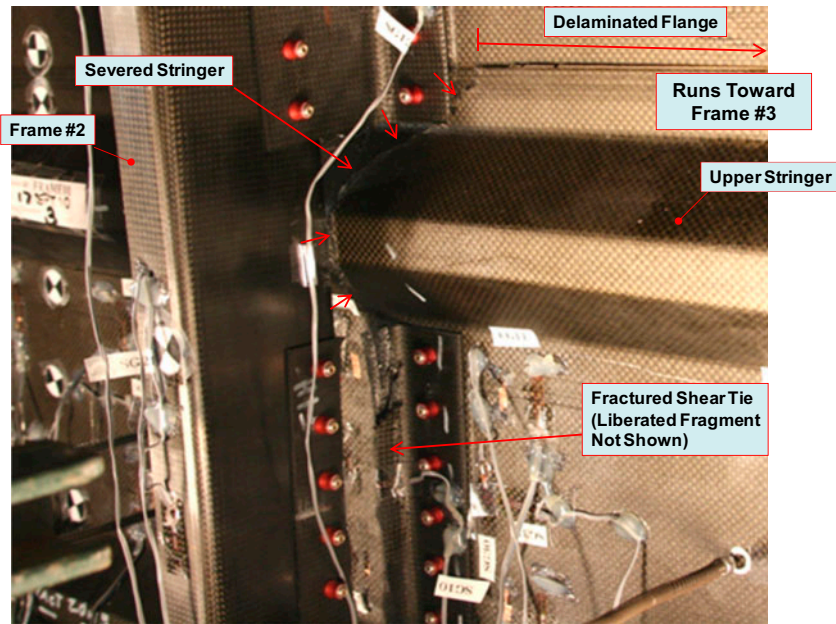
(a) Fractured shear tie, severed stringer, and delaminated stringer flange

Figure 9. Quasi-static specimen Frame01 component failure interior view.

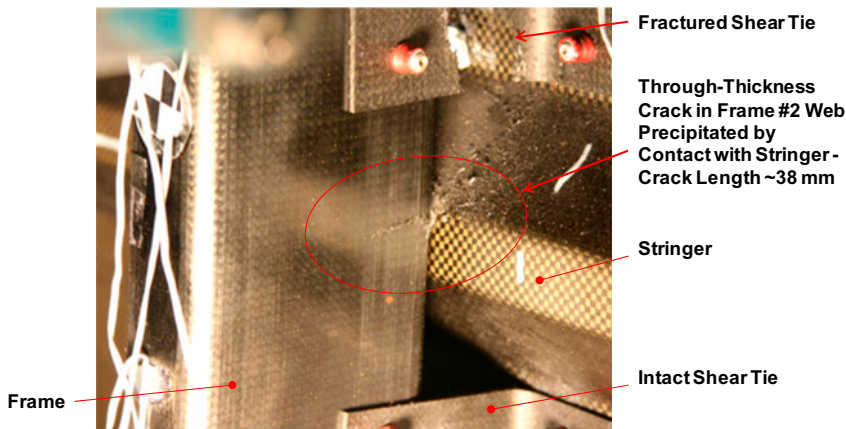
(b) Cracking of middle frame at stringer contact location

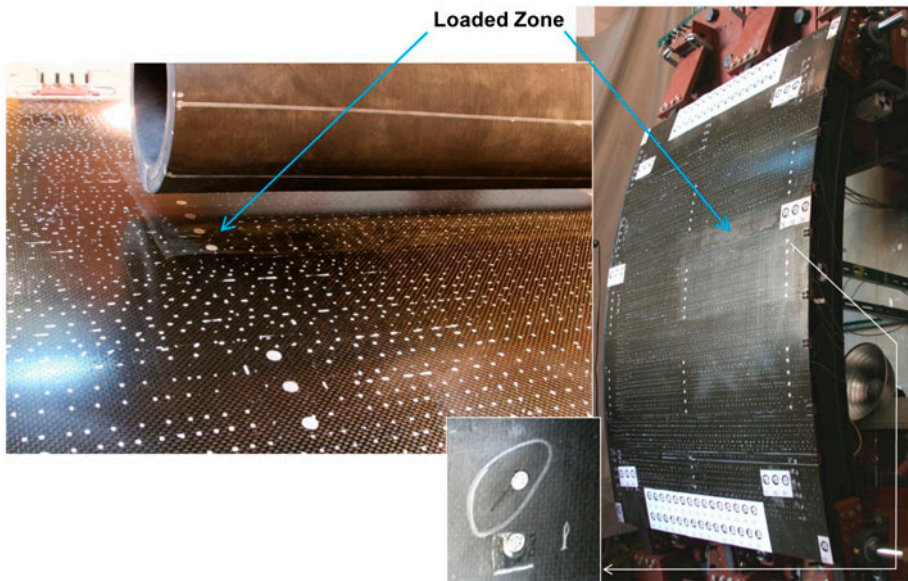
Figure 10. Quasi-static specimen Frame01 exterior view of test panel after loading showing no visual indications of internal damage.

Despite the development of significant internal damage, no clearly-visible exterior damage to the panel occurred, as shown in Figure 10, except for a small surface crack in the skin originating from the bolt hole of a shear tie connecting to Frame #1 near the loaded free edge (see figure inset). The permanent residual indentation of the skin was measured to be 19 mm at the loading location. This level of deformation existing over a 1.8 m span requires careful observation to detect.

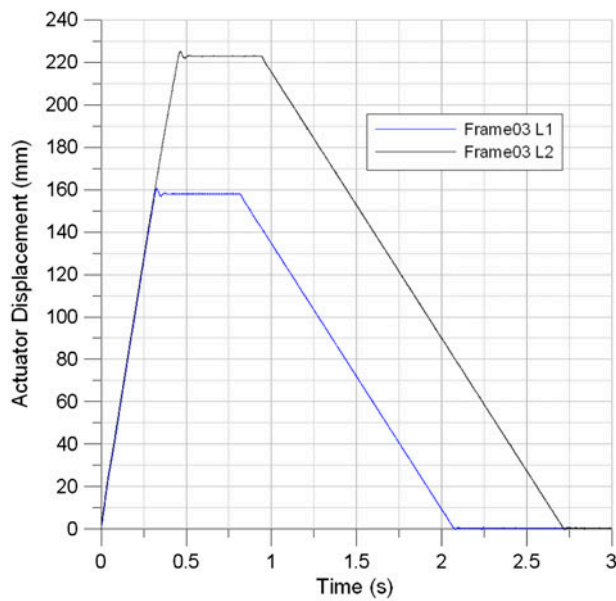
Figure 11. Dynamic specimen Frame03 displacement controlled loading histories.

Dynamic loading was applied by a fast servohydraulic actuator onto which the 1.0 m long bumper was mounted. The specimen was loaded two times under displacement control, referred to as L1 and L2, with the actuator stroke history shown in Figure 11. Each loading was applied at a constant velocity of 0.5 m/s, followed by a 0.5 s pause before unload. This 0.5 m/s impactor speed was based on observations at LAX airport of GSE operating in very close proximity to aircraft, e.g. while docking with them.

- During the second Loading L2, the total actuator stroke was 222 mm as shown in Figure 11. The initial portion of the re-loading was observed to intercept where the previous loading L1 stopped, which is visible in Figure 7. Figure 12 shows a sequence of high-speed video still captures that gives insight into the failure process, as viewed from beneath the specimen. Upon initial complete crushing of the middle three directly-loaded shear ties (see image 1 of Figure 12 corresponding to events D1 indicated in Figure 7), the load dropped significantly at a skin displacement of 35 mm due to the momentary gap in load path left by the broken shear ties.

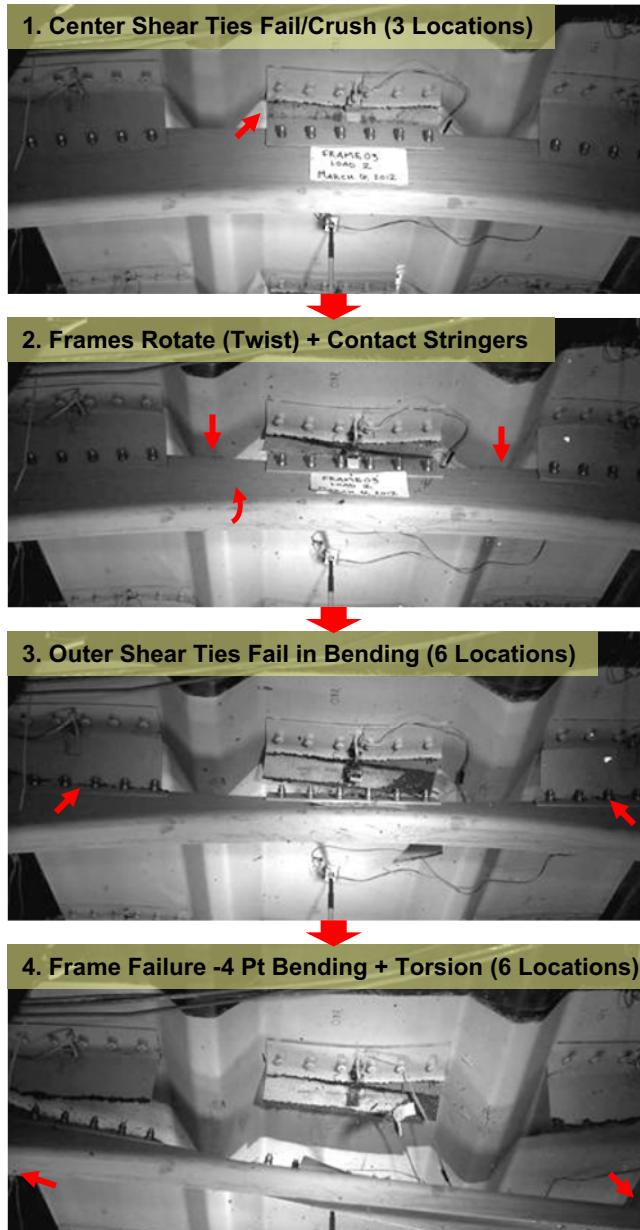
Figure 12. Dynamic specimen Frame03 high speed video stills showing failure progression.

- This gap was closed when the stringers made direct contact with the C-frames (see image 2 of Figure 12), thereby allowing the increasing load-up observed between 40 and 60 mm in Figure 7. High contact forces existed during this stringer-frame contact, which is confirmed by the scraping marks left on the stringers by the C-frames. As the impactor displacement increased, the C-frames rotated further, scraping along the stringer, leading to failure of the outer set of six shear ties (see image 3 of Figure 12 corresponding to locations D2 in Figure 8). The resulting major load drop at 63 mm (see event D2 in Figure 7) occurred due to the frames being able to freely rotate even further (see image 3 in Figure 12).

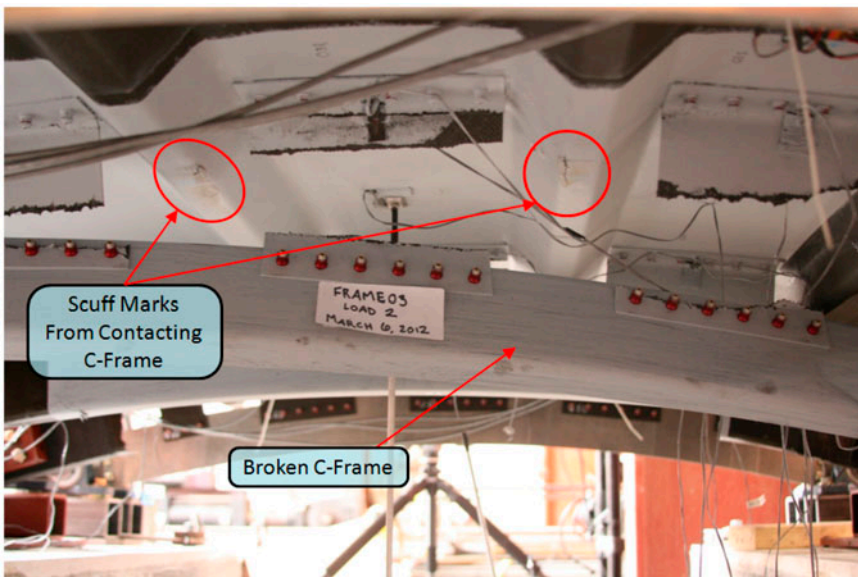
Figure 13. Dynamic specimen Frame03 shear tie damage.

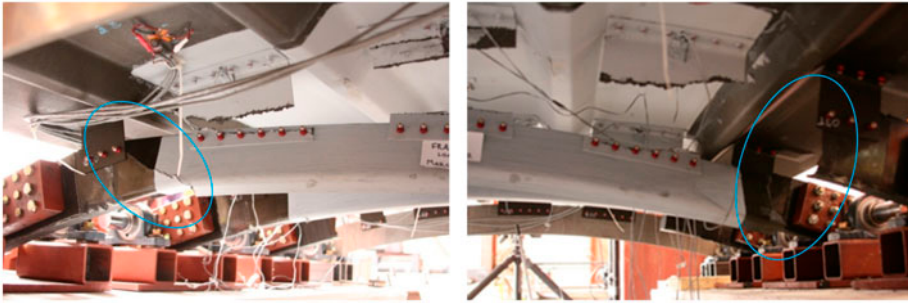
Figure 14. Dynamic specimen Frame03 fracture of frames near boundary supports.

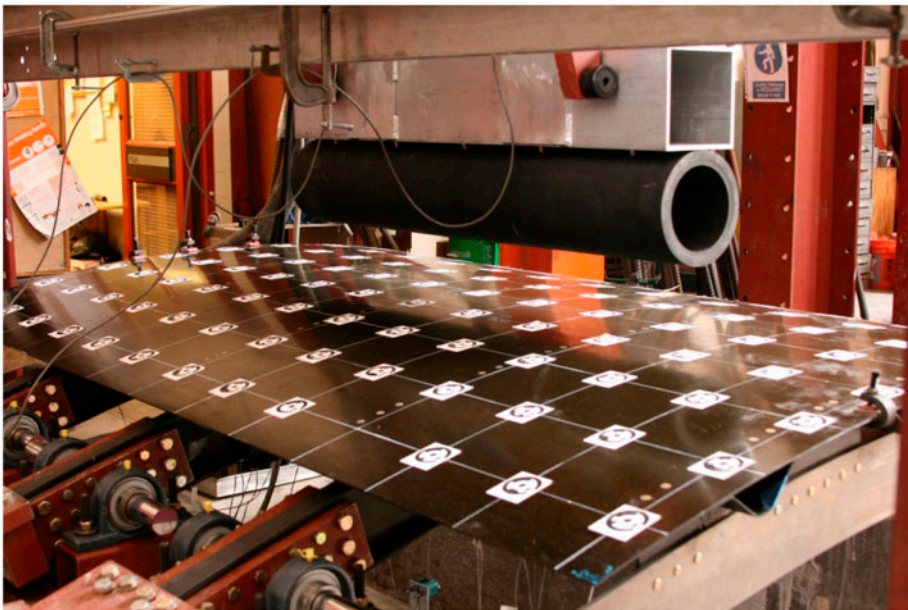
Figure 15. Dynamic specimen Frame03 exterior view after loading L2.

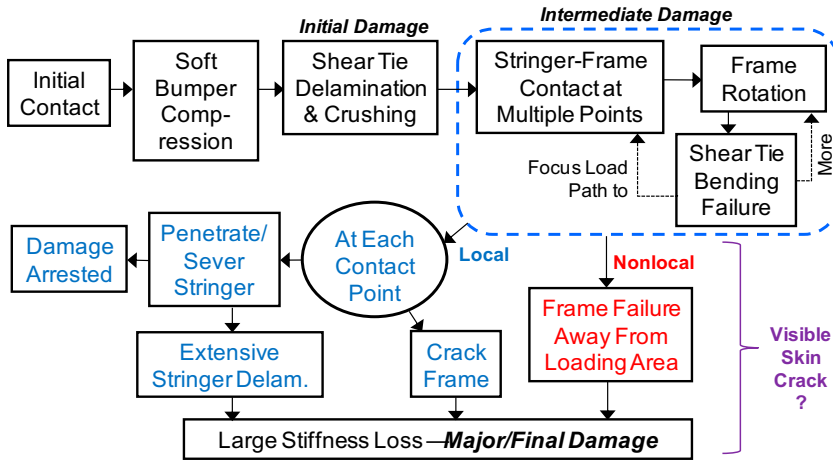
Figure 16. Damage progression process for wide area blunt contact indentation of stringer-frame stiffened composite panels.

The generalized blunt impact damage progression process for stringer + frame stiffened composite panels, based on the observations of these tests, is summarized by the flow chart in Figure 16. A key event is the onset of initial damage to the structural components that are in the direct loading path of the impactor. In the case of the specimens reported on herein, those shear ties directly opposite of the impact contact location completely failed, which then allowed for the stringers and frames to contact each other at multiple locations. These contact points serve as multiple direct loading paths from the impactor to the stiff frame substructure. Intermediate damage includes widespread failure of the shear ties, brought on in large part by the rotation of the frames during increasing loading/indentation. Major, or final, damage modes are those that

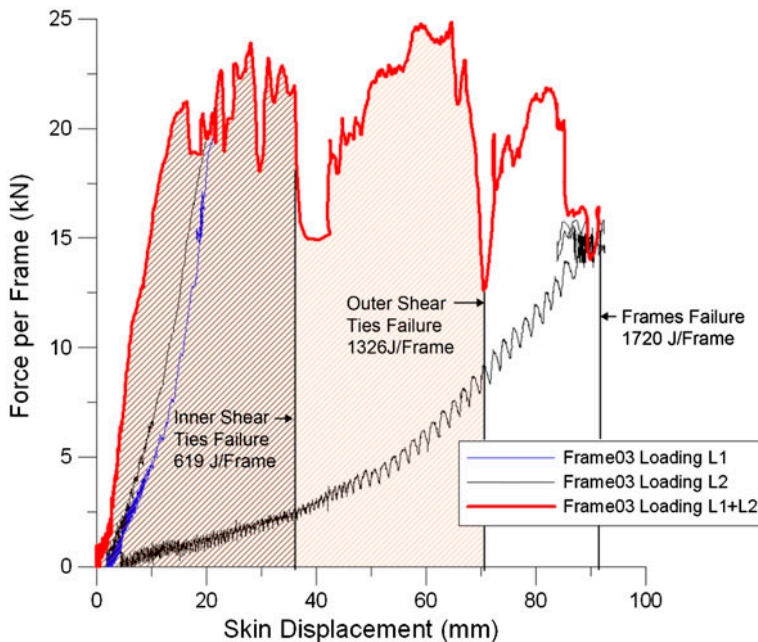
Figure 17. Energy absorption in specimen Frame03.

The relationship between these experimental results and actual in-service GSE impact events can be gauged by considering the energy absorbed under the load vs. displacement curves, as shown in Figure 17 for the specimen Frame03. The severity of damage and accompanying damage modes require the incoming GSE to have a certain amount of kinetic energy to (approximately) balance with. From the Frame03 test results, to achieve failure of the inner three shear ties, 1857 J (619 J/frame) of energy would be required, while 5160 J (1720 J/frame) is needed to fracture the frames. As an example, consider a 10,000 kg cargo loader incoming at 0.89 m/s (2 miles/h) has 3961 J of kinetic energy. This equipment rolling into a structure similar to Frame03 and contacting across three frames (1320 J/frame) would result in all the three immediate and six surrounding shear ties (nine total) to be broken. While specific to
