## Damage growth behavior and interlaminar fracture resistance of CFRP laminates under shear fracture mode

Hiroshi Suemasu<sup>a\*</sup> and Yusuke Tanikado<sup>b</sup>

<sup>a</sup>*Faculty of Science and Engineering, Sophia University, Tokyo, Japan;* <sup>b</sup>*Toray Corporation, Otsu, Shiga, Japan*

Interfacial failure problem of composite laminates was experimentally studied to know the dependence of interlaminar fracture resistance on various conditions as well as conditions of migration of the delamination into lamina to understand three-dimensional complex damage growths. A test method was proposed to realize a stable damage growth without influence of free edge under varying shear fracture mode in laminated composites. We could numerically evaluate critical energy release rate (ERR) for the delamination growth using a finite element method based on the measured shapes of the delamination and the applied load. Not only total ERR but also the ERR components in two directions parallel and normal to the fiber were calculated. The two components of the energy release were more appropriate to discuss the damage growth problem than the mode II and III components. When the norma

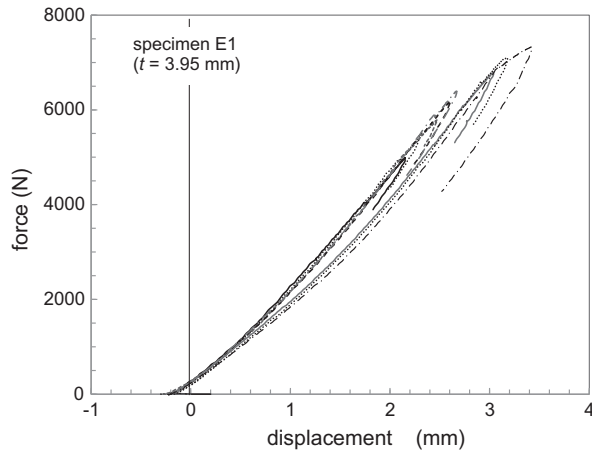
Figure 3. Relationship between load and center displacement. The loading and unloading was repeated several times with increasing the maximum load.

Figure 3 shows a relation between the applied load and cross-head displacement. The loading was suspended and repeated eight times. At each trial, the final load was increased by some amount to make the delamination grow. Hardening non-linearity was found due to Herzian contact at early stage of loading and due to finite deflection of the plate at high load region. Slight stiffness reduction caused by the damage growth was observed at the large load area, but no sudden drop of the load occurred during the testing, that is, no unstable damage growth occurred. The stiffness must reduce some amount at each trial since the delaminated area increased at each trial. At each step, C-scan images were taken from both sides. The shapes of the damage was carefully measured so as to get accurate energy release rate (ERR), since the ERR was calculated based on the measured shape of the delamination using a finite element analysis as explained in the next section.

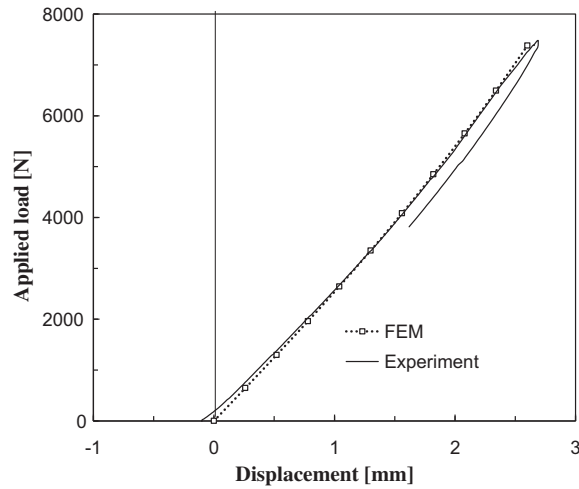
Figure 6. Comparison between the test and the numerical results.

The load–displacement relationship of the present finite element analysis agreed well with the experiment as shown in Figure 6 when the effect of Herizian contact (initial nonlinearity) was eliminated from the experimental result.

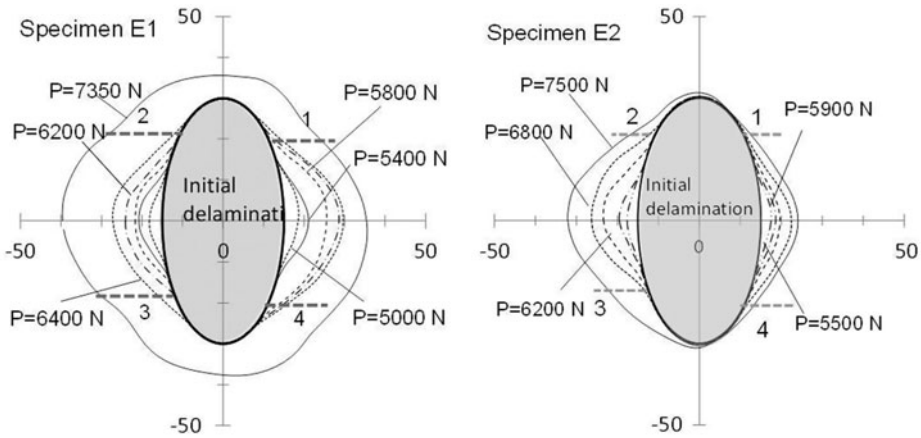
Figure 9. Measured damage growth profiles of specimens E1 and E2. The horizontal gray broken lines 1–4 indicate the position where the matrix cracks started.

Ultrasonic images of specimens E1 and E3 at several load levels are shown in Figures 7 and 8. The gray-colored portions are the delaminated areas. The delaminations grew with the load increase. The measured shapes of delamination fronts of the specimens E1 and E2 are indicated in Figure 9. The damage growth history is illustrated in Figure 10. The delamination edge initially spread from the center portions of the ellipse and propagated only in the horizontal direction at the interface (0/0) as shown in Figure 10(a). The propagated shapes might not be symmetric owing to the probabilistic nature of the interlaminar fracture resistance. As the delamination simply propagated, a critical ERR can be specified at this stage.

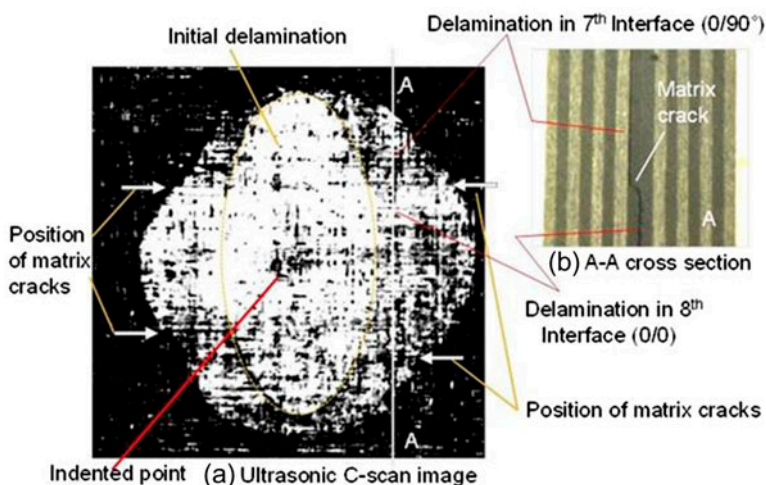
Figure 13. An ultrasonic C-scan image of E2 specimen and the photograph of a cross-section.

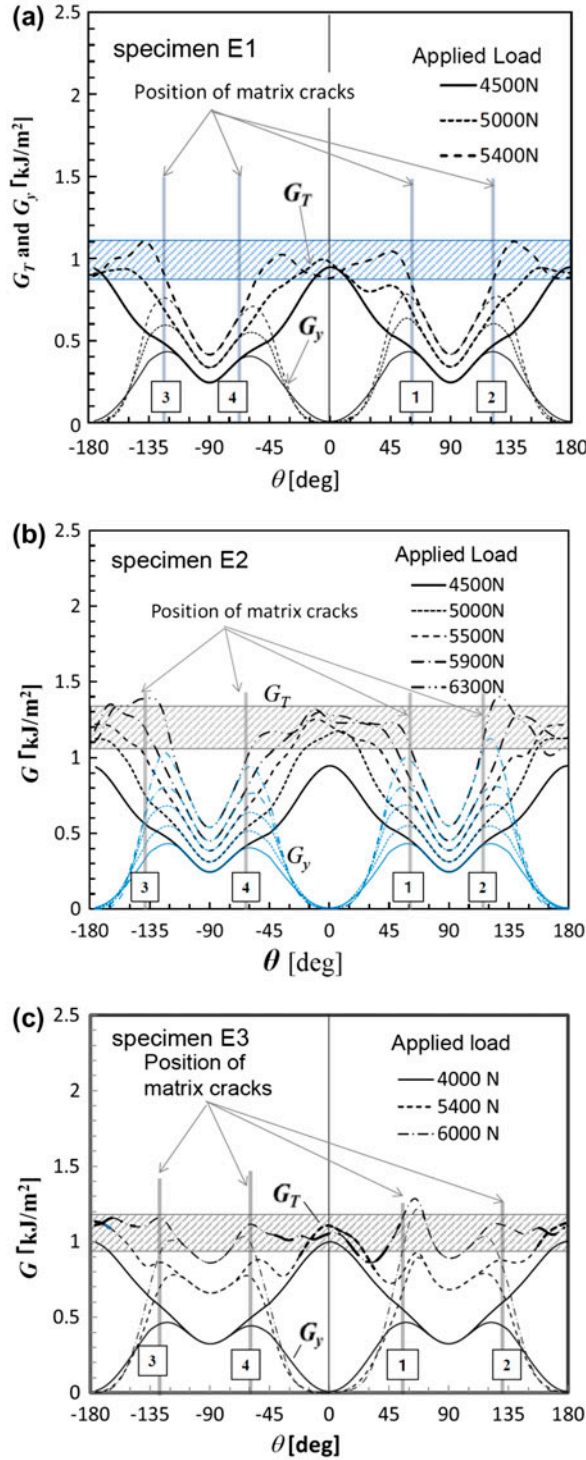
Figure 15. Total ERR  $G_T$  and its vertical component  $G_y$  for specimens E1, E2, and E3. The vertical lines numbered 1–4 indicate the positions from which the transverse matrix cracks originated.

The fracture resistance obtained in the stage 1 and 2 is discussed first, when no clear matrix crack was observed and delamination propagated transversely only in the  $0/0^\circ$  interface. Distributions of  $G_T$  and  $G_y$  are plotted against the angle  $\theta$  measured from rightward horizontal axis in Figure 15 for specimens E1, E2, and E3. As  $G_I$  was negligibly small,  $G_x \approx G_T - G_y$ . The  $x$ - and  $y$ -directions were the fiber direction of the  $0^\circ$  and  $90^\circ$  layers, respectively. Specimen E3 had a smaller embedded delamination. The plots of  $P = 4500$  N for E1 and E2, and  $P = 4000$  N for E3 are the ERR distributions before damage growth. The ERR values at these instants were lower than the interfacial fracture resistance of the specimens. The ERR values of the propagating delamination front must be the fracture resistance of the interface. The ERR values at the propagating delamination were relatively stable and ranged from  $0.9$  to  $1.1$  kJ/m<sup>2</sup> for specimen E1,

The component  $G_y$  was large in the directions of the matrix crack-origination point for all specimens at stage 1 as shown in Figure 15. So, the matrix crack origination is strongly governed by the ERR component  $G_y$  normal to the fiber direction. Once the delamination started migrating into the ply, delamination growth was arrested and  $G_T$  became very large. The condition of matrix crack initiation, that is, the migration is roughly  $G_{yer} \sim 1.0 \text{ kJ/m}^2$  from Figures 16 and 17. The initiation condition of new delamination growth in vertical direction in  $0/90^\circ$  interface from the edge of the matrix cracks is  $G_{Ter} > 1.5 \text{ kJ/m}^2$  from the figures. The farther growth of delamination in  $0/90^\circ$  interface may be controlled by  $G_T$ . The component  $G_x$  normal to the fiber direction must be small so that another migration would not occur in the  $90^\circ$  layer.

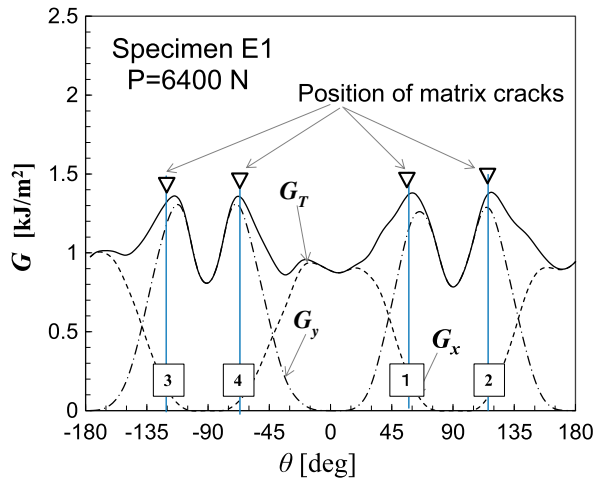
Figure 16. Total ERR  $G_T$  and its  $x$  and  $y$  components  $G_x$  and  $G_y$  of specimen E1 when  $P=6400$  N. The gray vertical lines with a number indicate the positions of the matrix cracks in  $0^\circ$  layers.

The total ERR  $G_T$  and two ERR components  $G_x$  and  $G_y$  of the specimen E1 at  $P = 6400$  N are plotted against the angle  $\theta$  in Figure 16. Matrix cracks originated at four positions of initial elliptic delamination as explained in Section 4.1. The four originating locations of the matrix cracks are indicated by triangular symbols and gray vertical lines. The ERR, that is, the fracture resistance became very high at these portions. It was thought to be caused by migrations of the delamination into lamina. So, it may be called the anchoring effect of the migrated crack. The ERR value of the propagating delamination between the

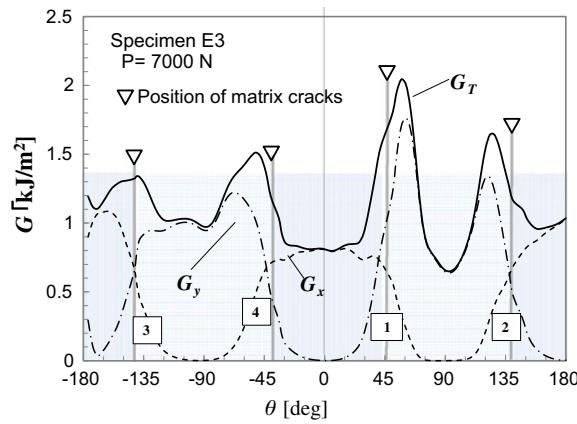
Figure 18. Total ERR  $G_T$  and its two components  $G_x$  and  $G_y$  of specimen E3 at  $P = 7000$  N (whole delamination edges were propagating). The delamination propagates in  $0/0^\circ$  interface in stripe shade areas and the delamination grows in  $0/90^\circ$  interface in check shade areas. The marks indicate the positions of the matrix crack tips in the  $0^\circ$  layer.

The total ERR  $G_T$  and two ERR components  $G_x$  and  $G_y$  of specimen E1 at  $P=7350$  N and specimen E3 at  $P=7000$  N are plotted in Figures 17 and 18 when the whole edge of damage was growing in radial direction. The peak ERR values of specimen E3 were larger than those of E1, but both results showed similar distributions and values except the peak values. The delaminations grew at the portions indicated by striped shadow in the 0/0 interface as well as the portions indicated by crossed shadow in the 0/90° interface one layer below. Vertical gray lines indicate the locations of the matrix crack tips at this moment. The fracture resistance was very high at the delamination edges of the 0/90° interface besides the matrix cracks. Fracture resistance of simple delamination propagation is discussed first. The value  $G_T$  was comparatively consistent comparing to the data variation of ENF tests.  $G_x$  was dominant at the delaminations in 0/0 interface, while  $G_y$  was dominant at those in 0/90° interface. The fracture resistances of delamination growth in 0/0 interface and in the 0/90° were about 0.85 and 1.0 kJ/m<sup>2</sup> for specimens E1 and E2. (Very small value obtained at the 90° direction in Figure 18 might be caused by the measured error of the delamination profile, which had very high EER value beside this point.) ERR of 0/90° interface seemed to be a little higher than that of 0/0 interface. But the difference is considerably small compared to the variation of fracture resistance. This fact is consistent with the ENF test result shown in Table 1. SEM micrographs of the failed surfaces of 0/0° and 0/90° interfaces are shown in Figure 19. The failed surface of 0/0 interface was smooth where the propagation was parallel to the fiber (A) and some inclined damage pattern was observed where the radial direction was inclined from the fiber (B). Most of the failed surface of 0/90° interface had the pattern of 90° layer (C) and (D). It showed that the delamination propagated in the fiber direction of the 90° layer near the 90° layer. There was also an inclined damage pattern in the 0/90° interface when radial direction inclined from the vertical fiber direction.

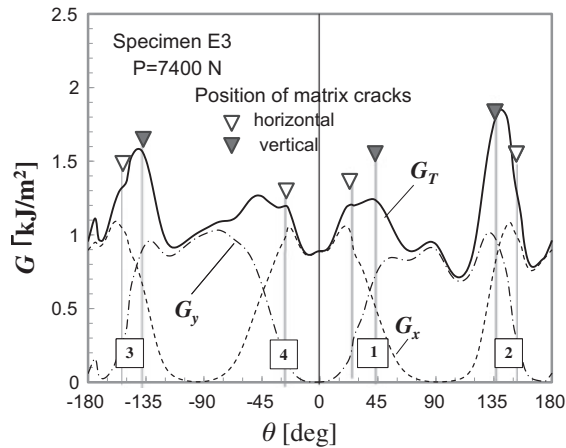
Figure 20. Total ERR  $G_T$  and the two components  $G_x$  and  $G_y$  of specimen E3 when whole delamination edges were propagating. The marks  $\nabla$  and  $\blacktriangledown$  indicate the positions of the propagated matrix cracks in  $0^\circ$  and  $90^\circ$  layers, respectively.

The total ERR  $G_T$  and two ERR components  $G_x$  and  $G_y$  of specimen E3 at  $P=7400$  N are plotted in Figure 20. The ERR at the edge of horizontal matrix crack reduced with the damage growth. The ERR increased at the edge of the newly grown vertical matrix cracks. At this points, the delamination in the  $0/90^\circ$  interface started to migrate into the  $0^\circ$  layer below.
