Bioinspired self-healing of advanced composite structures using hollow glass fibres

R. S. Trask, G. J. Williams and I. P. Bond*

Department of Aerospace Engineering, University of Bristol, Queen's Building, University Walk, Bristol BS8 1TR, UK

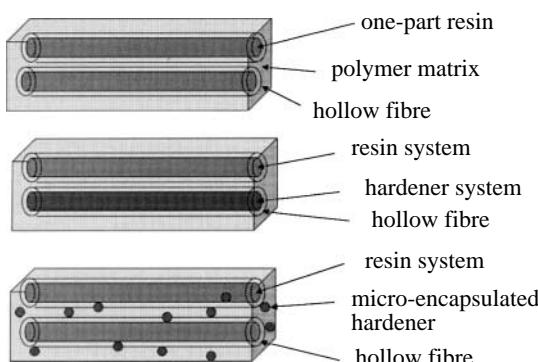
Figure 1. Schematic of different hollow fibre self-healing approaches (Bleay *et al.* 2001).

Hollow glass fibres (HGFs; Hucker *et al.* 1999, 2002) are used in preference to embedded microcapsules (Brown *et al.* 2003; Rule *et al.* 2005) because they offer the advantage of being able to store functional agents for self-repair as well as integrating easily with and acting as a reinforcement. A typical hollow fibre self-healing approach used within composite laminates could take the form of fibres containing a one-part resin system, a two-part resin and hardener system, or a resin system with a catalyst or hardener contained within the matrix material (Bleay *et al.* 2001). A schematic of these approaches is shown in figure 1.

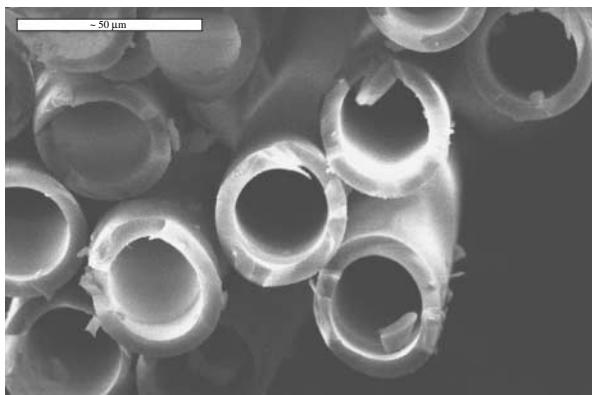
Figure 2. Typical hollow glass fibre (35 μm external diameter with 55% hollowness fraction).

A bespoke HGF making facility (Hucker *et al.* 1999, 2002) has been used to produce HGF between 30 and 100 μm diameter with a hollowness of approximately 50%, figure 2. These are then embedded within either glass fibre-reinforced plastic (GFRP) or CFRP and infused with uncured resin to impart a self-healing functionality to the laminate. During a damage event, some of these hollow fibres will fracture, thus initiating the recovery of properties by 'healing' whereby a repair agent passes from within any broken hollow fibres to infiltrate the damage zone, and acts to ameliorate the critical effects of matrix cracking and delamination between plies and, most importantly, prevent further damage propagation. This release of repair agent mimics the bleeding mechanism in biological organisms (e.g. human thrombosis).

The HGF chosen for this study had an external diameter of $60 \pm 3 \mu\text{m}$ and an internal diameter of approximately 40 μm yielding a hollowness fraction (ratio of internal to external area) of approximately 55%. This larger fibre diameter (compared to figure 2) gives a greater volume for healing agent storage. Once manufactured, the individual fibres were consolidated within a 913 epoxy resin film (42 gsm) which was selected to match the baseline laminate material. The healing resin can then be infused into the individual filaments using a vacuum-assisted capillary action. Once the ends have been sealed (Bostik BondFlex 100HMA high modulus silicone sealant), the infused hollow fibre layers (which can now be considered as standard 'pre-preg' plies) are incorporated into a laminate stacking sequence as required, and processed according to the resin film manufacturer's guidelines.

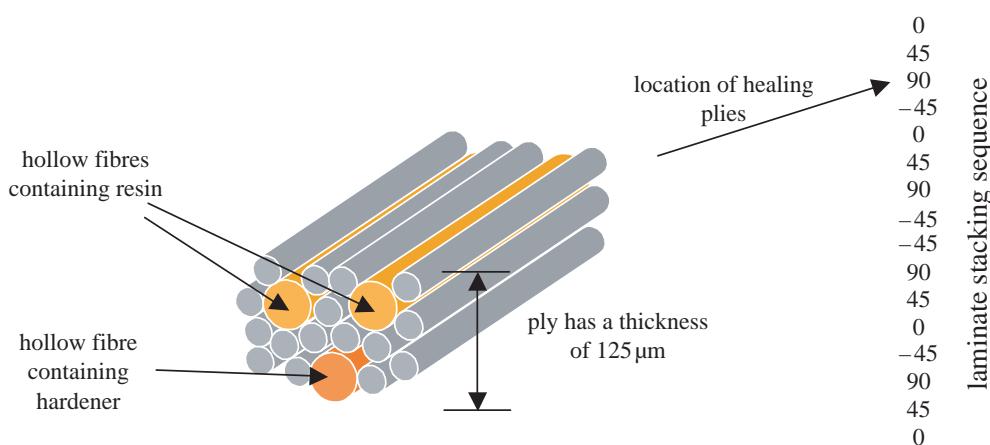
Figure 3. Location of resin and hardener self-healing filaments intermingled within an E-glass ply in the 16-ply stacking sequence of the composite laminate.

A 16-ply composite laminate with a $[0^\circ/+45^\circ/90^\circ/-45^\circ]_{2s}$ stacking sequence manufactured from pre-impregnated E-glass/913 epoxy resin (Hexcel composites) was selected for the first evaluation of the HGF self-healing approach. The self-healing filaments were introduced at four $0^\circ/45^\circ$ damage critical ply interfaces that were identified and reported previously (Trask & Bond 2006), as shown in figure 3. An epoxy resin system (CYTEC Cycom 823) was selected as the healing resin owing to the need to match the chemistry of the host laminate, its availability as a two-part system permitting inclusion in separate storage filaments, low-viscosity profile and time to gelation 30 min after mixing. Furthermore, it was observed experimentally that the individual components of the two-part Cycom 823 were sufficiently robust to survive the host laminate curing process (120°C for 1 h) after infiltration into the hollow filaments within the laminate stack.

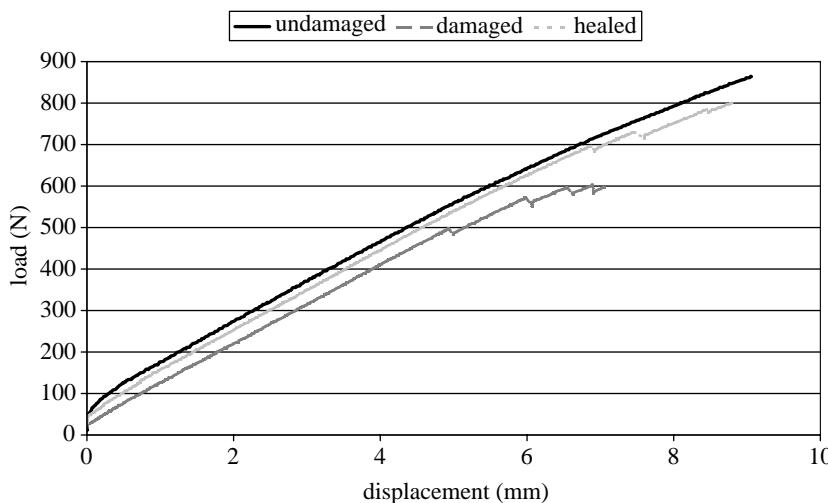
Figure 4. Comparative load–displacement curves under four-point bend for undamaged, damaged and healed for 70 μm spaced HGF.

Figure 4 shows typical load–displacement curves from the flexural testing. The relative placement of the undamaged, damaged and healed traces for 70 μm HGF spacing gives a clear representation of the effects of damage and healing events on the flexural performance for CFRP with embedded HGF.

Figure 4 shows that a damaged specimen containing HGF under load experiences a number of intermittent decreases in load as failure is approached. This is probably attributable to the propagation of matrix cracks and delaminations up to a critical level at which they affect the load-bearing performance of the

laminate. Conversely, the healed specimen appears to suppress these damage sites, inhibiting crack propagation and thereby delaying the failure of the laminate to higher load levels. Figure 4 also highlights the effectiveness of self-healing as the load–displacement curve for the healed laminate lies close to the undamaged curve.

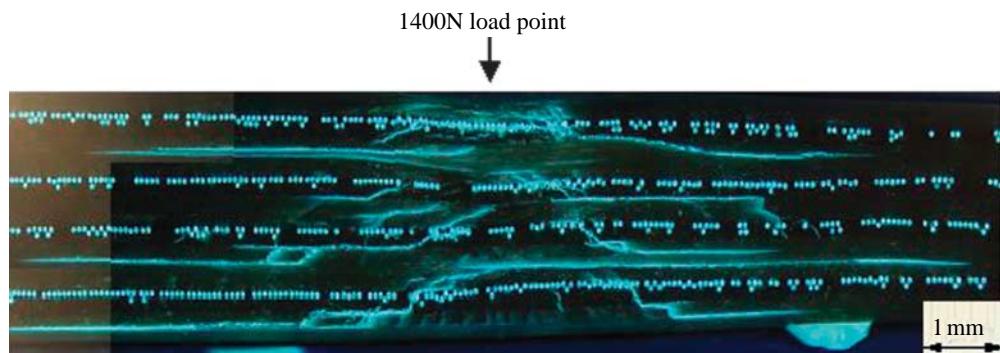
Figure 5. Impact damaged cross-section of $[0^\circ/ +45^\circ/90^\circ/ -45^\circ]_{2s}$ GFRP laminate containing healing filaments at the $+45^\circ/90^\circ$ and $-45^\circ/90^\circ$ interfaces.

A damaged and healed GFRP specimen was examined to determine whether healing resin had infiltrated the damage zone. A cross-section of the healed damage illuminated under UV light is shown in figure 5, which clearly illustrates the extent of the infiltration by the healing resin into the damage zone when viewed along the 0° fibre direction. This result suggests that the four self-healing layer locations were ideally placed within the complex damage network to fully infuse the damage site. To understand the mechanism involved in the self-healing of the damage zone, further microscopic examinations were undertaken. This examination indicated the occurrence of crushed hollow fibres under the impact zone (figure 6a,b) and healing resin bridging fracture surfaces (figure 6c,d).

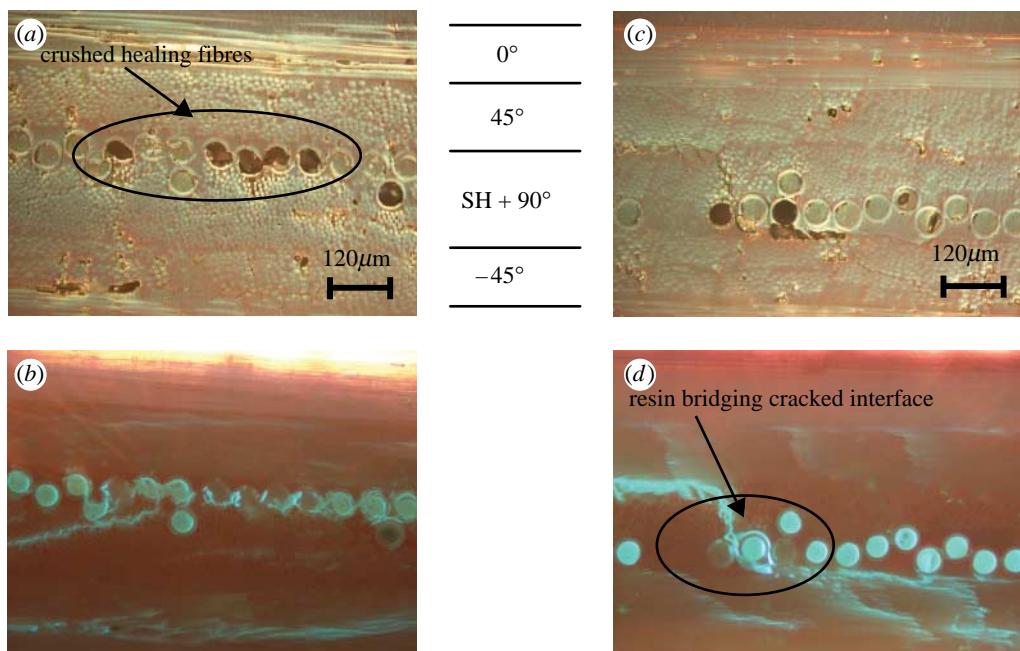
Figure 6. Crushed-healing fibres located under the impact site viewed under (a) normal and (b) UV illumination. Healing resin bridging cracked interface viewed under (c) normal and (d) UV illumination.

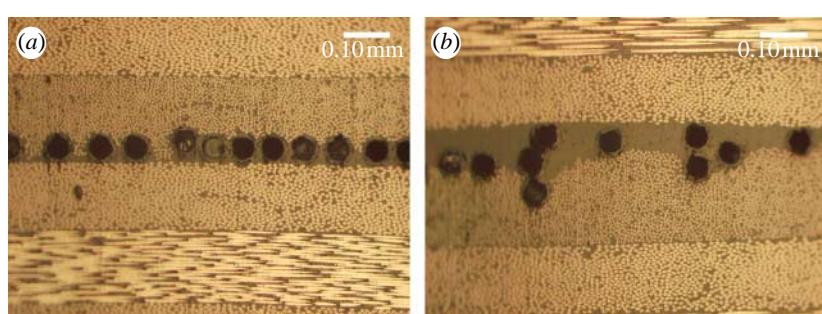
Figure 7. HGF spaced at $70\ \mu\text{m}$ showing (a) good embedment and (b) fibre clumping within host laminate.

Analysis of table 2 shows that the 70 μm fibre spacing resulted in the largest reduction in undamaged strength (8%). This can be attributed to a significant disruption in fibre architecture (figure 7). However, after a quasi-static impact at 2000 N peak load, this configuration exhibited a significant amount of damage tolerance compared with the 200 μm fibre spacing and control laminates. The large volume fraction of HGF also provides a considerable reservoir of healing agent as shown by a 97% recovery of undamaged strength (equivalent to 89% of the undamaged strength of the control laminate).

A fibre spacing of 70 μm (figure 7) highlighted several issues about the resulting quality of embedding HGF within a laminate. This small pitch spacing was selected to ensure that the HGF were in close proximity and thereby facilitate a high degree of healing efficiency. However, during preparation, HGF could be mislocated resulting in disruption to the host ply (figure 7b). This was attributed to fluctuations in the fibre pitch control at low HGF spacing combined with poor tackiness of the 914 epoxy resin at ambient temperature. This was seen to result in lengths of HGF detaching from and reattaching to the surface producing fibre clumping and resin-rich regions post-cure.

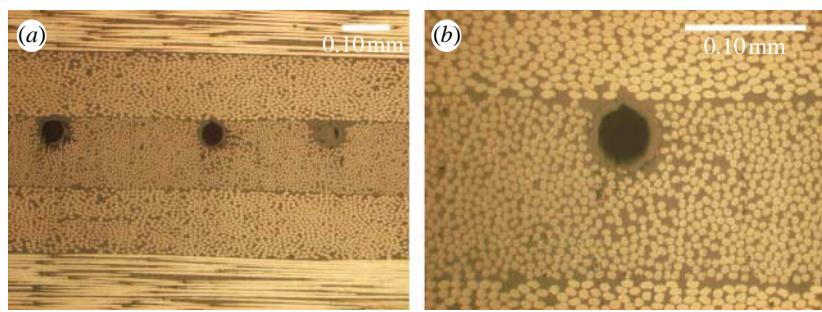
Figure 8. HGF spaced at $200\ \mu\text{m}$ showing (a) consistent spacing and (b) excellent embedment within host laminate.

The 200 μm HGF spacing specimens exhibit little reduction in undamaged strength (2%) attributable to the reduced disruption to the host laminate (figure 8). These specimens behaved similarly to the control laminate when damaged, presumably due to the limited amount of HGF available for crushing. However, healed samples achieved 82% of their undamaged strength (equivalent to 80% of the undamaged strength of the control laminate), despite the significantly lower volume of available healing resin.

A fibre spacing of 200 μm resulted in a much higher integrity laminate (figure 8). The resin-rich regions surrounding the HGF are minimized and there was no evidence of fibre clumping. The large spacing between fibres allowed the low tackiness of the 914 resin system to hold them in place, any that did detach were able to reattach without interfering with neighbouring fibres. The large spacing between the HGF permitted excellent consolidation during cure, further improving overall HGF embedment and reducing disruption to the laminate.

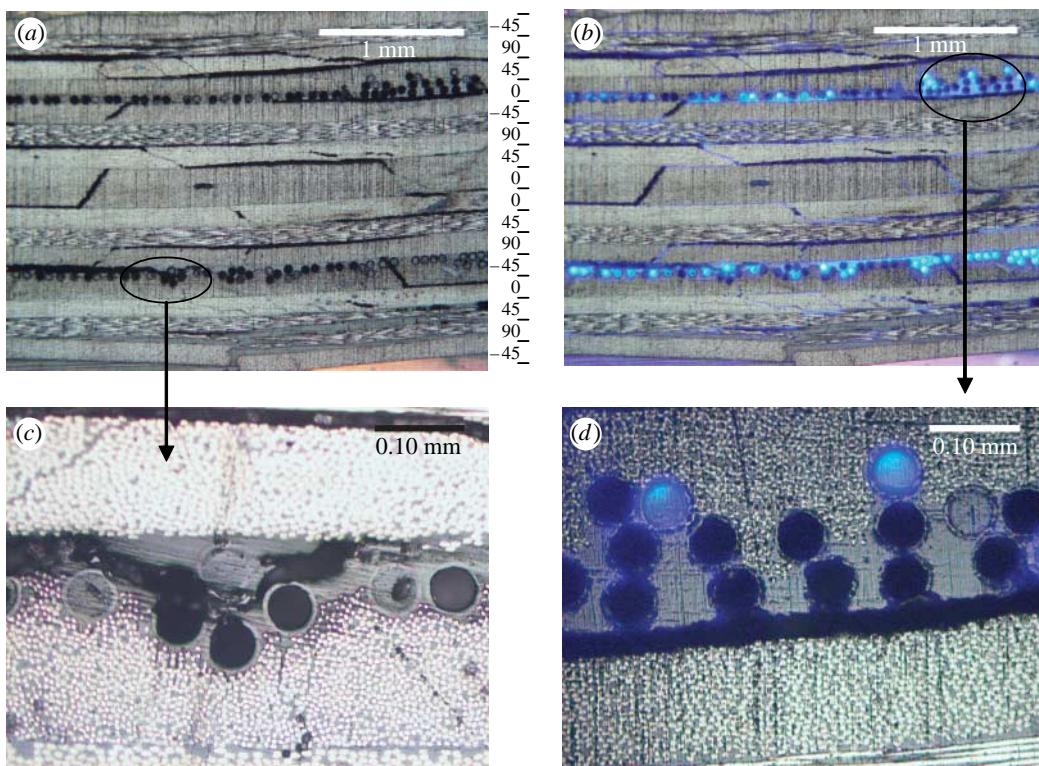
Figure 9. (a) Damage distribution within laminate, (b) damage infiltration with healing resin and fluorescent dye, (c) delaminations deviating from interface and (d) propagating along interface causing HGF fracture.

within the laminate is evident from figure 9a where shear cracks and delaminations are seen to intercept regions of HGF. Furthermore, figure 9b shows similar damage infiltrated with healing resin mixed with fluorescent dye. It can be seen from this image that the larger delaminations (greater than 30 μm) contain little or no healing resin. This could be due to the inability of capillary action alone to draw significant volumes of resin into the relatively wide cracks, combined with the limited lengths of HGF available for delivery of resin (test specimen width provided approx. 40 mm HGF length adjacent to damage site).

As expected, delaminations were observed to propagate along interfaces between plies of dissimilar fibre direction. It can be seen that this initiates HGF fracture via two mechanisms. In figure 9c, clusters of HGF cause deviation of a delamination, presumably due to a fibre cluster and the resulting resin-rich region causing a weakness in the laminate. However, the propagating crack passes directly through HGF causing fibre rupture and release of healing resin. In figure 9d, HGF are ruptured as the delamination propagates along a ply

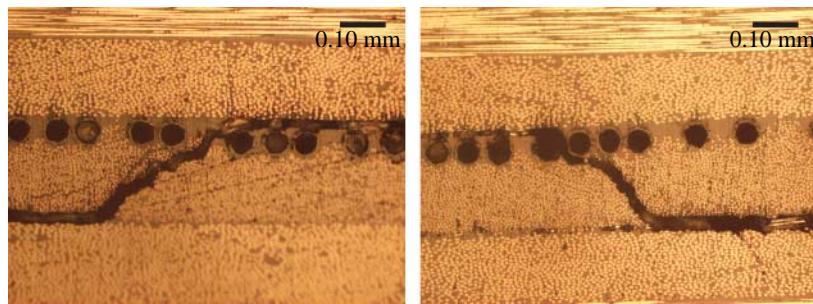
Figure 10. Intra-ply shear cracks intercepting HGF within a self-healing CFRP laminate.

The presence of intra-ply shear cracks linking delaminations provide connectivity between different damage sites in the laminate and facilitate healing at multiple interfaces. Shear cracks can be seen to initiate HGF fracture by similar mechanisms to delaminations (figure 10). However, the width of shear cracks is generally smaller than delaminations (approx. 10 µm compared with approx. 30 µm) and so encourage a stronger capillary action to transport healing resin.
