Stability and tolerance to impurities of the fluorinated surface of hydrogen-absorbing alloys

X.-L. Wang, S. Suda

Abstract

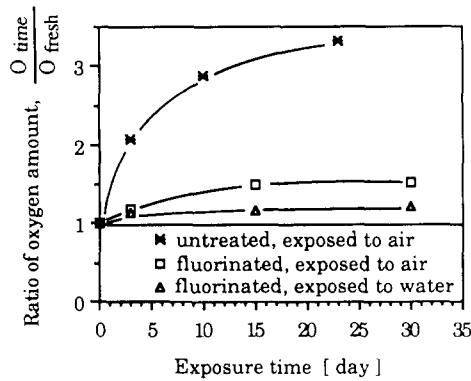
Fig. 4. The comparison of the change in oxygen amount on the surface after exposure to water and air for various periods; O_{fresh} is the oxygen amount on the surface before exposure and O_{time} is the oxygen amount on the surface after exposure for various periods.

Regarding the change in oxygen, a small splitting in the O 1s core level was observed (532 eV and 530 eV) after exposure for longer than 15 days to air and 30 days to water [9]. By exposing the sample to water, the splitting of the O 1s core level appeared much later than that by exposing the sample to air. This indicates that no heavy hydroxidation occurred during exposure to water and the surface was much more stable than during exposure to air. The smallness of the O 1s core level splitting in both exposures indicates that no heavy oxidation or hydroxidation occurred. A quantitative analysis of the change in oxygen was performed. Fig. 4 shows the comparison of three different samples, i.e. the samples exposed to water and air, and the sample without F treatment (hand crushed). The ratio of the oxygen content on the fresh surface (before exposure) to the oxygen content on the surface after exposure for various periods was plotted as a function of exposure time. It can be seen that there was almost no oxygen increase up to 30 days exposure to water. The increase in oxygen on the surface of particles exposed to air was also very small. However, the surface was heavily oxidized for the samples without F treatment. When comparing these changes, it can be concluded that the overlying fluoride layer is stable regardless of the storage method and time and hence

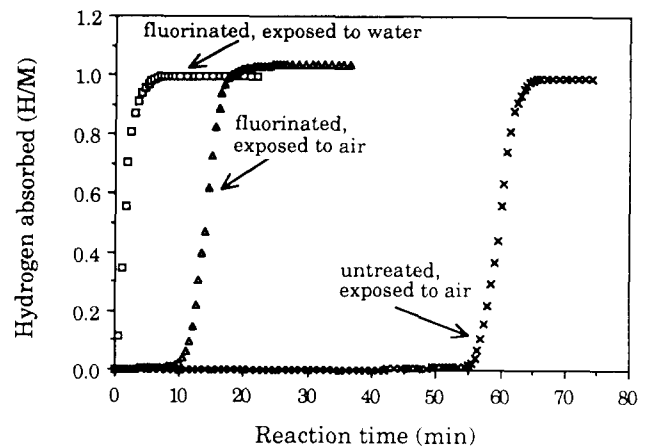
Fig. 7. Comparison of the initial activation for the untreated and fluorinated $\text{LaNi}_{4.7}\text{Al}_{0.3}$ after exposure to air and water for 60 days; the data were taken at 313.2 K under an initial hydrogen pressure of 1.0 MPa.

performed to determine the initial activation properties after exposing to air and water, and the tolerance to impurities under various conditions. Fig. 7 shows the comparison of the initial activation rates for both the untreated and fluorinated samples which were exposed to water and air for 60 days [10]. It was observed that the incubation time for the untreated sample was about 55 min after 60 days exposure to air because of the surface contamination, i.e. surface oxidation and hydroxidation. However, the fluorinated sample exposed under the same conditions showed a much shorter incubation time (only 10 min). In particular, for the water-exposed sample, no incubation was observed even after exposure for 60 days. These observations revealed that the excellent reactivity was still maintained and the F treatment can provide an excellent means for protecting from surface contamination by poisonous materials such as air and water. These reaction results are in concord with the results of the surface analysis obtained by EPMA and XPS.
