Model: Model U-C1 LCT (PS520)		Date: 22-Mar-05	No.: MB457001
Modified Article: Stand		Prepared by: S. Tomoe	
From: 1st Tech. Support Sec. Service Support Dept.			
Reason for Modification:	<input type="checkbox"/> Parts catalog correction <input type="checkbox"/> To facilitate assembly <input type="checkbox"/> Part standardization	<input checked="" type="checkbox"/> Vendor change <input type="checkbox"/> To improve reliability <input type="checkbox"/> Other	<input type="checkbox"/> To meet standards ()

Model: Model U-C1 LCT (PS520)		Date: 22-Mar-05	No.: MB457002
Modified Article: Rear Left Stand Bracket		Prepared by: S. Tomoe	
From: 1st Tech. Support Sec. Service Support Dept.			
Reason for Modification:	<input type="checkbox"/> Parts catalog correction <input type="checkbox"/> To facilitate assembly <input type="checkbox"/> Part standardization	<input type="checkbox"/> Vendor change <input type="checkbox"/> To improve reliability <input checked="" type="checkbox"/> Other	<input type="checkbox"/> To meet standards ()

Model: Model U-C1 LCT (PS520)		Date: 22-Mar-05	No.: MB457004
Modified Article: Control Board		Prepared by: S. Tomoe	
From: 1st Tech. Support Sec. Service Support Dept

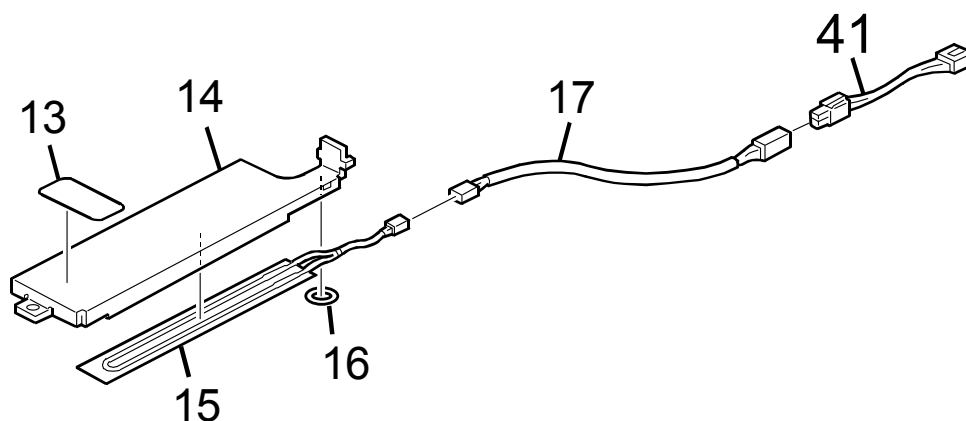
- 1) The material of the I/F harness (heater harness) was changed to a more environmentally-friendly type.
- 2) A relay harness was added (heater sub harness).

Note: The position of the LCT connector on the TH-C1 PSU is different from the previous model.

- 1) This is part of Ricoh's ongoing application of in-house environmental standards.
- 2) So that the LCT can connect to the mainframe PSU.
