# Car Stereo Service Bulletin

**CSA-14**

**Model:** CDX-51, CDX-51RF, CDX-71, CDX-71RF**No. 392****Subject:** Part Number Discrepancies: Lower Case & Spring Arm.**Date:** April 5, 1996**Symptom:****(\*\*)**

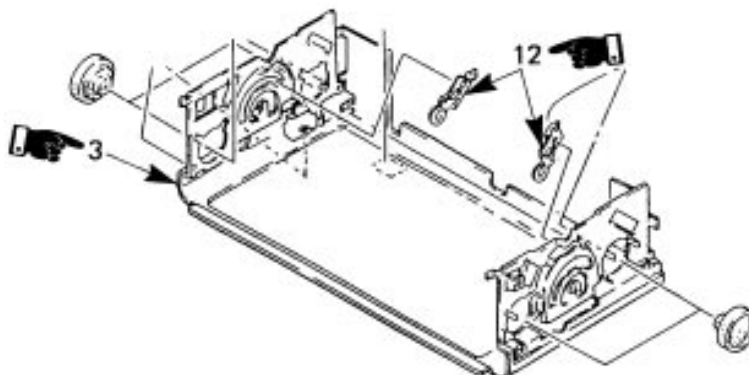
Parts different than those described in the service manuals were used in production, depending upon the model. Also, the lower case and spring arm assemblies used in the CDX-51RF and CDX-71RF are not being supplied as spare parts, therefore, when changing either of these parts the other must be changed at the same time.

REF	DESCRIPTION	PART NUMBER
12	ARM (SPRING) ASSY (2 PCS. REQUIRED)	X-3370-157-1
3	CASE, LOWER	3-919-139-01

For the CDX-51RF and the CDX-71RF, when *either* of the spring arm assemblies *or* the lower case needs to be replaced, order *both* of the part numbers shown below and replace both on the unit being repaired:
