Mechanism of Fatigue Crack Growth in Carbon Black Filled Natural Rubber

ABSTRACT: The present paper deals with the fatigue crack growth in a carbon black filled *cis*-1,4-polyisoprene rubber under relaxing loading conditions. The study focuses on the determination of the scenario of crack growth. For this purpose, an original “microcutting” method is employed to observe microscopic phenomena involved in the growth of the crack with a SEM. It reveals that the cavitation induced by the decohesion between zinc oxides and rubber matrix is the major fatigue damage and that the crack tip is composed of stretched elliptical areas surrounded by highly stretched and crystallized ligaments. Finally, the observations are considered to establish the fatigue crack growth mechanism.

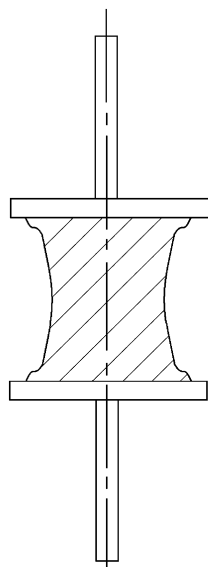
Figure 1. Geometry of the "diabolo" sample.

The sample geometry is similar to the one proposed by Beatty;¹² it is presented in Figure 1. The sample is axisymmetric and is usually called the “diabolo” sample. Its significant radius of curvature leads to a higher local deformation state in its middle than the enforced nominal deformation. Consequently, the predominant fatigue crack is initiated in the lowest diameter section, i.e., at the center of the sample.

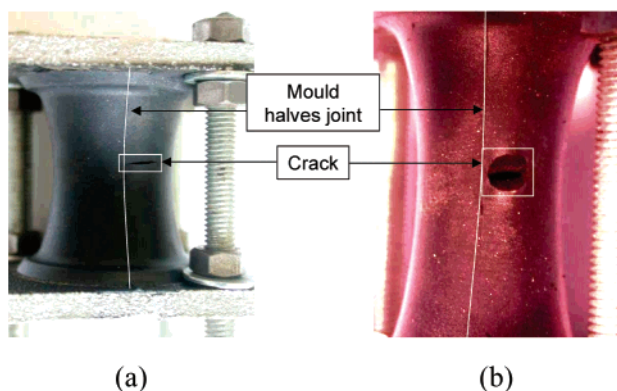
Figure 2. Sample and fatigue crack in the (a) undeformed and (b) deformed configurations.

2.4. Observation Method. The sample is fixed in a rudimentary static tensile apparatus (see Figure 2a), and it is statically stretched to the same ratio than the one enforced during the fatigue test (1.33) in order to open the crack (see Figure 2b). Then, this apparatus is placed in the SEM to observe the crack growth. As mentioned previously, the fatigue test led to initiation and propagation of a crack in the sample, and it involved a fatigue damage in the crack tip vicinity. Thus, the crack tip should be notched to reveal the fatigue damaged zones and to determine their origin. During SEM observations, it is obviously irrelevant to use a laboratory cutting tool to notch the crack. Nevertheless, it is possible to "microcut" the crack tip by imparting in situ a sufficient amount of energy to break cross-links between macromolecules. Two energy sources are used simultaneously; the first one is mechanical and consists of statically stretching the sample to a ratio equal to 1.67, i.e., higher than the level set during the cyclic loading, and the second one consists of locally concentrating the electron beam in the observation zone. In fact, the amount of energy needed to break cross-links cannot easily be determined since the number and nature of cross-links as well as the number of macromolecules in the irradiated zone are not well-known. However, the acquired experience enables us to correctly set the power of the electron beam and to recur experiments. The most favorable zones to perform microcut-

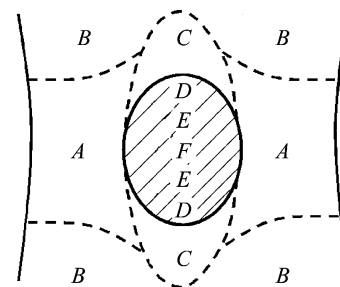
Figure 3. Schematic view of the crack (D–F) and its surroundings (A–C).

3.1. Crack Description. Figure 3 presents a schematic view of the crack and its surroundings. Six different areas are observed in the deformed configuration, i.e., as the sample is stretched to 1.67. Before the occurrence of the crack, there were only two zones: the central zone of the sample, denoted A in the figure, that is the most stretched part of the specimen, and the area situated on both sides of it and denoted B. When the crack occurs, four new zones appear: area C, which corresponds to the parts of area A relaxed during crack opening, and areas D, E, and F that stand for the crack itself. The photomicrographs of the three zones D, E, and F are shown in Figure 4. Area F stands for the crack tip, area D represents the material surfaces that were broken during the previous growth of the crack, and area E is the frontier between the former ones (see Figure 4a). The major difference between surfaces D and F is their stretching level. As shown in Figure 4b, area D is overlaid with wrenchings which are a typical feature of fracture surfaces observed under fatigue loading conditions.^{14,15} Here, the term "wrenchings" refers to highly stretched ligaments which break and shrink. Area F is composed of highly stretched ligaments which delimit elliptical smooth surfaces, and area E contains both wrenchings and ligaments. With regard to these observations, the number and size of ligaments in a zone seem closely related to its stretching level.

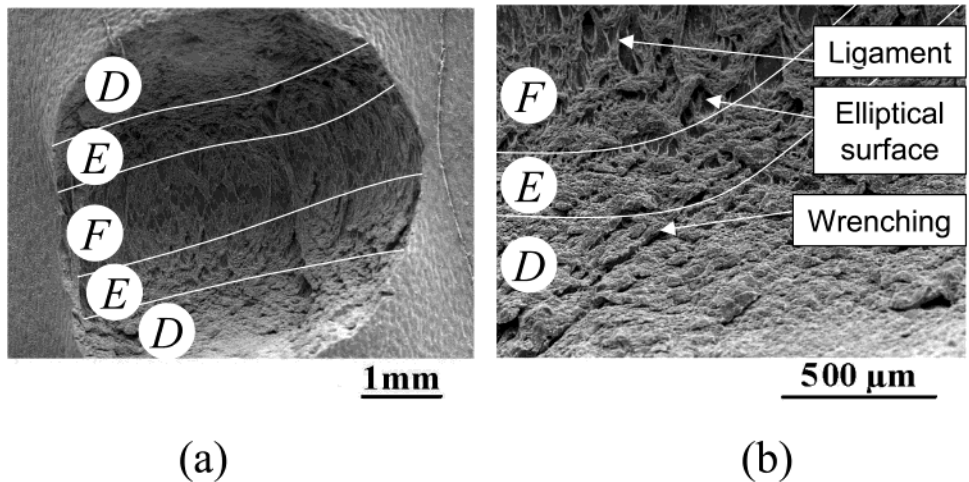
Figure 4. Details of areas D–F for two magnifications.

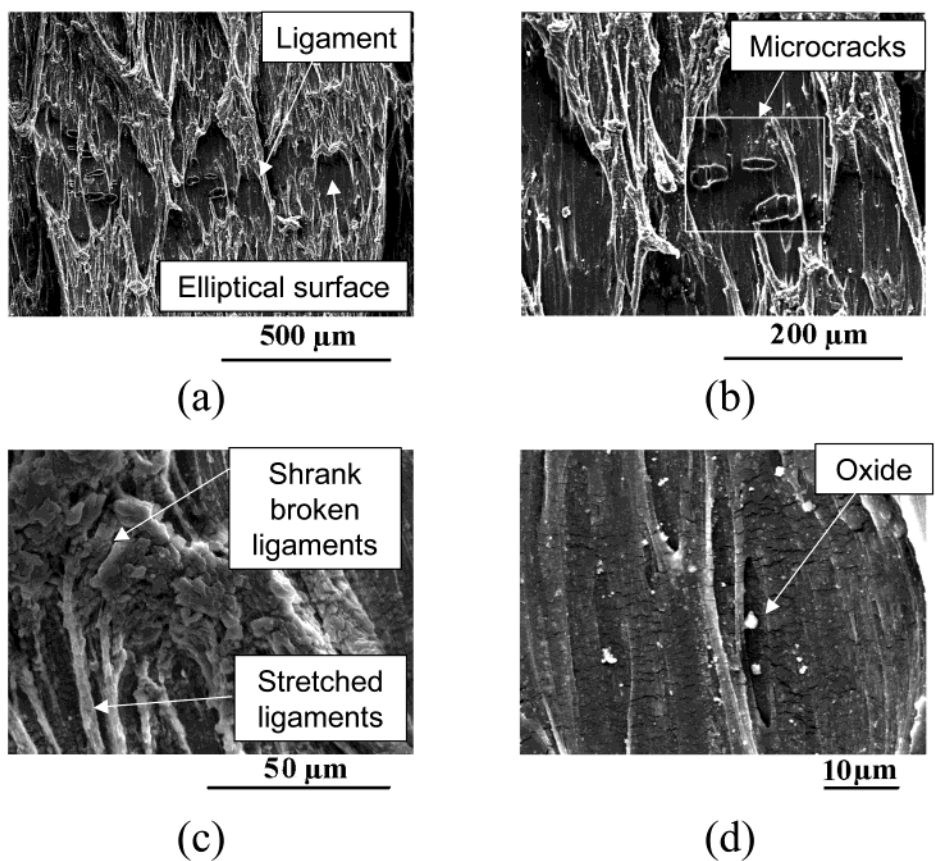
Figure 5. Details of the crack tip for four magnifications.

After this brief description of the crack, the crack tip F, in which our microcutting method will be applied, has to be more precisely examined. Figure 5 shows it for different magnifications. The crack tip is composed of a few hundred micrometers long ligaments which are highly stretched and surround smooth elliptical surfaces (see Figure 5a). Figure 5b–d presents the morphology

of these elliptical surfaces and their surroundings. First, microcracks take place in their middle part; their orientation is perpendicular to the stretch axis (see Figure 5b). The presence of these microcracks shows that the smooth areas are propitious to the propagation of the crack. This property will be used in the following to apply our microcutting method. Moreover, these smooth areas are delimited by ligaments whose extremities are located at their top and bottom. As an example, the photomicrograph in Figure 5c shows the top of any surface. It contains both stretched ligaments and a rough surface that corresponds with broken ligaments which shrank. Finally, using a larger magnification, Figure 5d shows that some zinc oxides are embedded in the relief of smooth elliptical areas. Oxides can be

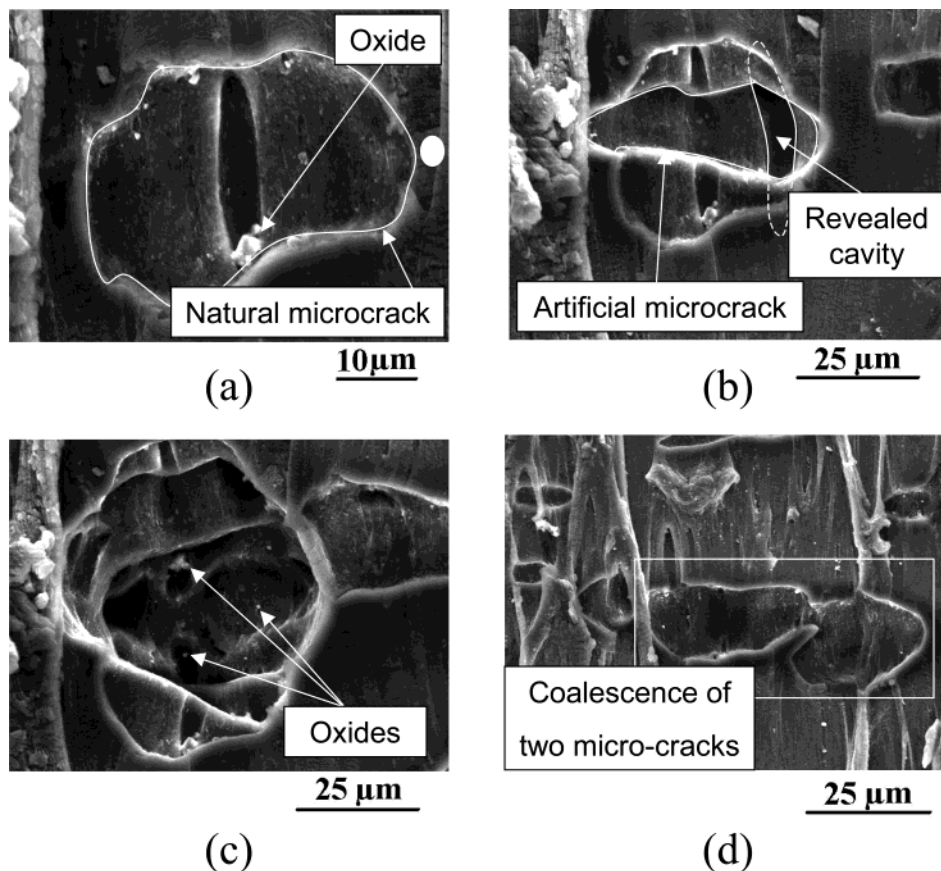
Figure 6. Chronology of the microcut experiment.

5b). Figure 6 presents the chronology of the real-time observation. The observation zone is shown in Figure 6a. It contains a natural microcrack near a ligament. In the middle of this microcrack, a stretched cavity containing an oxide takes place. Then, the electron beam is focused a few seconds beside the microcrack (see the white circle in Figure 6a). It leads to an artificial microcrack which initiates at the beam concentration point, slowly propagates to the other side of the natural microcrack, and stops at the ligament, as shown in Figure 6b. During its propagation, this artificial microcrack revealed a cavity similar to the one observed in the natural microcrack. By continuing to focus the electron beam, new microcracks are propagating in the sample depth and are revealing cavities. Most of these cavities contain oxides (see Figure 6c). Moreover, note that this microcutting can also be used to induce the coalescence of existing microcracks by concentrating the electron beam between them (see Figure 6d). Finally, it should be mentioned that, as the electron beam is focused on ligaments (the SEM power settings being unchanged), they do not break even if they are exposed for a long time. It seems to indicate that the microstructures of ligaments and elliptical areas between them are different. More precisely, this difference might be mainly due to the distribution of the crystallization ratio: the highly stretched ligaments represent the most crystallized zones of the crack tip. These results obtained under fatigue loading conditions are quiet similar to those recently established under static conditions by Trabelsi et al.,¹⁶ who demonstrate that a crystallized zone appears at crack tip of initial cut lengths 0.5 and 1 mm for stretch ratios greater than $\lambda = 1.3$.

This experiment highlights that cavities take place in the vicinity of the crack tip due to decohesion between oxides and rubber matrix. Similarly, Layouni et al.¹⁷ associate the volume change of elastomers under mechanical loading with the decohesion between zinc oxides and matrix. Cavitation in rubber is a well-known phenomenon that was thoroughly studied in the past for static loading conditions.^{18,19} Recently, it has been shown that the number of preexisting microvoids per unit volume strongly correlates with the mechanical performance of elastomers.²⁰ For fatigue loading, only internal crack growth under high hydrostatic pressure has been studied.²¹ Nevertheless, in the present case of relaxing tensile fatigue, the origin of cavitation is not established: is it only a consequence of the stress state at the crack tip, or is it also due to fatigue loading conditions? To answer these questions, a second experiment is carried out. It consists of generating a self-initiated fatigue crack and observing the cavities distribution in the sample.

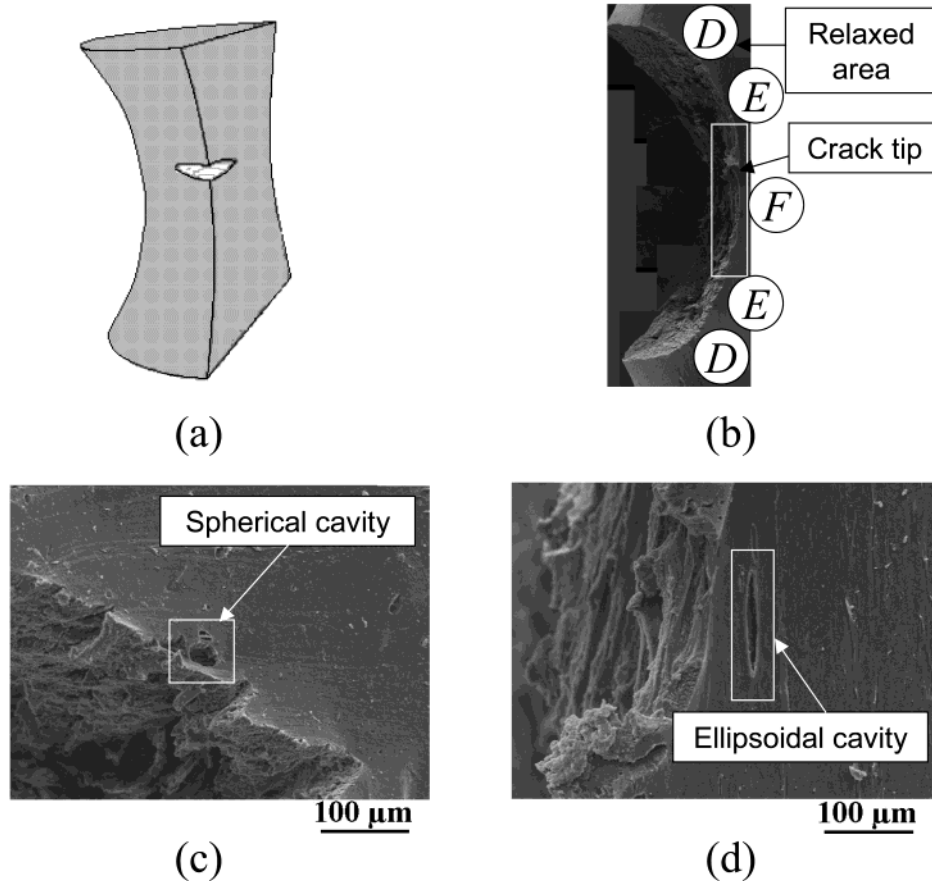
Figure 7. Second experiment: (a) cut sample, (b) global view of the crack, (c) details of relaxed areas, (d) details of the crack tip.

Figure 7 summarizes this second experiment. To observe cavities in the sample, it is cut in its undeformed configuration, as shown in Figure 7a. Afterward, it is stretched using the tensile apparatus presented above and introduced in the SEM. Figure 7b shows the opened crack tip and its surroundings. One can again distinguished relaxed zones with numerous wrenchings at the top and the bottom of the crack, and the most stretched area, i.e., the crack tip, in the middle. Large cavities are observed in both areas near the crack faces, and their shapes highly differ: they are spherical in the relaxed zones (see Figure 7c) and ellipsoidal (due to the stretching level) behind the crack tip (see Figure 7d).

Moreover, it is important to notice that the size of the large spherical cavity in Figure 7c (as compared with the size of an oxide) demonstrates that this cavity grew under cyclic loading. Examining the cut surface of the sample, a large number of cavities are revealed; most of them contain oxide, and their size rapidly decreases with their distance from the crack. From a sufficiently long distance, no more cavities are observed.

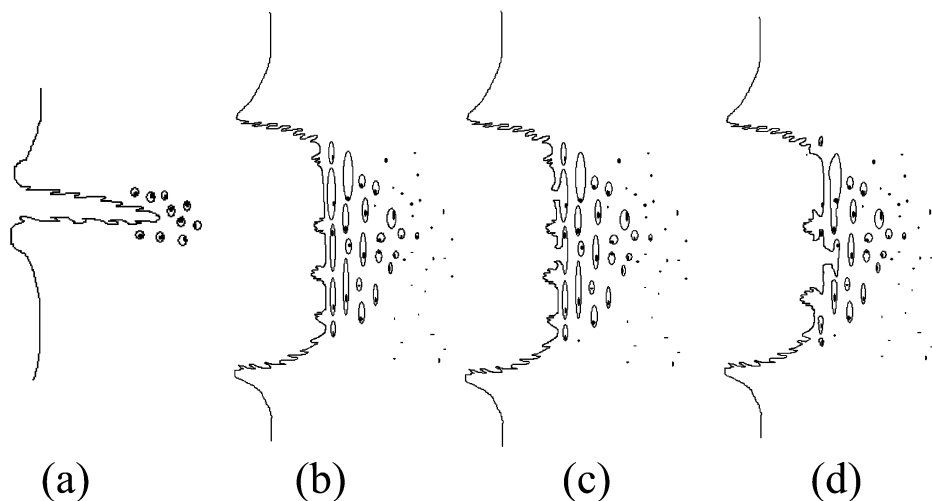
Figure 8. Crack growth mechanism: side view.

3.3. Crack Growth Mechanism. Using the previous observations, the scenario of fatigue crack growth is proposed in this section. It will be described thanks to two chronological sketches which correspond to two views of the phenomenon. Figures 8 and 9 present respectively the side and front views of crack growth. These two views will be used to accurately describe the three-dimensional nature of the phenomenon. It is to note that the chronology of the two figures are different; i.e., the stage of Figure 8a does not correspond to the one of Figure 9a.

The crack growth phenomenon can be seen as the succession of elementary sequences from initiation to final failure. Before examining this elementary sequence, let us recall that both fatigue loading and the stress state in the neighborhood of the crack tip generate cavitation due to the decohesion between oxides and rubber matrix as shown in Figure 8a. The elementary sequence is composed of three steps:

(i) As the crack tip is stretched, elliptical areas take place with ligaments on both sides and wrenchings at the top and bottom. Cavities are situated behind these areas, and their shape is ellipsoidal (see Figure 9a). As shown in Figure 8b, the wall that separates the crack tip and cavities is thin, such that it can be considered as a membrane.

(ii) This membrane tears and reveals most of the cavities situated behind it (see Figure 8c). The corresponding microcracks propagate perpendicularly to the crack growth direction (see Figure 9b).

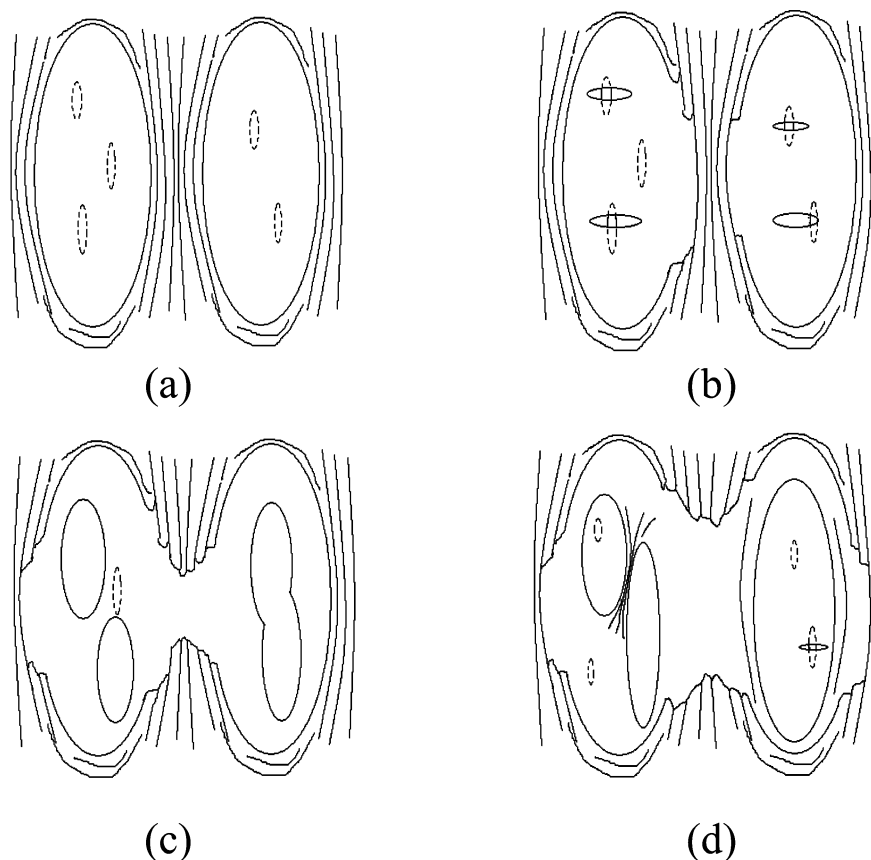
Figure 9. Crack growth mechanism: front view. Hidden parts are represented by dotted lines.

(iii) Then, microcracks grow and eventually coalesce until the destruction of the elliptical areas. Moreover, ligaments break and relax to form the wrenchings which lie at the top and bottom of these elliptical zones (see Figure 9c). This fracture may be due to the fatigue of ligaments or/and to the new stress state in ligaments generated by their neighborhood. Schematically, the crack tip breaks, the crack grows, and the processus restarts at (i) (see Figure 8d). It should be noted that the coalescence of microcracks can be limited with the result that the elliptical zones are not completely destroyed and that ligaments occur between microcracks, the consequence being the formation of several new elliptical areas (see Figure 9d).
