Field Service Report For

LM 2500 Repair

**Facility: WG-Pratt & Whitney
Unit: 481-642**

REPAIR SUMMARY LM2500 481-642

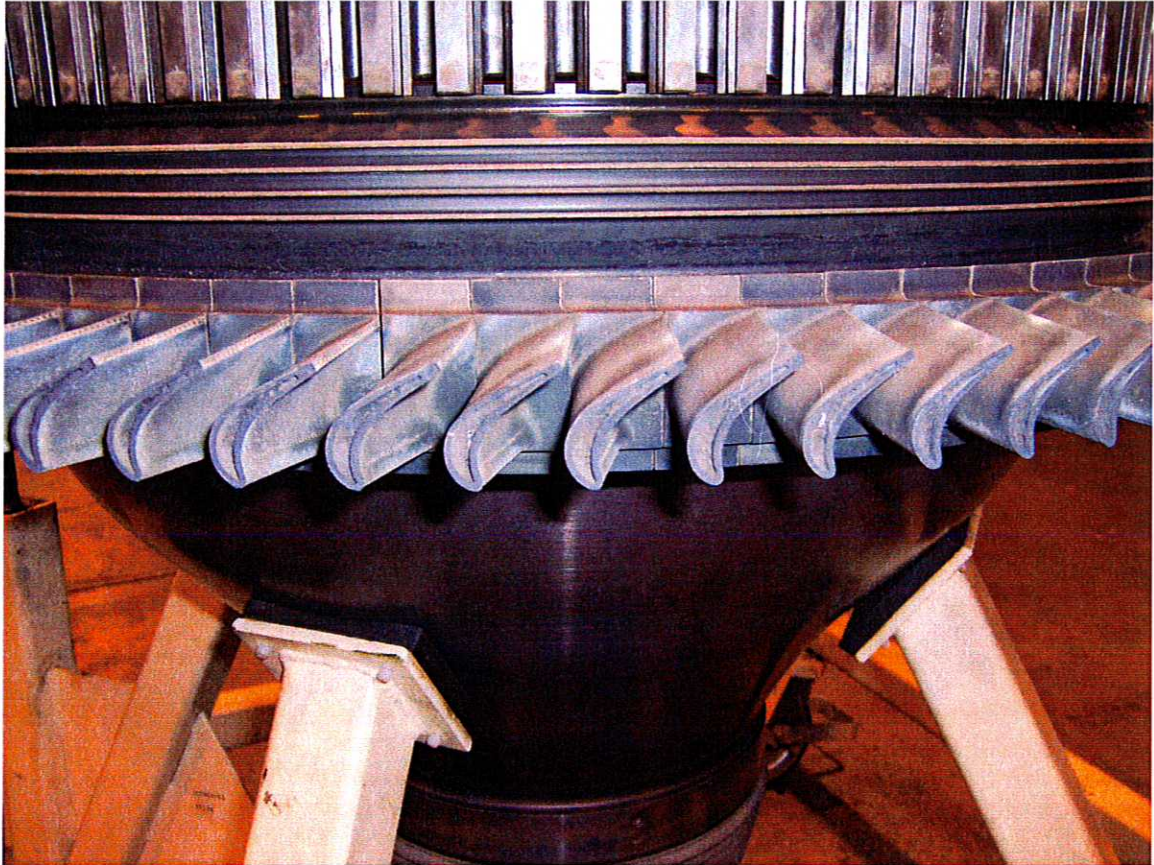
HPT ROTOR STAGE 1 BLADES

481-642: HPT blades and stage 2 nozzle has been sent of to Chromalloy. They will recoat the blades and inspect the stage 1 blade shrouds which according to GEK 93710 chapter 5 gives you the limit and as inspected are in serviceable condition. To make the shroud look better there is a possibility of recoating which will be determined upon price and time. HPC is being hand cleaned since the top case removal. Minor dents will be blended if necessary. The stage 1 HPC blade dampers show wear and missing material. This is not uncommon on units that operate at low and fluctuating loads. The condition was not mentioned in the second party inspection. Will determine the outcome after reviewing the BSI report. JTS has blades if necessary. FYI they will give us a quote for overhauled and one set that is serviceable. If the blades were not mentioned in the inspection report I would not replace them. Attached are some of the pictures from the JTS shop with recommendations. As we all know these are their recommendations and to benefit their profit. This unit will only need minor work since the inspection after tear down.

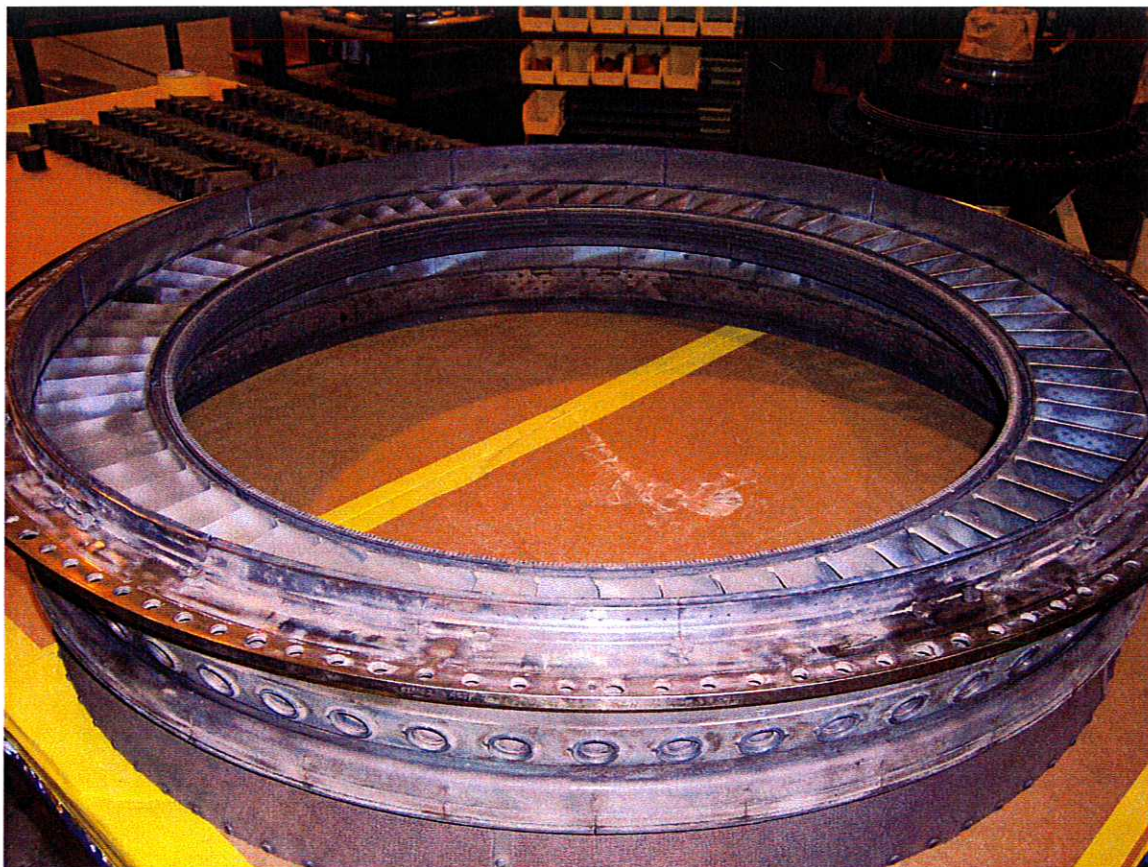
**STAGE 2 NOZZLE ASSEMBLY PRIOR TO CLEAN UP
AND REPAIR**

2. The stage 2 nozzle assembly is being disassembled today since it arrived from Chromalloy. It was shipped back due to no facility in the US. The damaged shrouds will be removed and replaced. This will take a few days. When finished the nozzle will need to ship out for grind. I forwarded Cost for this earlier but will attach it again. We have a few options on what shrouds to use and we should try and keep the cost down by using their Pratt parts. When the nozzle returns it will be reassembled and installed.

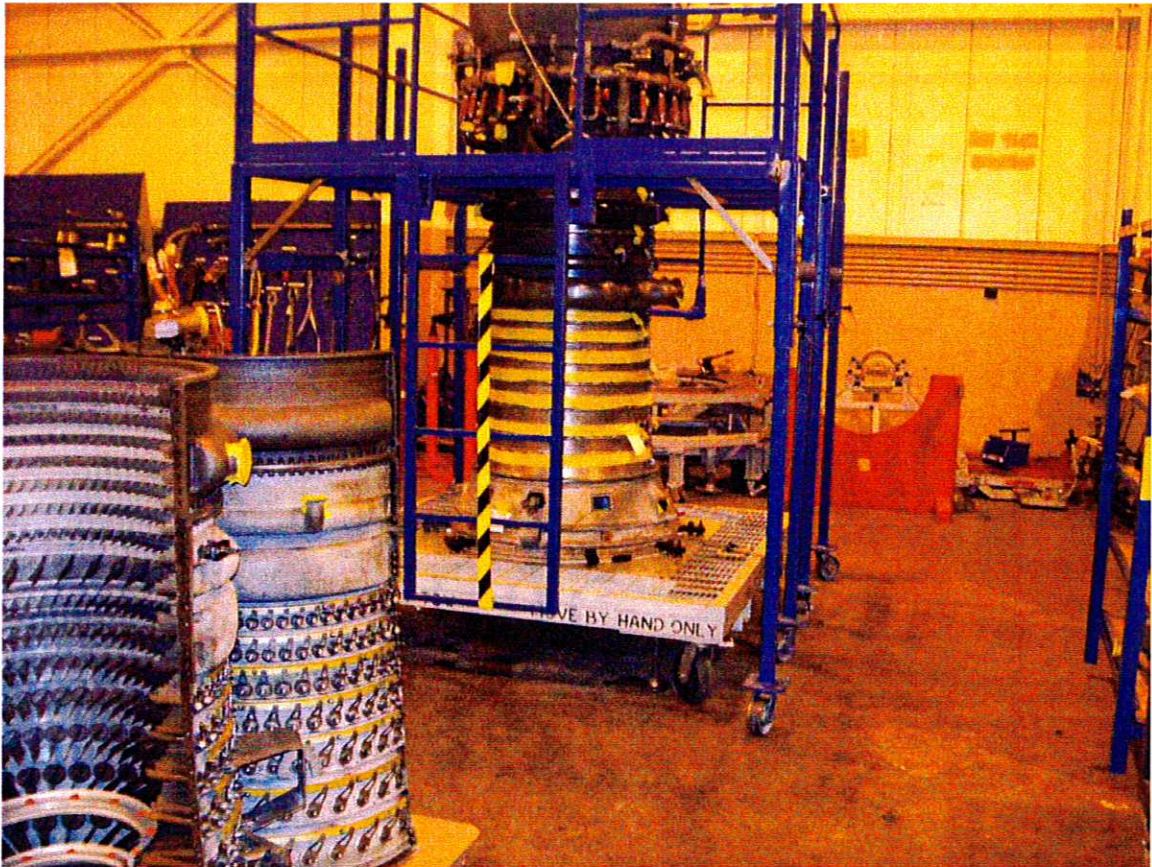
**DEBLADED HPT ROTOR WAITING FOR BLADES TO
COME BACK FROM REPAIR**

1. The stage 1 blades are being recoated as we speak. The word from Chromalloy is that they will be done in 15 days then shipped back to the facility. The blades will then be installed and shimmed for measurement to make sure that the shroud grind will have proper tolerance.
