# PANZER VOR!

German Armor at War 1939-45

Frank V. De Sisto

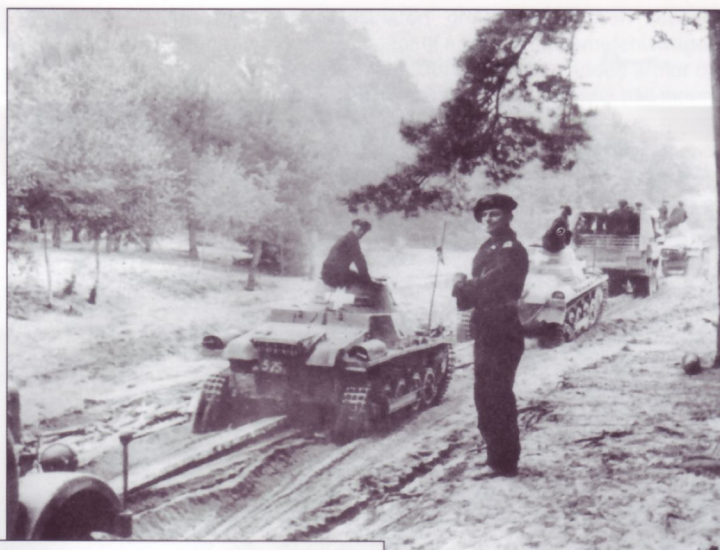
A Panzer crewman looks on as a Pz.Kpfw.I Ausf.A moves along a sandy forest track during the Polish Campaign of September 1939. Note the thick white balkenkreuz national insignia on the turret, characteristic of that campaign. The vehicle (which is a 2.serie/La.S chassis as denoted by the view port on the rear face of the superstructure) has additional fittings, which were ordered to be attached at various times during the year 1937. They include a "Nebelkerzenabwerfvorrichtung" (smoke candle deployment rack) on the hull rear, as well as armored cowls over the engine air intakes and exhausts. Note also the single engine exhaust mufflers on the rear of both fenders and what appears to be a pennant on the antenna.

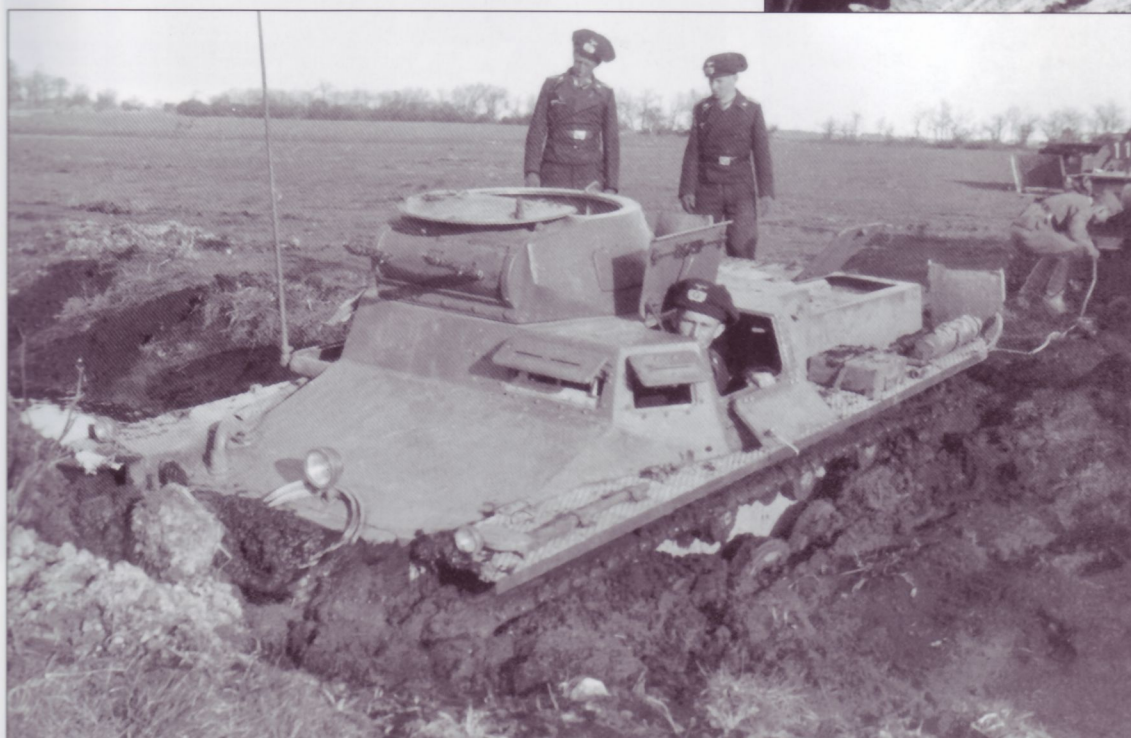
A thoroughly bogged-down Pz.Kpfw.I Ausf.B stands idle while it is prepared for extrication. Note the man in the far background who is running a tow cable out to another vehicle. The panzer is devoid of markings and should be finished in the two-color scheme of dunkelgrau Nr.46 base with dunkelbraun Nr.45 oversprayed. It is recognizable as an Ausf.B by the longer engine compartment which housed a Maybach NL38TR gasoline engine, as well as the lack of exhaust mufflers on the rear of the fenders. Note the black panzer crew uniforms and the quite oversized appearance of the berets, which covered a padded inner helmet.

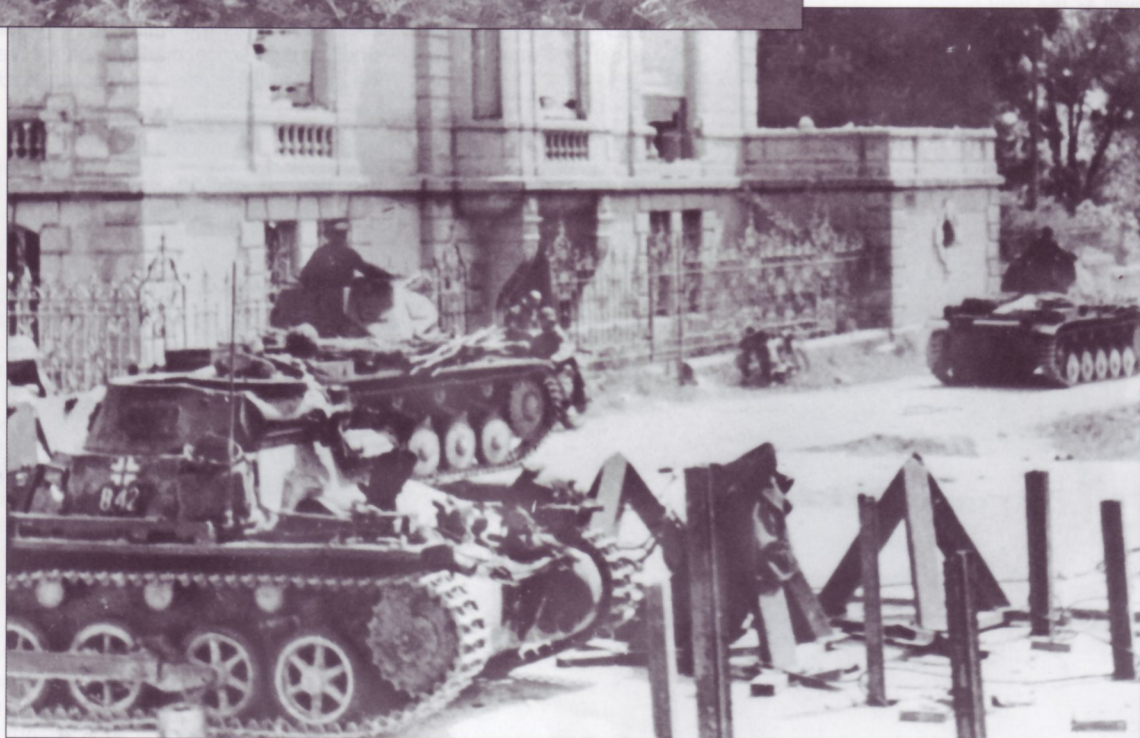
This Pz.Kpfw.I Ausf.A belongs to the 8.Kompanie of the Panzer-Regiment as denoted by the Tac number "842", which along with an outline-style balkenkreuz, is painted in white on the superstructure side. The panzer is laid-up next to steel anti-tank obstacles, probably in a French city during the 1940 campaign. Of note is the way in which the road-wheel hubs as well as the drive sprockets have collected a coating of mud and dust, while the tires have not. From this angle, it is identified as an Ausf.A by certain features of the suspension system such as: the way the track slopes downwards after the third return roller, as well as the girder and spring configuration. A pair of Pz.Kpfw.IIs in the background continue the onslaught.

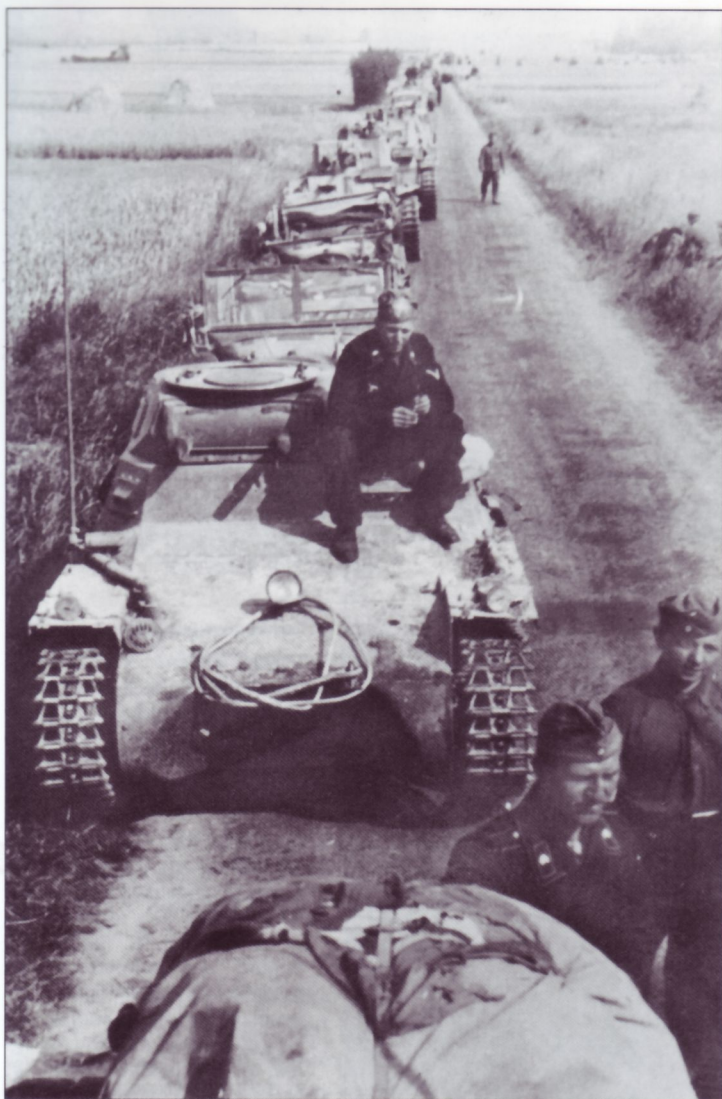
A Pz.Kpfw.I Ausf.B leads a column consisting of wheeled vehicles and Pz.Kpfw.38(t)s, during the French Campaign. From this angle the panzer is identified as an Ausf.B by the lack of a vehicle jack stowed on the right front fender (although some Ausf.Bs did, in fact, have a jack stowed in that position). A close look at the superstructure, next to the radio antenna, as well as the front plate will reveal an inverted "Y" with three dots, which was the divisional insignia of 7.Panzer-Division, which was equipped with the Pz.Kpfw.38(t); this marking is seen on one of those panzers later in this book.

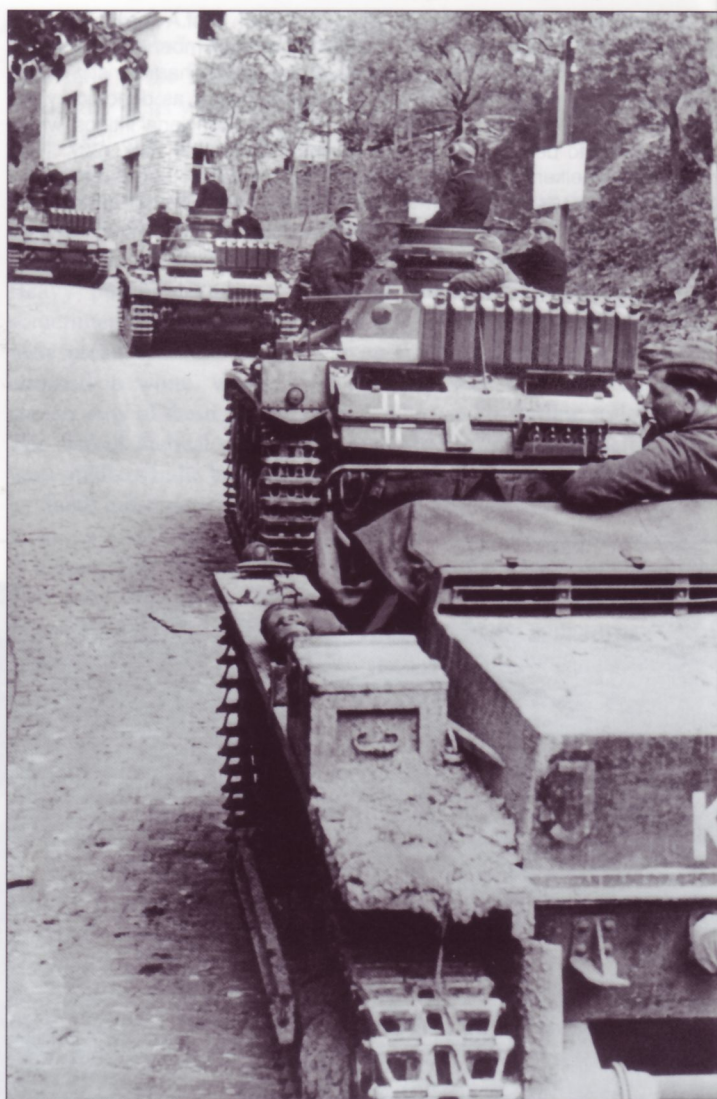
A column of Pz.Kpfw.III (Ausf.D, E or F) leads a Pz.Kpfw.I Ausf. B ohne Aufbau, which has been converted into a vehicle to carry maintenance equipment for the panzer company's repair and recovery sections, by the removal of its superstructure and turret. It was also known as "Instandsetzungskraftwagen I". Note the yellow gothic "I" (which appears to be a "J") that identifies the vehicle's function, on the rear corner of the engine deck, as well as the white "K" of Panzergruppe von Kleist. Note also the small square tactical markings on the rear turret face of the Pz.Kpfw.IIIs and the racks for jerry cans on their rear decks.

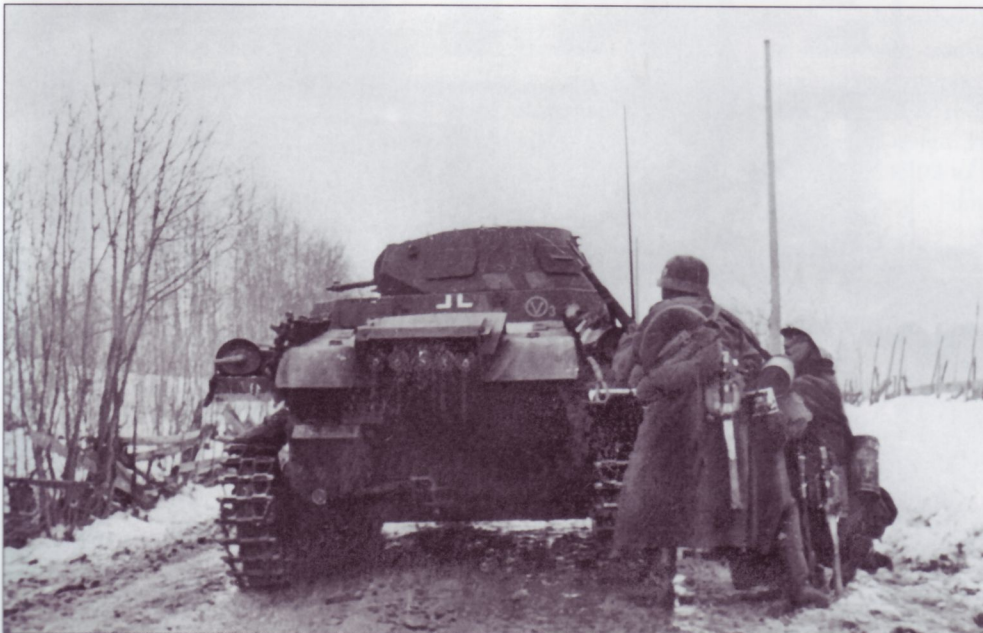
No Panzer Divisions took part in "Operation Weserübung", the invasion of Norway. However, a small number of panzers were deployed as part of "Panzer-Abteilung z.b.V.40". By April 25, 1940, after seeing combat, the unit reported 29 Pz.Kpfw.I, 18 Pz.Kpfw.II and four kl.Pz.Bef.Wg, as well as three "Neubau-Pz.Kpfw.IV as being operational. Some of its panzers came from Panzer-Regiment 15 or 31 from 5.Panzer-Division, which is indicated by the over-painted markings on the turret. These consisted of a segmented yellow-black-yellow band at the base of the turret. In this photo, the band as well as the Tac number (possibly "29") have been over-painted. The insignia of 3.Kompanie, z.b.V.40, is on the superstructure rear plate along with a white-outline balkenkreuz. This is a 2.serie/La.S chassis as denoted by the view-port to the left of the balkenkreuz. It has the retro-fitted armored cowls over the air intakes as well as "Nebelkerzenabwerfvorrichtung" (smoke candle deployment rack) on the hull rear.

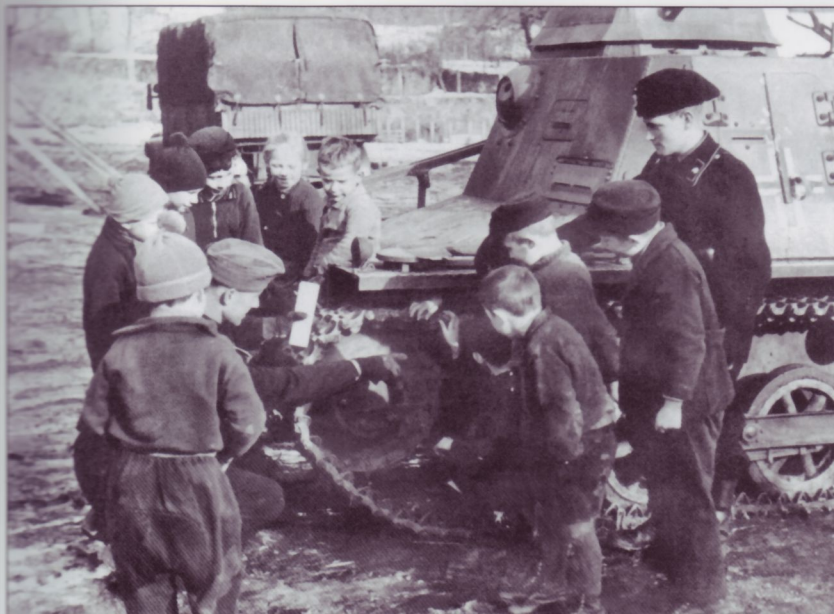
An apparently fascinated group of children receive instructions on the running gear of a kleine Panzerbefehlswagen from one of the crewmembers. The vehicle has added armor on the superstructure front; note how the visors and MG ball mount are flush with the surface, compared to the previous photo. There is no bolted-on armor plate on the superstructure side at the fender top and no Notek blackout head-lamp has been fitted (although the device was accepted for use in June of 1939). The balkenkreuz national insignia consists of a black center with a white outline, but it has been over-painted on the bottom. Both crewmen wear the black M1934 uniform; one wears an M1935 "Feldmütze" (field cap), while the other wears the black M1934 beret over a padded inner helmet. This combination of uniforms, vehicle finish and features, as well as the weather and terrain may place this photo in the early part of 1940, prior to the French Campaign.

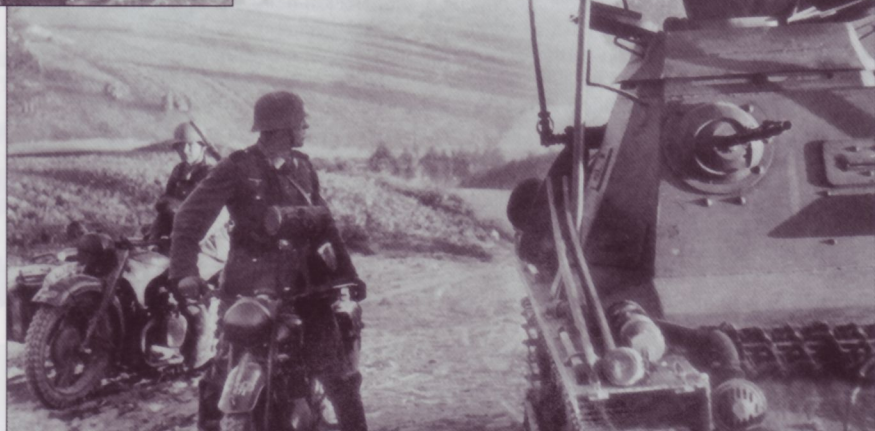
A motorcycle dispatch rider converses with the commander of a kleine Panzerbefehlswagen (Sd.Kfz.265), probably during the opening stages of "Operation Barbarossa" in June of 1941. At this time, the vehicle would have been painted in overall dunkelgrau RAL 7021; there are no markings visible. This vehicle has the added "Rahmenantenne" (frame antenna), which was sometimes seen in service after the campaigns of 1939 and 1940. Note how the posts that support the frame are themselves reinforced with strips connecting them to the superstructure. The motorcyclists are wearing their gas mask canisters slung across their chests, a common practice. The motorcycle combination in the background is based on the BMW R75, which is identified by the characteristic framework forward of the fuel tank; the near one is a DKW NZ 350.

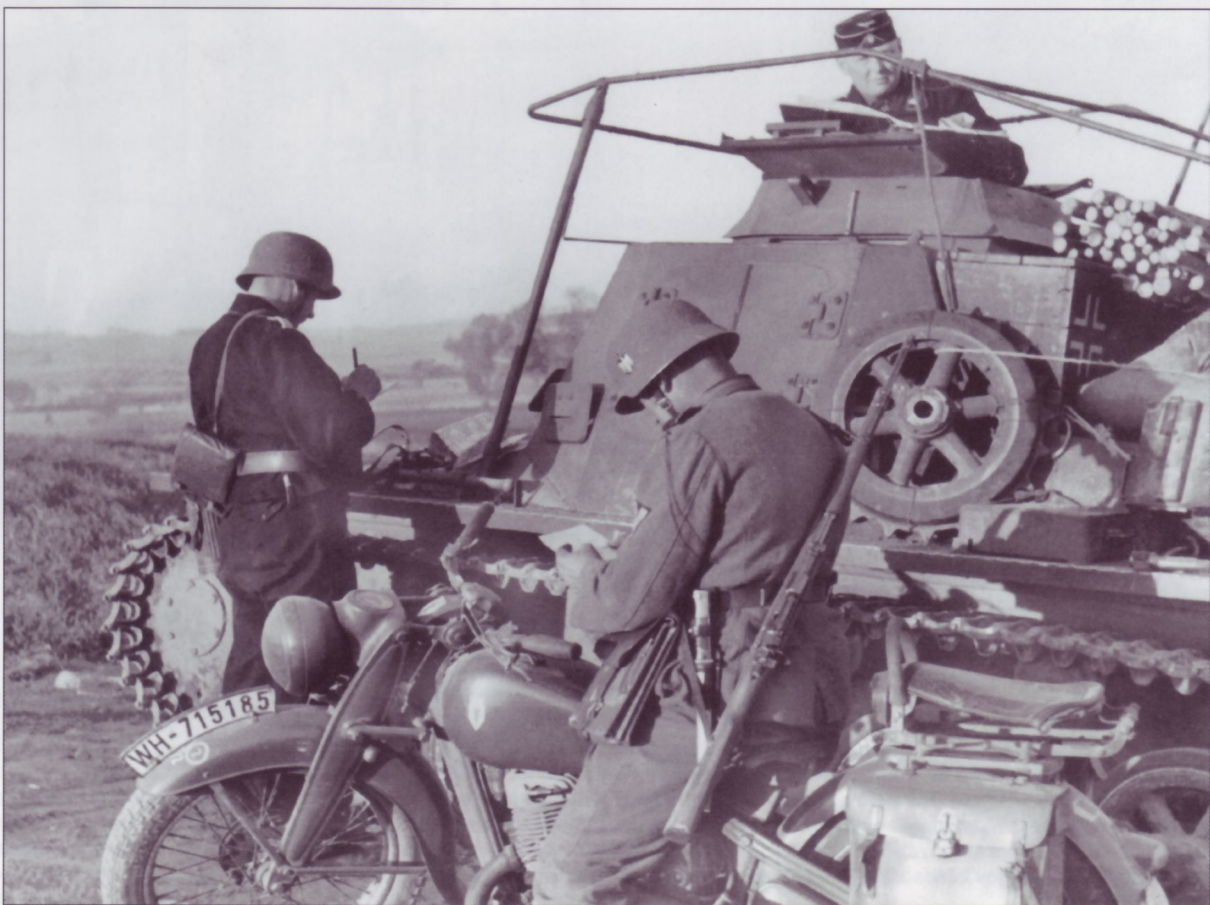
In a second view of the same kleine Panzerbefehlswagen, a solo-motorcycle dispatch rider as well as a Panzer crewman (sensibly wearing his steel helmet while away from his mount) quickly scribble information from the commander of the panzer. The motorcycle is a DKW NZ 350. Note the extensive stowage on the panzer, including: small logs wired together to help in overcoming soft ground, spare road-wheel, box, tarp, etc. This panzer has a stowage locker behind the superstructure, which carries a black balkenkreuz with a white outline.

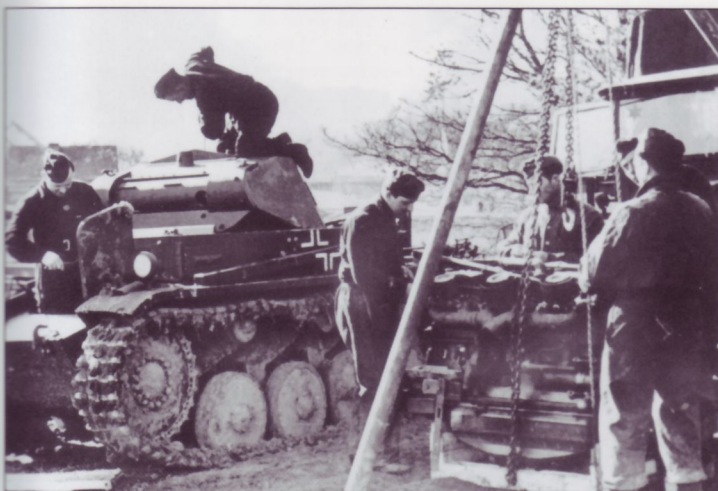
This Pz.Kpfw.II (Ausf.A, B or C), is undergoing a rather extensive bit of maintenance in a field workshop. The rear half of the superstructure has been lifted away to allow the engine to be removed for easier access to its components. A crewmember stands in the open bow hatch, where he could access the panzer's transmission and final drive unit. The 2cm KwK30 main gun, as well as the co-axial MG34 have been removed from the mantle for disassembly and cleaning. The panzer has some of the later retro-fitted features such as turret, superstructure and bow supplementary armor, but retains the original split hatch arrangement for the commander, rather than the vision cupola. There is no Notek head-lamp fitted. The markings consist of two small yellow dots representing the 2.Panzer-Division (as of November 1, 1939), while the white-outlined balkenkreuz national insignia is split between the superstructure side and the antenna storage trough. The environment, vehicle features and markings indicate this photo may pre-date the French Campaign of 1940. If this is the case, the panzer should be finished in the two-tone scheme of dunkelgrau Nr.46 base with dunkelbraun Nr.45 overspray.

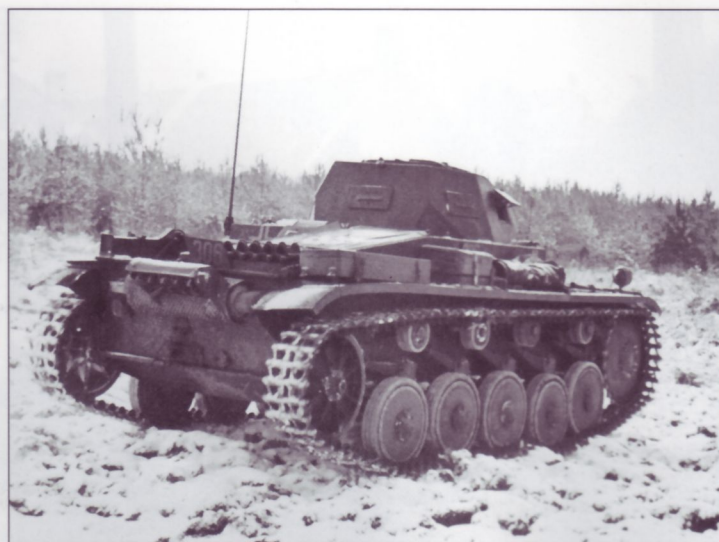
This Pz.Kpfw.II is an Ausf.A, B or C photographed during training. It carries a small rhomboid plate behind the "Nebelkerzenabwerfvorrichtung" (smoke candle deployment rack) with a solid-colored (probably yellow) "306" as a Tac number. Further on, there is a bit of the balkenkreuz national insignia on the rear face of the superstructure in white outline form. Another rhomboid plate, as well as another balkenkreuz can be seen on the superstructure sides, behind the stowage. Another point to note is not only the angles of the spring bundles for the suspension system, but the fact that some have a different number of spring plates within a bundle. The snow and the style of markings indicate that this photo may have been taken in the winter of 1939-40, during the so-called "Sitzkrieg" in the west prior to the French Campaign. The lack of the tail-lamp from the Notek black-out driving system also makes this more likely. The color scheme should be the two-tone type consisting of dunkelgrau Nr.46 base with dunkelbraun Nr.45 overspray.

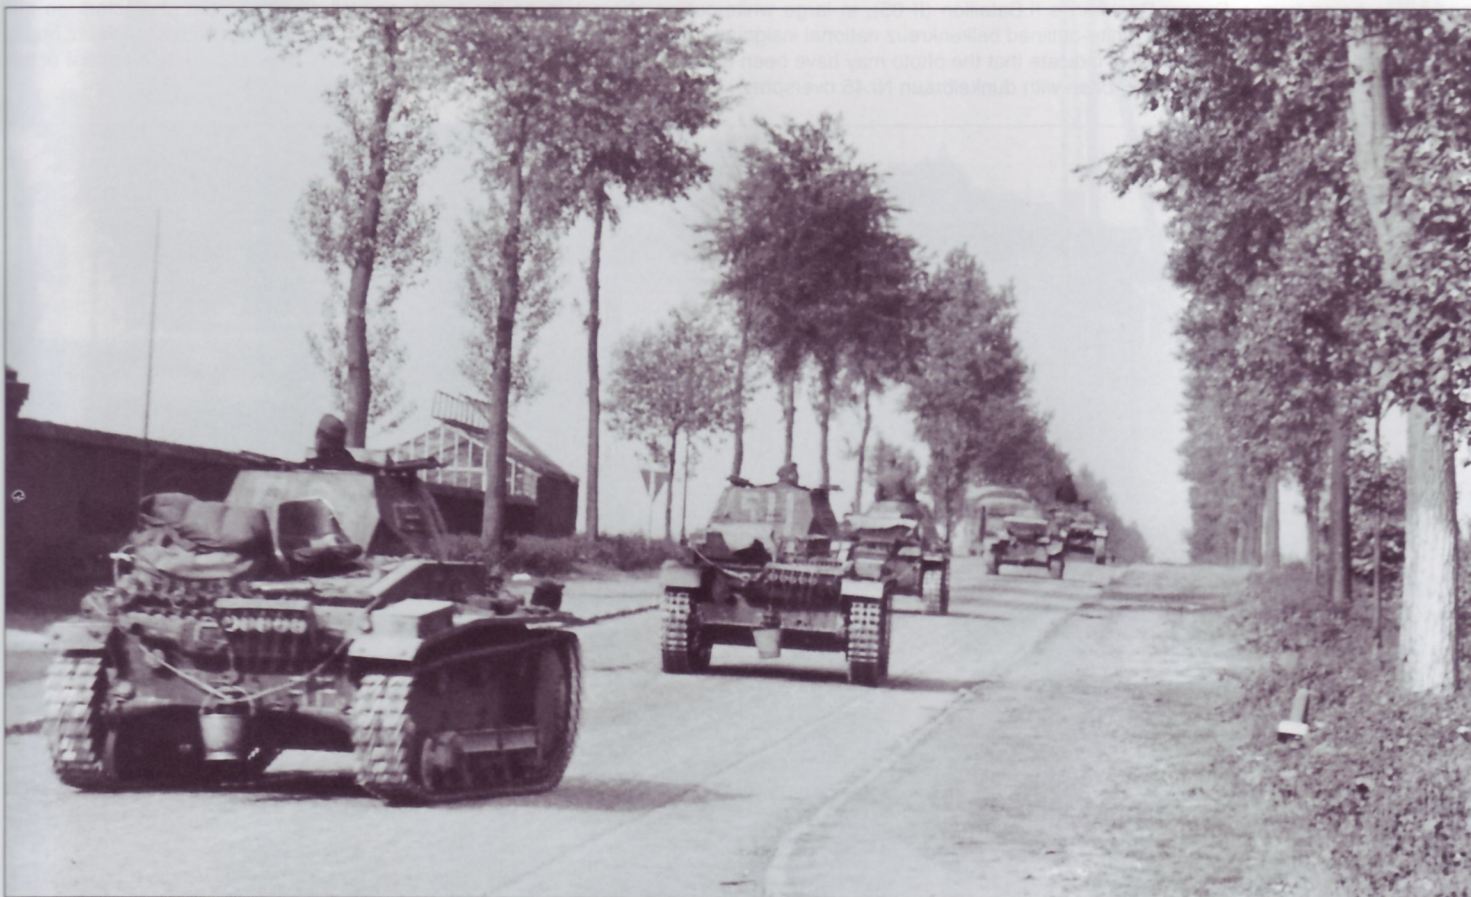
This column of panzers moves up a slight incline along a tree-lined road, probably during the French Campaign of 1940. Note the characteristic girder on the suspension of the near panzer, which identifies it as a Pz.Kpfw.II Ausf.b (note that the designation was in lower case letters; this is not a miss-print). There are no cupolas on the tanks, although these were retro-fitted to the Pz.Kpfw.II series later on. The next furthest vehicle has a tactical number ("511") on the turret rear, probably in yellow; the near vehicle's number is obscured by stowage on the engine deck. The far tanks are difficult to identify, but may include a Pz.Kpfw.35(t) or 38(t).

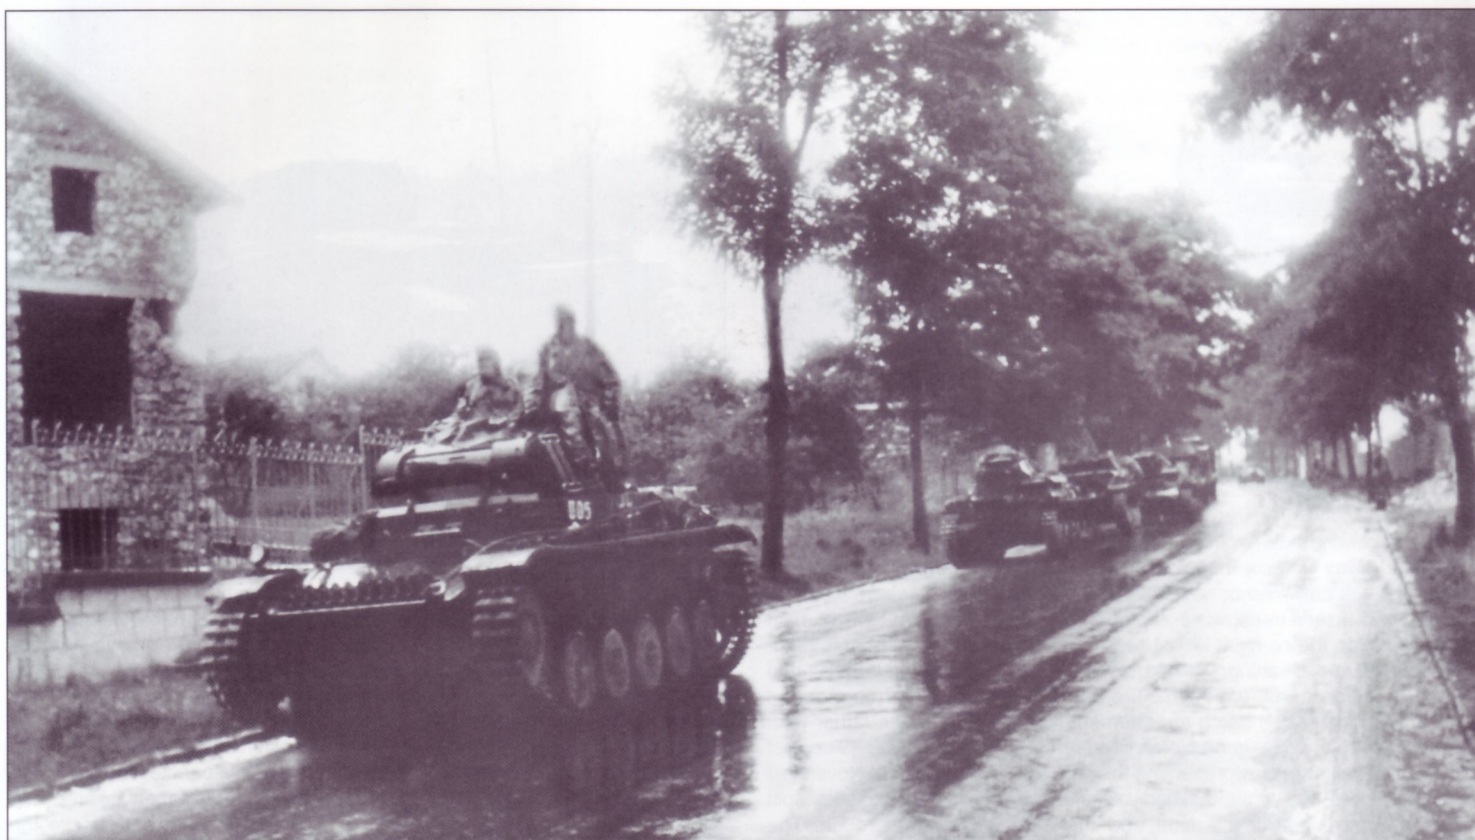
It is a bit difficult to determine which model of a Pz.Kpfw.II (Ausf.A, B or C) one is viewing unless certain features such as the vision ports can be clearly seen. The panzer in the foreground can be any one of these, but it does have a visible retro-fitted feature, the addition of 20mm armor to the turret front (note the bolt heads towards the top of the curved portion to the side of the mantle). When this was done, the superstructure front also had additional 20mm armor fitted, as did the bow. In the latter case, its profile was changed from round to square, giving the armor the added benefit of being "spaced". This panzer is marked as being from a Panzer-Regiment's II.Bataillon (II 05), in large white-outline characters on the turret, as well as small solid characters on the superstructure side. There is also a white-outlined balkenkreuz national insignia further back on the superstructure side. The lack of a Notek black-out headlamp, as well as the hard-surface road, indicate that the photo may have been taken during the French Campaign of 1940. Colors should then consist of the two-tone scheme of dunkelgrau Nr.46 base with dunkelbraun Nr.45 overspray.

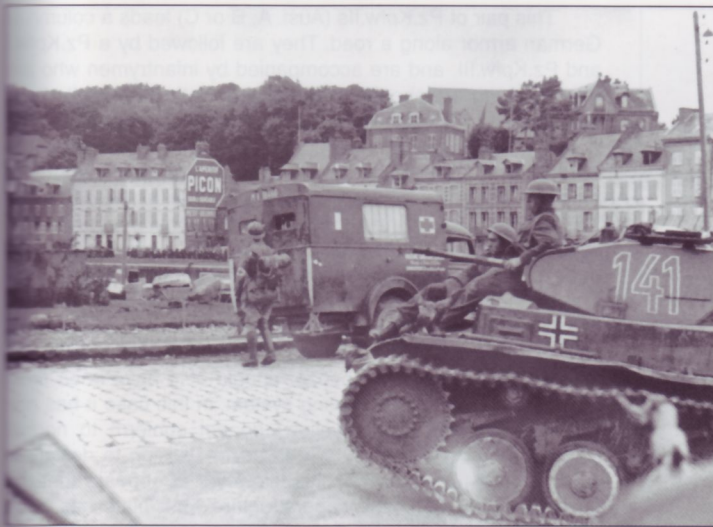
A pair of captured "Tommies" of the BEF (British Expeditionary Force) ride a Pz.Kpfw.II (Ausf. A, B or C) through a coastal French town, while a French Army medic loiters behind an ambulance. The panzer has the retro-fitted armor on the turret front, superstructure and bow; note also a welded patch on the lower edge of the turret, beneath the first numeral of the Tac number ("141"). This is painted in white outline form. The superstructure side has a black balkenkreuz, outlined in white as well as the divisional sign for the 7.Panzer-Division (an inverted "Y" followed by three dots) painted in yellow. Modelers should also note the various shades and patterns of the metal on the 2cm KwK30 gun tube; they should not be confused with painted-on stripes.

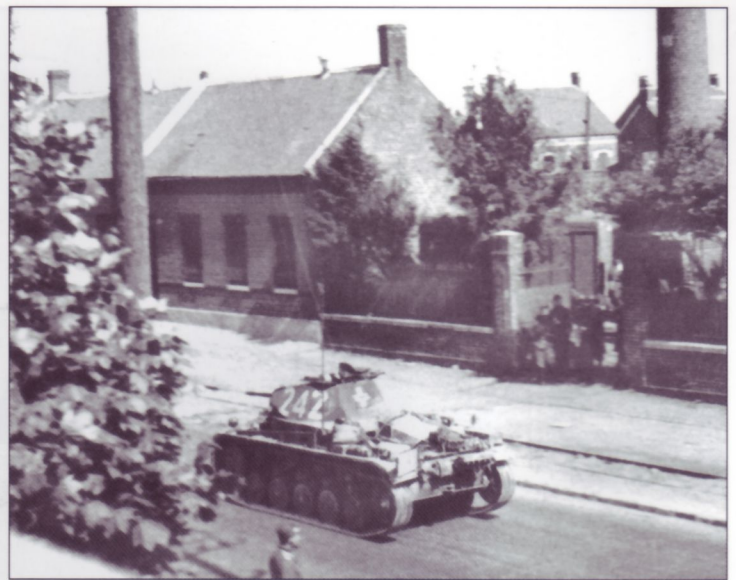
This photograph of a Pz.Kpfw.II (Ausf. A, B or C) was possibly taken surreptitiously by a French citizen, as the panzer passed through his or her town. Note the other local citizens standing warily out of the way between the gate-posts of the building across the street. The panzer has the original split hatch as well as the retro-fitted "Nebelkerzenabwerfvorrichtung" (smoke candle deployment rack) fitted over the exhaust muffler. The large Tac numbers on the turret ("242") as well as the balkenkreuz on the turret rear characterized panzers assigned to the 7.Panzer-Division (see photos elsewhere in this book).

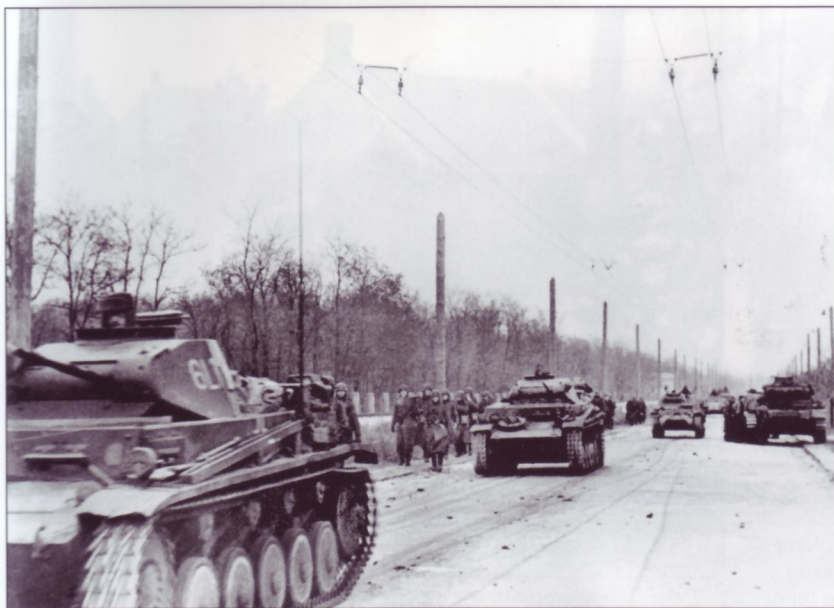
This pair of Pz.Kpfw.IIs (Ausf. A, B or C) leads a column of German armor along a road. They are followed by a Pz.Kpfw.I and Pz.Kpfw.III, and are accompanied by infantrymen who are moving along the shoulder of the road. Both Pz.Kpfw.IIs have the modifications introduced due to experience reports from the Polish and French Campaigns. These include bolted-on armor on the turret fronts, superstructure fronts and a spaced-armor array covering the originally-rounded bow with angled plates. There was also a new circular commander's cupola with periscope vision blocks that replaced the original split-hatch design; note the head protection pad on the opened hatch lid. The armor addressed the problems encountered by enemy use of anti-tank rifles, while the cupola enhanced the vision of the commander when the panzer was buttoned-up. With the modifications shown, the panzer should also have been fitted with the Notek black-out driving system; in this case it has not. The markings, "6L..." (in yellow) do not conform to normal practice, but were used by the 4.Panzer-Division to designate "leichter" (light) tank companies. However, it appears that the divisional insignia on the superstructure front plate has been obscured. Note how the balkenkreuz national insignia (with white outline) on the superstructure side, carries over to the radio antenna's protective storage trough.

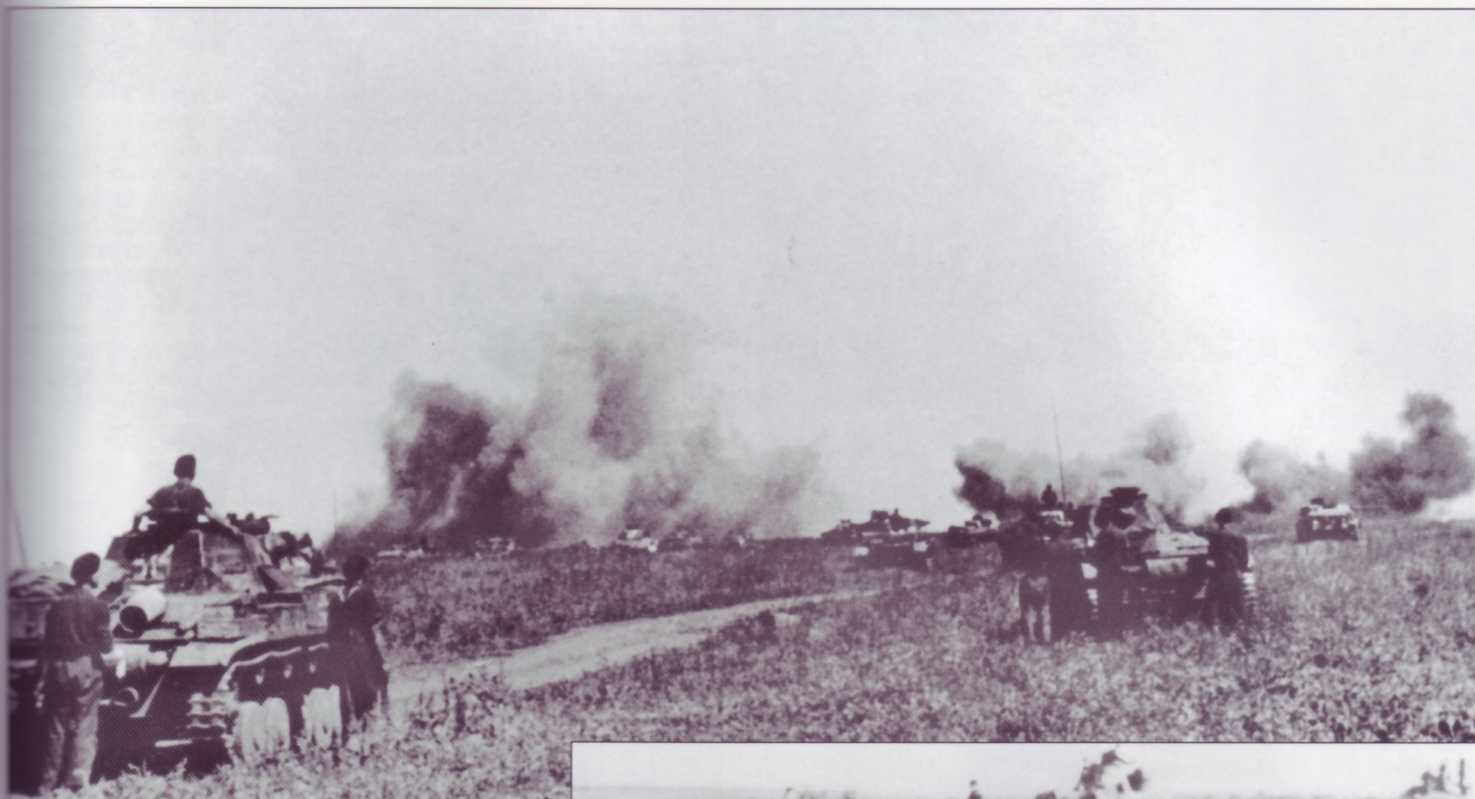
A pair of Pz.Kpfw.IIs (Ausf.A, B or C) shelter in the lee of a ridge as an artillery barrage bursts in the distance. The panzer closest to the camera has a large stowage bin added to the near fender, which was a retro-fitted item. The later circular commander's cupola is also fitted. The Pz.Kpfw.II to the right also has the cupola fitted. The panzer closest to the camera has a white three-digit tactical number on the turret rear (possibly "212") as well as a white-outline balkenkreuz national insignia below it; this is a rather unusual arrangement. The crew members of the near vehicle are in shirt-sleeve order, and wear their berets over the padded inner helmet.

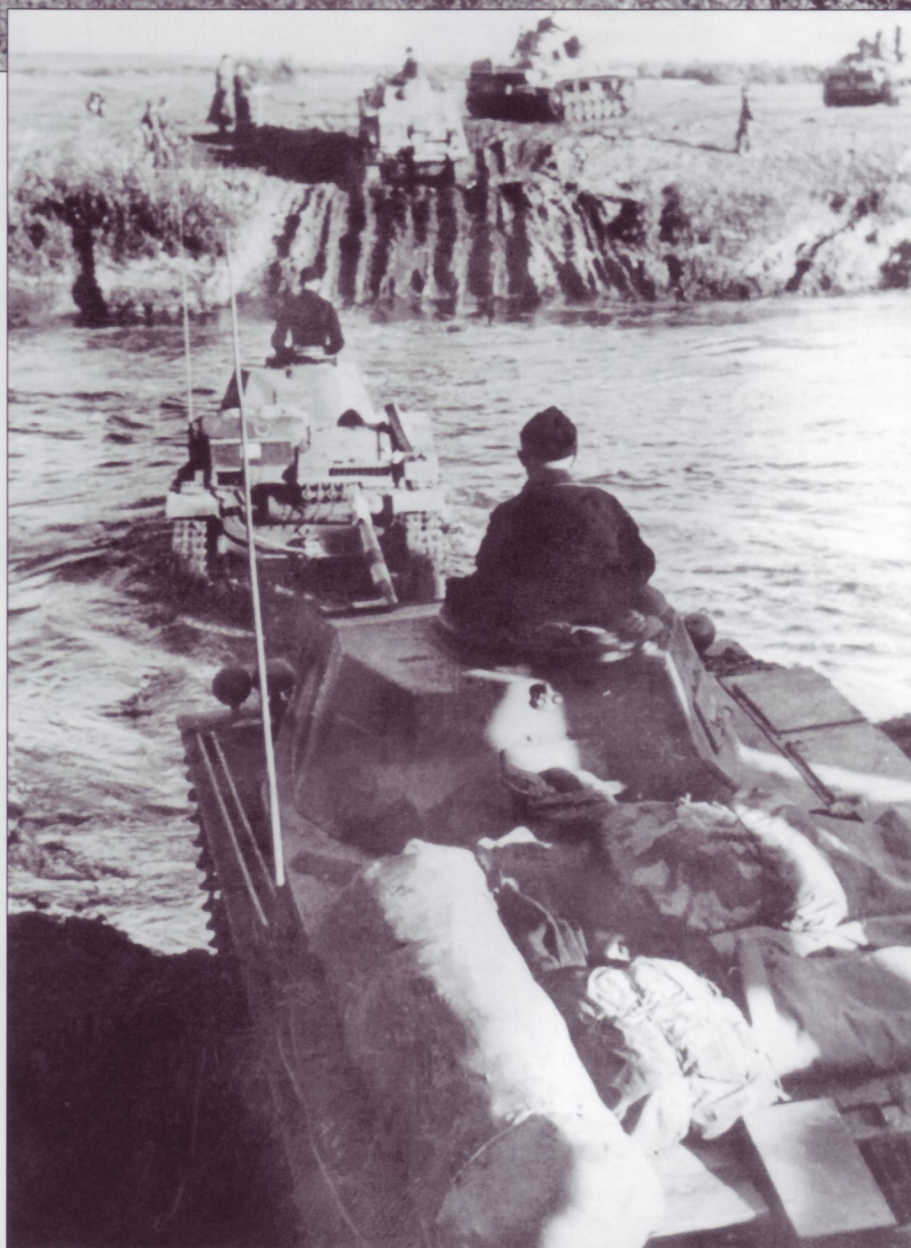
This trio of Pz.Kpfw.II (Ausf.A, B or C) crosses a river behind a pair of Pz.Kpfw.IIIs. They are fitted with the circular vision-block-equipped commander's cupola as well as the large stowage bins on the fenders, while the nearest panzer has the additional armor on its gun mantle and a Notek head-lamp next to the standard head-lamp on the fender. All are cluttered with stowage items. Also of note is the pattern of metal-work on the 2cm KwK30 gun tube, which makes it appear as if stripes are painted on it.

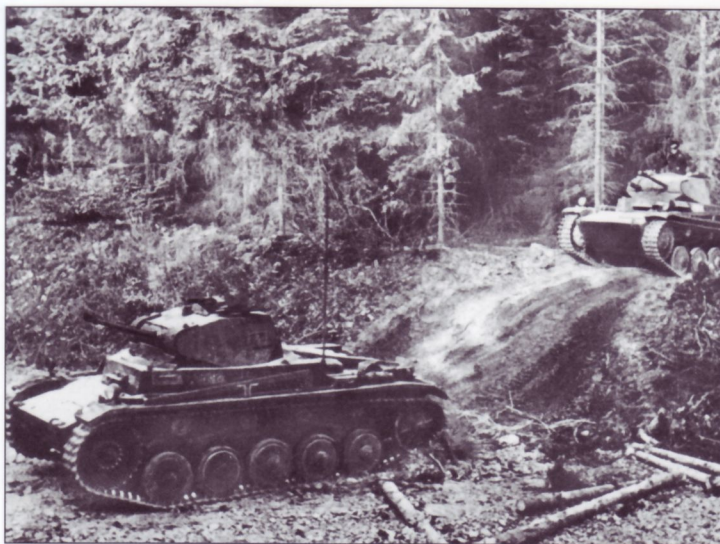
This pair of Pz.Kpfw.IIs (Ausf.A, B or C) break cover as they emerge from a forest. Both are fitted with extra armor plating over their curved bow sections, which as a result, are now squared-off. This extra armor was fitted as a result of experience in the Polish Campaign, where Polish anti-tank rifle fire was often quite intense. The lead vehicle is fitted with the original split hatch for the commander, while the only marking visible is a white-outline balkenkreuz.

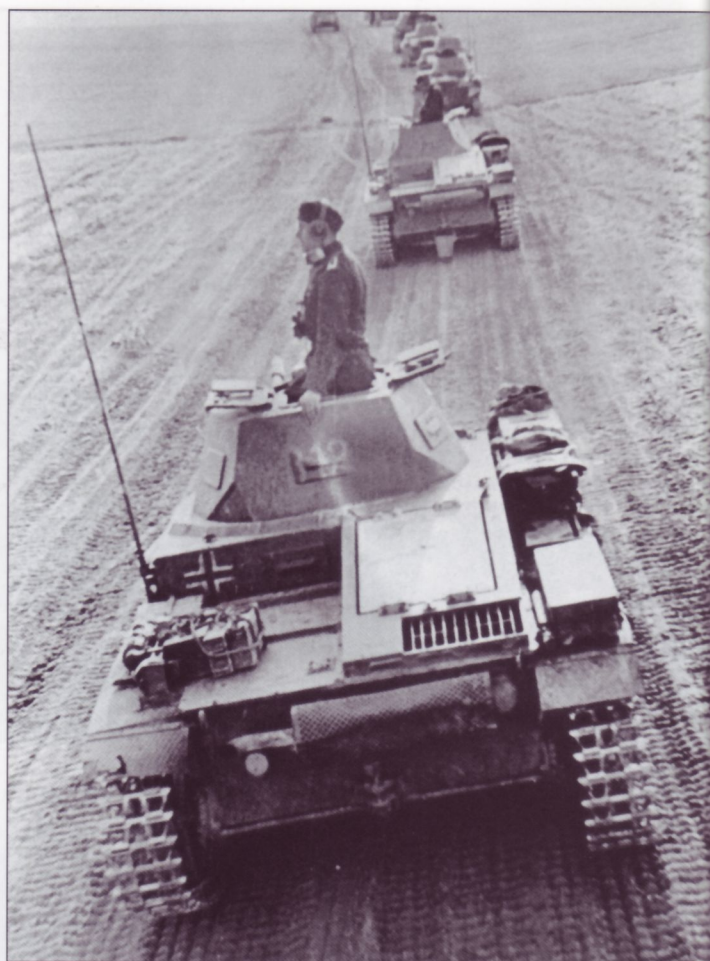
A pair of Pz.Kpfw.IIs (Ausf.A, B or C) bring up the rear of a column of panzers. The near panzer carries a black balkenkreuz with a white outline as well as a Tac number in yellow ("312") on the rear face of the turret. It has the early split hatch for the commander as well as a large stowage locker on the right fender. Stowage includes 7.92mm ammunition boxes secured on the flat part of the engine deck.

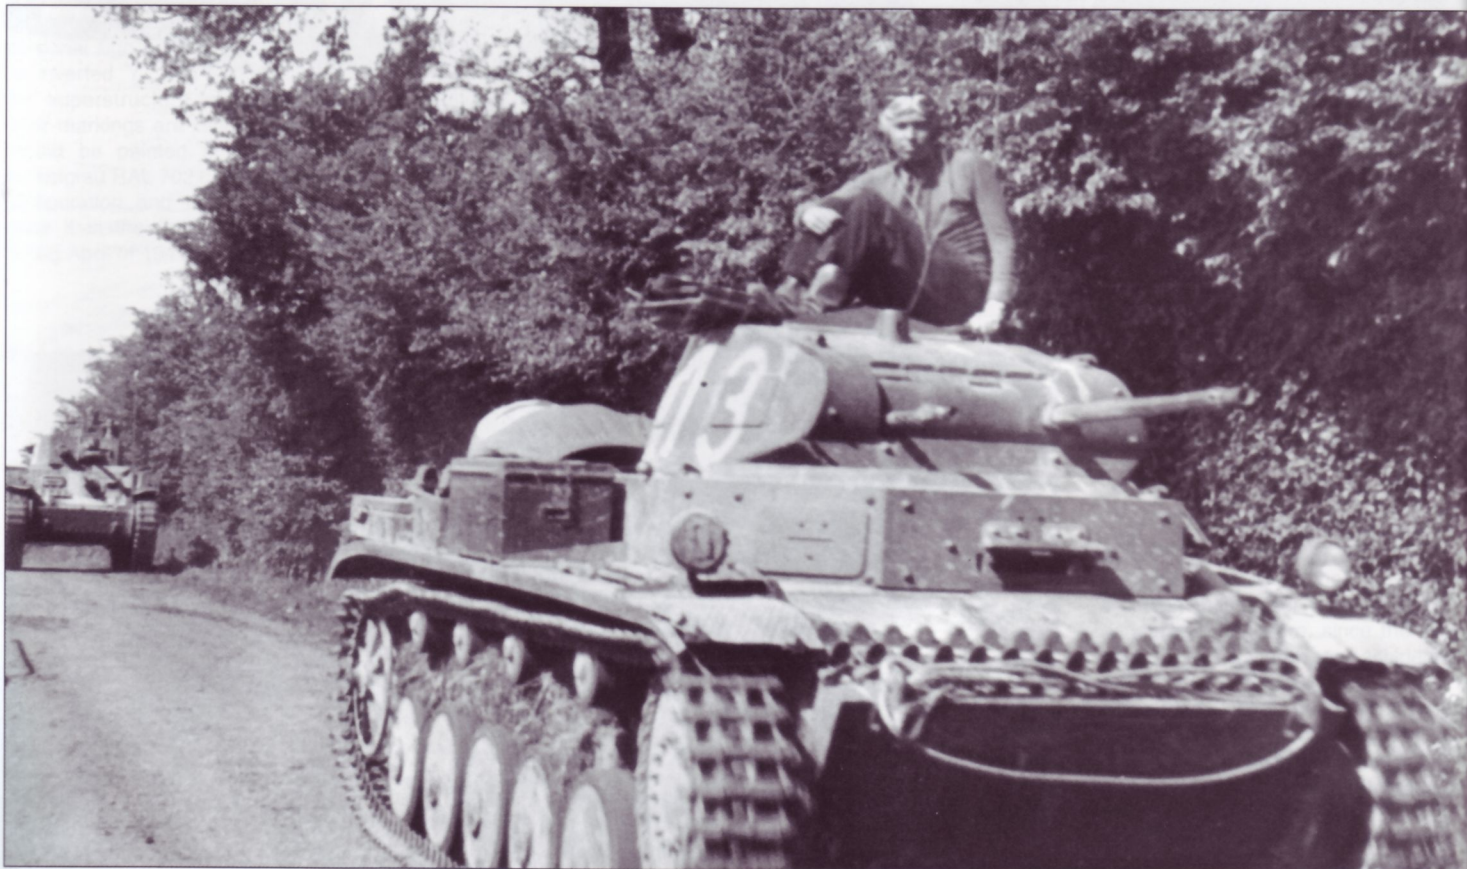
This Pz.Kpfw.II shows the retro-fitted armor arrays quite well. Note the bolt patterns on the turret face as well as the superstructure front plates, which indicate the fitting of the extra armor. The bow's shape was also changed from rounded to angular with the addition of the upper and lower glacis plates. Note the storage box fitted to the fender as well as the spare track and tow cable fixed to the glacis plate. The forward part of the Tac number on the turret, a large "3", is the only numeral completely visible. Note how the road-wheel hubs have become dust-covered, while the tires have not, as well as the mud covering the spring assemblies; the panzer is also covered in so much dust that it appears much lighter in color than it actually was.

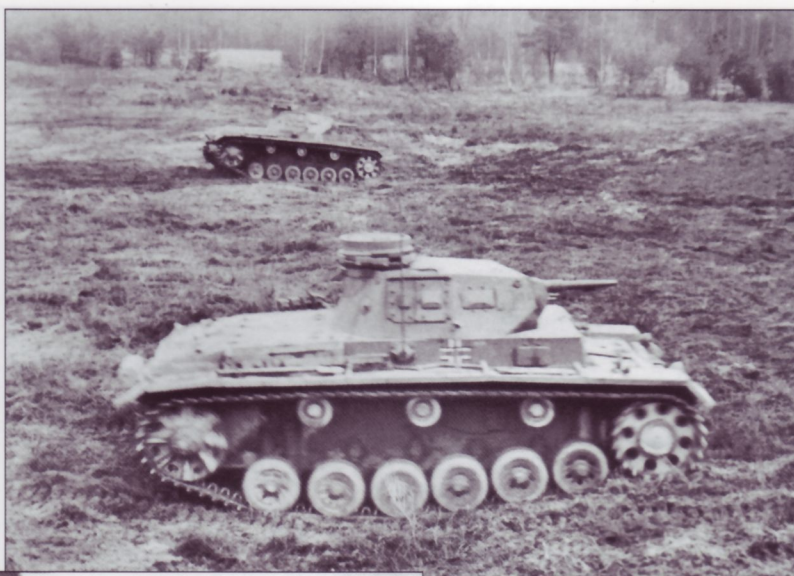
A pair of Pz.Kpfw.III Ausf.Es cross a rough field during a training exercise. Note especially how the panzer's torsion bar suspension easily and smoothly conforms to the broken ground. The Pz.Kpfw.III was the first modern main battle tank, possessing features that are still seen on tanks to this day. For instance, the turret crew had specific duties; the commander coordinated the actions of his crew and the actions of his panzer with others; the loader loaded the main weapon, while the gunner sighted and fired it. This is in contrast to other contemporary tanks where each of the turret crewmen was usually assigned more than one specific task (for instance, some French tanks had a commander who also loaded and fired the main weapon). The remainder of a Pz.Kpfw.III's crew (the driver and the radio operator) also had specific tasks that they performed in a combat situation. Thus, a properly trained crew could coordinate their actions to optimize their panzer's performance as an individual combat vehicle and concentrate their efforts in support of neighboring panzers.

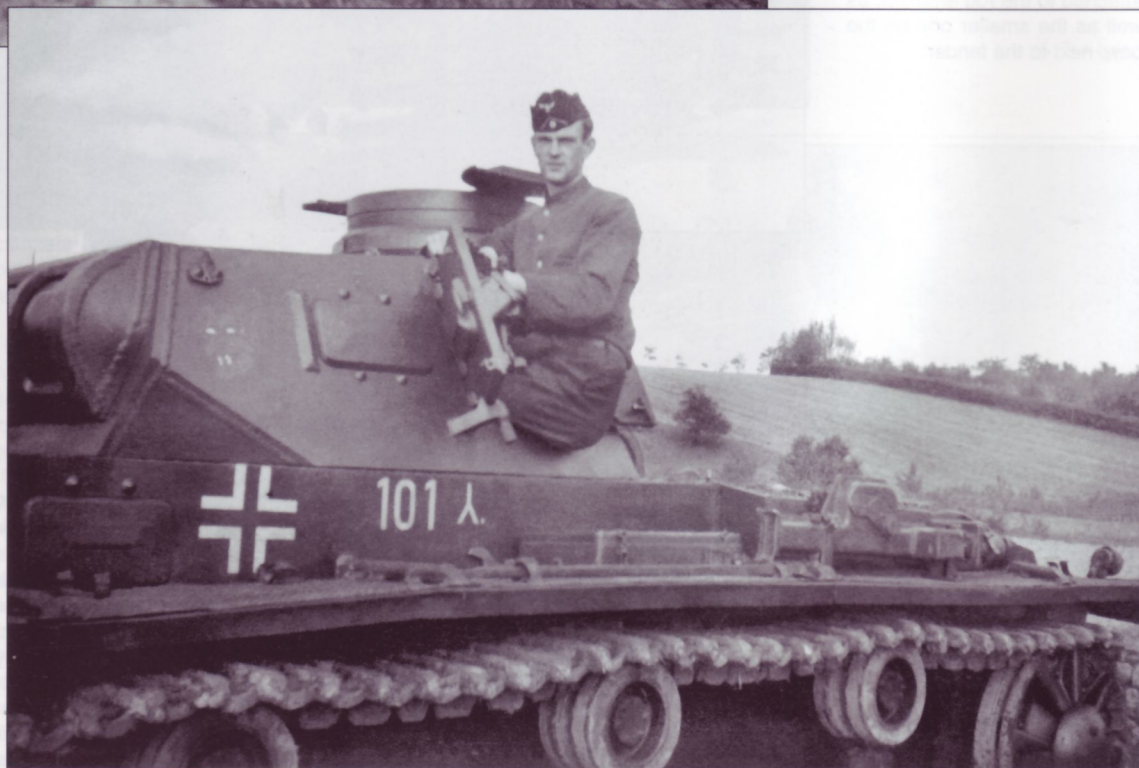
This Pz.Kpfw.III Ausf.E belonging to the 5.Panzer-Division is seen during training. It belongs to the 1.Kompanie of Panzer-Regiment 31. Note the small tactical numbers ("101") painted in yellow next to the divisional insignia (an inverted "Y" with one dot). The national insignia is in the white outline form, while the regimental insignia, a "Devil's Head" is just visible on the front edge of the turret side. No machine guns are fitted, while the only extra stowage other than the standard vehicle items is a length of spare track across the glacis plate. The crewman wears M1933 denim work clothes (in the later and more practical "reed-green" color) along with his black M1935 Feldmütze (field cap).

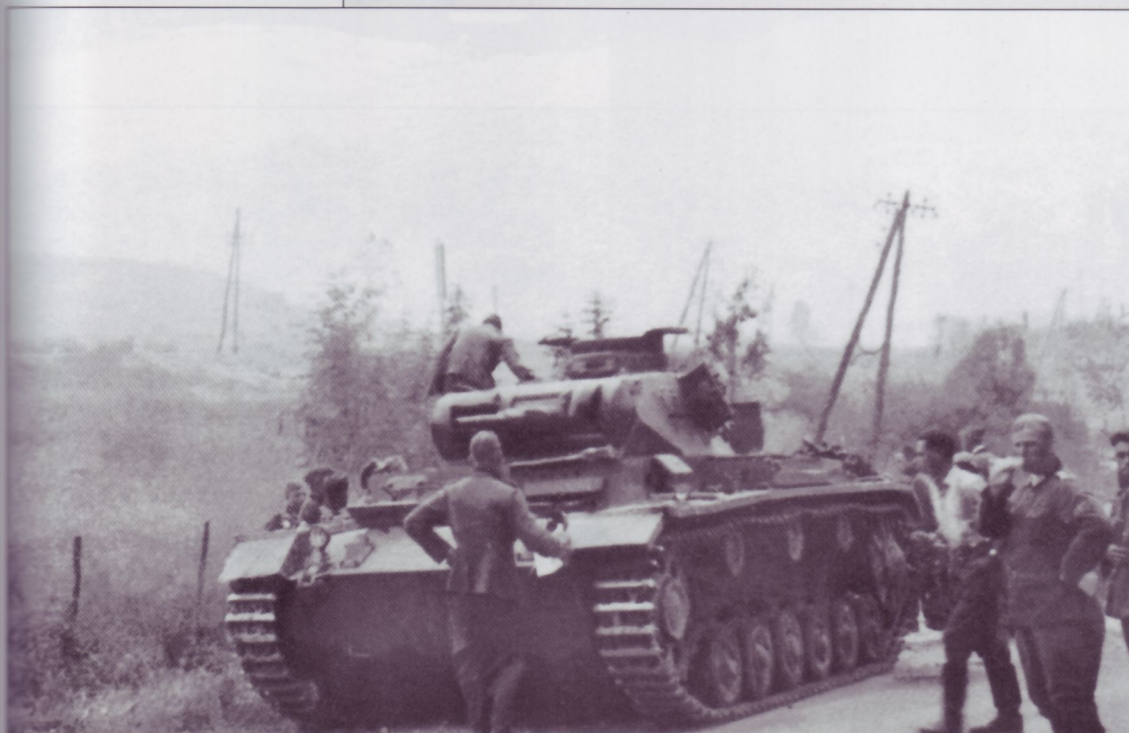
The Pz.Kpfw.III Ausf.F introduced the small armored cooling vents for the transmission on the glacis plate, as seen here. This panzer seems to be un-marked and does not mount a Notek head-lamp, while the surrounding elements suggest that the photo was taken during the French Campaign of 1940.
