# PANZER VOR!

German Armor at War 1939-45

Frank V. De Sisto

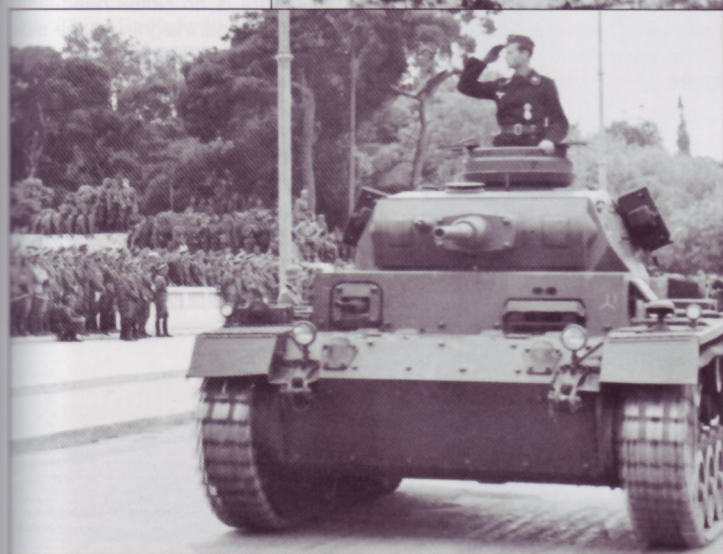
With the advent of the Pz.Kpfw.III Ausf.H (pictured here), a new cupola was added to the turret as was a circular vent on its roof; the rear face of the turret was a continuous plate, which the cupola did not intrude upon. The 5cm KwK38 L/42 fitted within a newly-designed external mantle was standard armament for most of these panzers; note the view ports on either side of the gun as well as the armored sleeve around the co-axial MG34. A new, pivoting driver's visor was fitted, while the hull's bow, glacis and superstructure all have bolted-on 30mm appliqué armor plates; note how they are fitted around the MG34, driver's visor and tow points. A Notek head-lamp is mounted on the driver's side fender, while the conventional head-lamps do not have slotted black-out hoods fitted. The visible marking next to the driver's visor (a yellow inverted "Y" with a single vertical stroke) represents the 2.Panzer-Division, after 1941. There also appears to be a small white outline square on the side of the turret, towards the front.

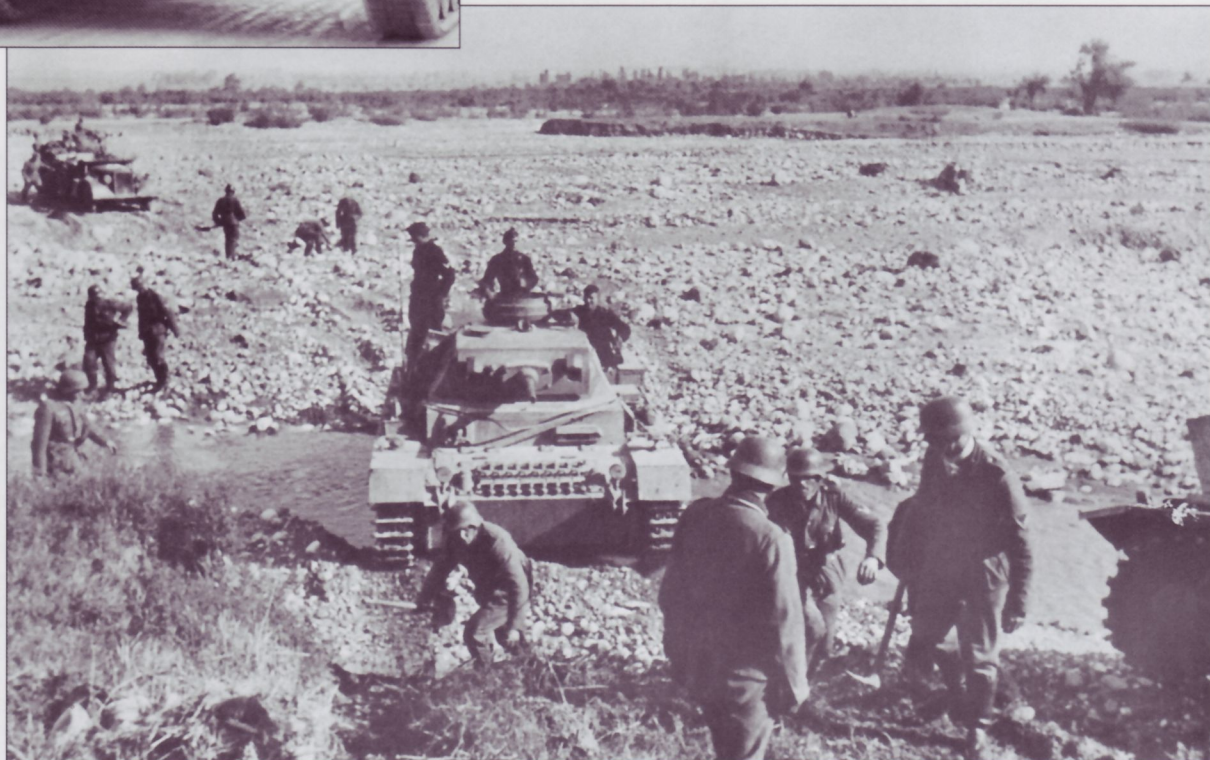
This Pz.Kpfw.III Ausf.G/H fords a small stream, while pioniere troops (combat engineers) work to keep the bank in condition to support a crossing by a large number of vehicles. Note the tow cables at the ready and the spare tracks stored on the glacis plate between the two transmission cooling-air cowl. The two visors on the mantle are open and there is a Notek head-lamp on the driver's side fender. No markings are visible in this head-on view.

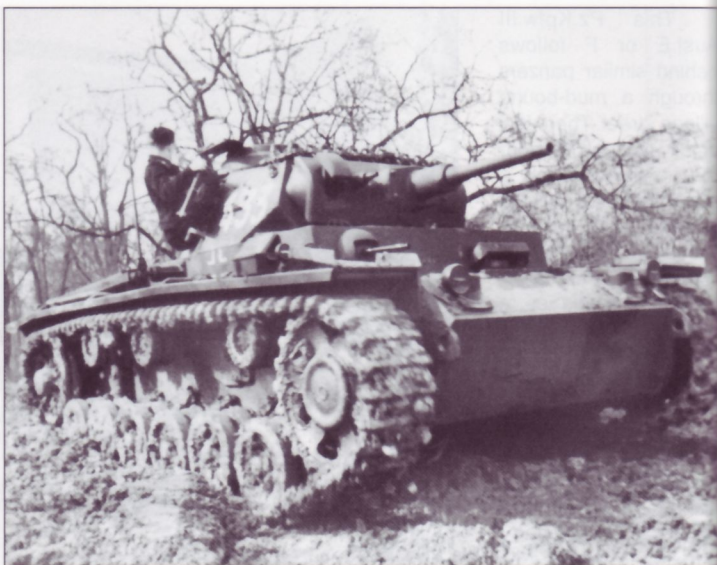
This fine photo clearly shows all of the main recognition features of the Pz.Kpfw.III Ausf.J: later drive sprocket and idler wheel (introduced on the Ausf.H); superstructure front plate of 50mm thickness with ball-mounted MG34 and hull side extensions drilled to accept tow hooks. Note the way the mud flaps could be folded back onto the fenders and the black-out driving slits covering the conventional head-lamps. There is no Notek head-lamp mounted. There is a white-outline balkenkreuz national insignia on the side of the superstructure and a white tactical number ("733") on the side of the turret.

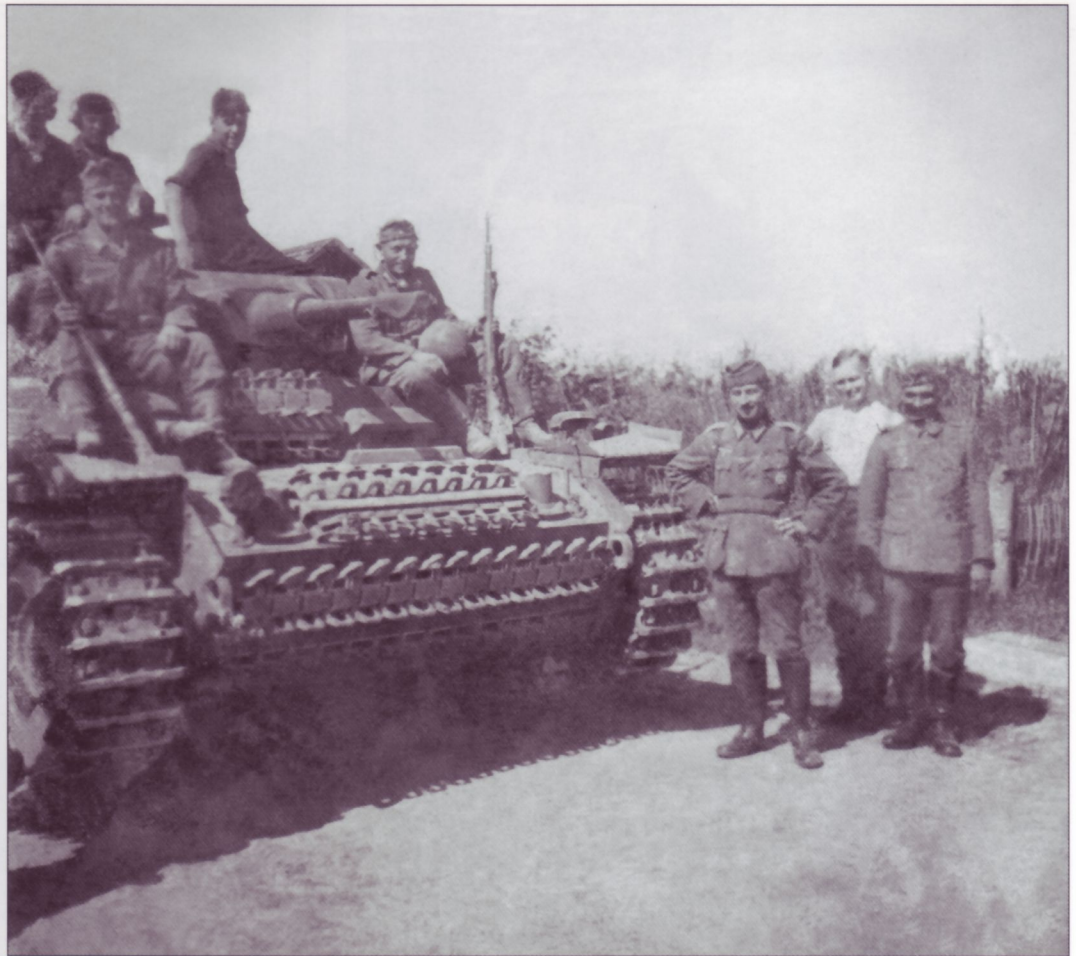
This Pz.Kpfw.III Ausf.J moves towards the front loaded down with almost 20 infantrymen. Note the new-style drive sprocket (introduced on the Ausf.H) and idler wheel as well as the hull extensions, which are drilled to accept tow hooks. There is a Notek head-lamp beneath the soldier perched on the near fender; note that both fenders lack their mud flaps.

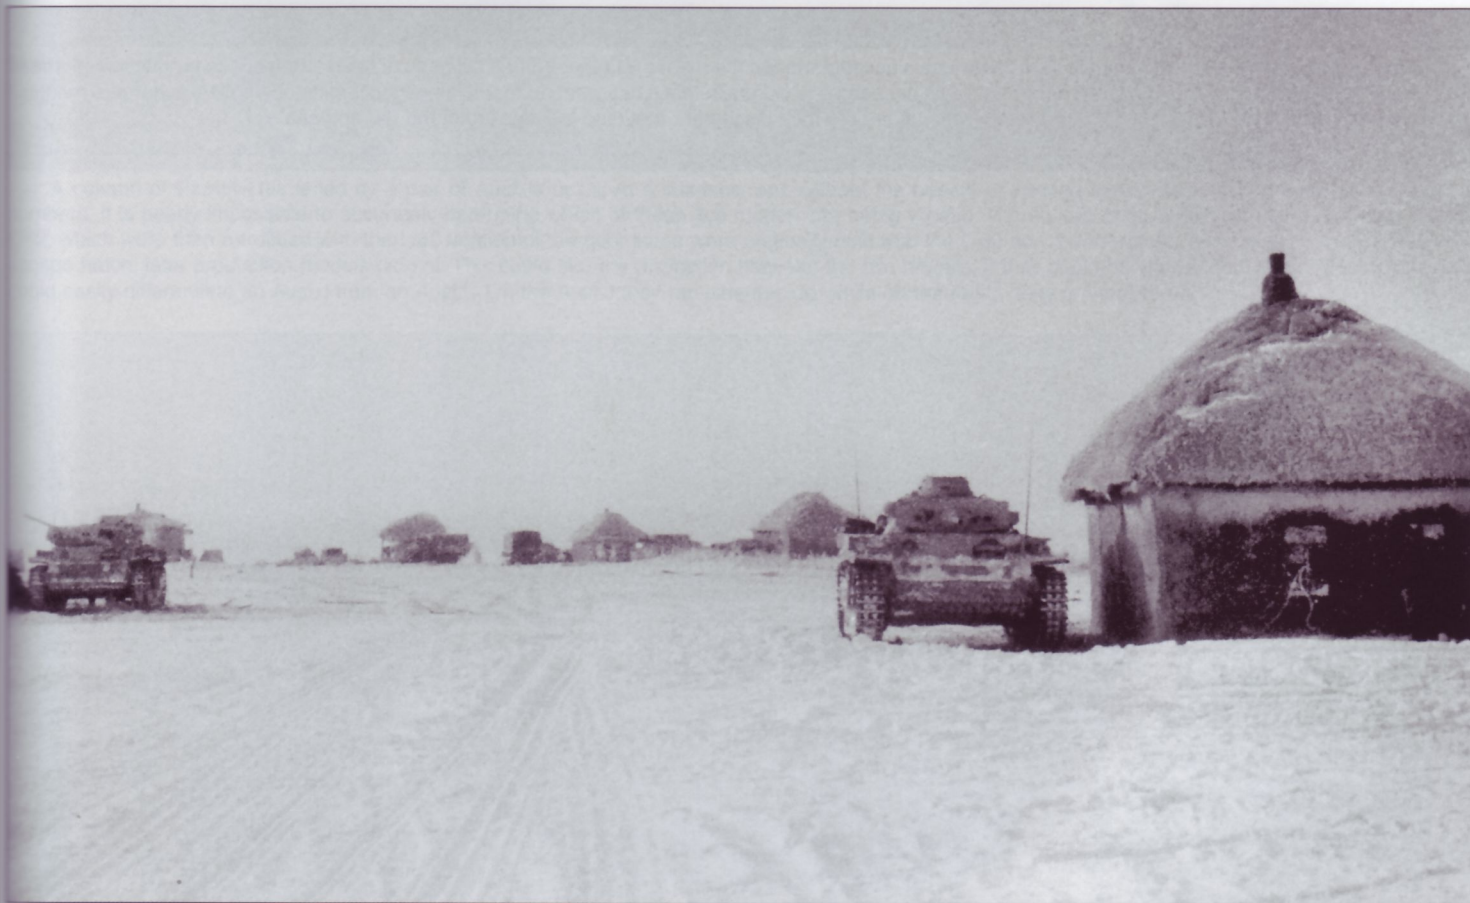
A Befehls-panzer, based on the Pz.Kpfw.III Ausf.J or L sits next to a peasant's home on the open steppes of the Soviet Union. There are two rod antenna masts, one on either side of the panzer, as well as 20mm spaced armor on the mantle and the superstructure front plates. This panzer also seems to be mounting the longer L/60 version of the 5cm KwK39 main gun.

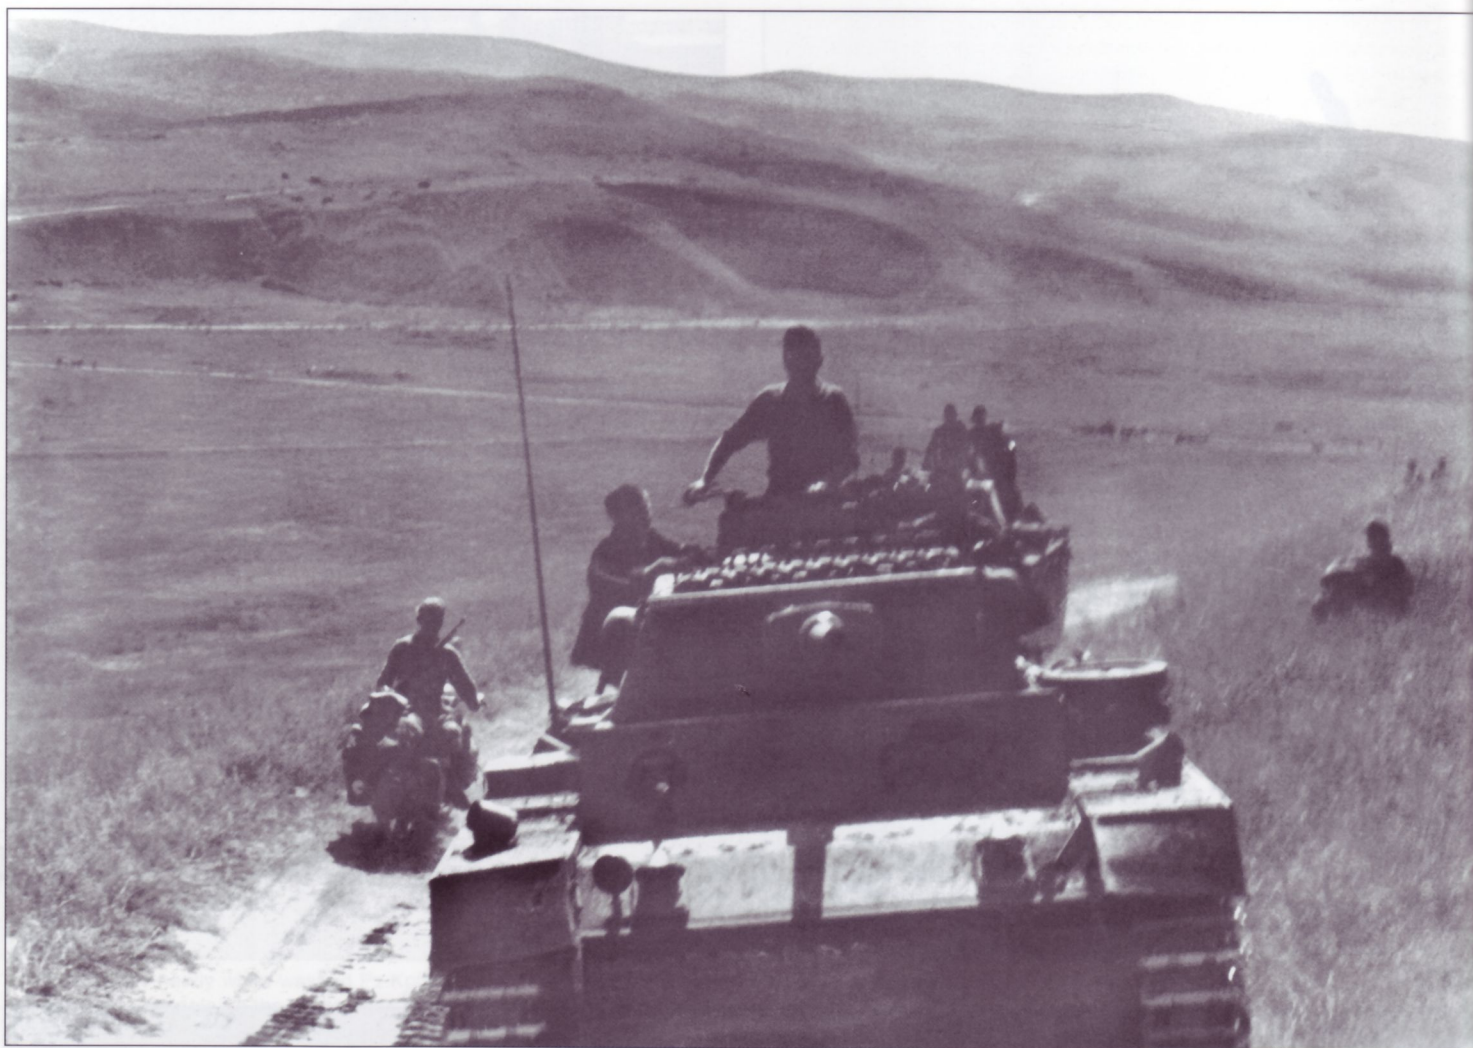
This Pz.Kpfw.III Ausf.J or L has the frame for additional spaced armor on the mantle, but the armor itself has not been fitted, due to production shortfalls. That on the superstructure front has been fitted. This particular panzer is unique in that it has what appear to be either S-mine or smoke dischargers mounted on each fender, just behind the mud flaps. There also seems to be a third discharger mounted just forward of the rod antenna.

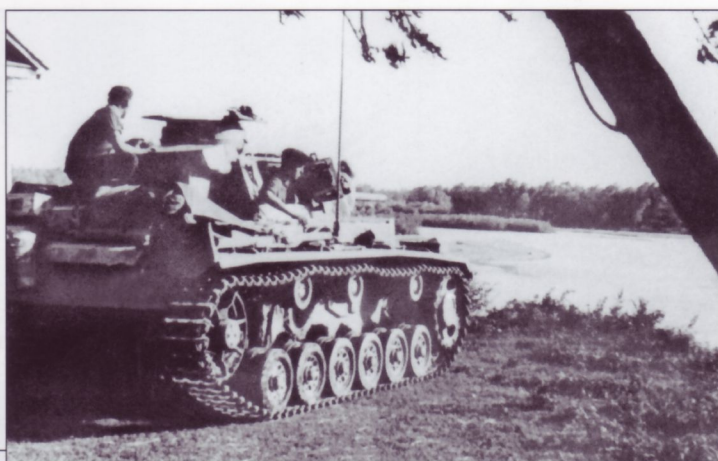
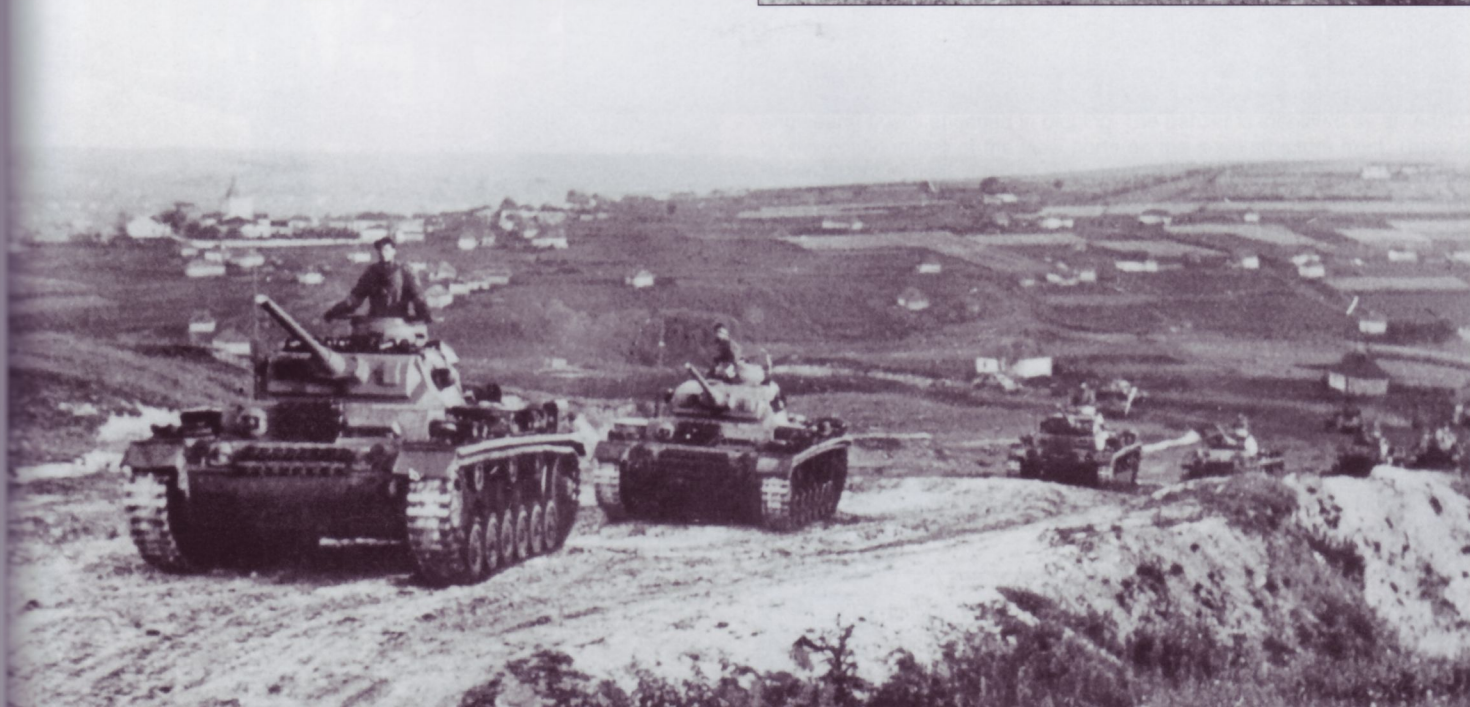
A column of Pz.Kpfw.III is led by a pair of Ausf.Js or Ls. At a distance, and without the benefit of viewing certain features, or knowing the chassis numbers, it is nearly impossible to accurately determine which of these two models are being viewed. There were Ausf.Js built with the short 5cm KwK38 L/42, which were then retrofitted with the L/60 version of the gun; some were originally built with the L/60 gun. Furthermore, early Ausf.Ls had the hull side escape hatch; later production models did not. This could blur the distinction between the two models. If they could be viewed, the engine deck vent cowl could easily differentiate an Ausf.J from an Ausf.L. On the Ausf.J they ran side-to-side, while on the Ausf.L they ran fore-to-aft.

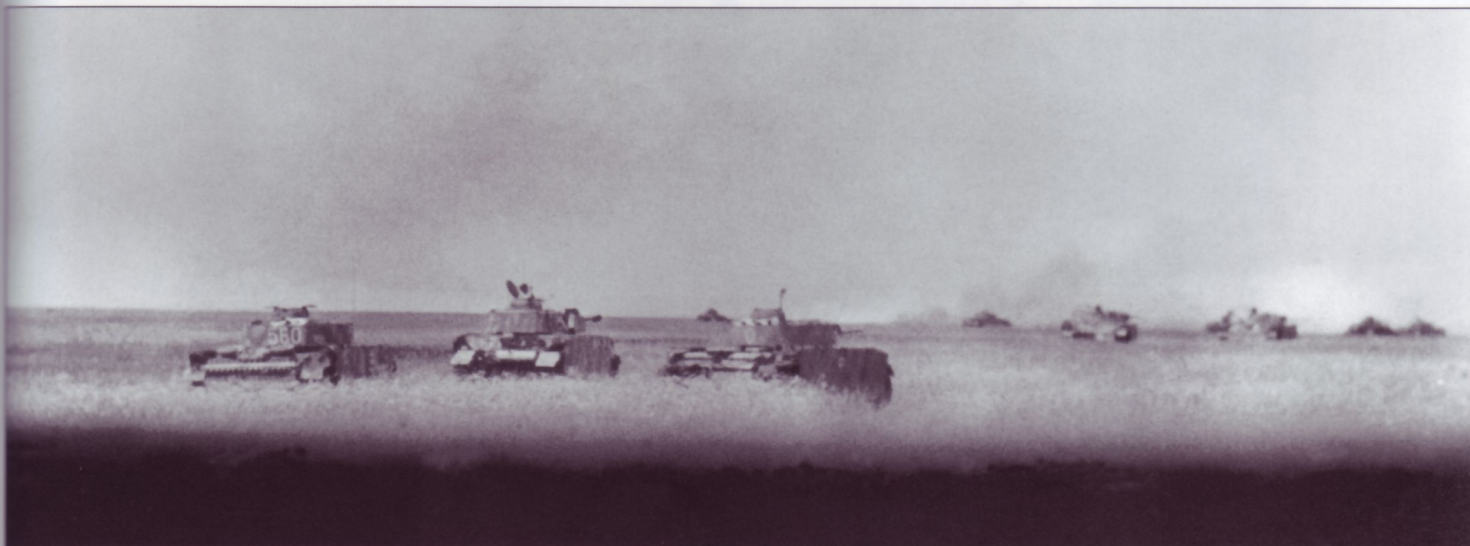
A pair of Pz.Kpfw.III (probably Ausf.Js) flank a Pz.Kpfw.IV Ausf.G or H, as seen through the view port of an accompanying AFV. All of these panzers have turret and hull "Schürzen" armor skirts, which were designed to protect their thinner sides from Soviet anti-tank rifle fire. Note the tactical number, "560" on the turret Schürzen of the Pz.Kpfw.III at left, and what may be a periscope projecting from the roof of the Pz.Kpfw.III at right. If this is so, the panzer is probably a Beobachtungspanzerwagen (armored artillery observation vehicle).

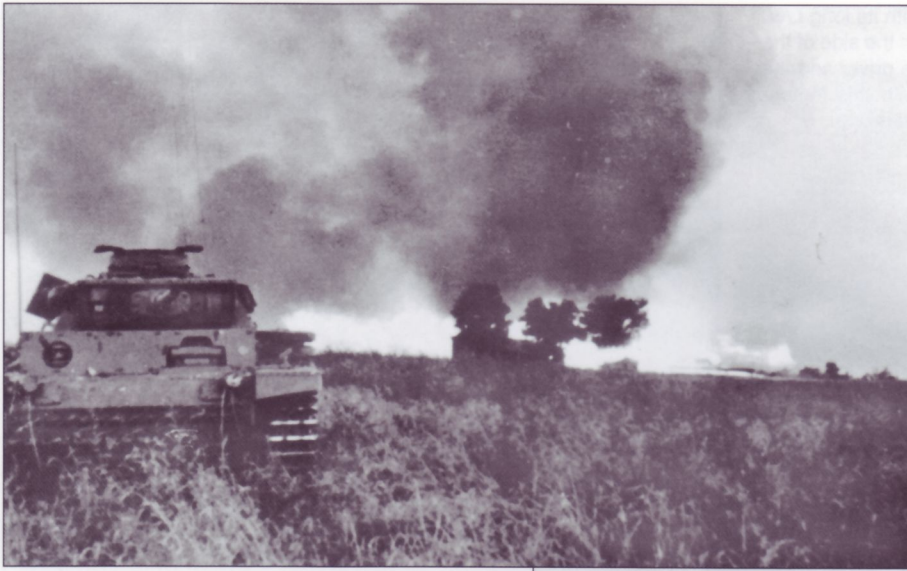
What is probably a Pz.Kpfw.III Ausf.L awaits developments under a sinister sky. The frame for the spaced armor is fitted to the mantle (but not the armor) on this L/60-armed panzer. To the right of the driver's visor, on the spaced armor, there appears to be a divisional insignia, possibly a "grenadier's head within a circle" of the 26.Panzer-Division.

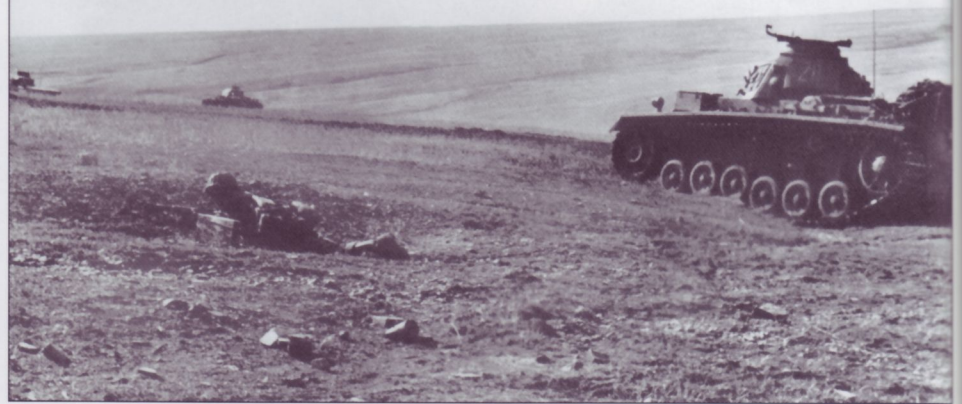
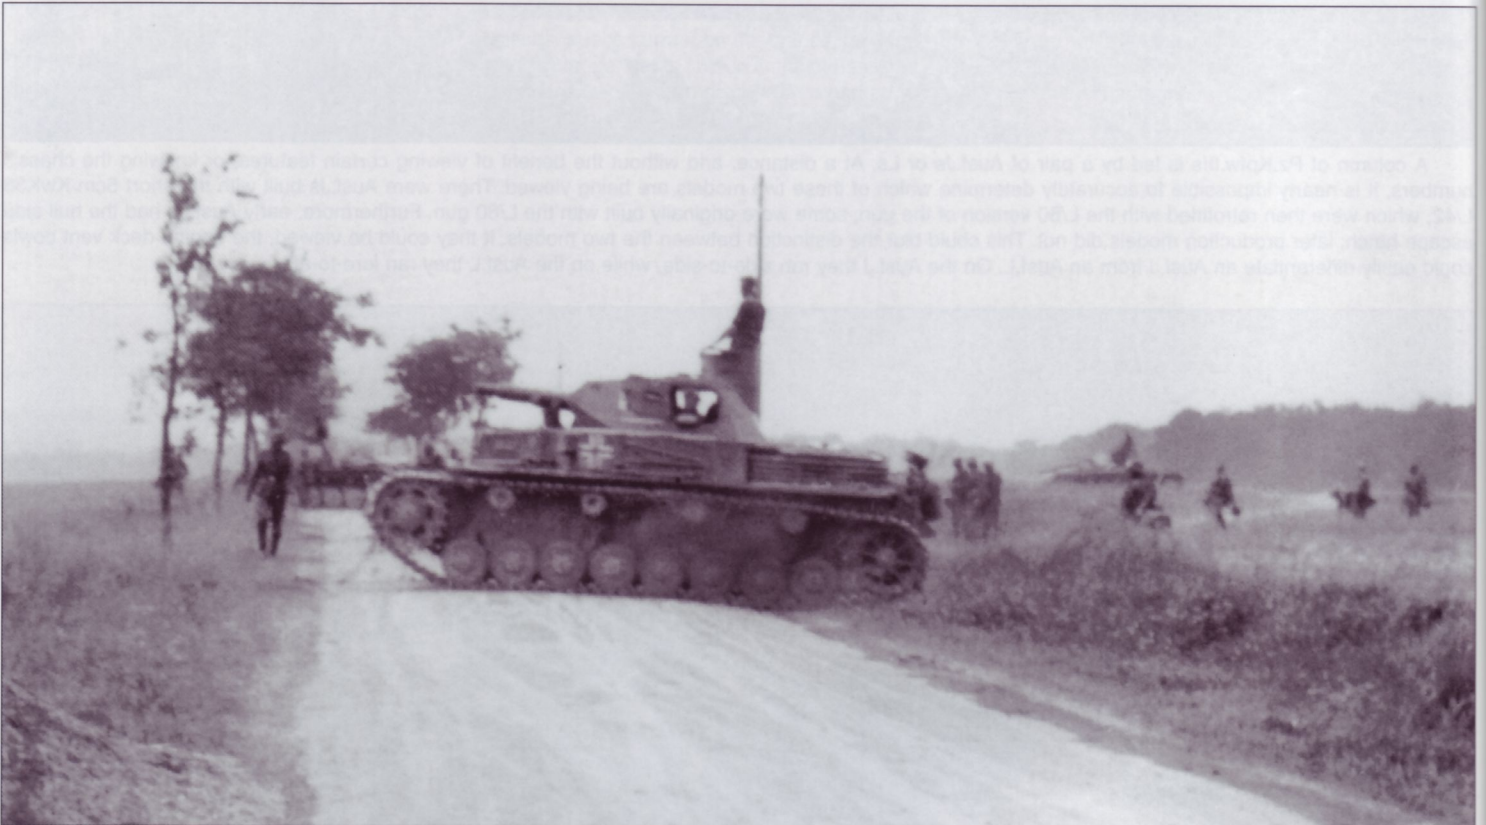
With only 35 built, the Pz.Kpfw.IV Ausf.A was a relatively rare panzer. This one is marked with the white-outline balkenkreuz on the superstructure side and also has an underlined tactical number (unfortunately obstructed by the open hatch) on the turret's side. It is distinguished as an Ausf.A by the shape of the commander's cupola as well as the triangular frame-like device on the side of the superstructure, behind the national insignia. This was a mount for an anti-aircraft machine gun, which could be swung away from the panzer in order to be trained on an aerial target. Other early panzers, such as the Pz.Kpfw.II also had a mount of this type.

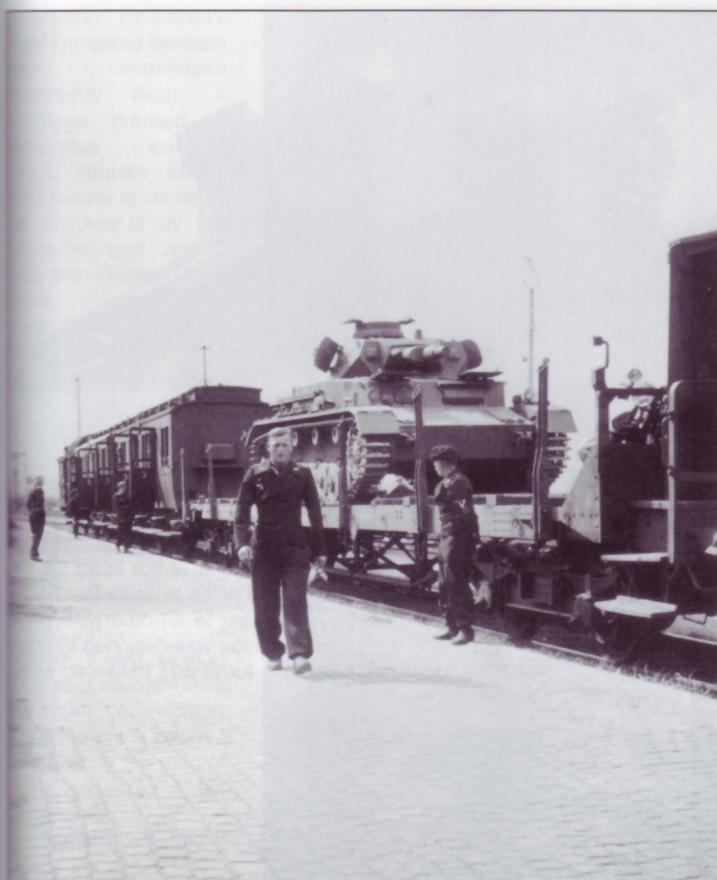
A lone Pz.Kpfw.IV Ausf.C sits on a platform wagon at a rail-head. The panzer is identifiable as an Ausf.C by the arrangement of the view ports on the superstructure front. Note also that the cupola differs from that of the Ausf.A seen in the previous photograph. There are no markings visible, while the crew members wear the black M1934 panzer uniform, along with the characteristic large black beret. Typically, the Germans did not chain tracked vehicles to rail wagons, preferring instead to use wooden blocks and chocks to prevent fore-to-aft and side-to-side movement.

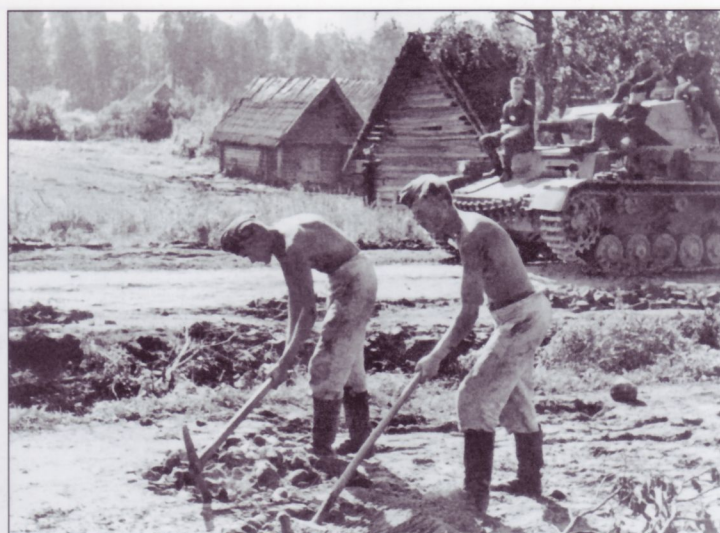
This Pz.kpfw.IV Ausf.C passes a pair of pioniere troops (combat engineers) busily engaged in digging. The panzer is identified as an Ausf.C by the configuration of the view ports on the superstructure front. There is length of spare track fitted to the bow and an improvised jerry can rack on the fender. The turret has been retro-fitted with a storage bin, a very common occurrence.

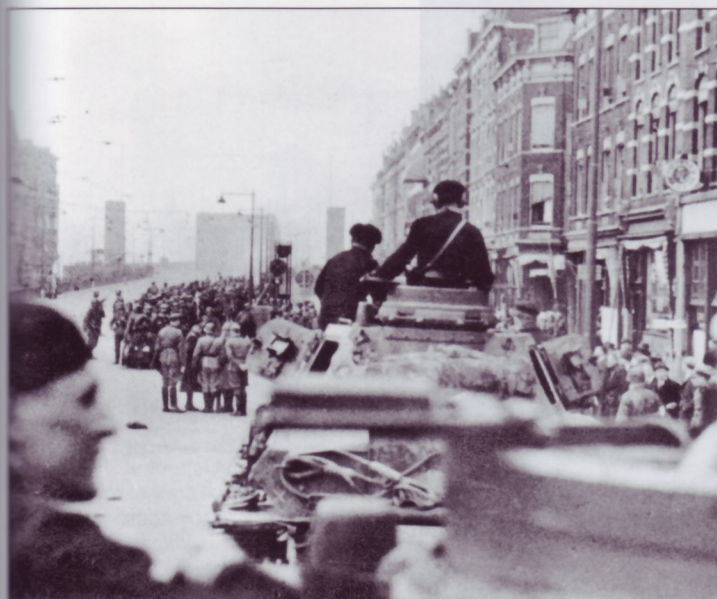
A column of Pz.Kpfw.IVs (Ausf.B, C or D) park on a wide western European boulevard, during the 1940 campaign. The cupola configuration identifies these panzers as being later than the Ausf.A. There is an "X" marking on the rear plate of the panzer in the center of the photo, indicating the 8.Panzer-Division, which fought in the campaign as part of KLI.Panzer-Korps under Panzer-Gruppe von Kliest. It is possible that there is a second "X" beneath the tow cable; if so this is a panzer from the 9.Panzer-Division of Heeresgruppe B in the Netherlands. All visible crewmen wear the black M1934 panzer uniform with berets, while the commander of the panzer in the center wears a "Sam Brown" belt.

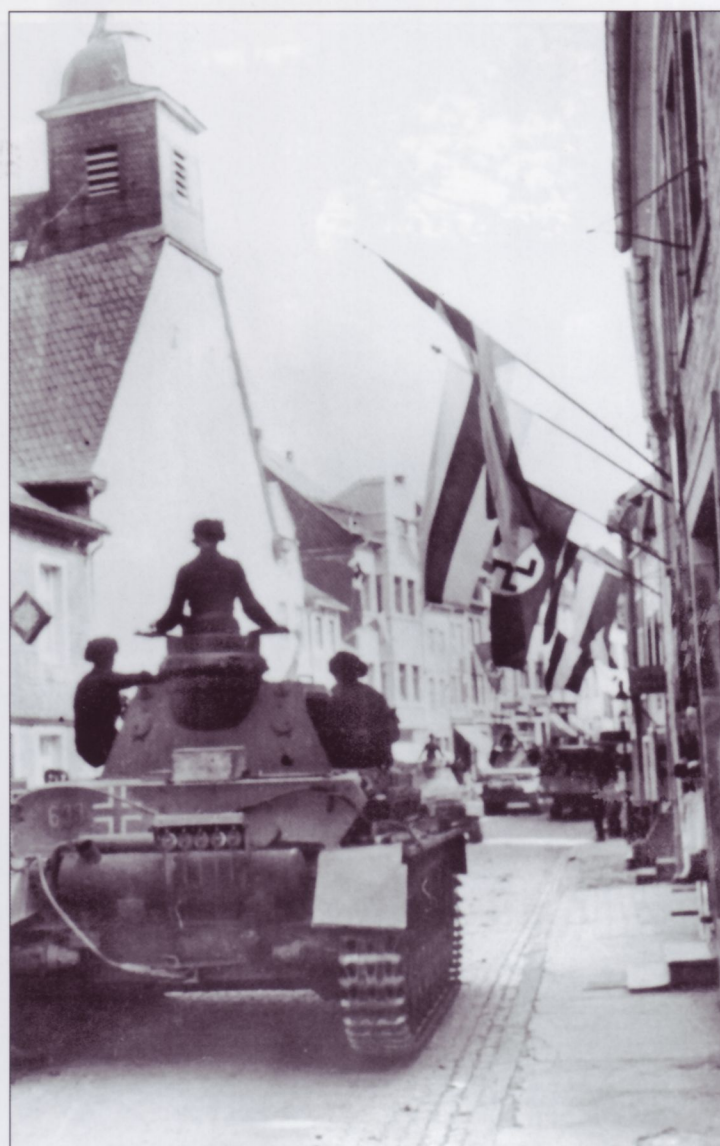
A Pz.Kpfw.IV (Ausf.C or D) winds its way along a narrow European street. Apparently some form of welcome by local Nazis has been prepared, as the banners and flags hanging from the building at the right indicate. The panzer wears a white-outline balkenkreuz as well as yellow tactical numbers ("633") on the superstructure rear plate.

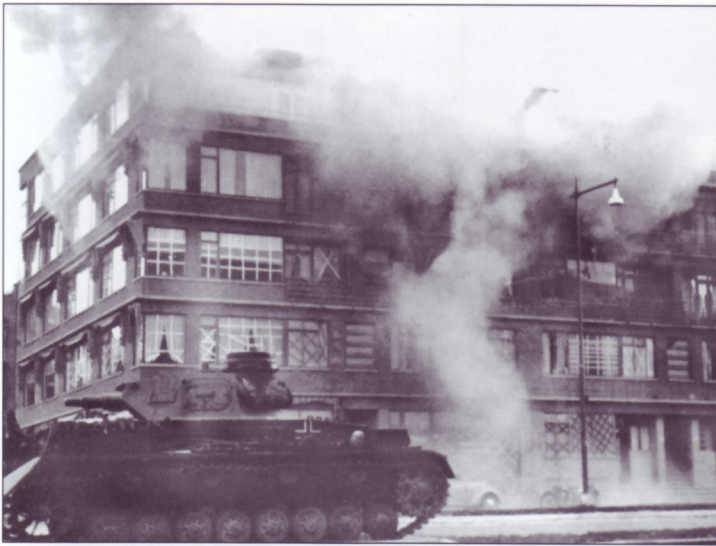
With its 7.5cm KwK37 L/24 trained towards its rear, a Pz.Kpfw.IV (Ausf.C, D or E) takes part in street fighting during the campaign in the west in 1940. Other than a white-outline balkenkreuz national insignia on the side of the superstructure, there are no other readily visible markings. Note that many of the windows on the buildings in the background have been taped over to mitigate flying glass caused by near-by explosions.

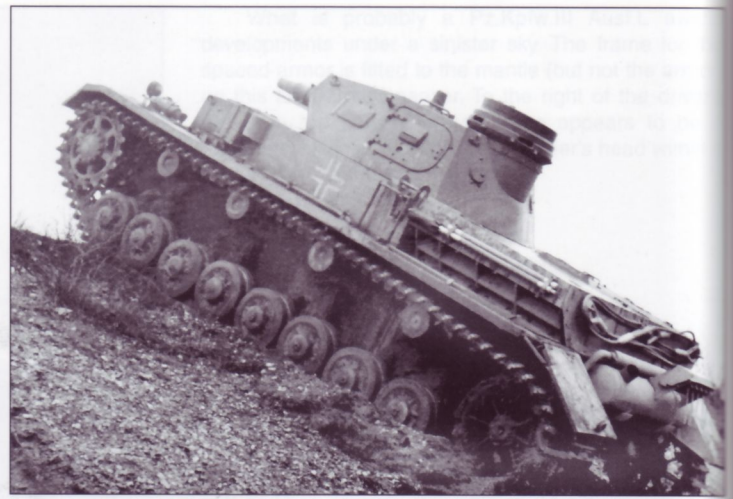
A neatly-stowed Pz.Kpfw.IV Ausf.D (note the bolt pattern over the turret side visor) passes over the crest of a hill, during a training exercise. It is very plainly-marked with a white-outlined balkenkreuz and is not fitted with a Notek system head- or tail-lamp. Interestingly, the poles to swab the 7.5cm gun's bore are un-painted, adding a bit of contrast to an otherwise plain panzer. The device directly under the 7.5cm gun tube was designed to push the panzer's radio antenna out of the way if the turret was traversed while the antenna was in an upright position.

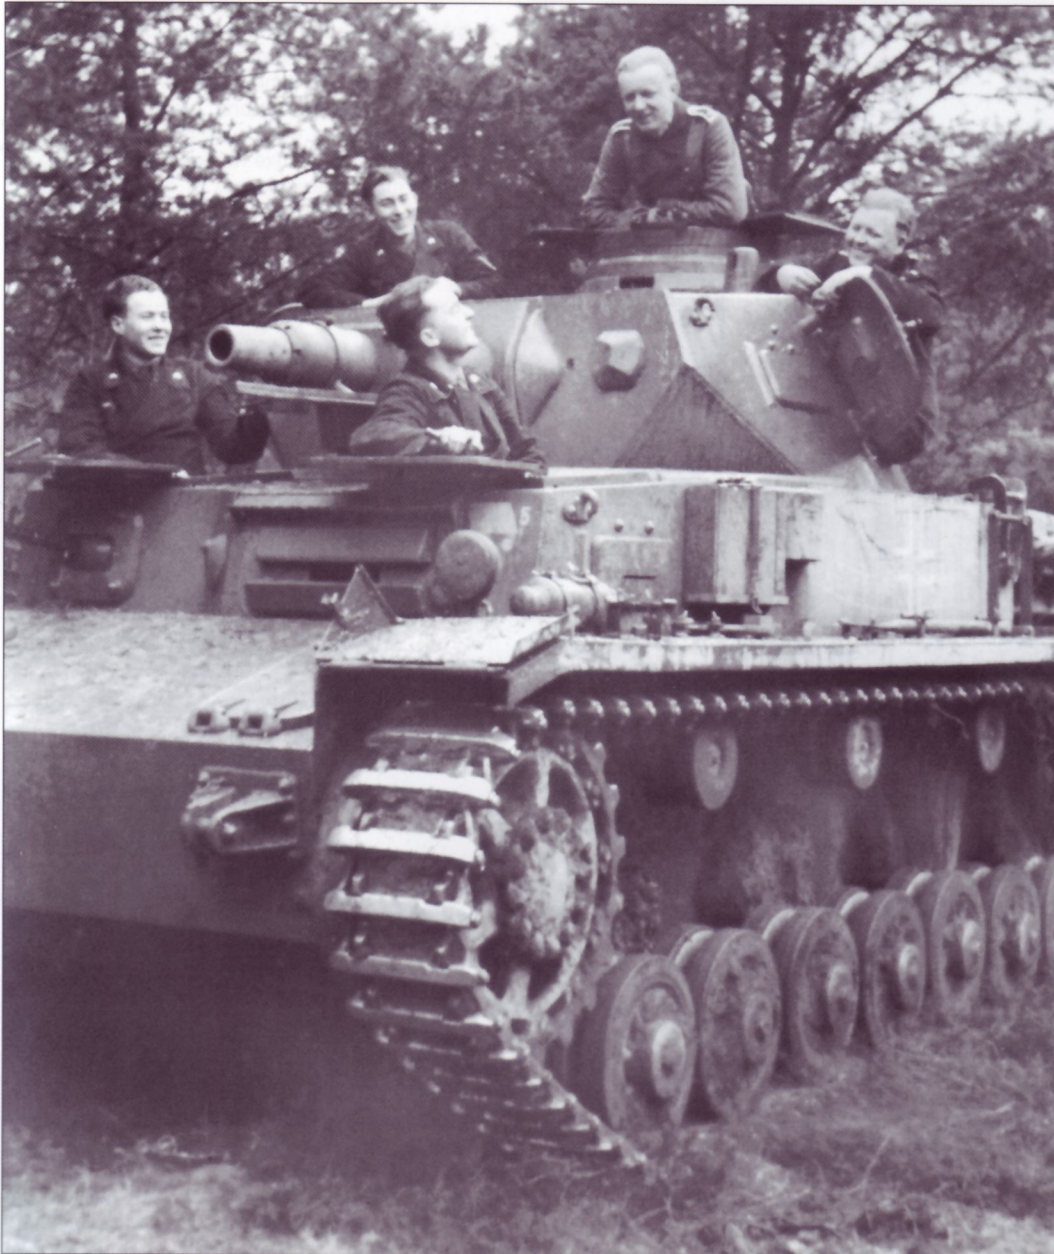
This fine study of a Pz.Kpfw.IV Ausf.D shows a full crew at rest who are obviously very happy about something. The commander is wearing his M1935 greatcoat over his uniform, while the remainder of the crew wears the black M1934 panzer uniform. Note the type of cupola, the external gun mantle and the lack of the Notek black-out driving head-lamp. There is a white panzer rhomboid marking with a number "5" on the superstructure front plate, while there is a white-outline balkenkreuz on the side plate. The tracks are the earlier, narrow 38cm type with smooth faces on the individual links.

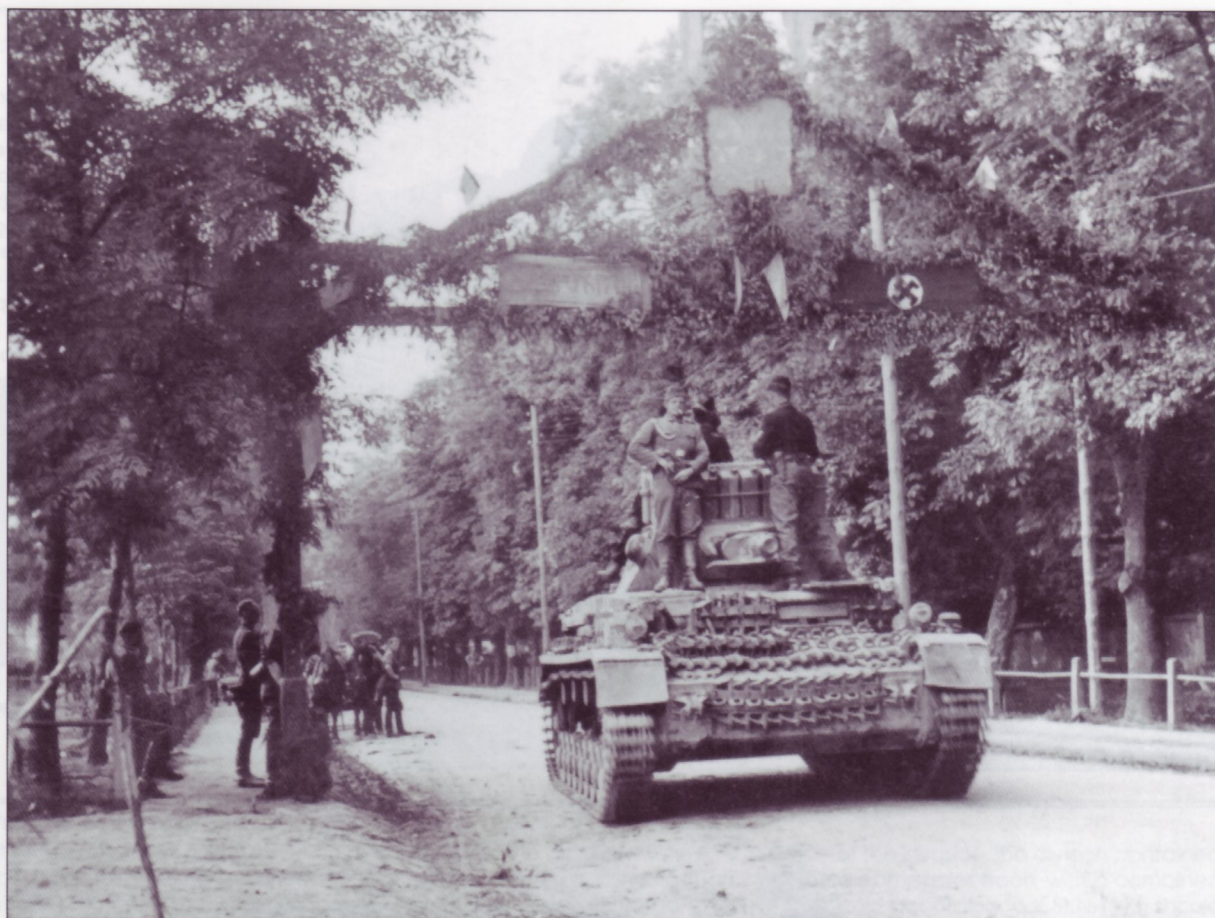
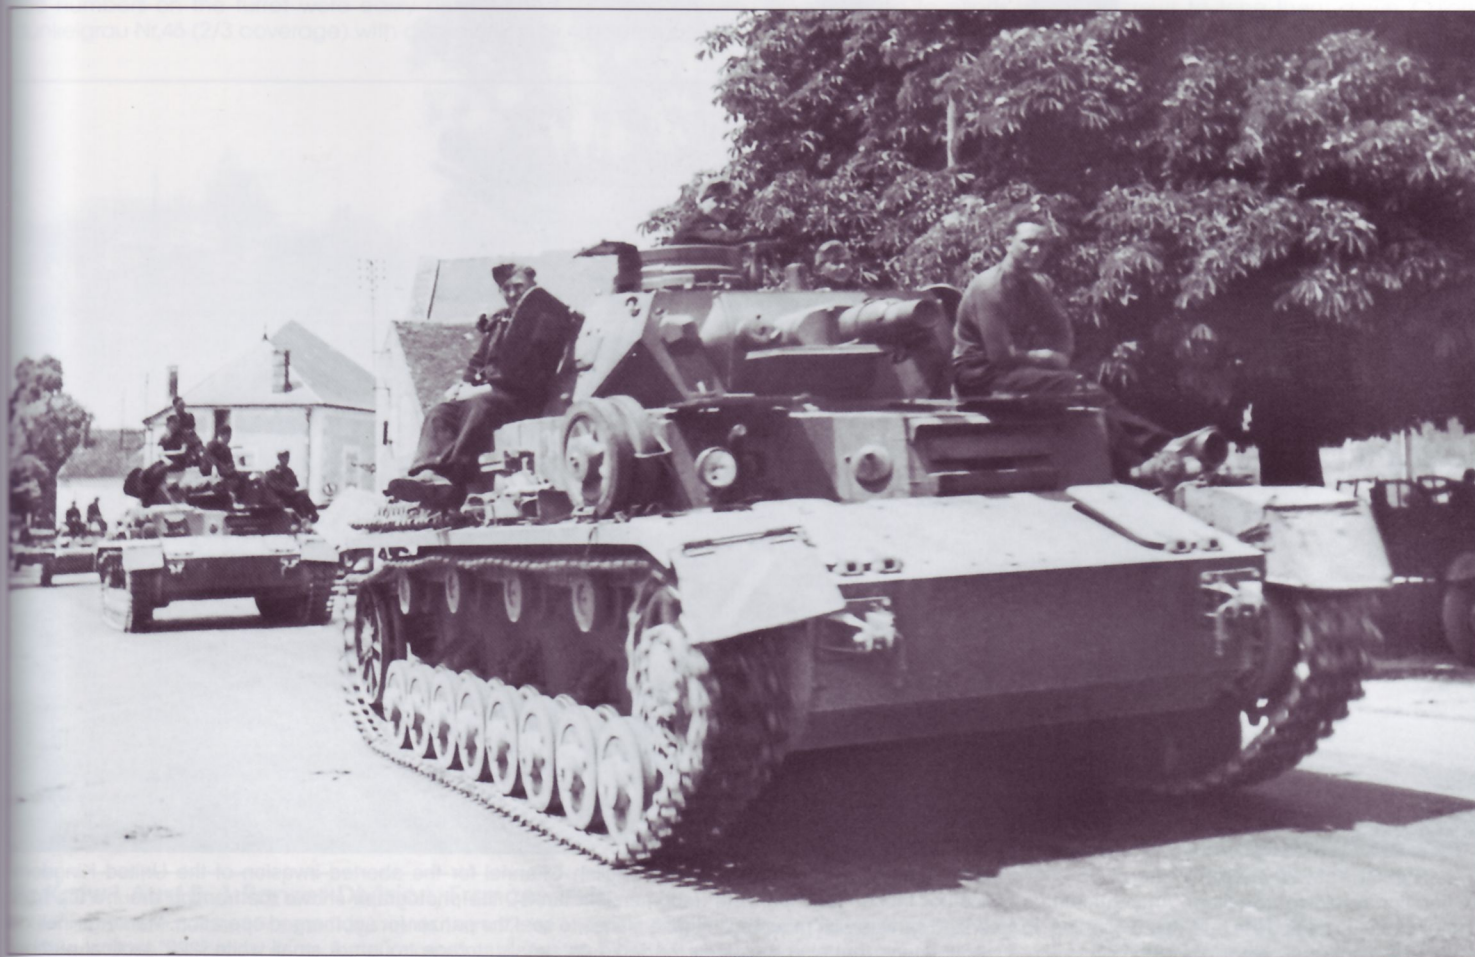
A Pz.Kpfw.IV Ausf.D leads a column of panzers through a town, probably after the French Campaign of 1940; note that the black beret is not worn, it being discarded shortly after the end of the battles in the west. There are no markings visible on this dusty panzer, while the only unique fitting is a frame to store a spare road wheel mounted on the near fender. This view also affords a better look at the radio antenna deflector strapped on to the gun tube.

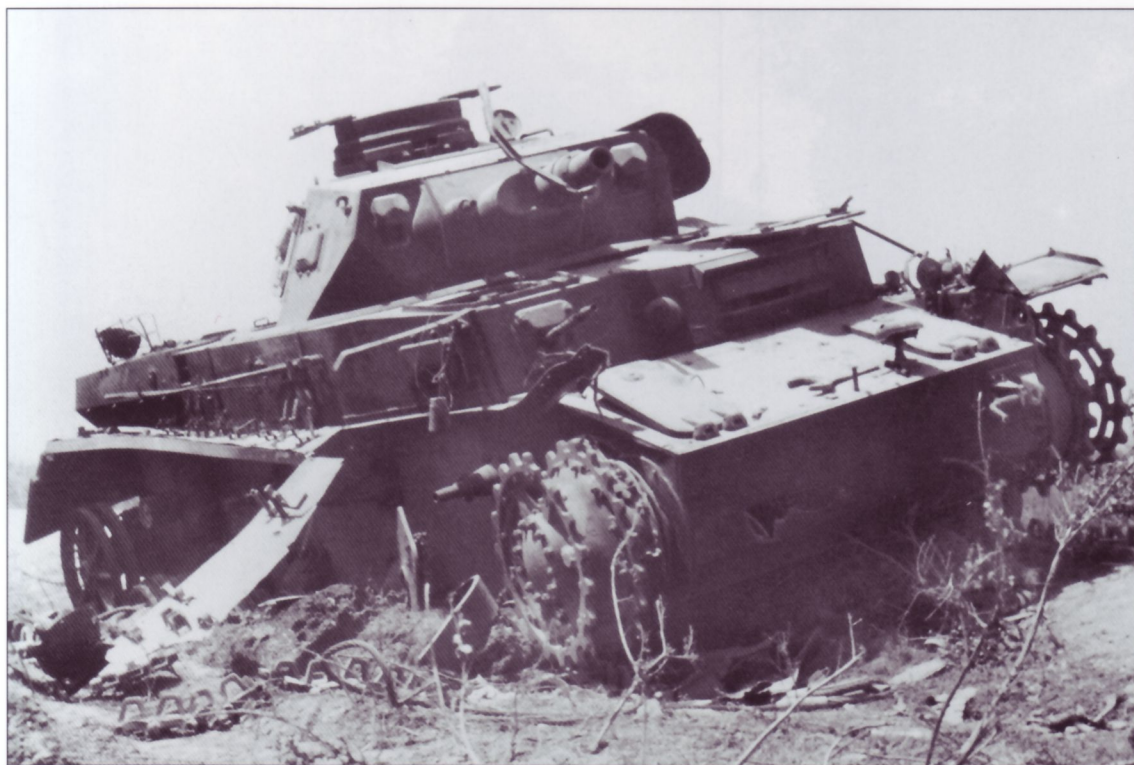
This destroyed Pz.Kpfw.IV Ausf.D is probably too far gone to be recovered and reconditioned, although it could certainly be cannibalized for spares. Note the hole in the armor on the lower front of the hull (which indicates that a fairly mangled transmission and final drive unit lies behind) and the lack of most of the suspension components on the near side. This panzer has a Notek headlamp in a very unique position towards the middle of the glacis plate.

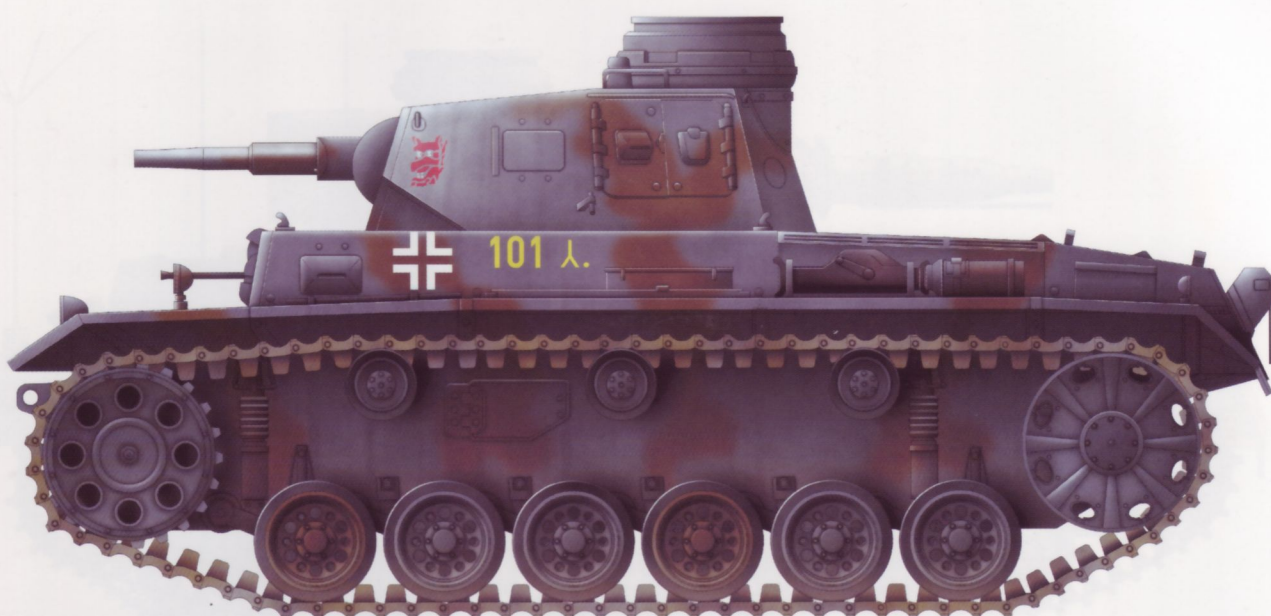
**Pz.Kpfw.III Ausf.E, 1.Kompanie, Panzer-Regiment 31, 5.Panzer-Division, France 1940**

The "Devil's Head" insignia of this unit was often seen later in the war on Pz.Kpfw.IVs and Panthers, photographic evidence has also emerged showing this device on Pz.Kpfw.IIIs as seen here. The division took a total of 52 Pz.Kpfw.IIIs with them as they raced towards Arras. Colors: dunkelgrau Nr.46 (2/3 coverage) with dunkelbraun Nr.45 blotch pattern (1/3 coverage)

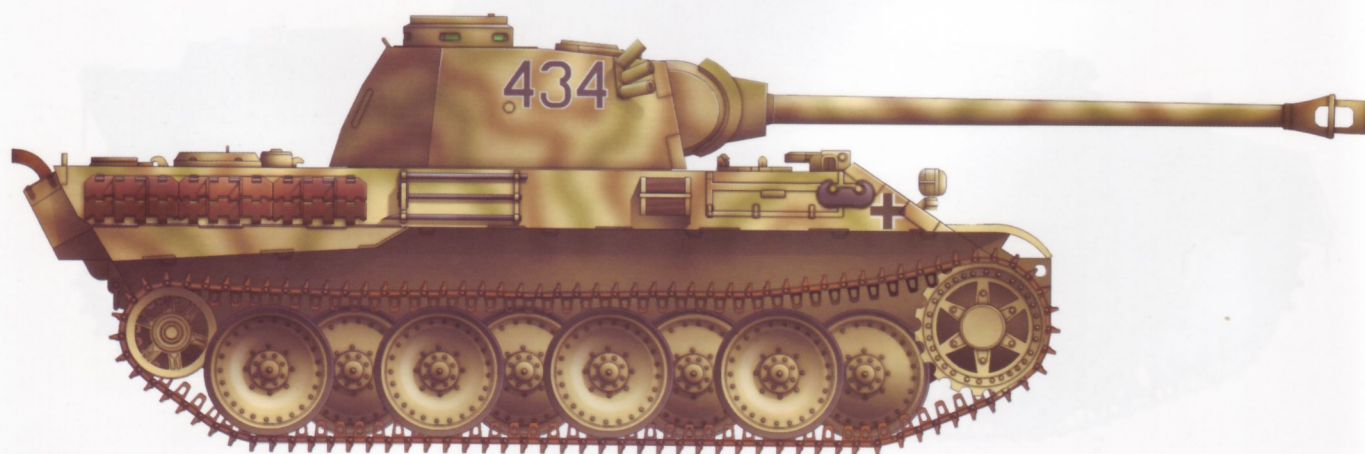
**Pz.Kpfw. Panther Ausf.D, 4.Kompanie, Panther-Abteilung 52, Panther-Regiment von Lauchert, Kursk, Russia, 1943**

This Panther Ausf.D was one of 96 panzers issued to this battalion as part of the build-up prior to Operation "Zitadelle". The entire regiment was attached to the "Großdeutschland" division on July 5, 1943. Out of a total of 184 Panthers committed to this operation, by July 17, only 44 remained operational. Colors: overall dunkelgelb RAL 7028, with light random mottle pattern of olivgrün RAL 6003 and rotbraun RAL 8017.

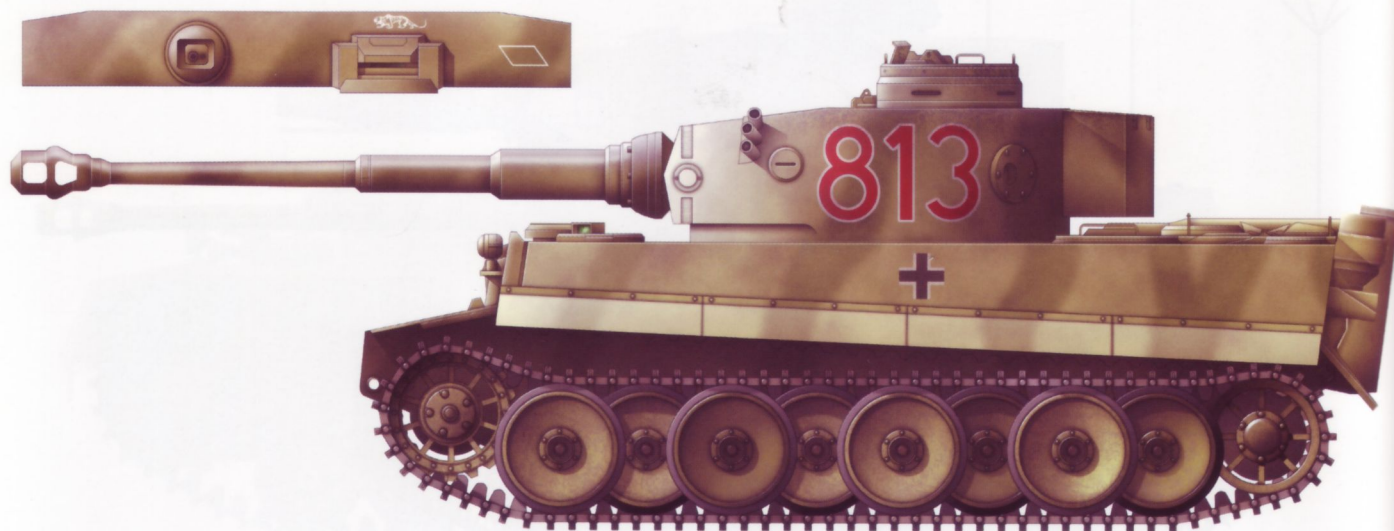
#### Tiger I, s.Pz.Abt.501, Tunisia 1943

This unit arrived in Africa beginning in November of 1942 and eventually fielded 20 Tiger Is and 25 Pz.Kpfw.III Ausf.M. It was attached to the 10.Panzer-Division and used during "Operation Ochsenkopf" which began on February 28, 1943. As the unit suffered attrition it was consolidated into the 8.Kompanie of Panzer-Regiment 7, thus the Tac number of "813" (which was also carried on the stowage locker on the turret's rear). The unit's "Stalking Tiger" insignia was seen on the front plate of the superstructure along with a panzer rhomboid. Colors: braun RAL 8020 (2/3 coverage) with grau RAL 7027 blotch pattern (1/3 coverage).
