# PANZER VOR!

German Armor at War 1939-45

Frank V. De Sisto

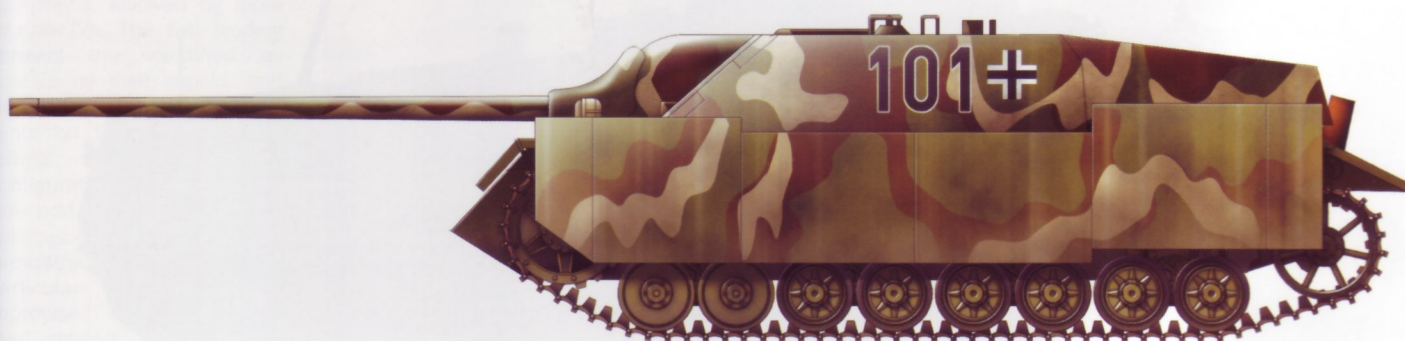
#### Panzer IV/70 (V), 1.Kompanie, s.Pz.Jg.Abt.655, Germany, 1945

This tank destroyer survived the final battles in northern Germany to surrender to Canadian troops at the end on May 5, 1945. By then, it had lost its Seitenschürzen. At one point in time, the unit consisted of a headquarters company of three Panzer IV/70 (V), while the 1. and 3.Kompanie contained 14 Panzer IV/70 (V) each, and the 2.Kompanie fielded 14 Jagdpanthers. Colors: overall olivgruen RAL 6003 with hard-edge pattern of broad stripes and blotches of dunkelgelb RAL 7028 and rotbraun RAL 8017.

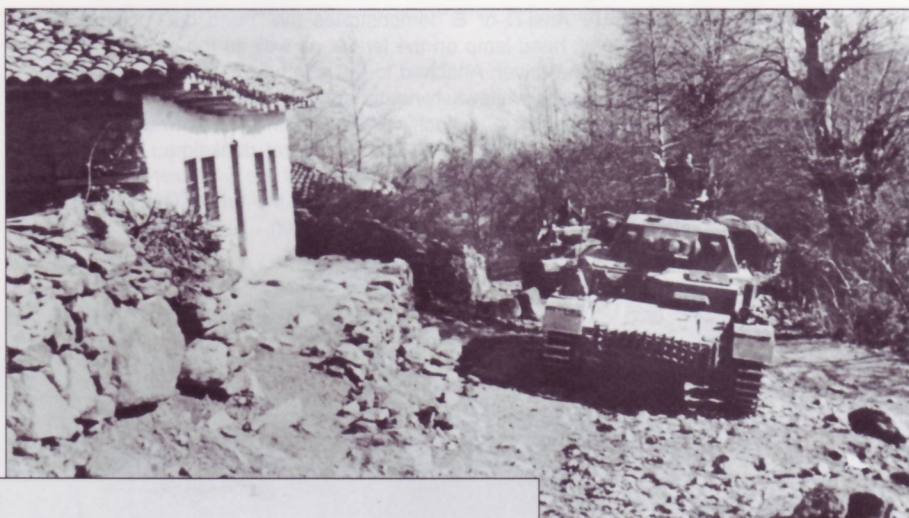
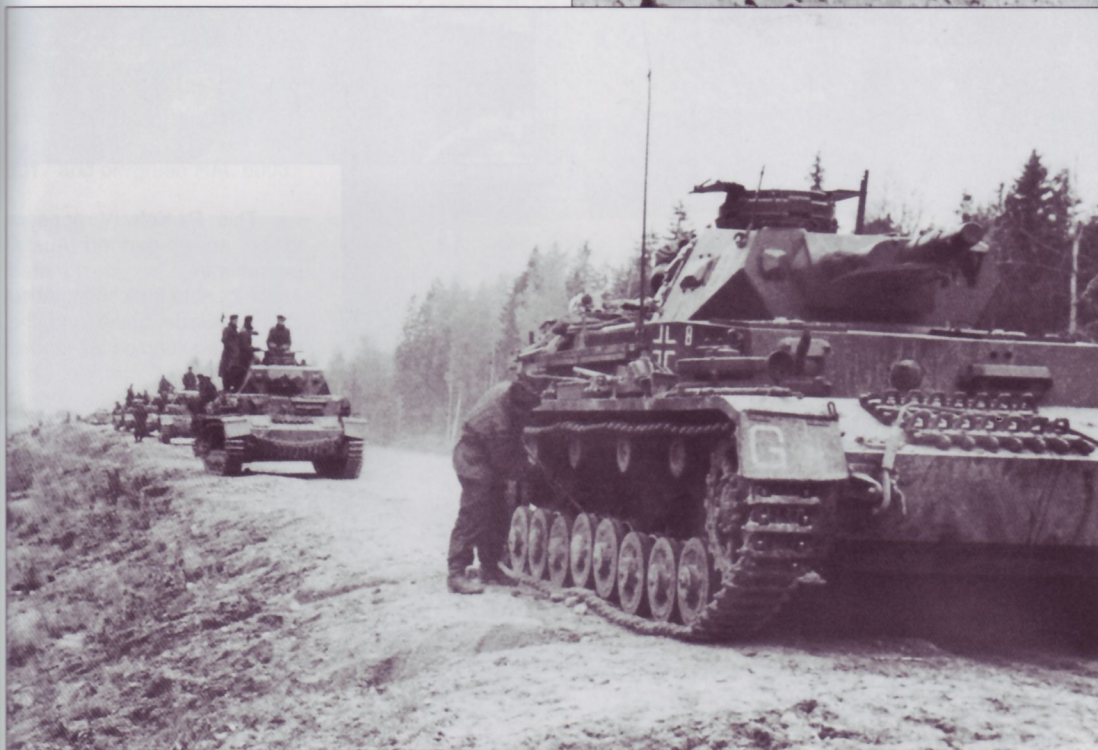
A column of panzers, led by at least two Pz.Kpfw.IV Ausf.Es (note the new cupola and the external mantle), stops for maintenance on a road march. Note the crewman next to the lead panzer using a pry bar to clear an obstruction from the road wheels. The lead panzer is marked with a white "G" as belonging to Panzergruppe 2, led by Guderian, while the clothes worn by the man with the pry bar indicate that this photograph may have been made during the first winter of "Operation Barbarossa". Guderian's command included the 3., 4., 10., 17. and 18. Panzer-Divisions. The panzer also has a small white "8" on the superstructure side (just forward of the white-outline balkenkreuz national insignia), as well as a larger "8" on the turret side.

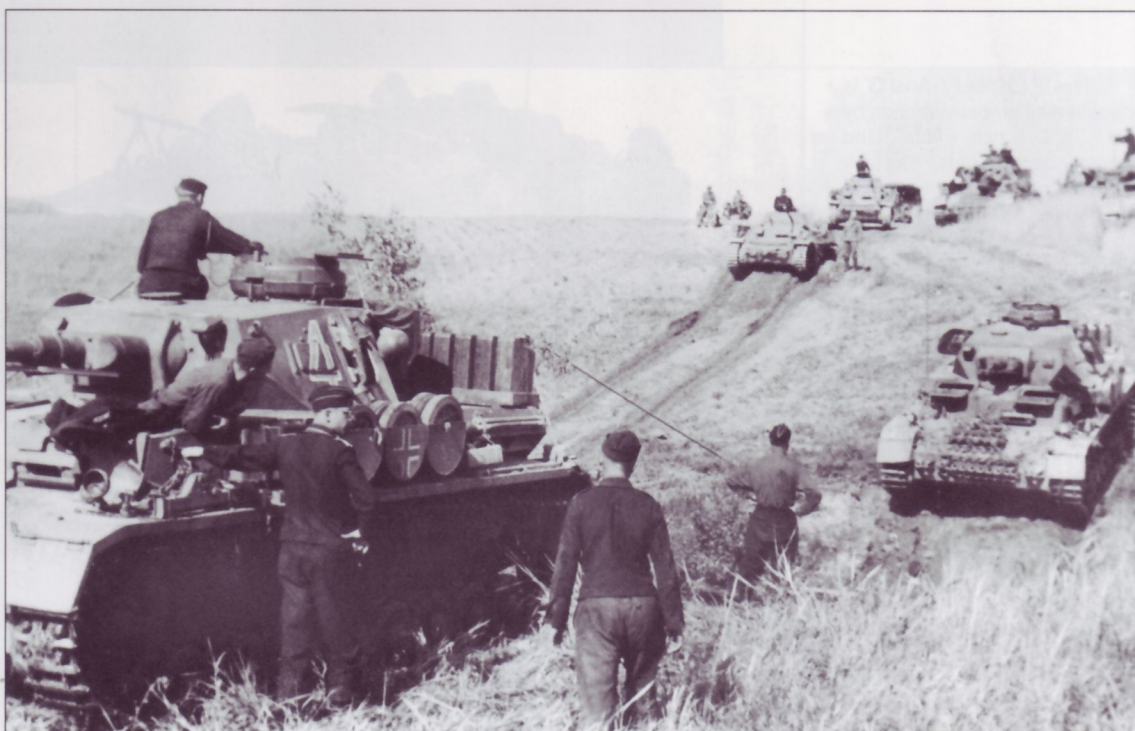
The driver of this Pz.Kpfw.IV Ausf.D or E demonstrates the "head out" position as he controls his panzer. Note the Notek head-lamp on the fender as well as the empty tray for the jack block, just below and behind the driver. Attached to the gun tube is the antenna deflector rail. The panzer has a rather complete whitewash neatly applied right up to the border of its balkenkreuz; the white edge of the cross is distinctly different from the whitewash. There is a small box next to the driver's visor, which was left in the original dunkelgrau color. Upon it appears to be the single "X", which was the post-1941 insignia of the 5.Panzer-Division, while the edge of a similar area is just visible on the forward side of the turret. The "devil's head" insignia of Panzer-Regiment 31 was commonly seen in this position.

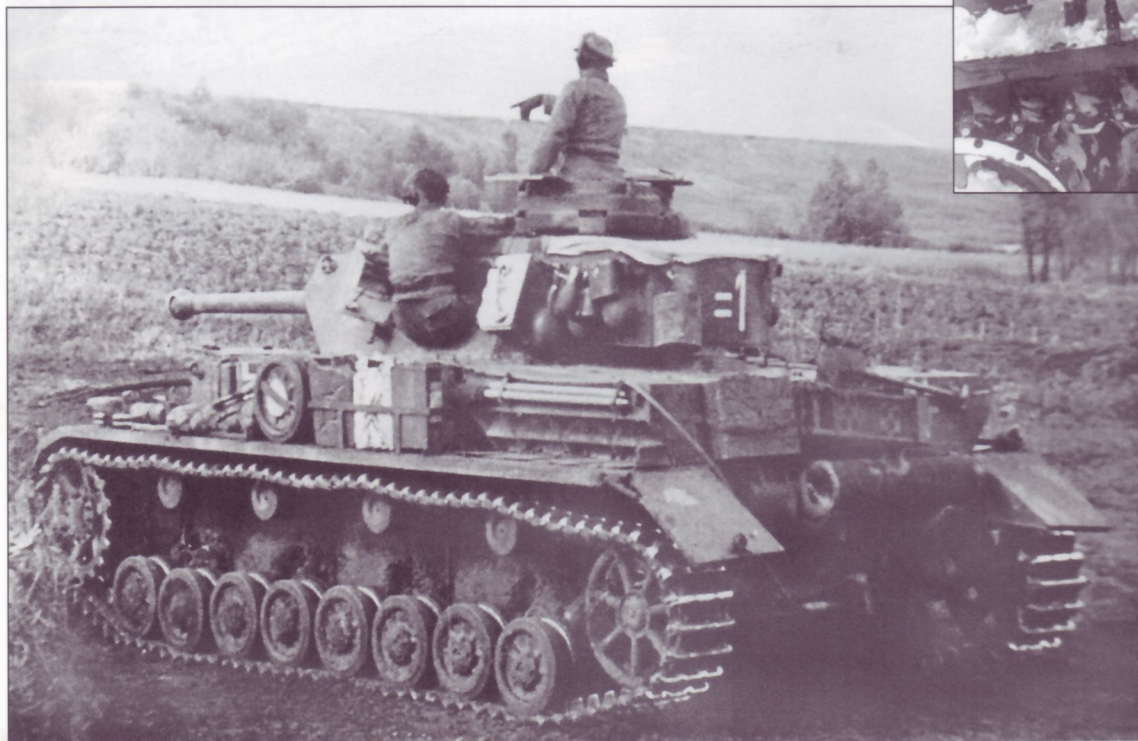
This Pz.Kpfw.IV appears to be an up-gunned Ausf.F (sometimes designated Ausf.F2); note the configuration of the muzzle brake and the Notek head-lamp on the fender. This panzer carries the characteristic "Stahlhelm" (Steel Helmet) insignia of the German Army's elite "Großdeutschland" Division, on the near mud flap in white. A unique Tac number "=1" is painted in white on the rear of the turret's storage locker. Note also the improvised nature of the spare road-wheel storage, as well as the different styles of jerry can next to it, on the near fender.

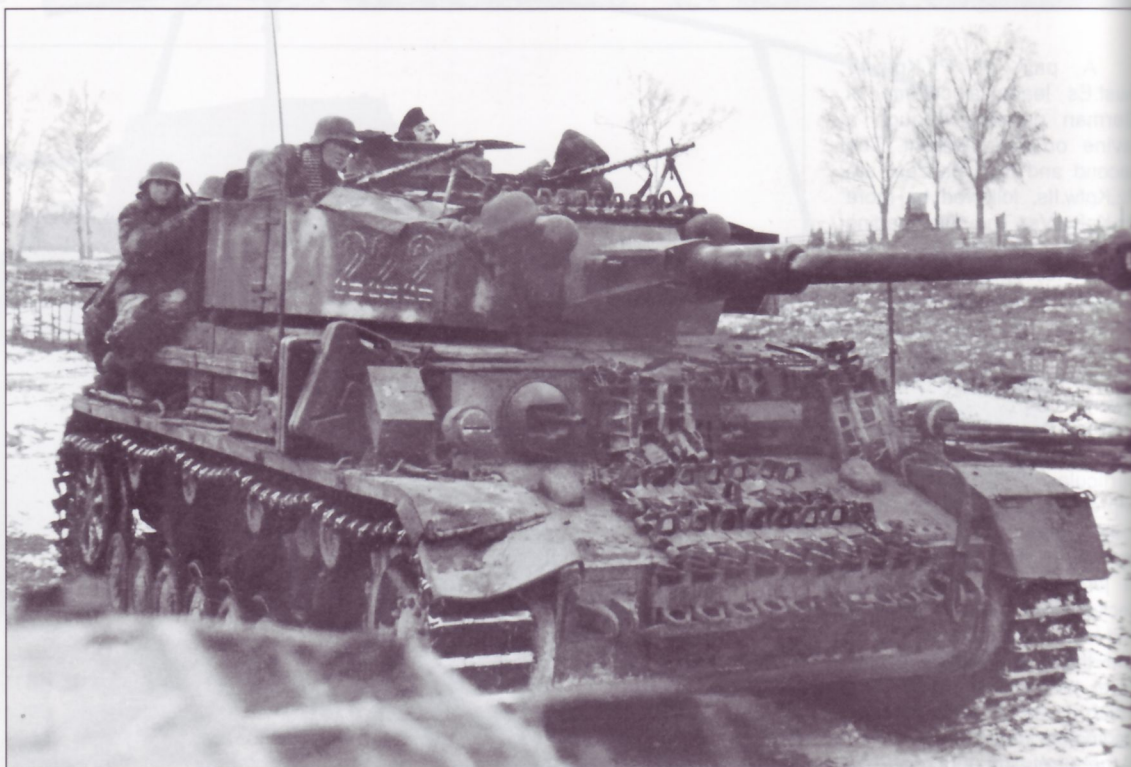
A late Pz.Kpfw.IV Ausf.G stands guard on the steppes of the Soviet Union while the crewmen observe a distant activity. This panzer is identified as a late Ausf.G by the single-piece hatch lid on the commander's cupola in combination with the position of the radio antenna and the application of a 30mm plate over the superstructure front plate's base of 50mm; note the cut-out area for the driver's twin periscope openings. The panzer has rails on its hull for "Schürzen" (skirts) as well as an array fitted to the turret. Note the white-outline tactical number of "621" on both the turret Schürzen's side and rear panels. The color scheme is dunkelgelb RAL 7028 base with an overspray of rotbraun RAL 8017 and olivgruen RAL 6003.

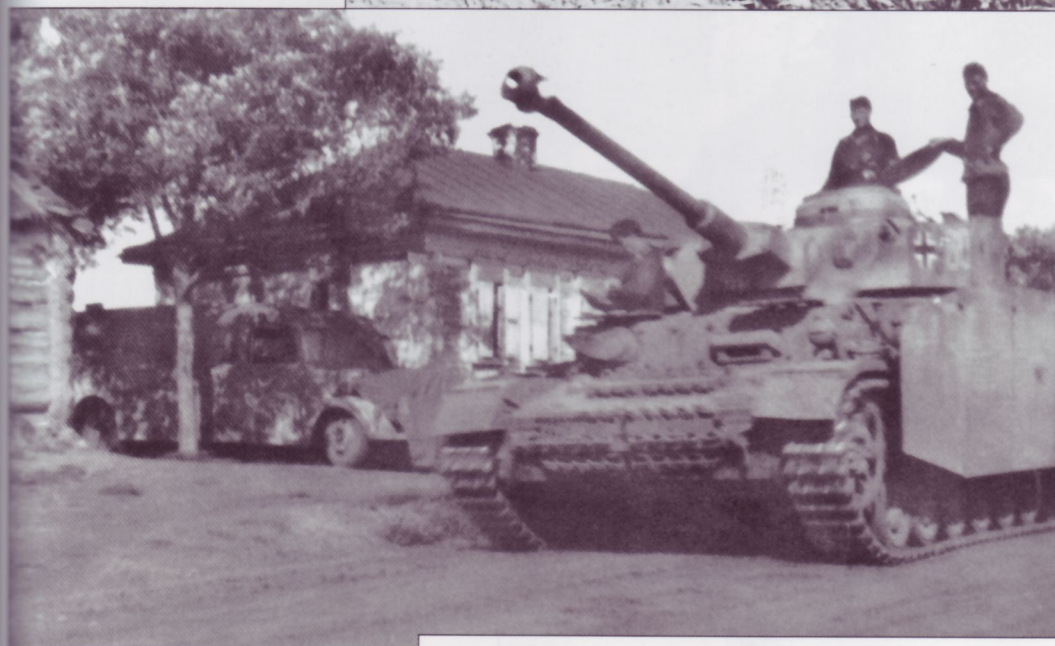
This later Pz.Kpfw.IV Ausf.G exhibits its identifying features quite well as it speeds past the camera. It has a single-piece lid on the commander's cupola, bolted-on 30mm plates on the superstructure front plate and a single Bosch head-lamp on the near fender. The Schürzen are mounted in a manner seen on early panzers and the drive sprocket (although distorted due to its motion) appears to be of the type seen on the Ausf.F, G and a few early H. There is a rain gutter on the turret front plate over the sight aperture for the gunner. The panzer is overall dunkelgelb RAL 7028, with a possible "80?" Tac number on the turret.

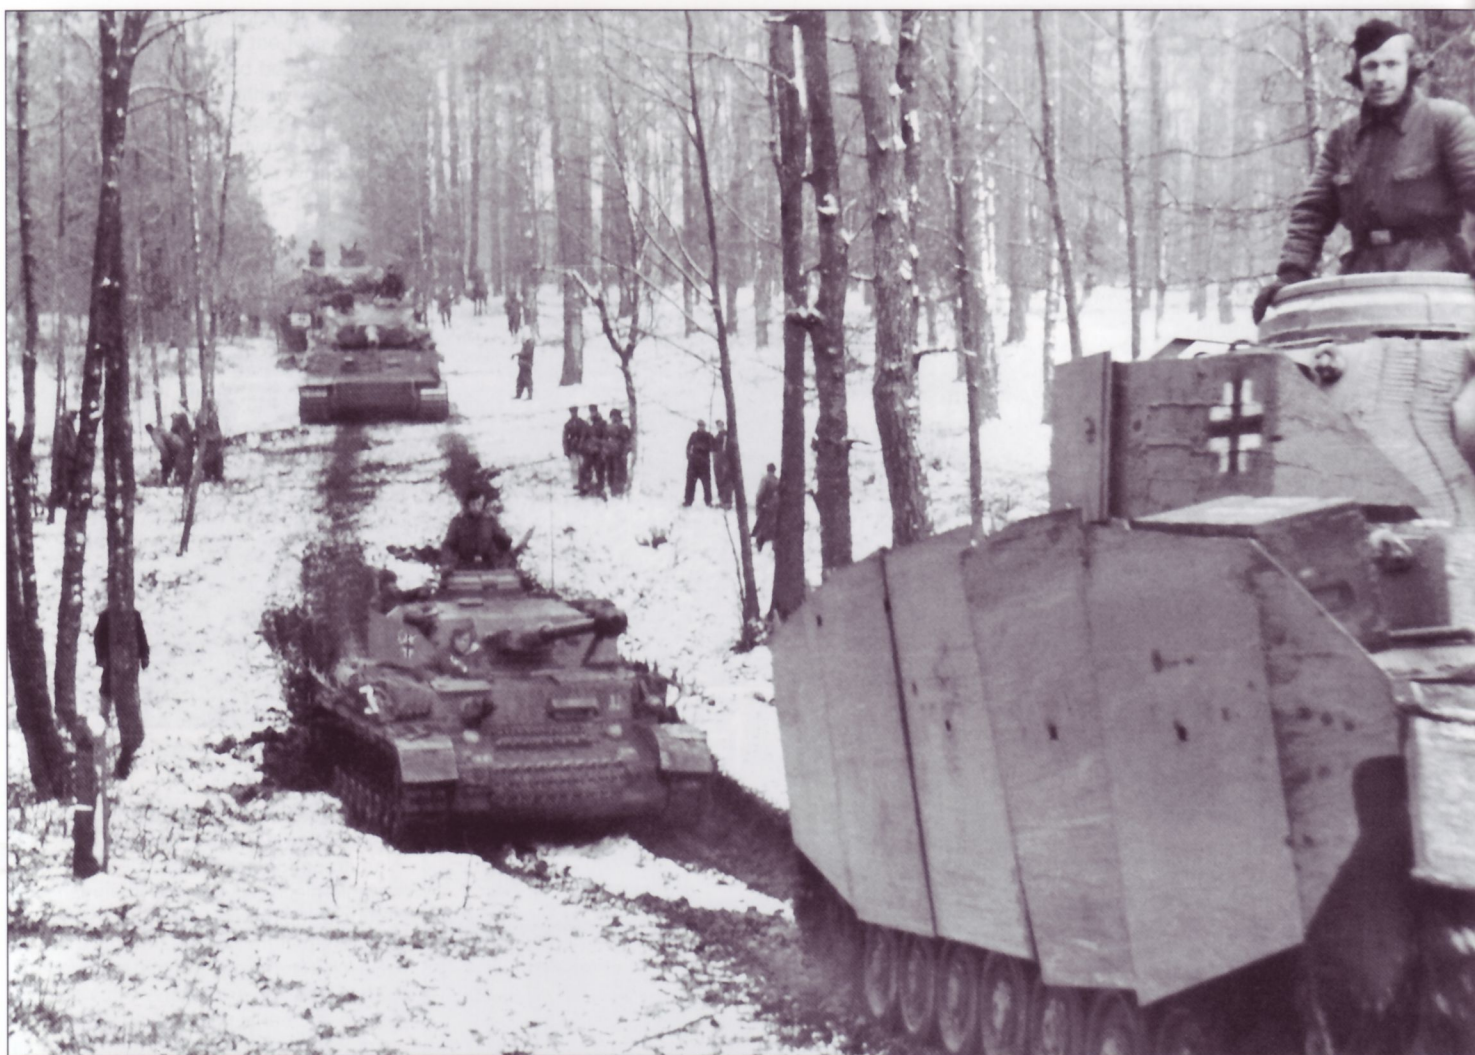
A pair of Pz.Kpfw.IV Ausf.Hs lead Tiger Is of SS-Division "Das Reich" along a forest track, on the Ostfront. The lead panzer is identified as an Ausf.H by the new drive sprocket which could not be fitted to an Ausf.G hull, unless the transmission and final drives were also changed. It has a single-piece lid on the commander's cupola as well as Zimmerit anti-magnetic mine paste, which was applied at the factory to panzers beginning in September of 1943. Note the cut-out portion of the small Schürzen plate just over the drive sprocket. The panzer is finished in the base of dunkelgelb RAL 7028 and has only a white-outlined, black balkenkreuz visible on the turret Schürzen. Other panzers in the column have the divisional insignia left-over from "Operation Zitadelle" (a horizontal bar with a pair of attached vertical bars, in white), which took place the previous July.

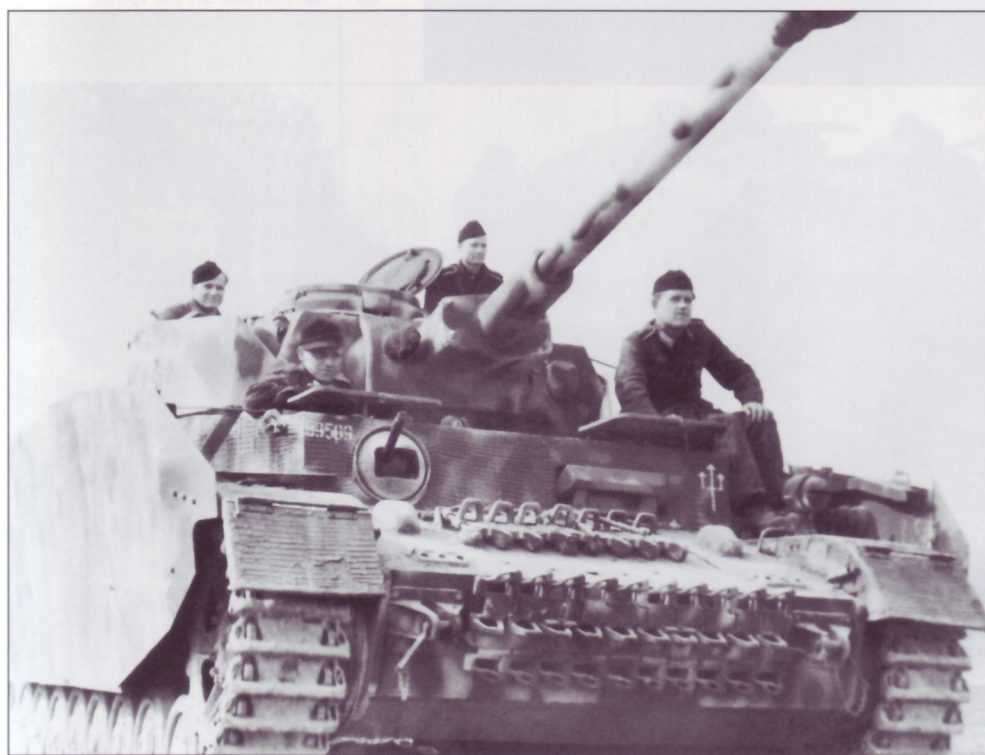
This familiar photo depicts a Pz.Kpfw.IV Ausf.J (note the chassis number, 89589 on the superstructure front plate). It belonged to the 8.Kompanie, II.Abteilung, Panzer-Regiment 3, of the 2.Panzer-Division, and was photographed in the west during training to meet the expected Allied invasion of France in 1944. The panzer is in pristine condition with a rather fresh paint-job, consisting of a base of dunkelgelb with an over-spray of olivgün and rotbraun on top of factory-applied Zimmerit. All visible markings are stenciled in white. The spare track links are stowed in standard, factory-applied racks on the glacis and transmission access hatch; they are of an earlier type with hollow guide teeth and smooth faces on the links.

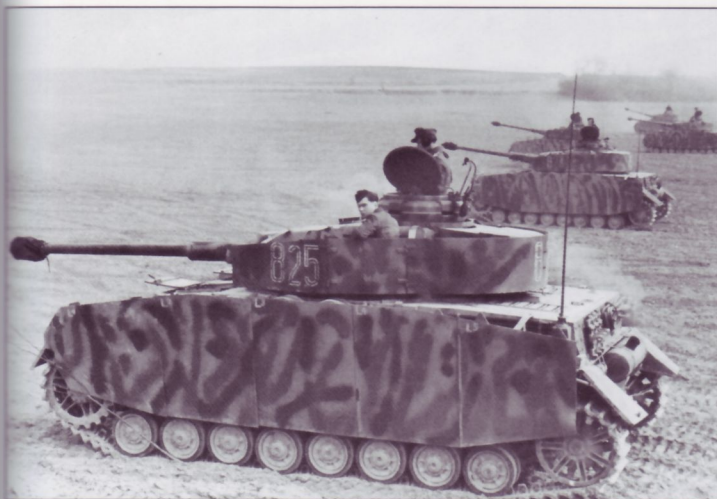
Another view of panzers from 8. Kompanie of Panzer-Regiment 3 during training in the west shows what, at first glance, might be another Pz.Kpfw.IV Ausf.J. However the use of the later cast idler wheel as seen here is not necessarily a sure means of identifying any model of the Pz.Kpfw.IV. The sure means of identifying this panzer as actually being an Ausf.H, is the retention of the small exhaust muffler for the turret traverse motor, next to the main muffler on the lower rear hull plate, as seen here. This device was eliminated, along with the motor (in favor of increased fuel capacity) on the Ausf.J.

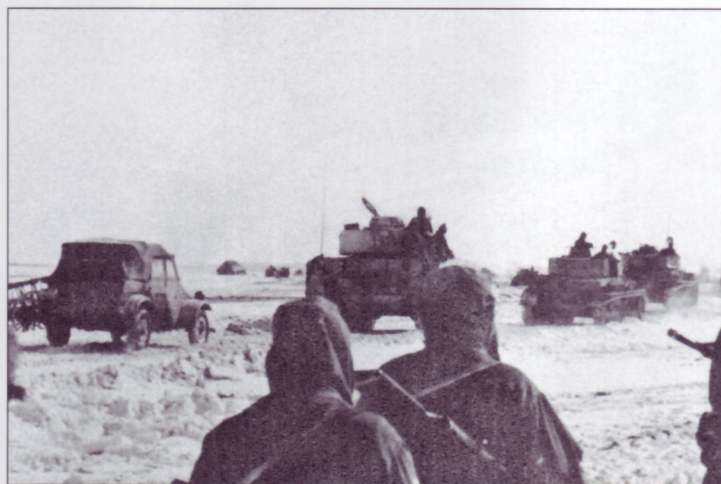
A column of panzers is followed by a Volkswagen Kübel and some infantry as it makes its way across the snow-bound Ostfront. The last Panzer in line appears to be a Pz.Kpfw.IV Ausf.J as it does not have an exhaust muffler for the deleted turret power-traverse motor. The panzers are white-washed for concealment against the snows of winter, while the last one has a dark tactical number on the turret Schürzen, next to the balkenkreuz. There is also an unfortunately unrecognizable unit insignia (a shield-shaped device) on the rear superstructure plate.

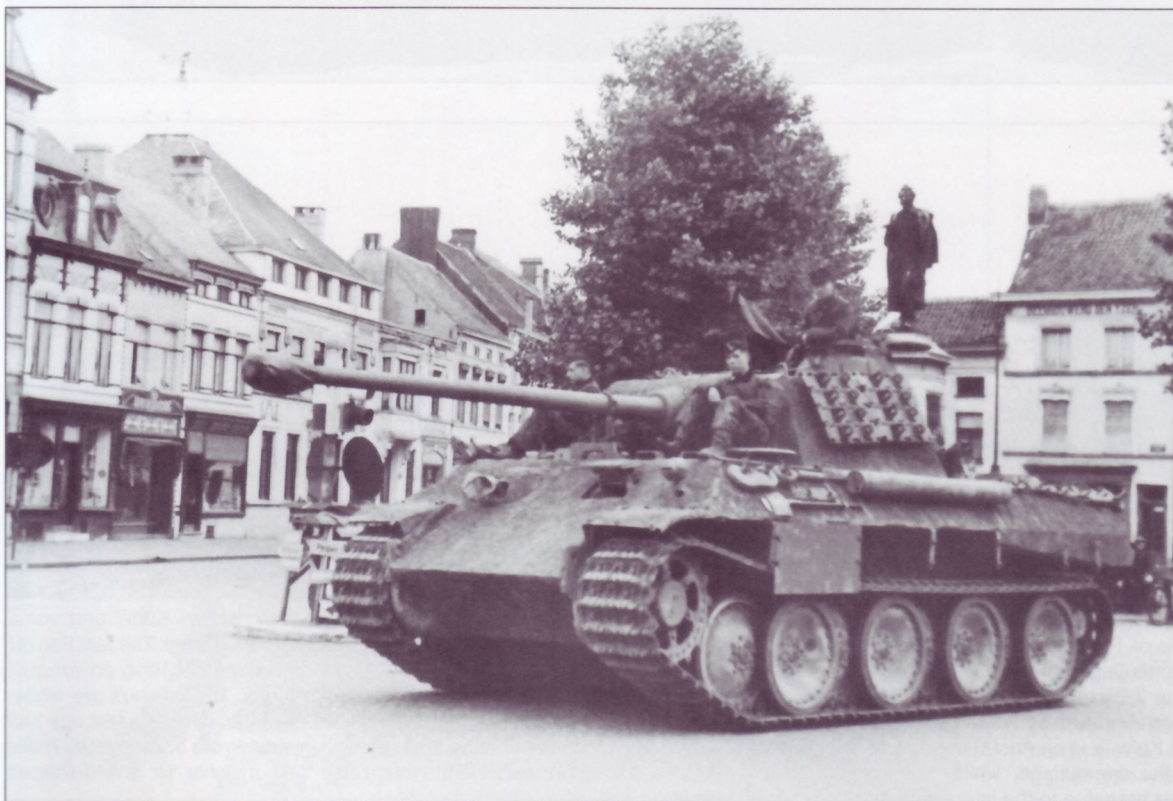
An SS Panther Ausf.A moves through a French town on its way to meet the Allied armies in Normandy; note the long L/70 gun tube locked in the travel crutch. It is from SS-Panzer-Regiment 1, of 1.SS-Panzer-Division "LAH". It features spare track hung on the turret sides as well as what's probably an anti-aircraft MG mount on the commander's cast cupola, under the cloth; the hull MG34 as well as the main gun are also protected from the elements by cloth covers. Only one Schürzen section remains on the rear side, although all of the hangers are still intact. It is covered in Zimmerit anti-magnetic mine paste. The color scheme has the base of dunkelgelb almost completely covered with olivgrün and/or rotbraun.

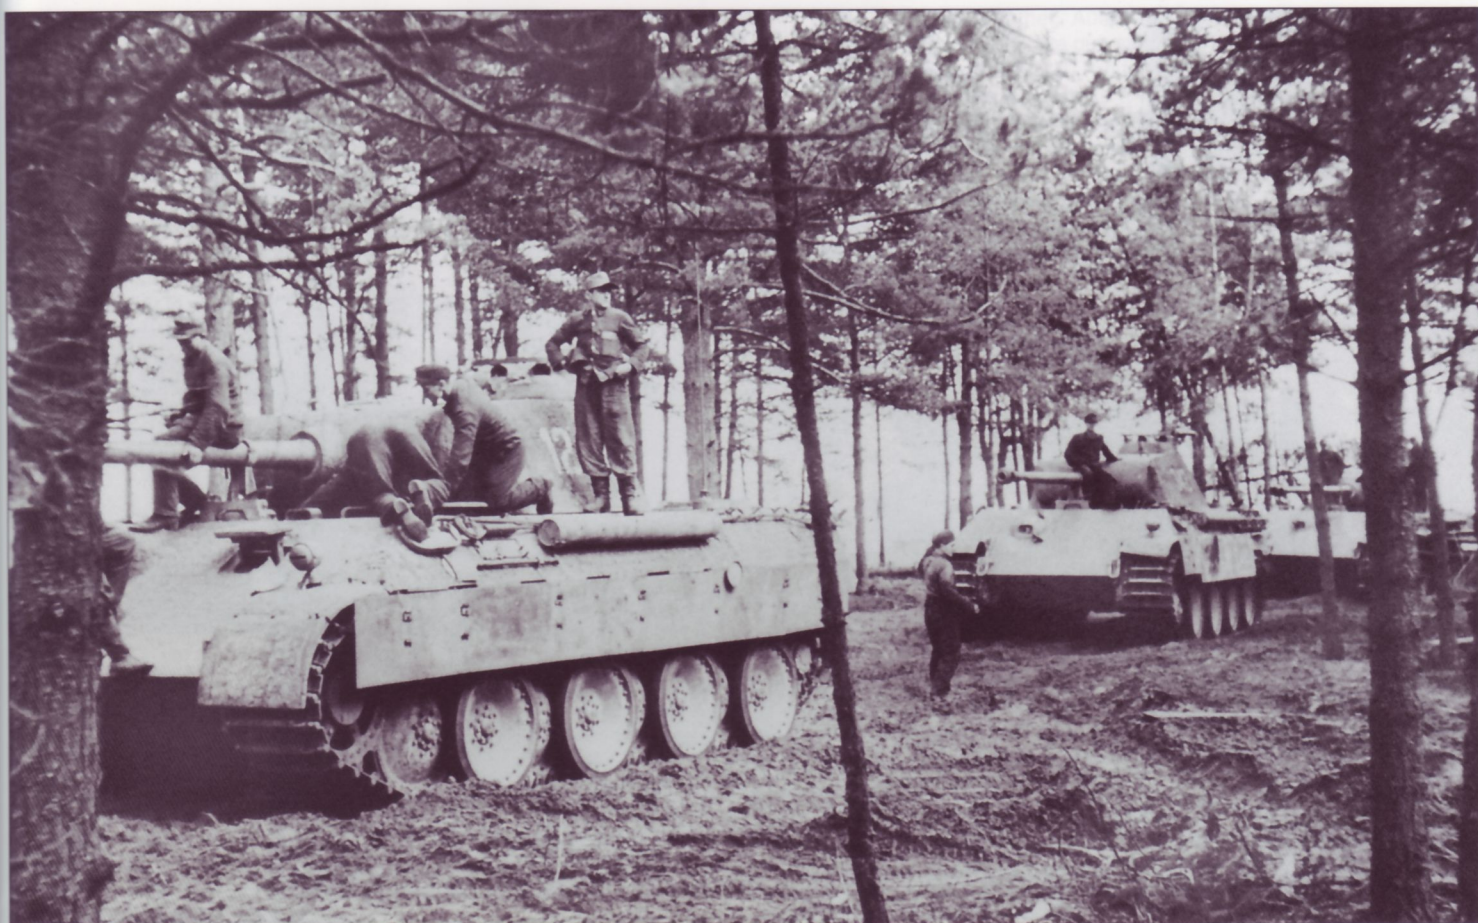
This column of Panthers is led by an Ausf.A (note the cast cupola), which has the full front mud-flap extensions. The 7.5cm KwK42 L/70 gun is resting in the travel crutch. It would appear that the second Panther is an Ausf.G, since there is no view-flap on the upper glacis plate, although at this distance it's hard to say. The Ausf.A has parts of a tactical number, in white, visible on the side of the turret, but is otherwise unremarkable in appearance.

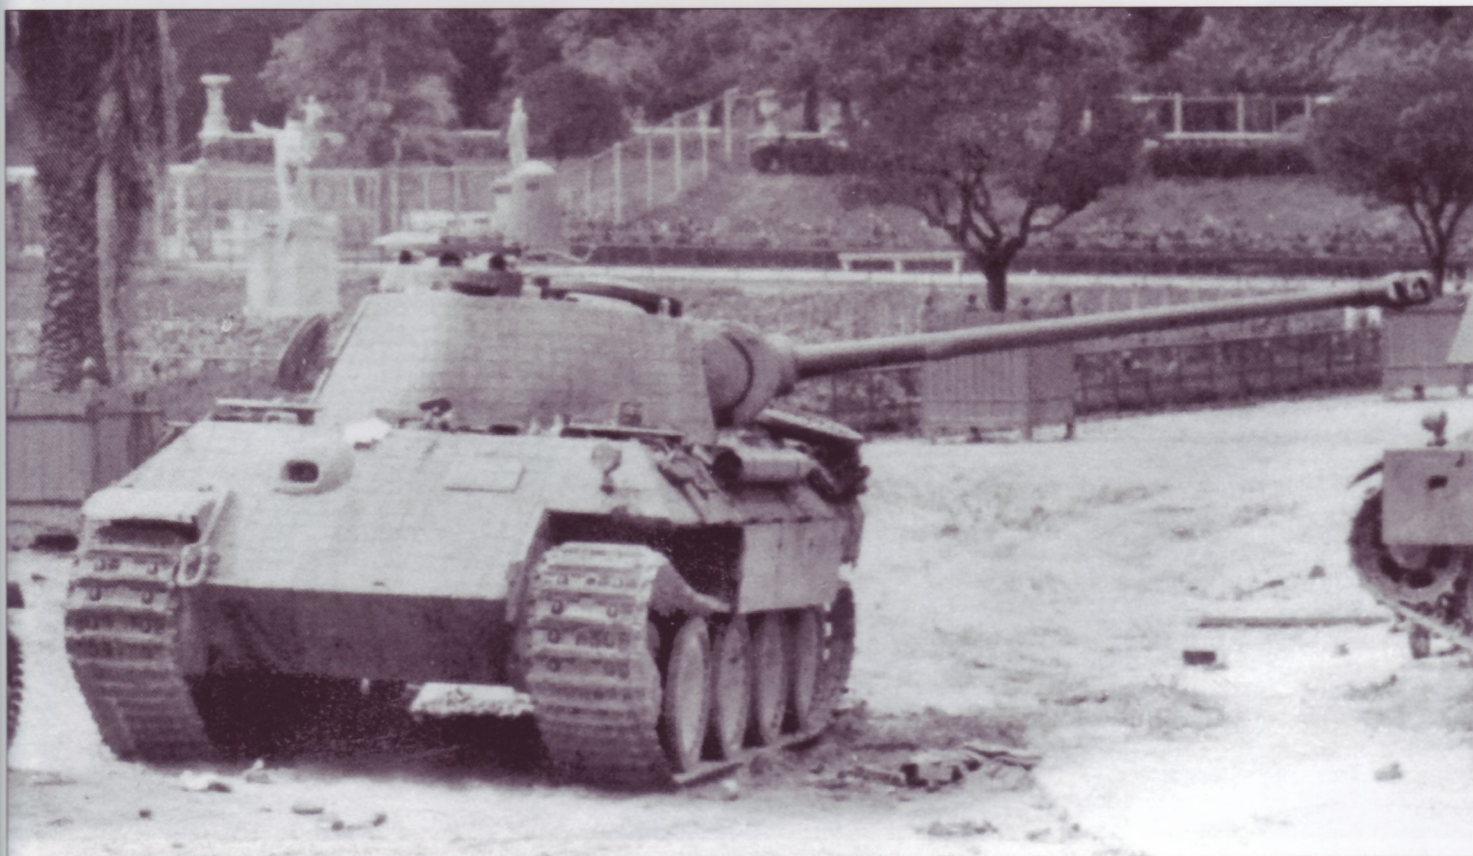
A pair of abandoned Panthers as well as another tracked vehicle litter a road, which, by the looks of the statues, fountains and trees, could be somewhere in Italy. The Panther in the center of the photograph is an Ausf.A, readily identified by the MG ball mount and the open driver's visor on the upper glacis plate. It is covered in Zimmerit and still wears most of its Schürzen. It is finished in a monochrome coat of dunkelgelb and carries no visible markings. Note the spare road wheels on the turret roof and engine deck.

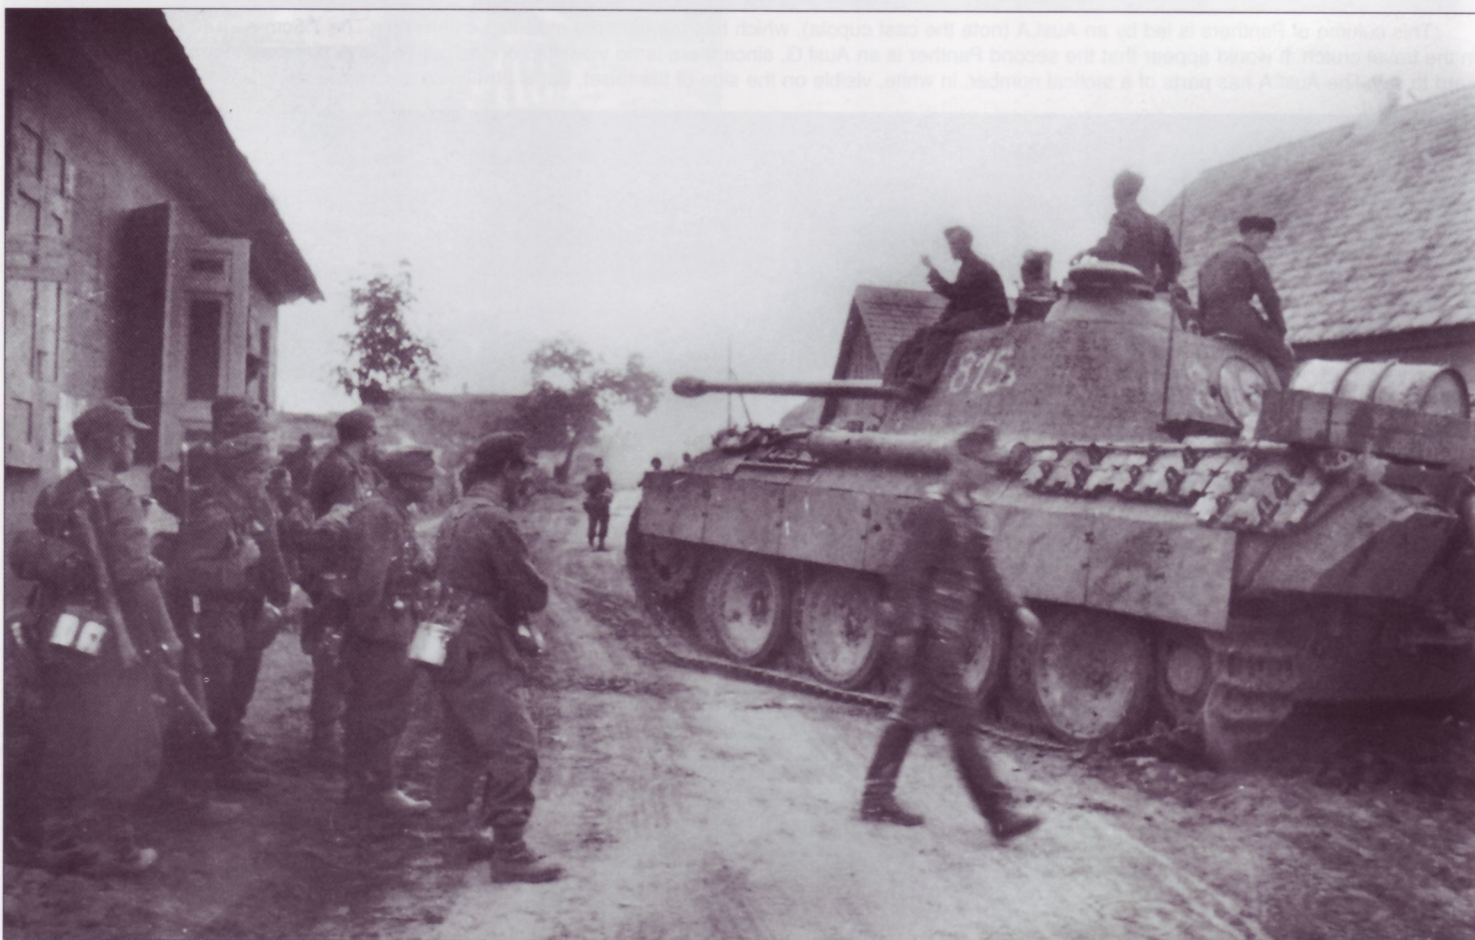
A heavily stowed Panther Ausf.A awaits orders to pull out, under the watchful eyes of a group of infantrymen. Aside from the usual tool, cable and spare track stowage, this panzer also carries a large wood beam, probably for use in extricating itself from ditches. There is also a 200-liter fuel drum on the engine deck (indicating a road march is being contemplated) and a bucket hanging from the triple exhaust pipe on the hull rear. It carries a full set of Schürzen, while the vehicle jack is stored in a later horizontal position. The relatively crudely applied tactical number ("815" in yellow or white) places this panzer in the 8.Kompanie of a Panzer-Regiment's II.Abteilung. The panzer is coated in Zimmerit and finished in a base of dunkelgelb, with patches of a secondary color.

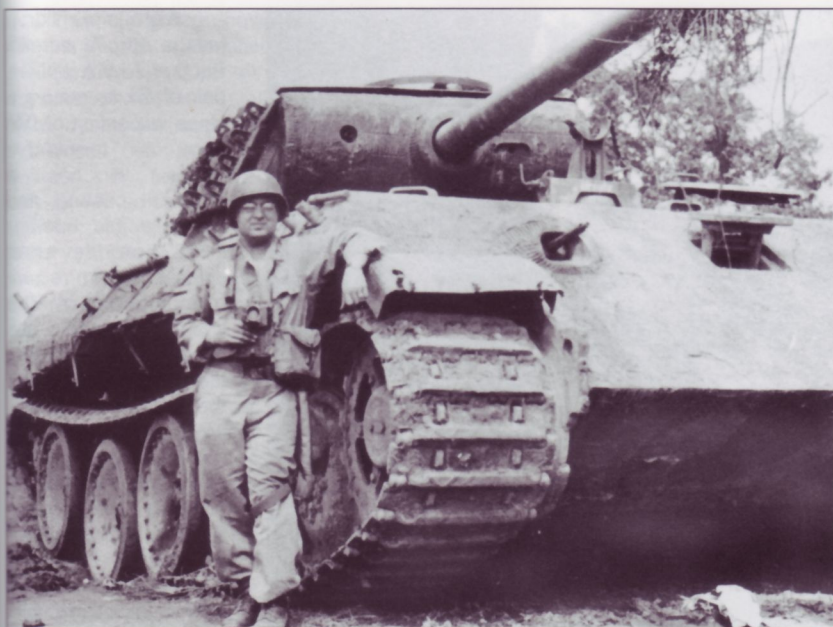
This Panther Ausf.A sports Zimmerit as well as a monocular T.Z.F.12a gun-sight aperture in the mantle with a rain guard welded over it. The turret also has retro-fitted hangers for spare tracks, as well as a rain guard above the mantle. Note also how the driver's visor opens and how it is supported. When the "Kugelblende" (ball mount) for the MG34 was installed on the upper glacis plate, the radio operator's forward-facing periscope (seen on the Ausf.D) was eliminated.

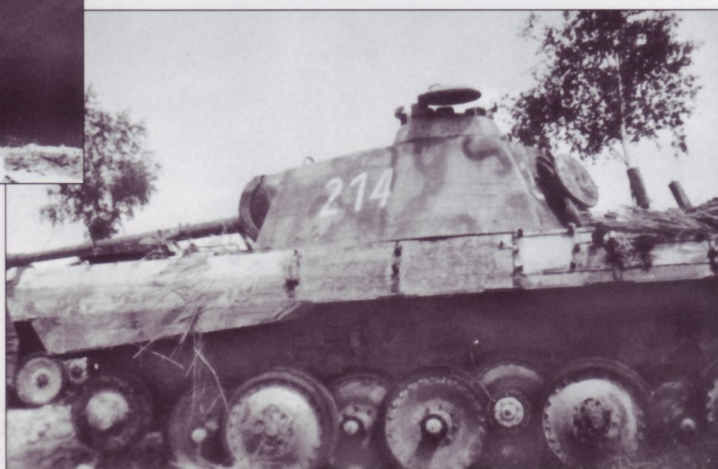
This Panther Ausf.A has been stripped of many useful items, notably the tools and spare track, as well as many of the road wheels. Note that all outer wheels have been removed, as well as one of the pair on the fifth wheel station from the front. This affords a rare view of this configuration. The panzer is covered in Zimmerit, but only on areas not normally blocked by tool or spare track storage. The base color is dunkelgelb with a "curlicue" pattern composed of the supplementary colors of olivgrün and rotbraun. The Tac number, "214" in solid white characters is also seen on the turret rear, partially on the escape hatch.

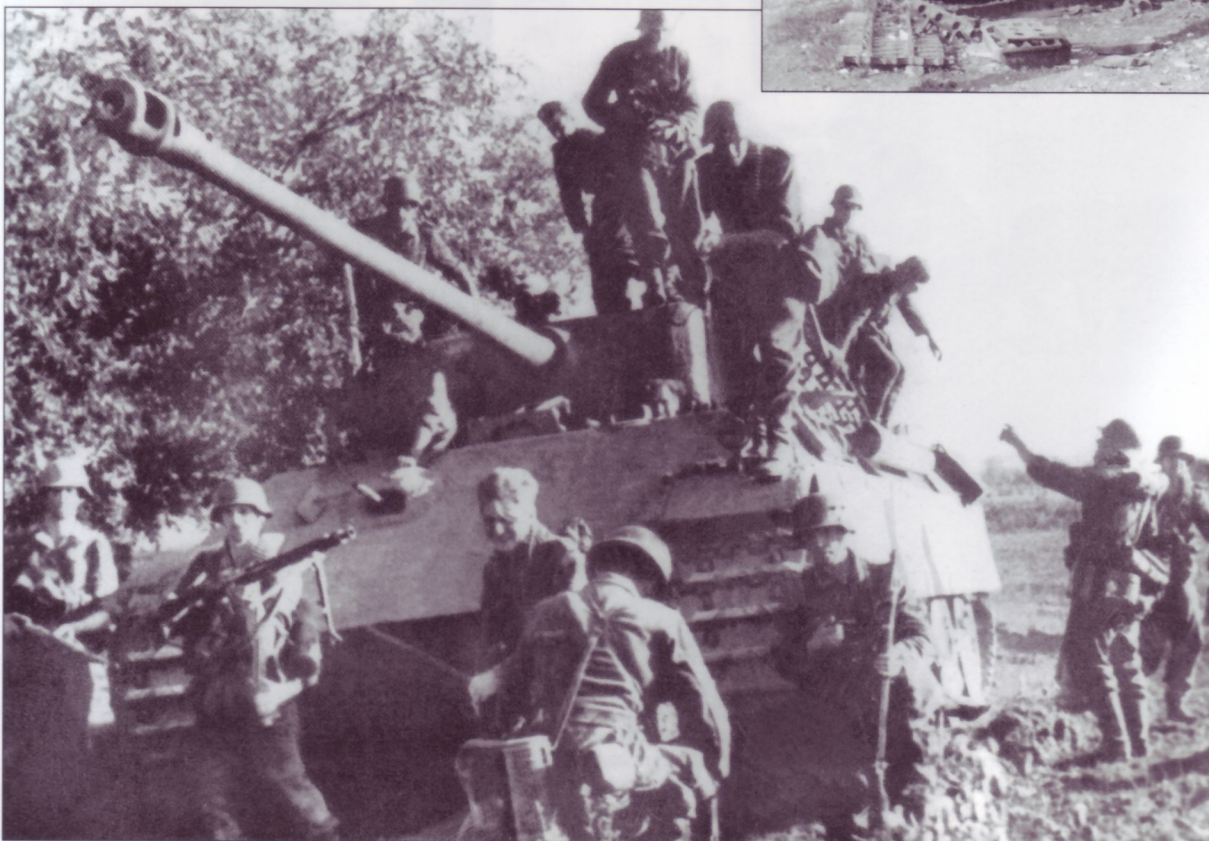
Most of an infantry section, including their MG42 team, dismounts from a Panther Ausf.G. This panzer is identified as an Ausf.G by the location of the Bosch head-lamp, the absence of a driver's vision flap, as well as the configuration and position of his rotating periscope at the forward edge of the hull roof/glacis plate joint. Note the Schürzen plates, which are of a different pattern from the Ausf.D and A. This early Ausf.G is covered in Zimmerit, and has a base coat of dunkelgelb; there are no visible markings.

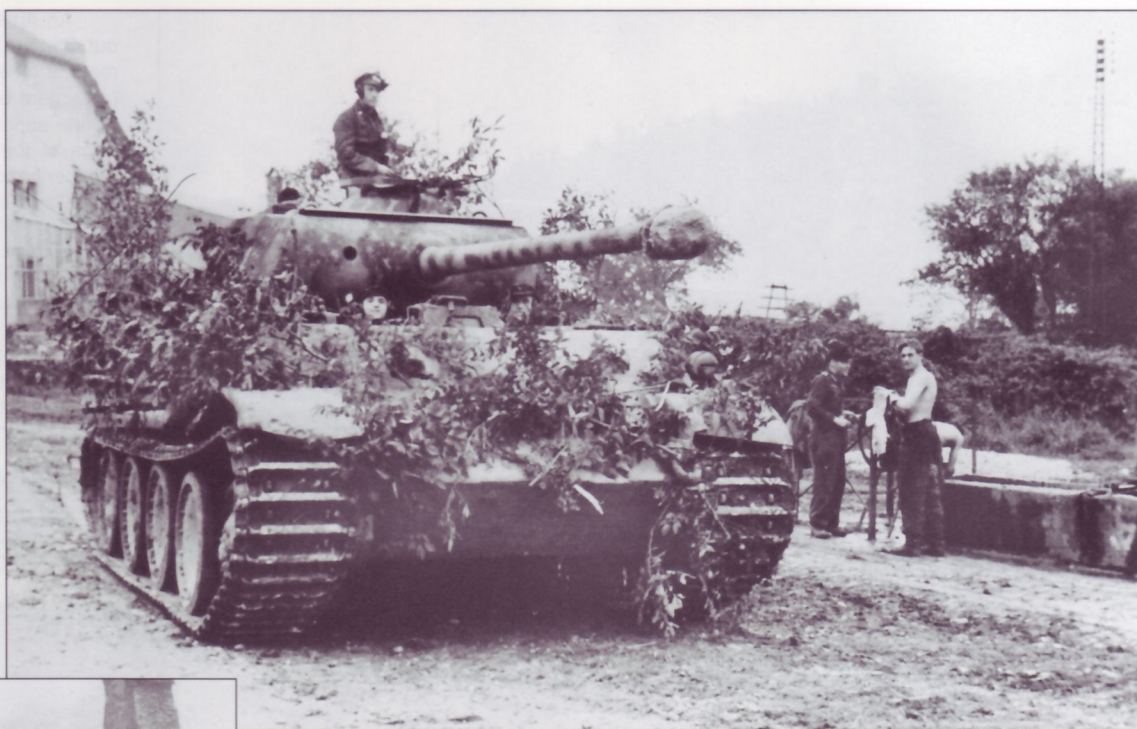
This foliage-covered Panther Ausf.G is identified by the continuous slope of the superstructure-side armor plate, as well as the position of the Bosch head-lamp on the driver's side fender. It also carries the so-called "Ambush Pattern" camouflage which was factory applied at the same time that German panzers were ordered built without Zimmerit anti-magnetic mine paste. Camouflage was to be applied at the factory and consisted of primer rot RAL 8012 as the base color, with dunkelgelb and olivgruen patches and spots, either sprayed on or hand-painted. No markings are visible. It does not have the new pattern Schürzen, while another later feature, the rain guard over the gun mantle can be clearly seen.

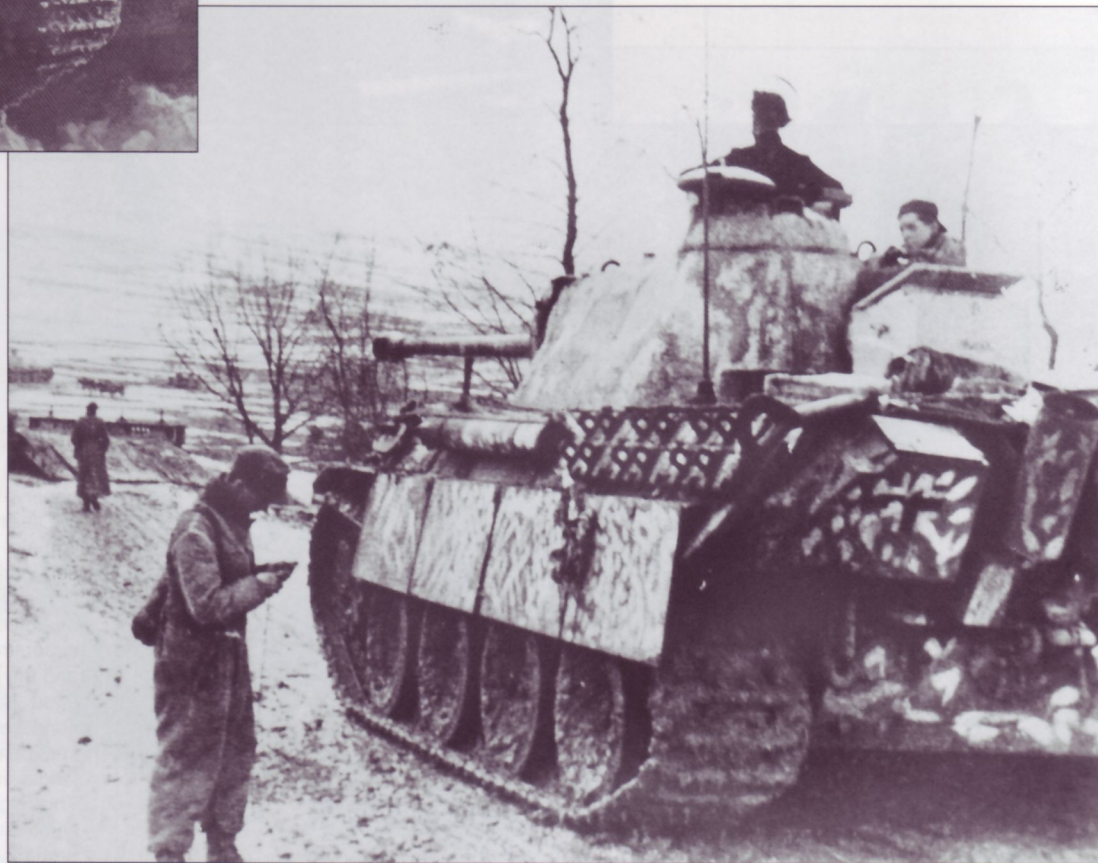
This Panther Ausf.G exhibits many features of the final production series. These include high fan tower for the "Kampfraumheizung" (crew compartment heater) and "Flammvernichter" (flame-dampening) exhaust mufflers. Note also the vertical storage of the vehicle jack as well as the heavy-duty tow point on the circular engine access plate. This view also illustrates how the Schürzen were hung; careful scrutiny will show that the plates overlap each other, with the forward-most on top of the one behind it, etc. This made it slightly less-likely that the plates would be torn off. This panzer has a hand-applied whitewash consisting of short strokes, spots, blotches and cross-hatch patterns over what should be a factory camouflage scheme of either rot primer or olivgrün base. There appears to be an open space on the turret within which may be a tactical number.

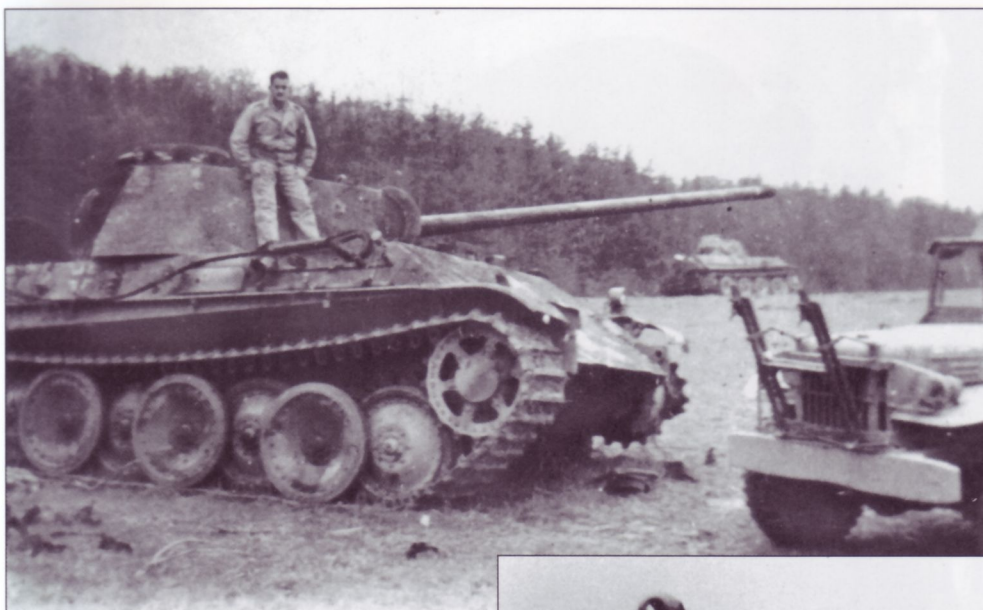
An American soldier poses on a knocked-out Panther Ausf.G, while in the background rests another similar panzer. Note the unusual placement of the balkenkreuz national insignia on the superstructure side, just below the rear edge of the turret. This panzer is covered in Zimmerit and is finished in dunkelgelb base with the supplementary colors of olivgrün and rotbraun sprayed on in broad mottled patches. Note that the Bosch black-out driving headlamp (mounted on the far mud guard) has lost its cover. The purpose of the unusual device on the Dodge WC-series truck is not known; it would appear to be a bit elaborate for use as a wire-cutter, something which was a commonly fitted to the bumpers of US wheeled vehicles to prevent injury from wires strung across roads.

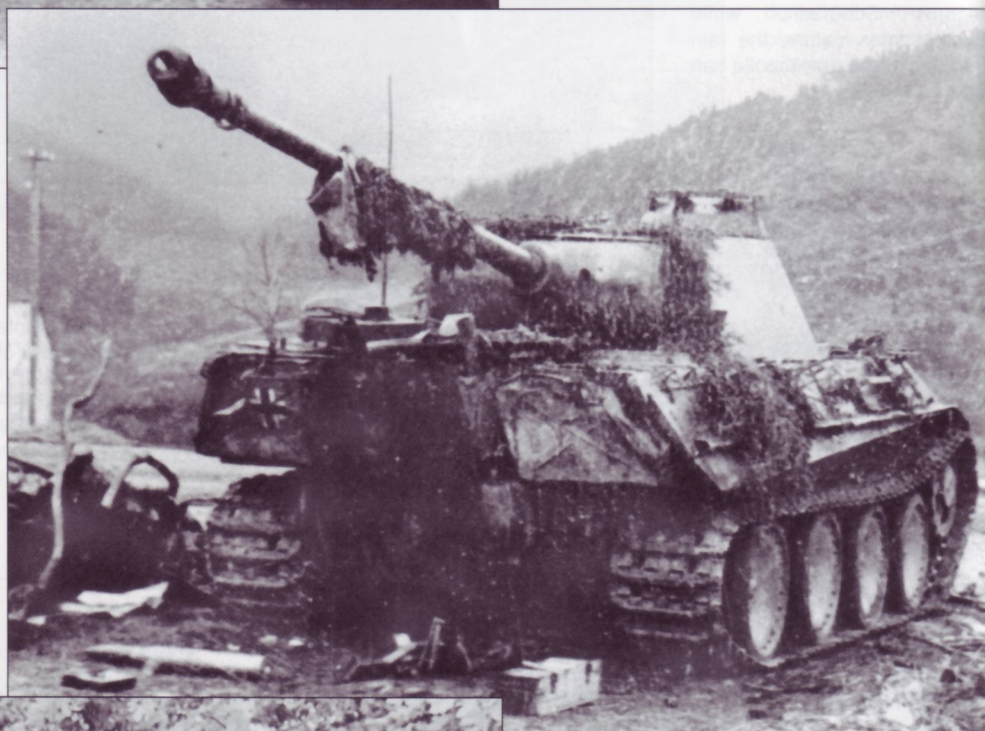
This abandoned Panther Ausf.G is fitted with the higher fan tower for the "Kampfraumheizung" (crew compartment heater), on the engine deck. The stowage lockers on the rear plate are thoroughly crushed; note the balkenkreuz on the left-hand locker. The configuration of the exhaust pipes is also curious, as their ends point vertically, instead of being bent to point rearwards. This would appear to be a deliberate modification, as the shields around the pipes are not crushed like the stowage lockers.

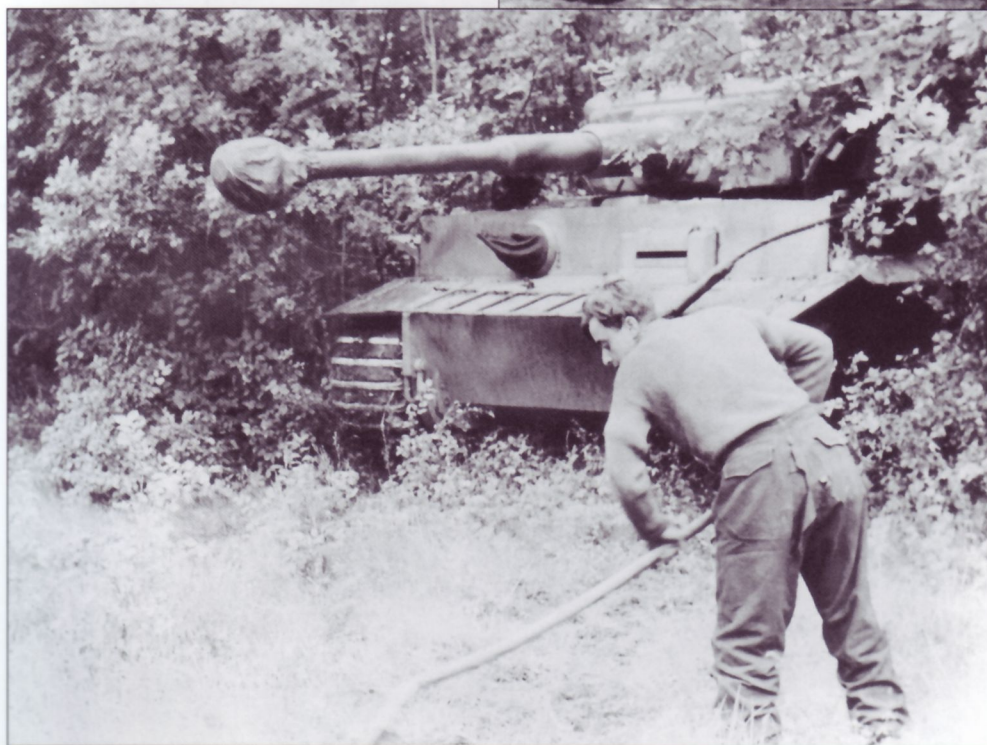
A crewman covers the tracks of a well-hidden Tiger I from possible enemy aerial observation; note the tattered appearance of the seat of his trousers. This is a relatively early vehicle as evidenced by the straight configuration of the hull-side extensions for the tow shackles. The Bosch head-lamps are not mounted in their usual places on each of the superstructure front corners. Both the main gun and the bow MG are covered with their custom-fitted dust covers, indicating the panzer is conducting a road march, with combat not imminent. It is unclear what the purpose of the ladder-like device is on the upper glacis plate. This Tiger is finished in a base of dunkelgelb with faded blotches of secondary colors, probably olivgrün and rotbraun.
