# PANZER VOR!

German Armor at War 1939-45

Frank V. De Sisto

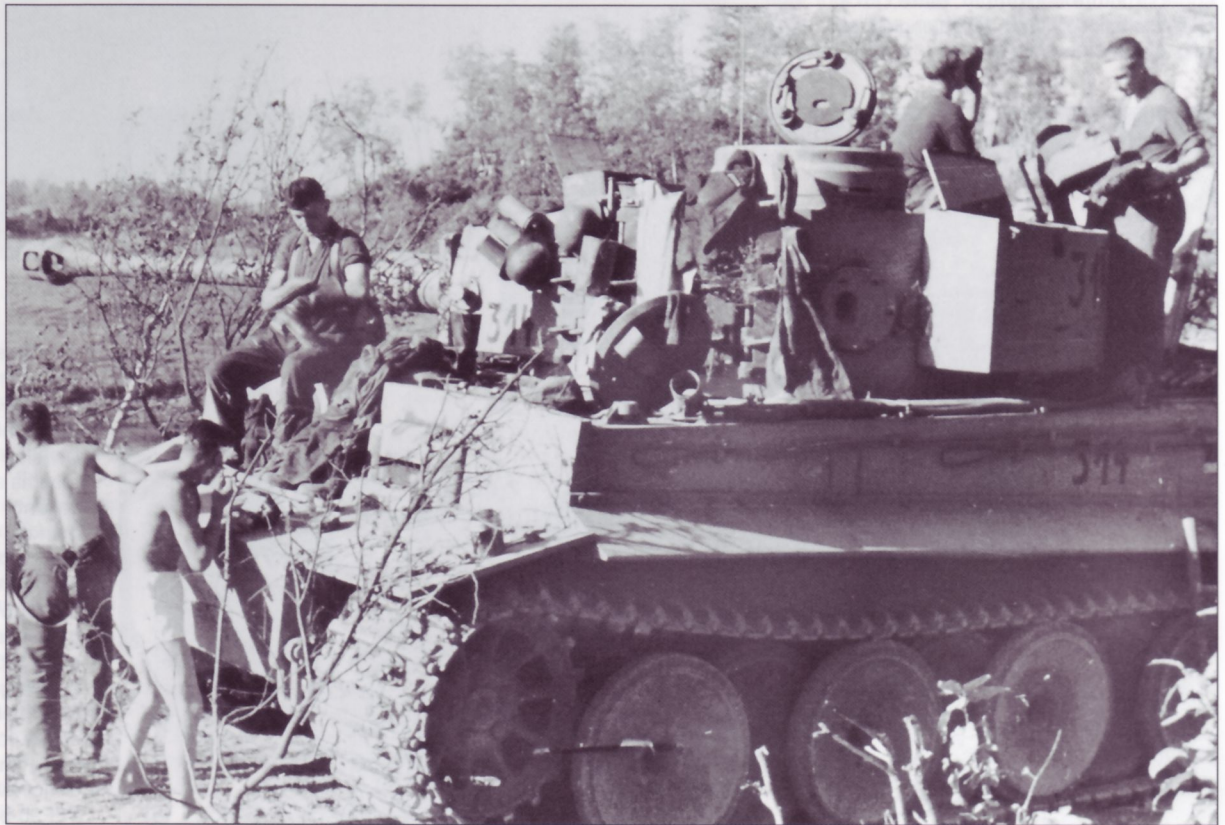
Tiger Ausf.E, Tac number "311" (from 3./s.Pz.Abt.502), fords a stream. It has a small ladder stowed on the upper glacis and dust covers fitted over the main gun as well as the hull MG mount. Note also the periscope just forward of the loader's hatch, which was ordered to be fitted starting in March 1943. This view shows the hinges for the front mud flaps to excellent advantage. These, as well as the rear mud flaps could be folded over; then, the side sand shields/fenders and the outer road wheels were removed, and finally, the wide cross-country tracks were exchanged for narrow "transport" tracks. This was done to prepare the overly-wide Tiger I for transport on specially-designed six-axle railway flat-cars.

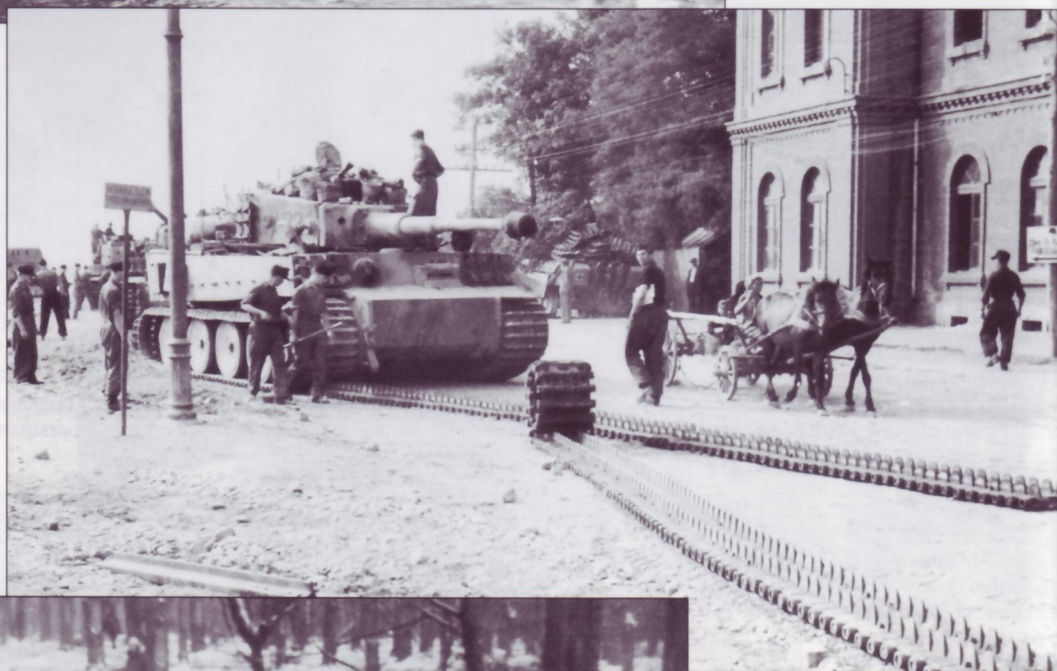
This companion photo to an earlier image of a Pz.Kpfw.IV shows a Tiger I belonging to the "schwerer Kompanie" (heavy company) of SS-Division "Das Reich", several months after the battle for the Kursk salient. The division's temporary marking of a white horizontal bar topped by two vertical bars is plainly seen on the superstructure front plate, while the company's white gnome insignia can be seen on the turret side. This Tiger I has S-mine dischargers on the hull roof, but does not have a periscope in front of the loader's hatch on the turret roof. The mantle has reinforced armor over the two openings for the TZF9b binocular gun sight.

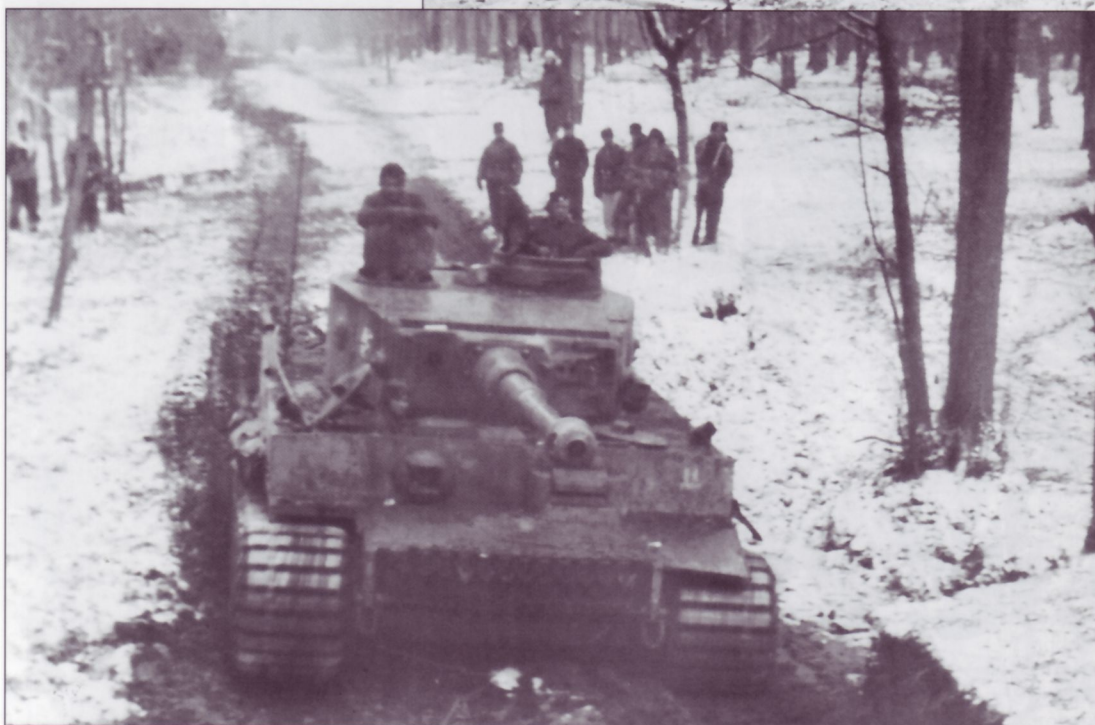
A so-called "mid-production" Tiger I is seen on the snow-covered Ostfront, with a Pz.Kpfw.IV Ausf.G or H in the background. There is a heavy motorcycle/sidecar combination next to it, probably a BMW R75. The panzer has the new cast commander's cupola, which was ordered into production during July of 1943, as well as a periscope in front of the loader's hatch on the turret roof. The Tiger I is covered with Zimmerit anti-magnetic mine paste that was ordered to be applied at the factory during August of 1943. This is in turn covered in a winter whitewash; the base color would be dunkelgelb, possibly with the two supplementary camouflage colors applied.

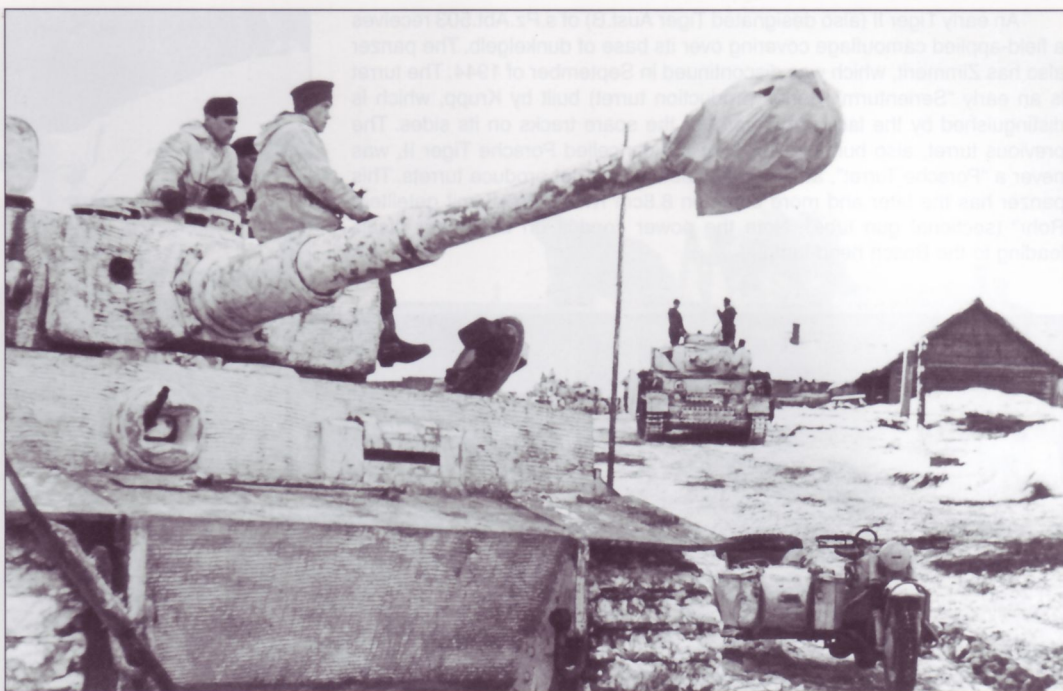
This Tiger II belonging to s.Pz.Kp.(Fkl.)316 was disabled in Drieux, France in November of 1944. The company was attached to Panzer-Lehr-Division since early 1944. It is a very early machine (reportedly among the first five production vehicles) as indicated by the Krupp turret, which was designed to fit on the aborted Porsche Tiger II chassis. Other early features are drive sprockets with 18 teeth, as well as the deep-fording cover on the rear of the engine deck. The single-piece 8.8cm KwK43 L/71 gun tube (seen here) was soon replaced by the sectional version. The panzer is covered in Zimmerit and finished in a base of dunkelgelb; note the very large Tac numbers ("11") on the turret and the partially obscured balkenkreuz national insignia beneath the forward fender section.

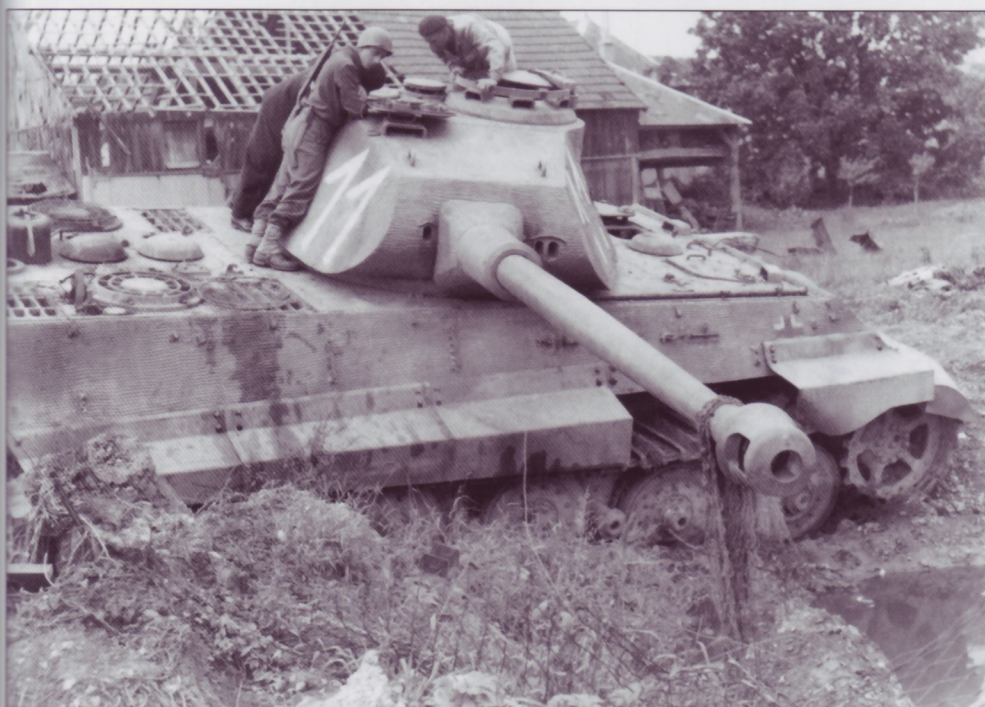
This photo also depicts a Tiger II of s.Pz.Kp.(Fkl.)316, which had been disabled. This company was equipped with the first five Tiger IIs to be produced, three Tiger Is, nine StuG.IIIs and dozens of radio-controlled Borgward B-IV demolition vehicles, thus the designation "Fkl.", the abbreviation for "Funklenkpanzer" (radio-controlled tank). Note again the 18-tooth drive sprocket and the early turret with the one-piece gun tube. The Tiger II is covered in Zimmerit with a base color consisting of dunkelgelb. The large Tac number, "02" is painted in white; note also the style and location of the balkenkreuz national insignia.

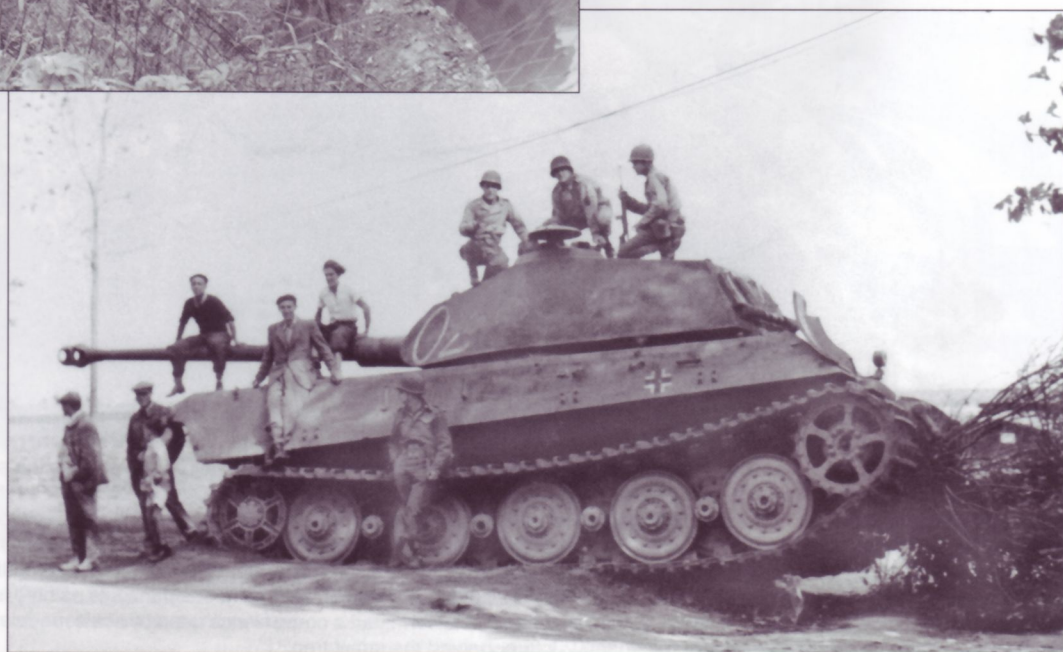
An early Tiger II (also designated Tiger Ausf.B) of s.Pz.Abt.503 receives a field-applied camouflage covering over its base of dunkelgelb. The panzer also has Zimmerit, which was discontinued in September of 1944. The turret is an early "Serienturm" (series production turret) built by Krupp, which is distinguished by the lack of hangers for the spare tracks on its sides. The previous turret, also built by Krupp for the cancelled Porsche Tiger II, was never a "Porsche Turret", as that manufacturer did not produce turrets. This panzer has the later and more common 8.8cm KwK43 L/71 "mit geteiltem Rohr" (sectional gun tube). Note the power conduit on the upper glacis leading to the Bosch head-lamp.

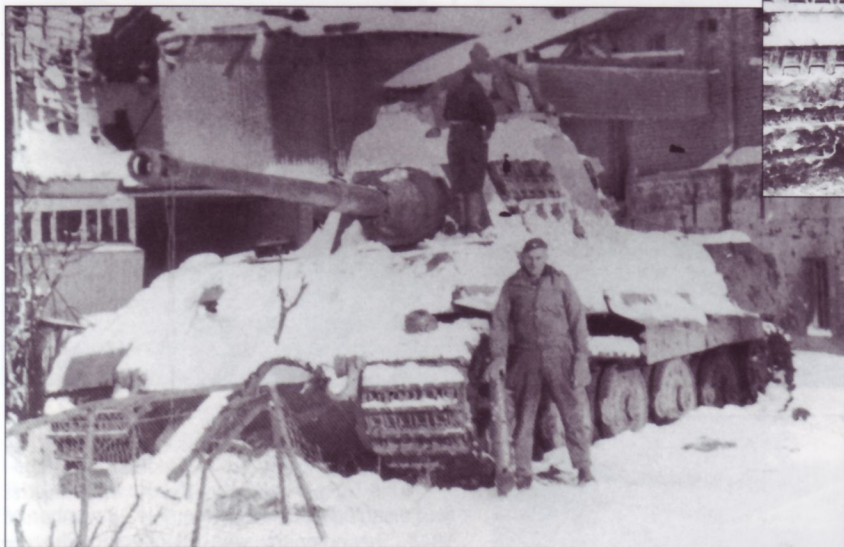
Clothed in a shroud of fallen snow, this abandoned Tiger II lies derelict in a destroyed town, while what appear to be British/Commonwealth troops inspect their once formidable adversary. This Tiger II has the "Serienturm" (series production turret) built by Krupp and mounts an 8.8cm KwK43 L/71 "mit geteiltem Rohr" (sectional gun tube).

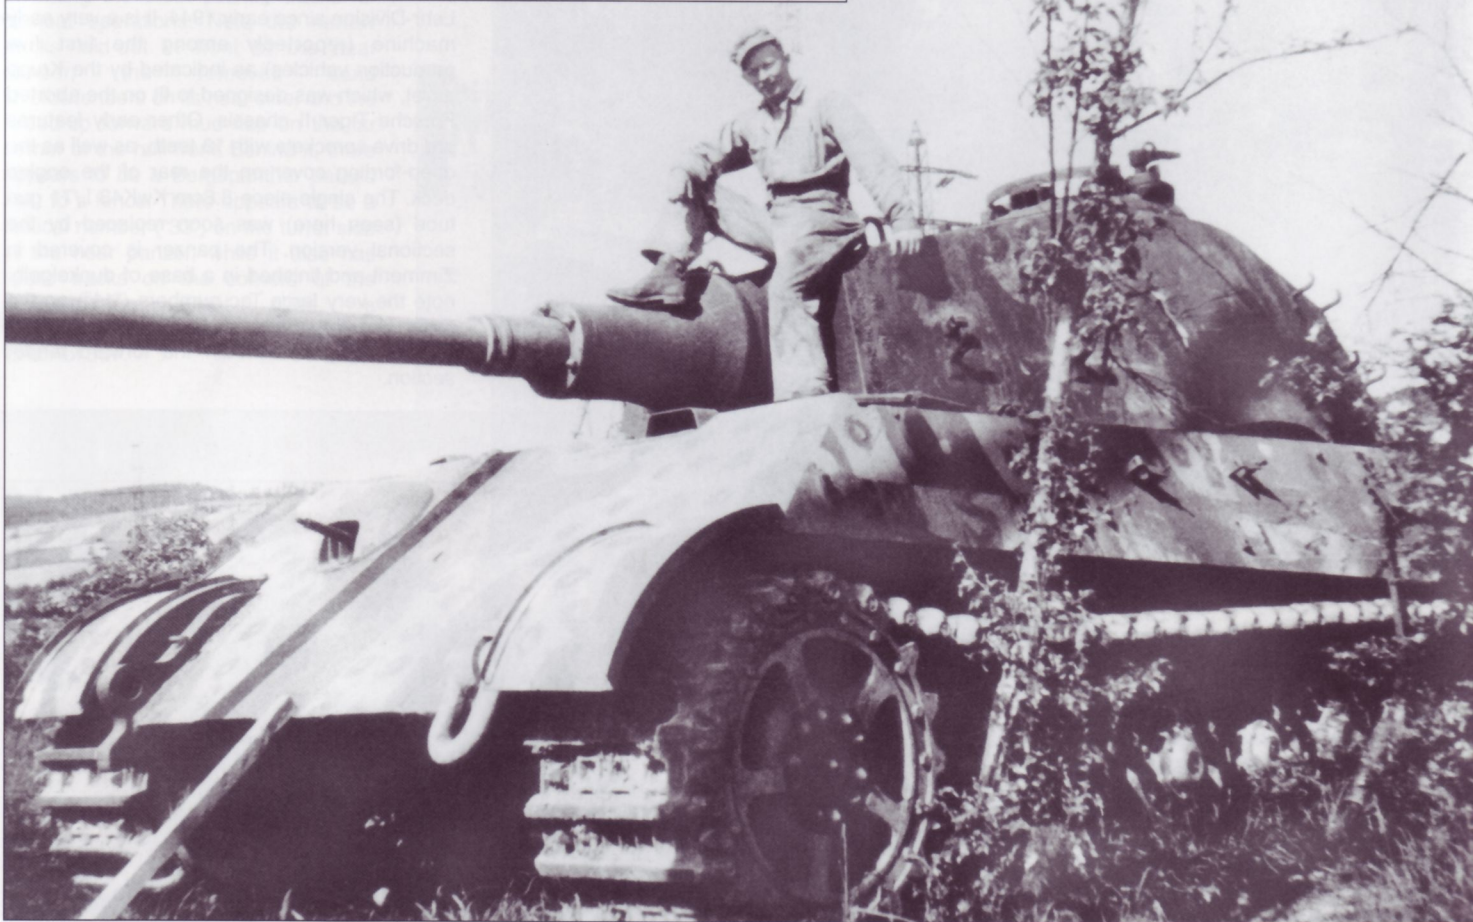
An American soldier poses atop a later production Tiger II, probably in the spring of 1945. Of interest is the second style of "smooth" gun mantle without the ridges around its circumference and the 8.8cm gun in full recoil. The latter indicates that the crew disabled the gun by removing hydraulic fluid from the recoil apparatus, and then firing a round. The panzer is fitted with narrow transport tracks and is fitted with an 18-tooth drive sprocket, which was re-introduced towards the end of the war. The front mud flaps also have the reinforcing rib seen on late-production Tiger IIs, while the turret still retains the ring for the AA machine gun mount and has mounts to carry only four track sections on each side. Later turrets dispensed with the ring and had a different configuration for the track storage, so that the new single-link Kgs 73/800/152 battle tracks would fit. Finally, this panzer is painted in a base of olivgrün, with dunkelgelb stripes and spots in the so-called "Octopus pattern" (which is not an official term, but a convenience used by scale modelers). Of special interest is the "checkerboard" paint pattern seen on the near corner of the superstructure, behind the small tree.

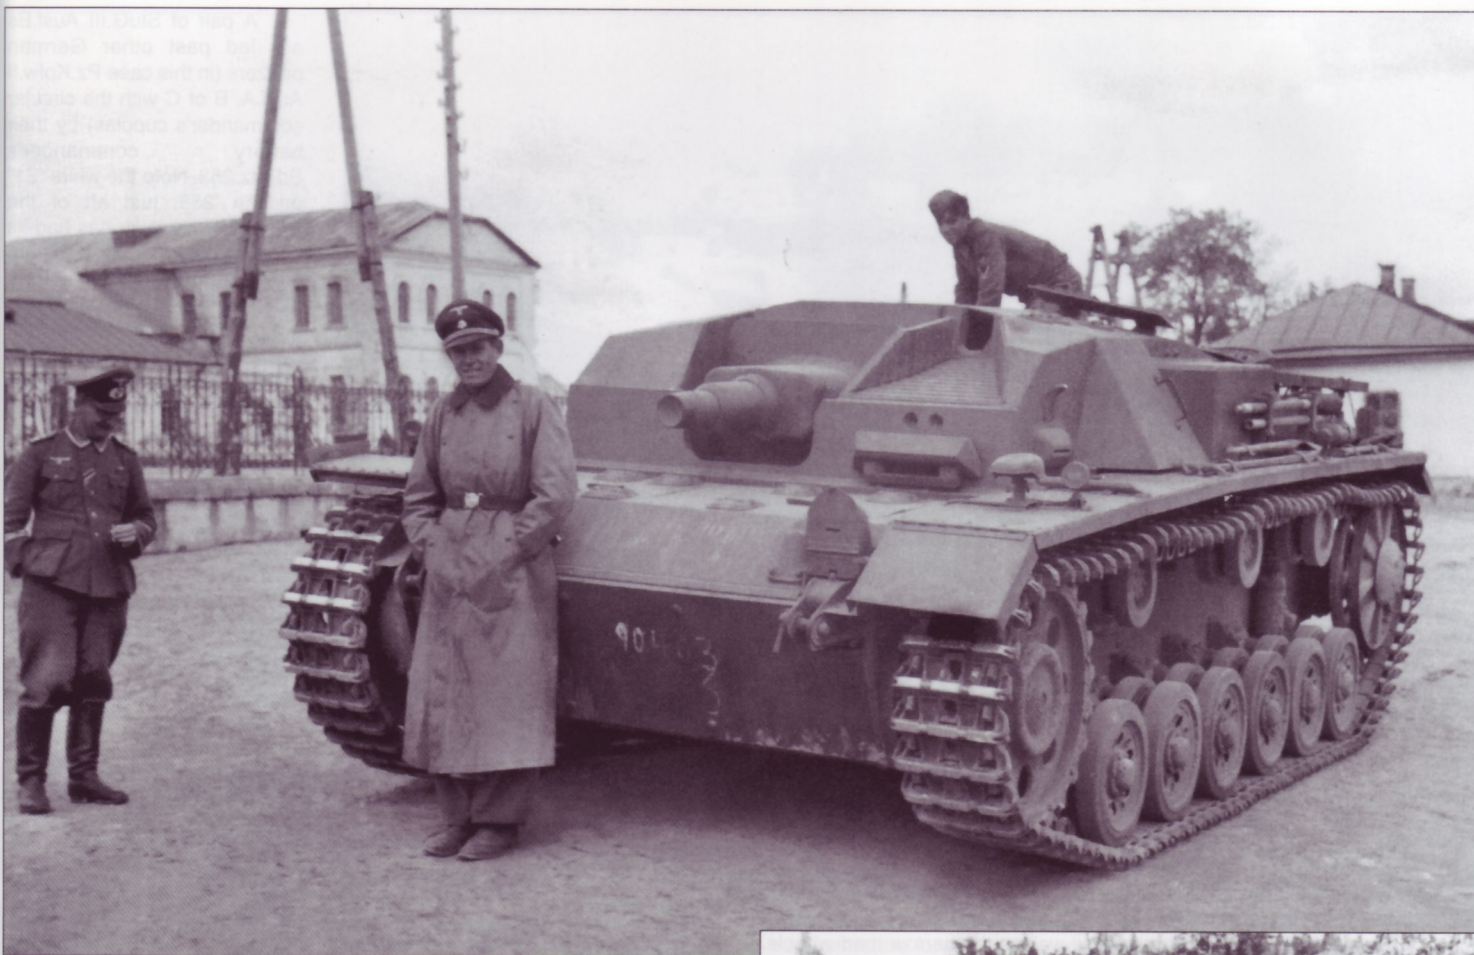
This photograph shows a very rare sub-type of the equally rare StuG.III Ausf.A. It belongs to the second production batch of 20 vehicles, which were derived from Pz.Kpfw.III Ausf.G chassis. It is identified as such by the chassis number on the lower glacis plate, 90403. Other identifying features of this variant are the configuration of the hatch hinges on the upper glacis plate as well as the bolted-on armor on the lower glacis plate. These assault guns saw service after the end of the French Campaign and would have been finished in a solid covering of dunkelgrau RAL 7028. Note the presence of a Notek black-out driving head-lamp, which also would date this photo as post-June 1940. The officer in front of the StuG wears his trousers bloused over his boots, while the Hauptwachtmeister to the left wears his boots in the standard fashion with breeches tucked in; note the cuff-bands on both of his sleeves.

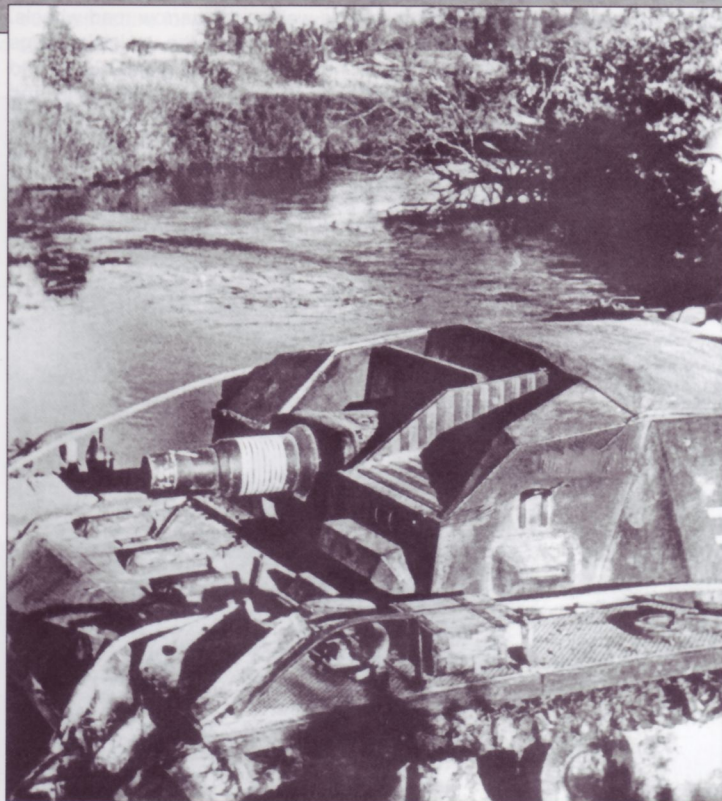
Another StuG.III Ausf.B, this time crossing a small river, shows some of its distinguishing characteristics. Note the way the "tunnel" that leads to the gun sight aperture is interrupted at intervals by strips designed to deflect bullets and fragments from a straight path into the otherwise un-protected opening. Compare the way the hinges on the upper glacis plate are configured, to the Ausf.A in a previous photograph. Note the open-style of the white-outline balkenkreuz national insignia as well as the stripes around the gun tube, which represented "kills" made by this assault gun. There is a cover fitted to the bore of the gun tube and brush-guards around the head-lamp arrays on both fenders.

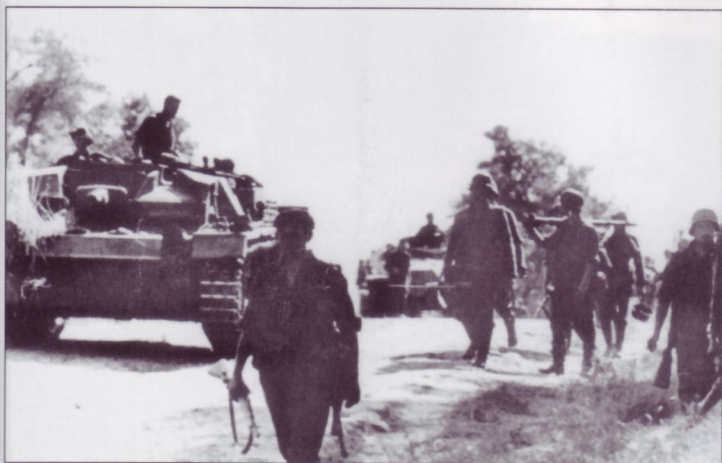
A group of infantrymen move along the side of a road, supported by a StuG.III Ausf.B, which is itself followed by an Sd.Kfz.252 ammunition carrier. The StuG is identified as an Ausf.B by the configuration of the periscope gun sight aperture.

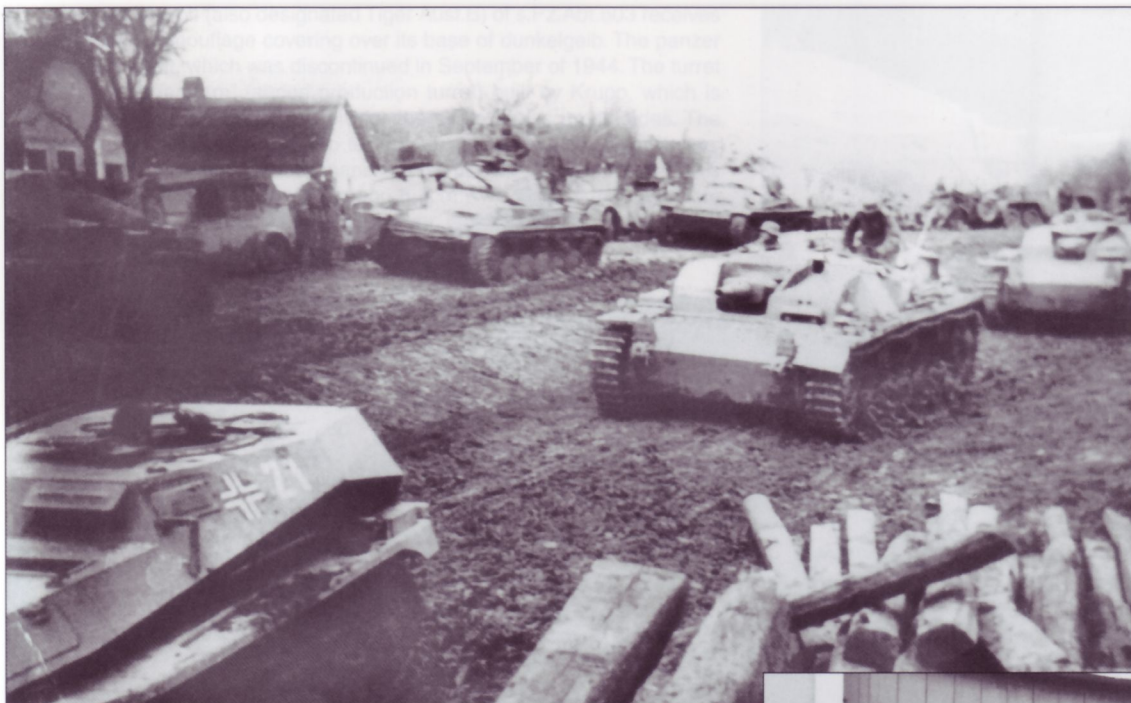
A pair of StuG.III Ausf.Bs are led past other German panzers (in this case Pz.Kpfw.II Ausf.A, B or C with the circular commander's cupolas) by their battery commander's Sd.Kfz.253. Note the white "Z1" on the '253, just aft of the balkenkreuz (which has had its borders cleaned up a bit so they are more prominent). It appears that the assault guns are covered in a white-wash over their dunkelgrau base color, which probably places them in the winter of 1941/42, on the Ostfront.

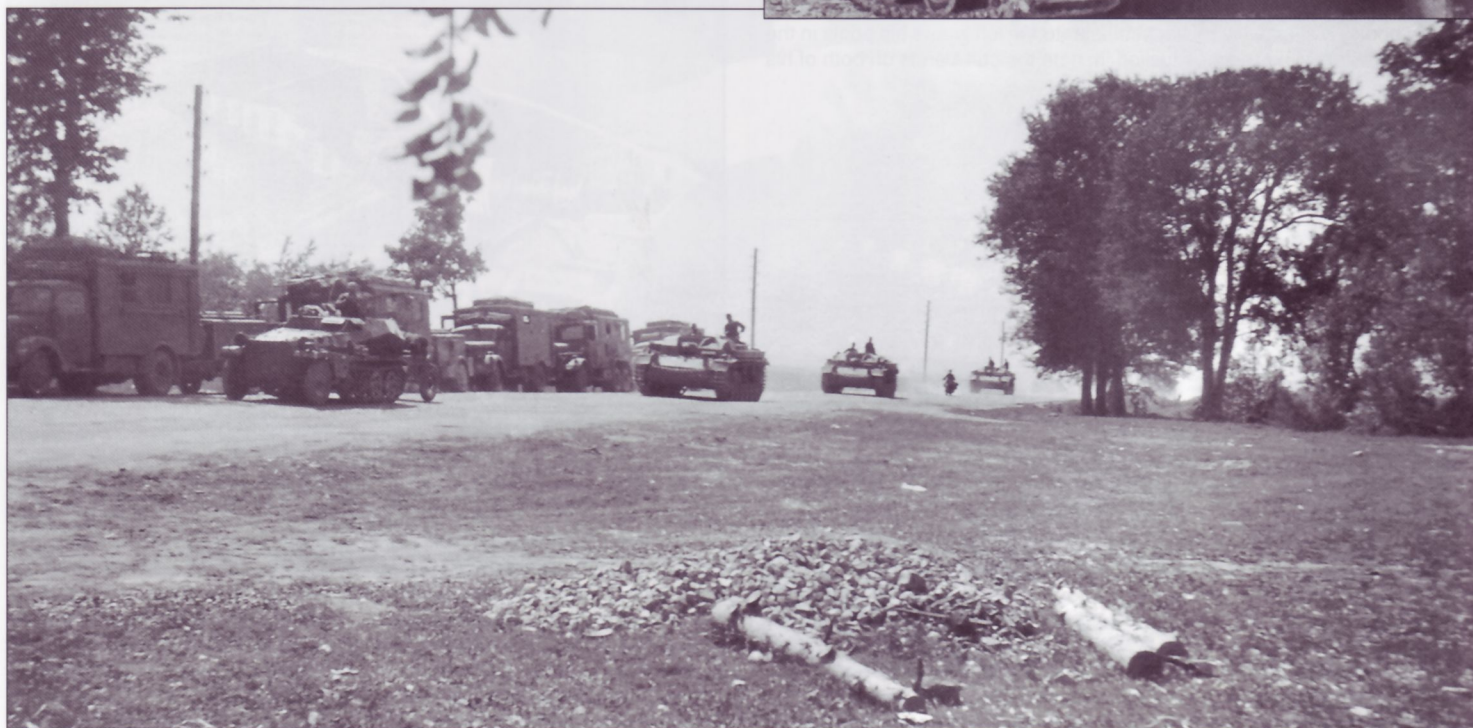
An Sd.Kfz.253 leads a battery of StuG.III Ausf.Bs past a group of German 3-ton trucks (probably from a communications unit). The '253 tows a small trailer, but the configuration of the superstructure identifies it as not being an Sd.Kfz.252 ammunition carrier, which would normally haul an ammunition trailer.

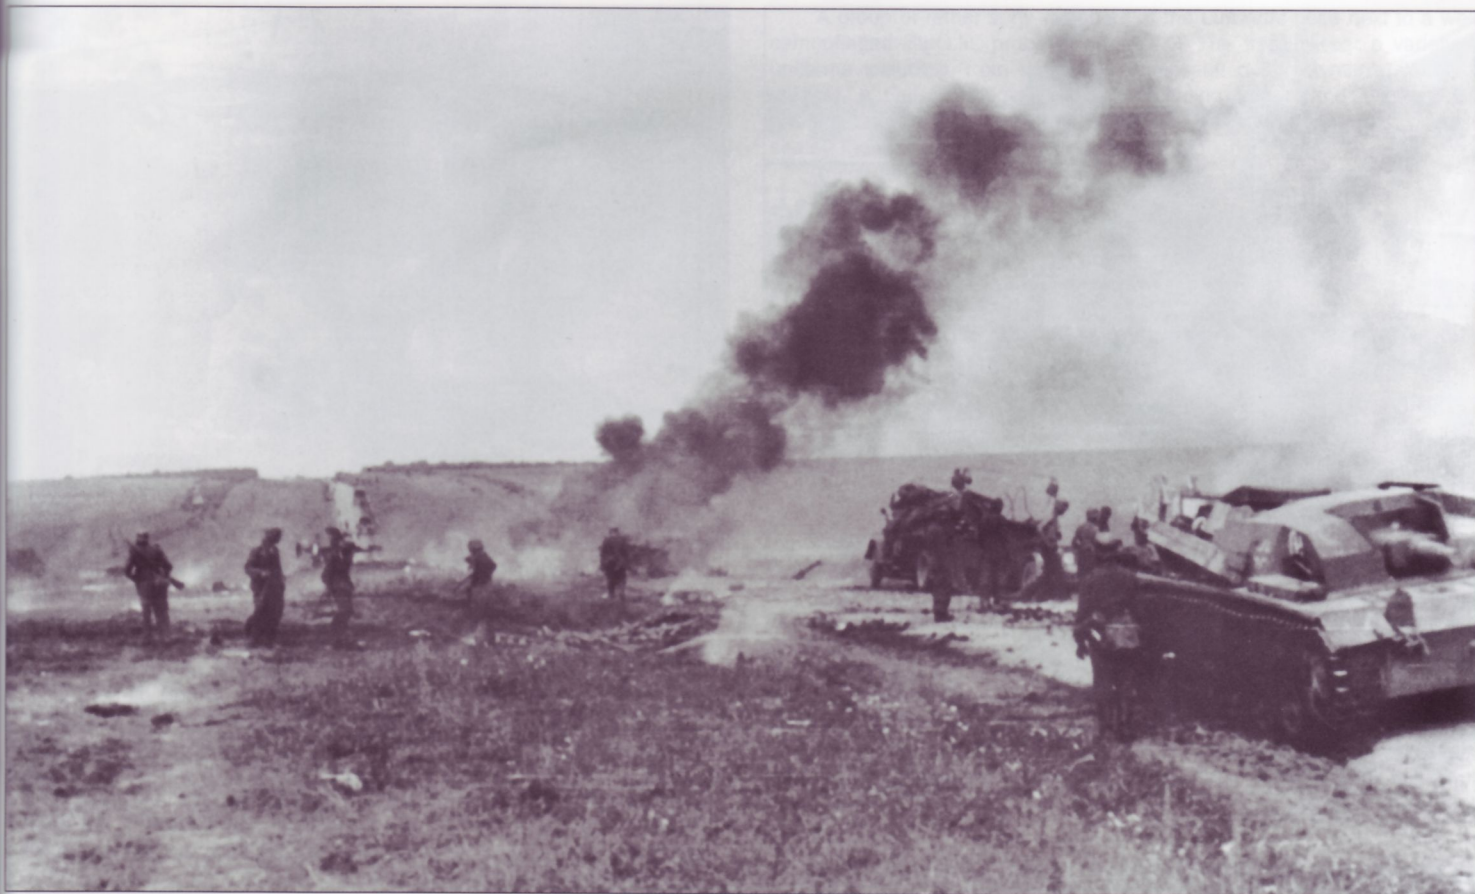
A StuG.III Ausf.B stands amid a group of German troops milling about on a road, where some action apparently has just taken place. Of note on the assault gun is a white-outline balkenkreuz and what is probably a letter (on the superstructure forward of the spaced armor panel) indicating the vehicle's place within its battery. Also of note is lack of most standard vehicle fittings and stowage items on the near fender, and the large timber beam further back along the superstructure side.

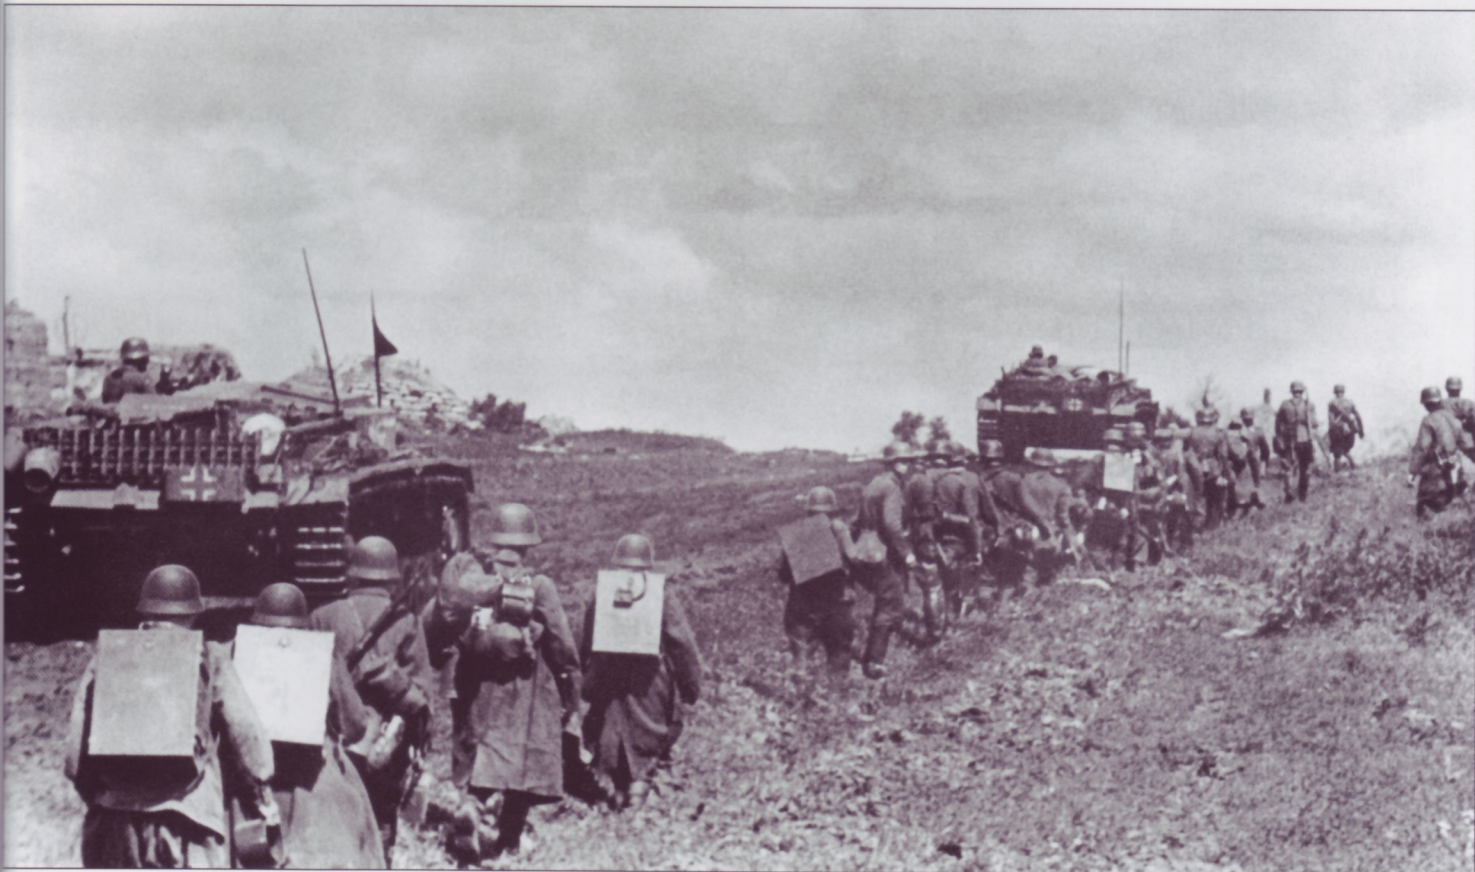
A pair of StuG.IIIs (at this angle, they could be either Ausf.B, C, D or E) pass a section of radio-equipped troops, somewhere on the Ostfront. As the periods of combat lengthened, the supply situation for Germany steadily worsened. Thus, many combat vehicles began carrying large amounts of spares and consumables. The near assault gun typifies this trend by mounting spare tracks on its engine deck, which also act as a framework to keep other loose items in place, such as the buckets towards the left.

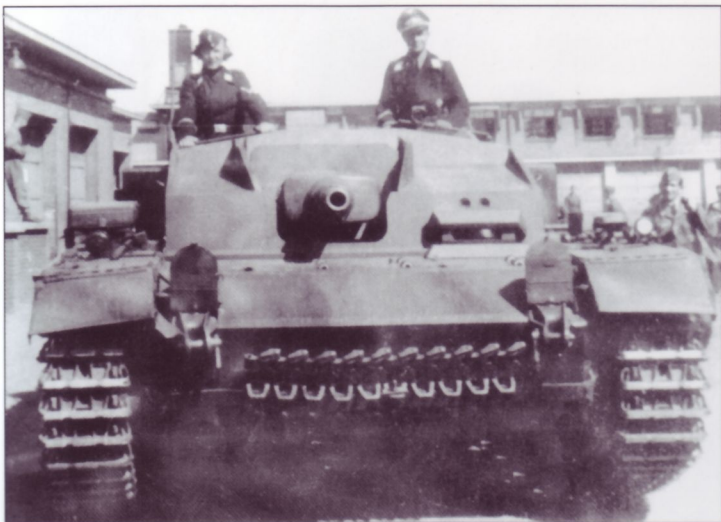
This StuG.III Ausf.E is crewed by Luftwaffe troops, suggesting it is part of the "Hermann Göring" formation (note their collar tabs, the commander's hat insignia and their cuff title bands). It is identified as an Ausf.E by the configuration of the superstructure, above the driver's compartment. The earlier aperture for the gun sight has been eliminated and the plate angle changed. The hinges for the hatches on the upper glacis plate have also been re-designed. It is probably finished in the "tropaen" (tropical) color scheme of braun RAL 8020 and grau RAL 7027, which would have been applied to vehicles assigned to combat in the Mediterranean area, such as Italy and Tunisia, both destinations of elements of this elite Luftwaffe formation.

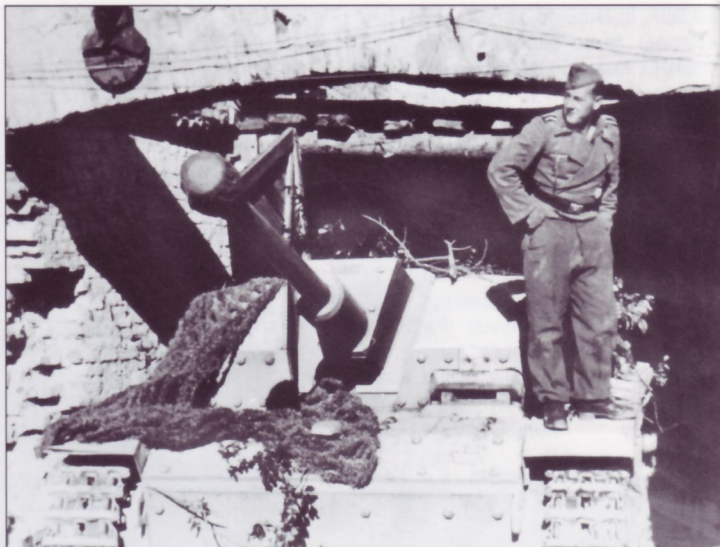
An initial-production StuG.III Ausf.G stands ready to do battle, as it emerges from a shed somewhere on the Ostfront. This model had a steeper angle to the plates on the superstructure side extensions, which are not visible here. What positively identified this as an initial-production vehicle are the two circular ports for the driver's periscope, just above his view-port. Note also the characteristic bolted-on 30mm armor plates on the superstructure front plates, as well as the upper and lower hull glacis plates. The assault gun still appears to wear a winter white-wash over its original dunkelgrau base coat (since these were produced in December of 1942, before the three-tone system, when the dunkelgelb base color became the new standard). The crewman wears the field-grey version of the panzer crewman's uniform, which was a distinction of the assault gun troops, who were officially part of the artillery branch.

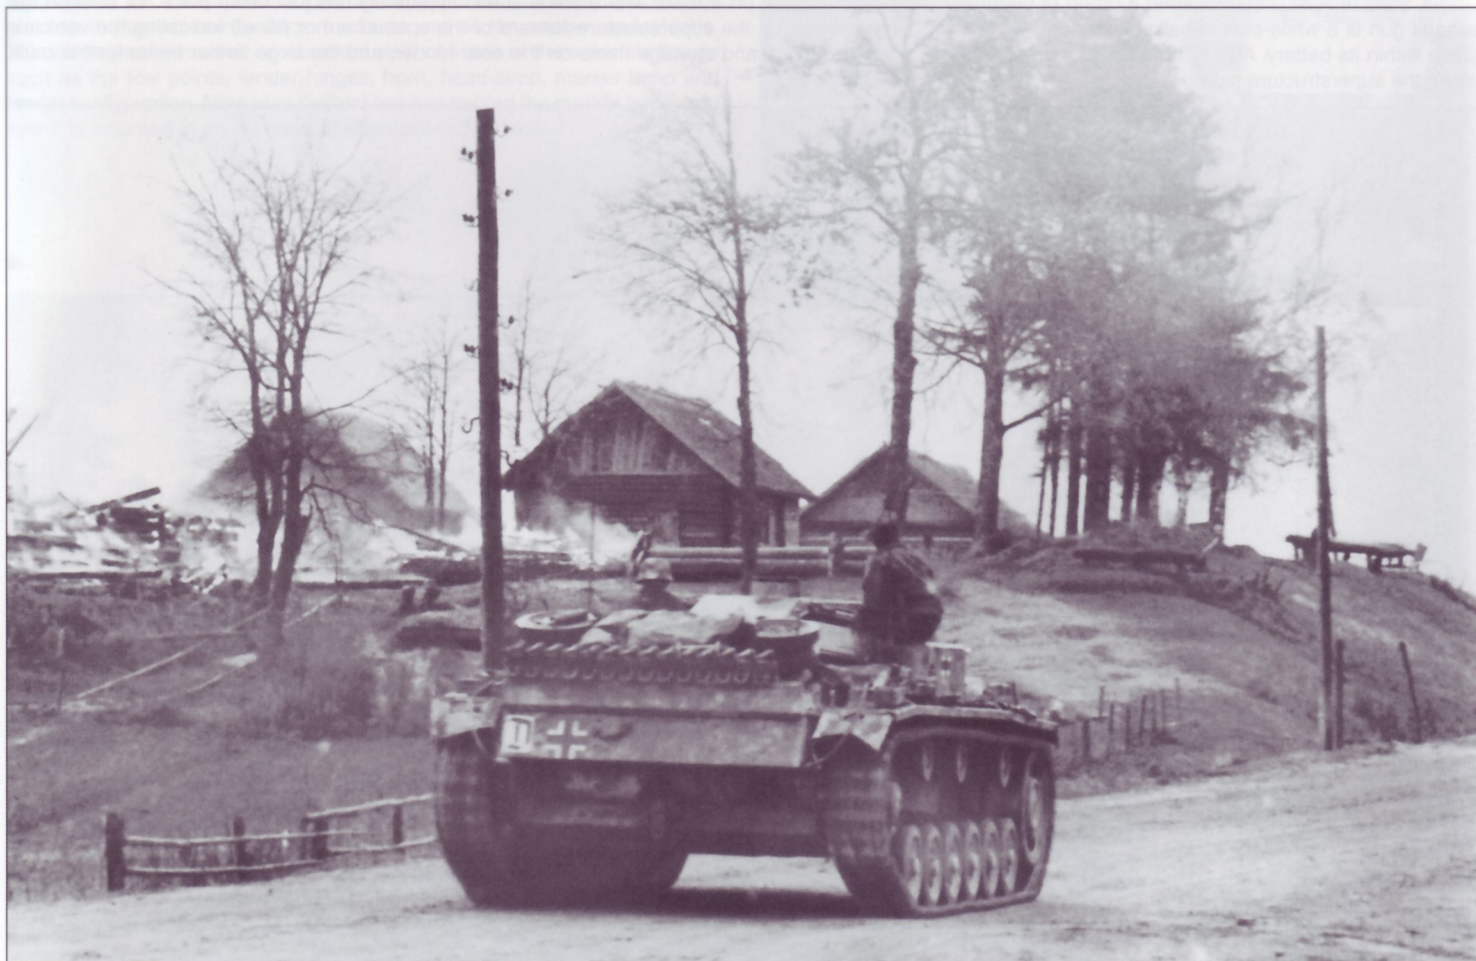
This assault gun is identified as a StuG.III Ausf.F/8 primarily by the configuration of the hull's rear plate. The characteristic raised central part of the superstructure roof, incorporating the circular fume extractor fan cover, was introduced earlier by the initial Ausf.F. The assault gun has a Gothic "D" (gun "Dora") on a light-colored area on the rear plate, next to a standard black/white balkenkreuz. The color scheme appears to be a base of dunkelgelb with a mottle pattern consisting of one or both of the supplementary colors (olivgrün or rotbraun).

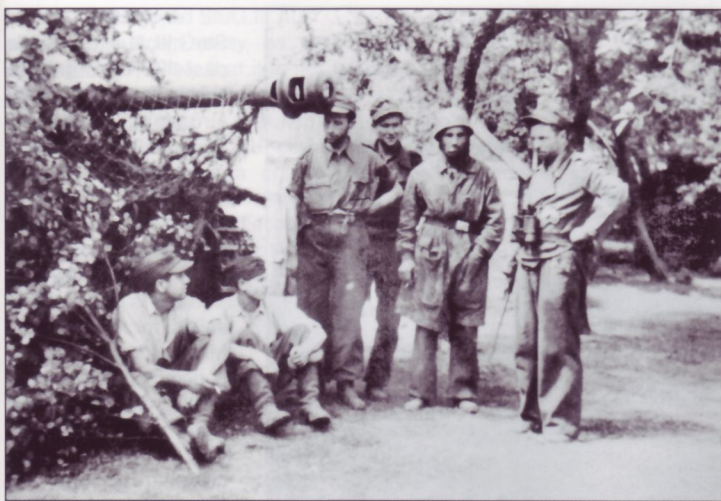
A group of rather surly members of the Luftwaffe pose next to a well-camouflaged StuG.III, probably an Ausf.G. The troops wear a variety of uniforms including, from the right, an assault gun crewman's field-grey uniform, a Fallschirmjäger's uniform including helmet and jump smock, another assault gun crewman's uniform, an officer in tropical tunic and two seated men wearing their trousers tucked into long boots.

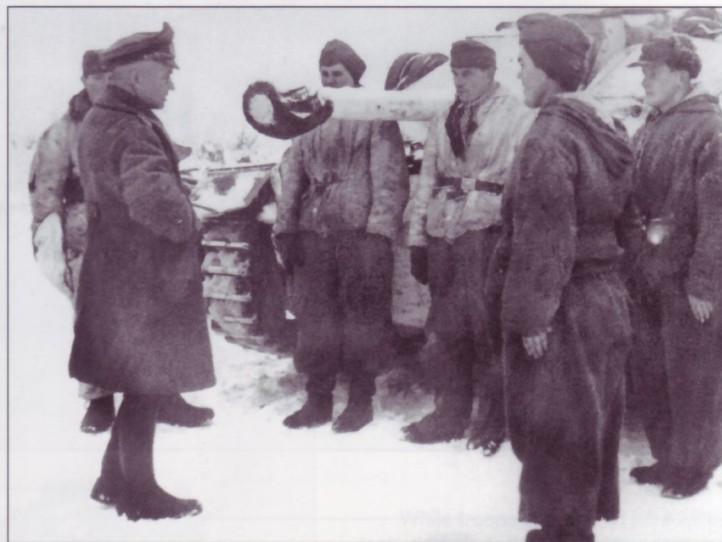
Another group of assault gun crewmen stand before a high-ranking officer on the snow-bound wastes of the Soviet Union. They wear the padded reversible two-piece winter suit, some with the mouse-grey side exposed, others with a very dirty white side exposed. Their white-washed StuG.III Ausf.G has a canvas cover on its muzzle brake. Note also the stowage of a road-wheel in a common spot on the superstructure side farthest from the camera.

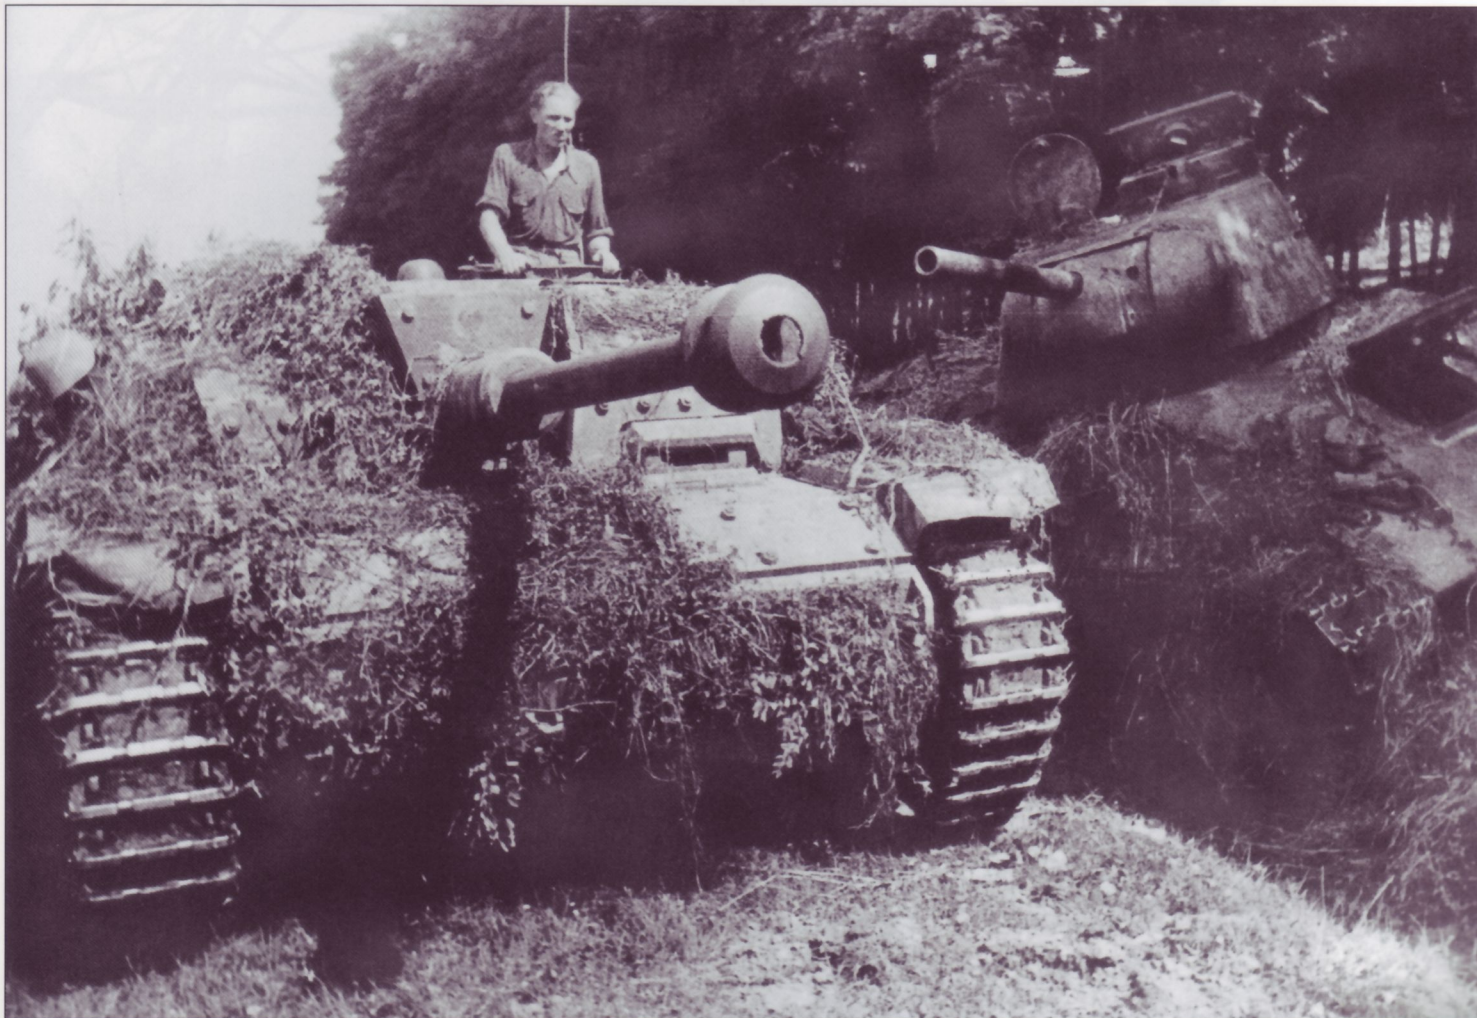
A well-camouflaged StuG.III Ausf.G passes a knocked-out Soviet T-34 Model 1943 with a commander's cupola and sharp-nose hull front (characteristic of tanks produced at Factory 174 during the spring of 1943). The assault gun has bolted-on 30mm appliqué plates on the upper and lower glacis plates as well as the front plate of the driver's compartment. Those plates were originally 50mm, so the vehicle now had 80mm of armor plate on its front. The only stowage of note is the steel helmets, one on the roof, with another on the superstructure side.

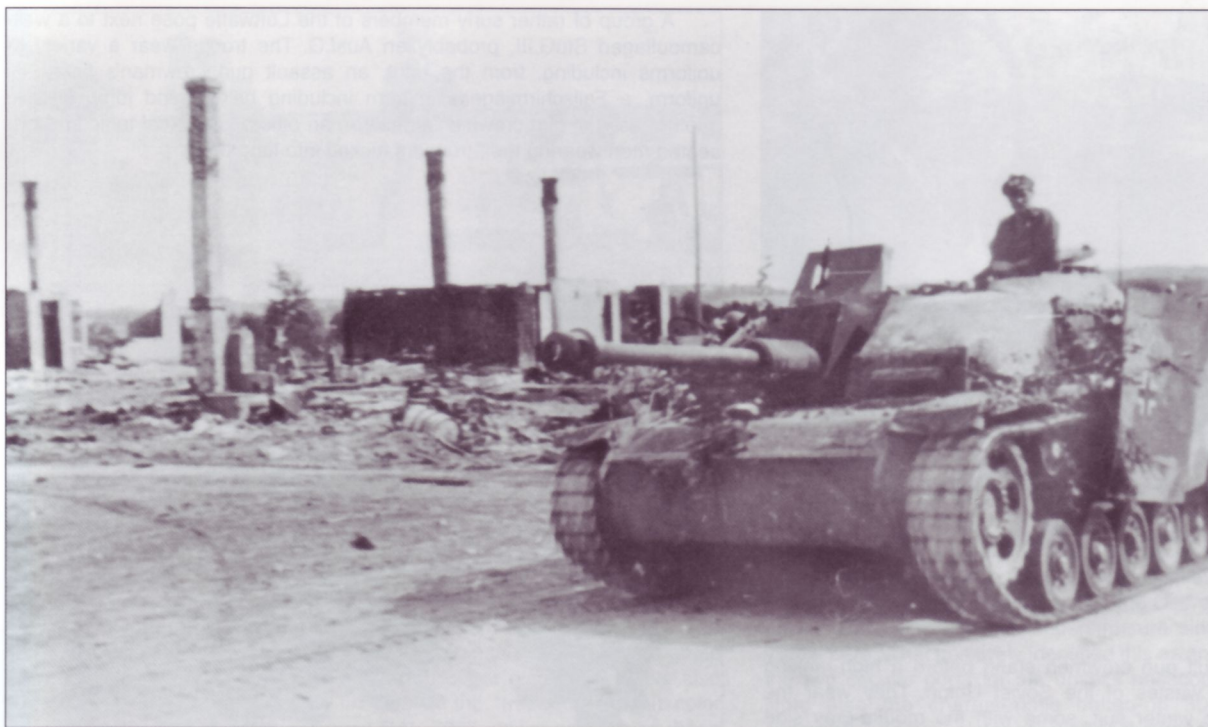
A later model StuG.III Ausf.G speeds past the ruins of some sort of industrial structure. Note the 80mm upper and lower glacis plate armor; compare its configuration to that of the assault gun in the previous photograph. There is a folding shield for the loader's MG34/42 as well as concrete reinforcement of the superstructure front. Note the Schürzen, with a balkenkreuz on the forward-most panel. The camouflage very likely consists of a base of dunkelgelb with large areas covered in the supplementary colors of olivgrün and rotbraun.

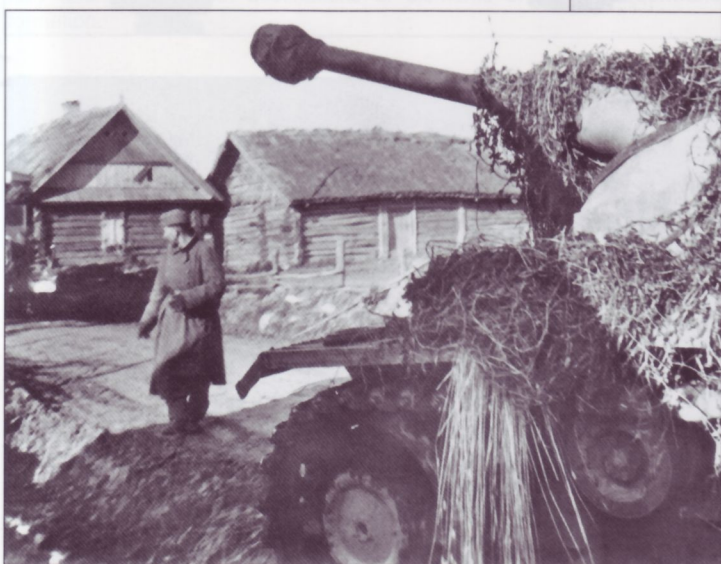
This detail photograph shows a StuG.III Ausf.G with a concrete-reinforced front superstructure. The 7.5cm StuK40 L/48 has a canvas cover on its muzzle brake and part of the fender is missing.
