# PANZER VOR!

German Armor at War 1939-45

Frank V. De Sisto

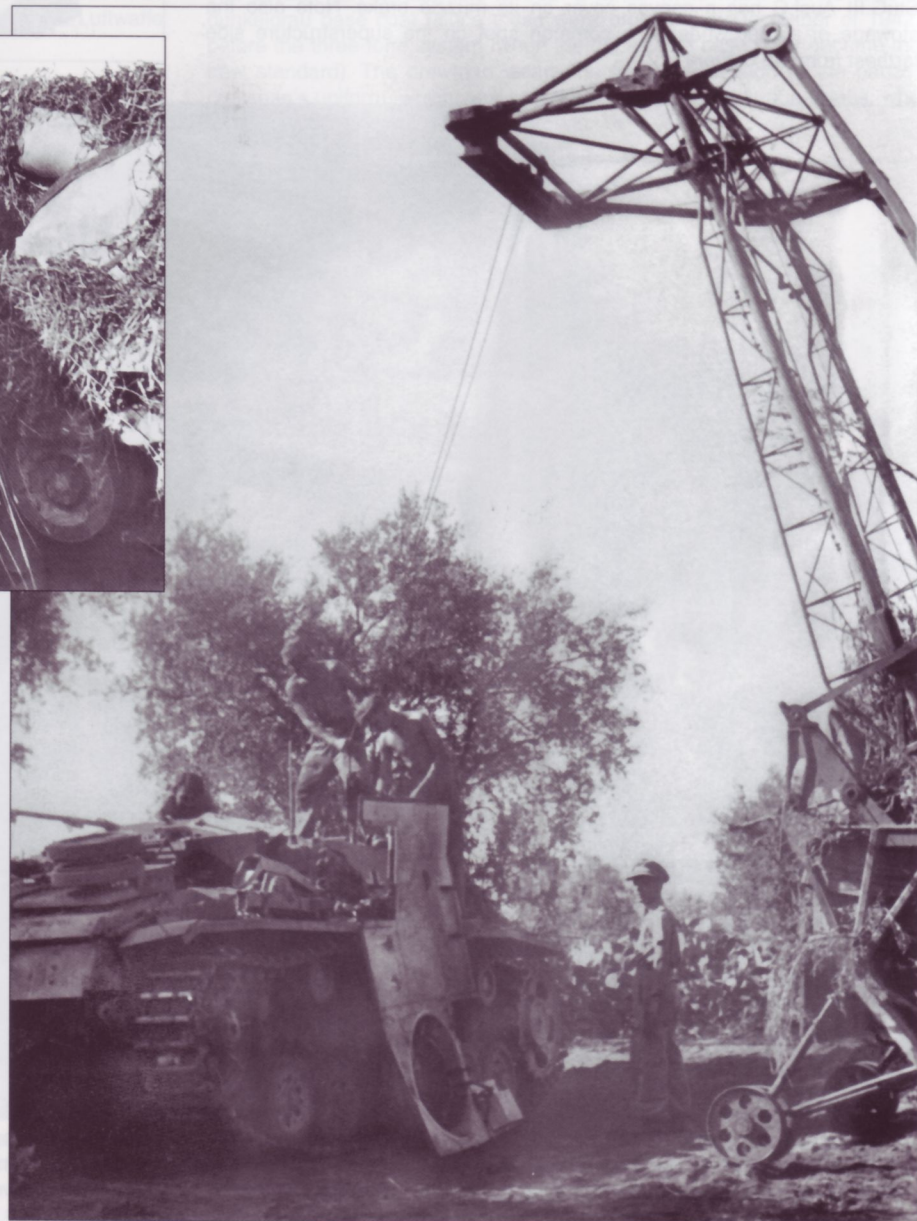
A StuG.III Ausf.G receives some serious attention from a maintenance team; note the removed roof plate leaning against the assault gun's side. The uniform on the man standing between the vehicle and crane, as well as the terrain, suggest that this may be a "Hermann Göring" assault gun.

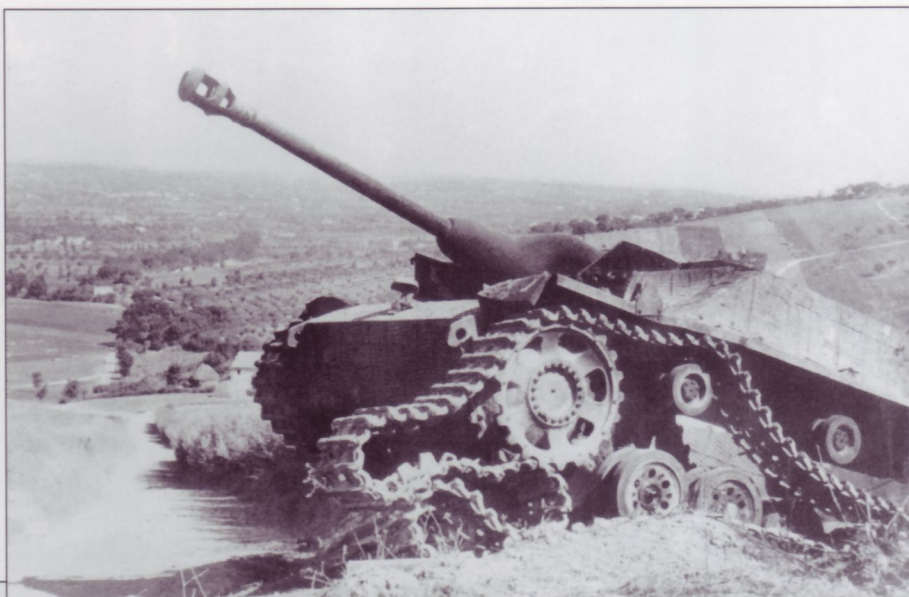
This destroyed StuG.III Ausf.G has had much of its suspension blown away, as well as the roof plate, making it very likely that it is not salvageable. It has a later cast "Topfblende" (pot mantle), which is usually incorrectly called a "Saugkopfbende" (pig's head mantle). It also has the so-called "waffle pattern" Zimmerit, which was a characteristic of the Alkett factory; note how it is also applied to the lower side of the hull. There is a single balkenkreuz applied to the superstructure side, which is covered in a base color of dunkelgelb; any other colors are hidden under dust or stains from battle damage.

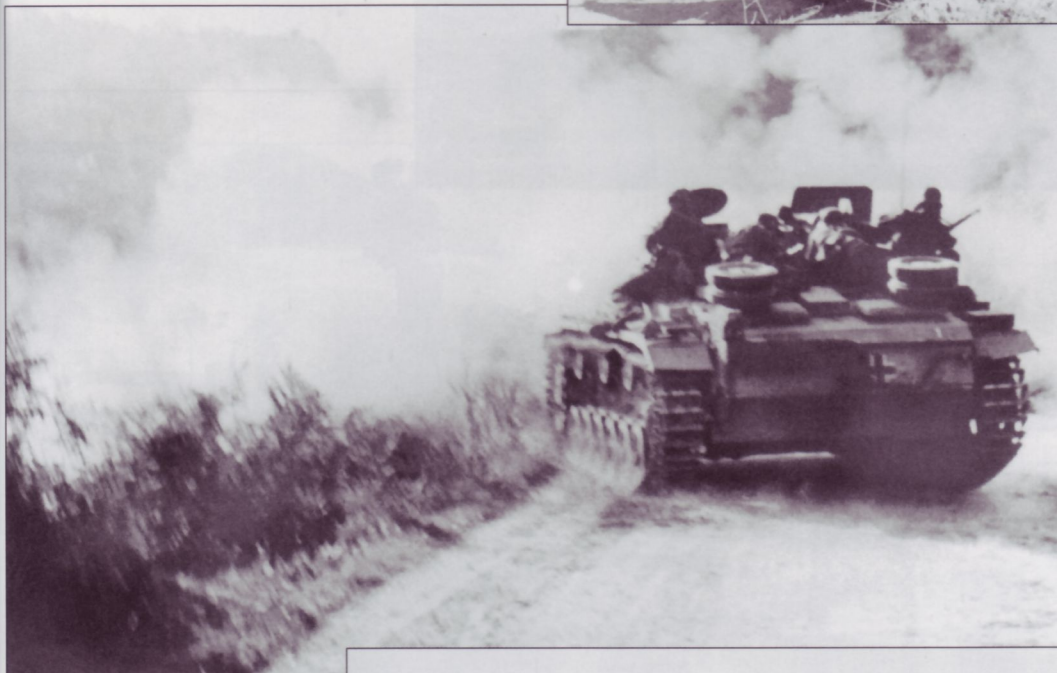
While troops seek cover on its rear deck, this StuG.III Ausf.G fires its main gun at the enemy. Note the storage of the engine starter crank on the rear plate, the standard stowage of two spare road-wheels on each of the rear-most engine ventilation cowls, as well as the erected MG shield on the superstructure roof.

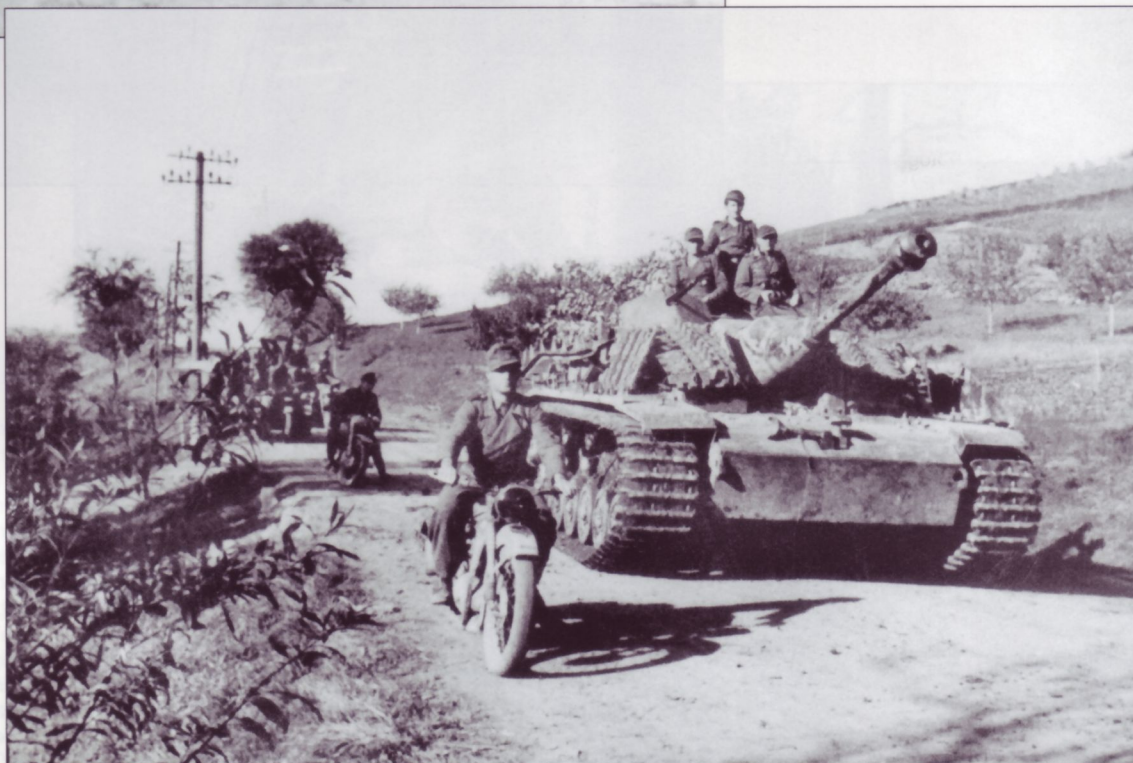
This later StuG.III Ausf.G has a number of interesting features. It is fitted with the wider "Ostkettten" (east tracks) on its running gear and also has these as spare track sections on the superstructure front angled plates. It has 80mm armor as a basis; note the upper and lower glacis plates as well as the lack of bolts on the single 80mm plate on the near, vertical corner of the superstructure front. A gun travel crutch is fitted next to the Notek head-lamp, while the gun itself is housed in a cast "Topfblende" mantle. Note the improvised gun shield around the loader's MG; at first glance it would appear to be the standardized "Rundumfeuer" rotating remote-control mount. However, it more closely resembles the MG shield commonly seen on German armored half-tracks.

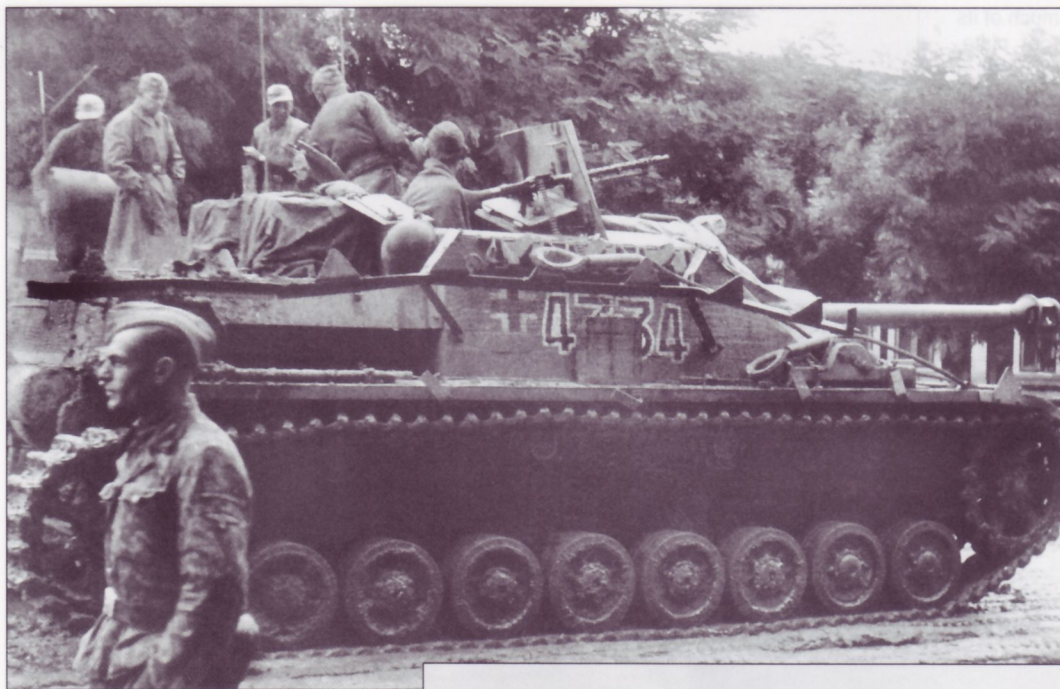
To further supplement the supply of assault guns, Germany also fielded a hybrid vehicle based on a StuG.III Ausf.G gun and superstructure mounted on a Pz.Kpfw.IV Ausf.H or J chassis; this was designated StuG.IV. Seen here is an earlier version as evidenced by the folding shield for the loader's MG34 on the superstructure roof and the earlier drum-type exhaust muffler on the hull rear. Note the four-digit tactical number "4334" on the superstructure side, just forward of the balkenkreuz national insignia. This assault gun appears to have been covered in Zimmerit paste and has lost its Schürzen plates, although the rather distressed mounting rail and frames are still retained.

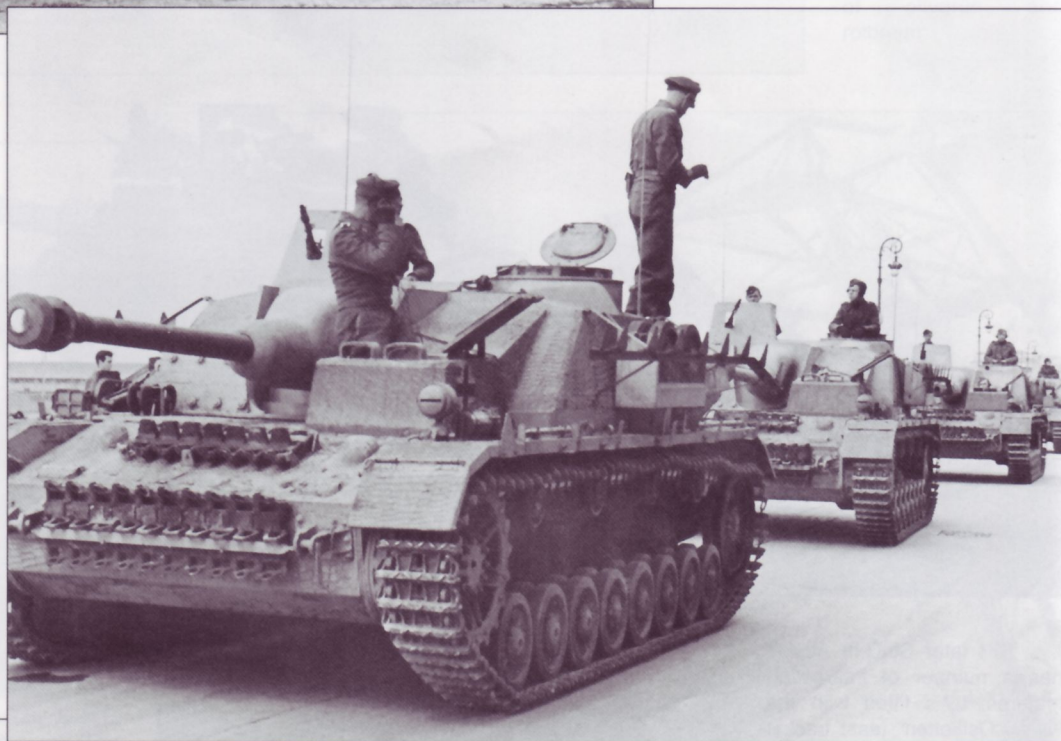
A line of new StuG.IVs halts on the side of a road. Note that they have Zimmerit paste and are finished in a monochrome base of dunkelgelb. There is a black/white balkenkreuz on the driver's compartment side. Features to note are the "Topfblende" cast gun mantle, reinforced armor forward of the commander's cupola, and the rain gutter just behind the driver's hatch. Note also the tool, spare road-wheel and track storage, as well as the mounting rails for Schürzen.

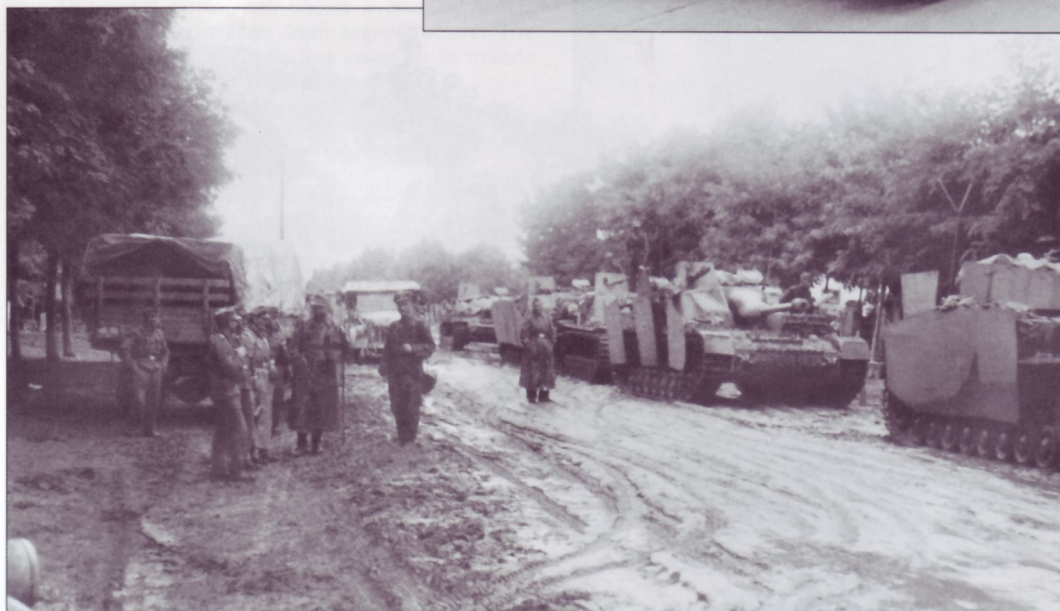
This line-up of StuG.IVs is led by the rarely-photographed Befehlspanzer IV; note the rod antenna on the turret roof and the star antenna on the rear. The StuG.IVs all have the earlier folding MG shield and are fitted with Schürzen and/or the mounting rails; there is a balkenkreuz national marking on the middle Schürzen plate of the first StuG.IV.

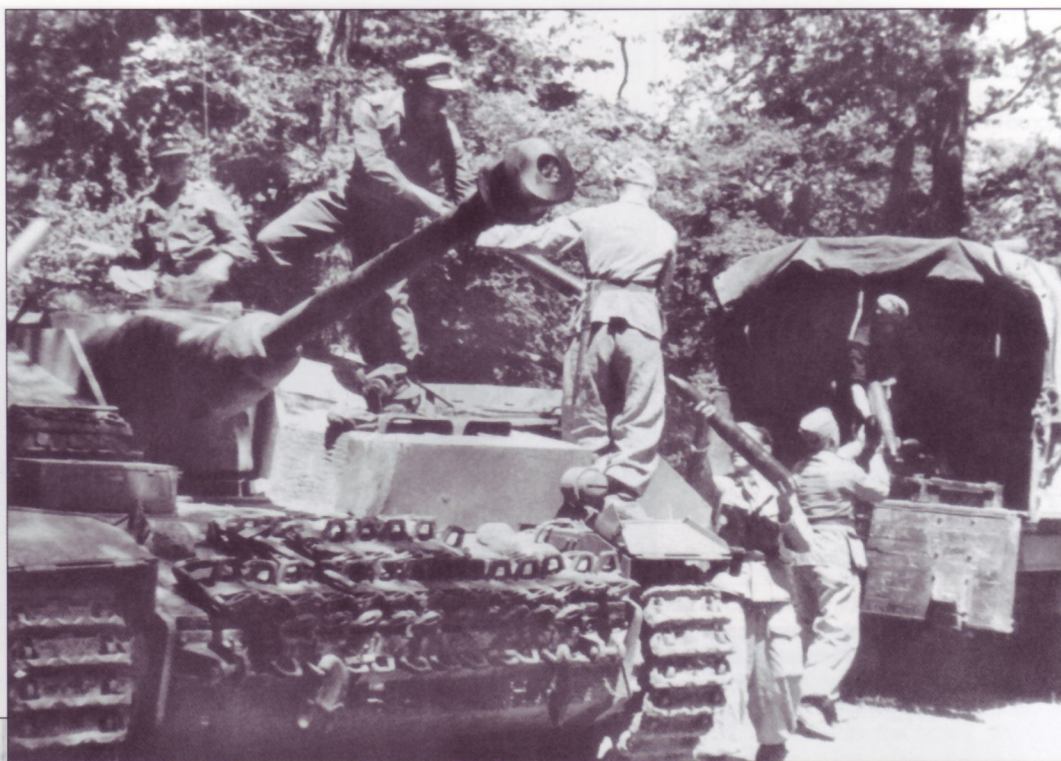
It would appear that this vehicle is a pre-production version of the Jagdpanzer IV, designated as a "Jagdpanzer IV A-0". It has the curved superstructure front with two MG ports as well as a muzzle brake on the 7.5cm PaK39 L/48 main gun. Zimmerit paste has been applied. Note the shell penetration just to the right of the driver's visor, the sign on the opposite fender and the legend on the gun tube.

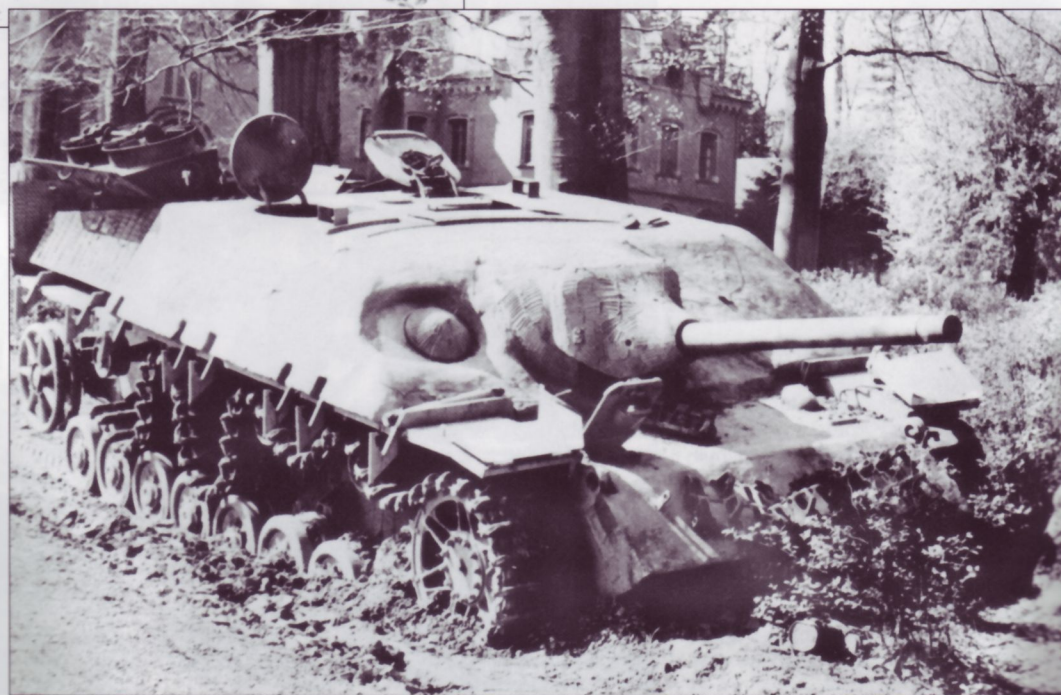
This Jagdpanzer IV has suffered an internal explosion, which has separated the armored superstructure from the hull. The ammunition was stored in unprotected racks on the inner walls of the 40mm superstructure sides; any serious penetration accompanied by a fire, was bound to set them off with catastrophic results. A curious US soldier inspects the remains.

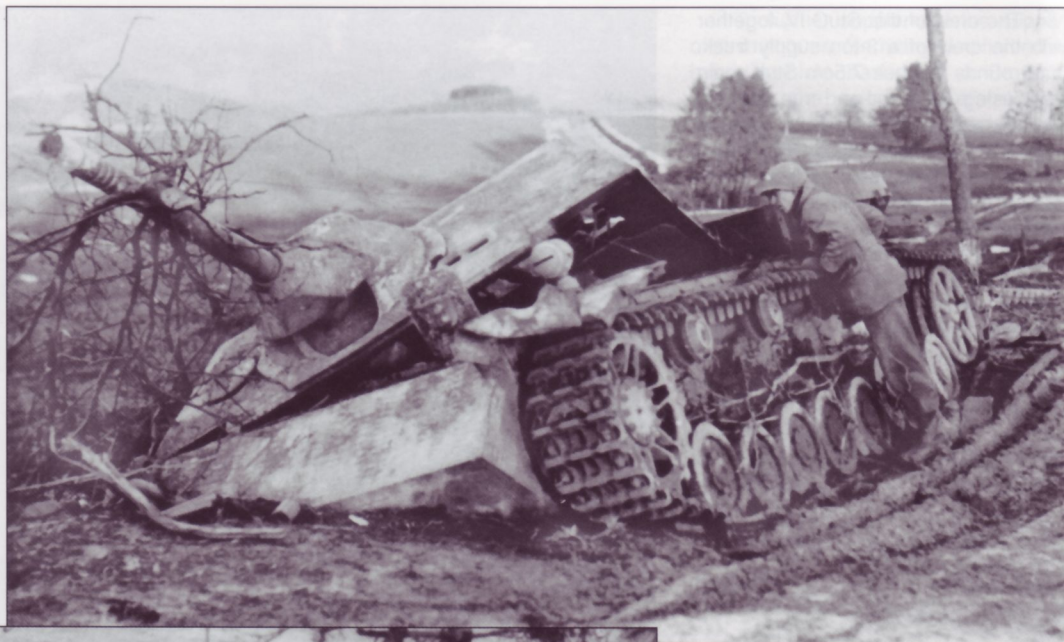
A far more potent development of the Jagdpanzer IV, was the Panzer IV/70 (V), which mounted a variation of the Panther medium tank's 7.5cm KwK42 L/70 main gun, designated 7.5cm PaK42 L/70. This gun could destroy nearly any tank in existence at ranges up to 1,000 yards; some at even longer ranges. Note the crutch on the glacis plate, which was needed to secure the gun's heavy tube during travel. This Jagdpanzer also has the later transmission/final drive access hatches, which dispensed with the air cooling vent cowls, replacing them with handles. A catastrophic explosion has torn the roof plate from the vehicle.

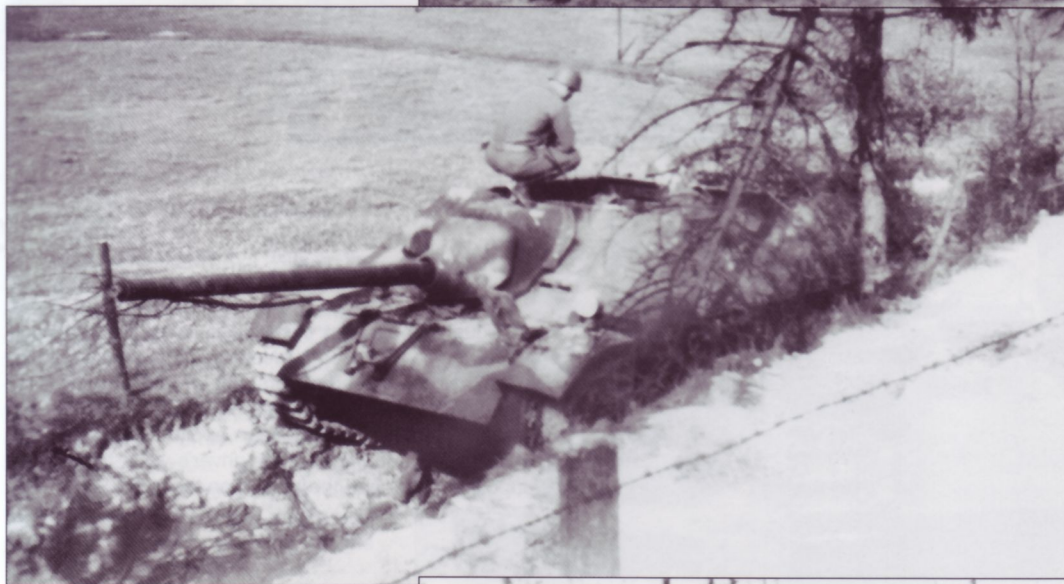
An abandoned Panzer IV/70 (V) is seen from the rear. This affords a view of some late-production features such as: "Flammvernichter" (flame-dampening) exhaust mufflers and hull side plates extended and drilled to act as tow hook attachment points; it is difficult to tell, but there may also be only three (instead of four) return rollers on the hull-side suspension system. Note also the storage of spare roadwheels (including a steel-rimmed pair), the jack and spare tracks, all on the rear deck.

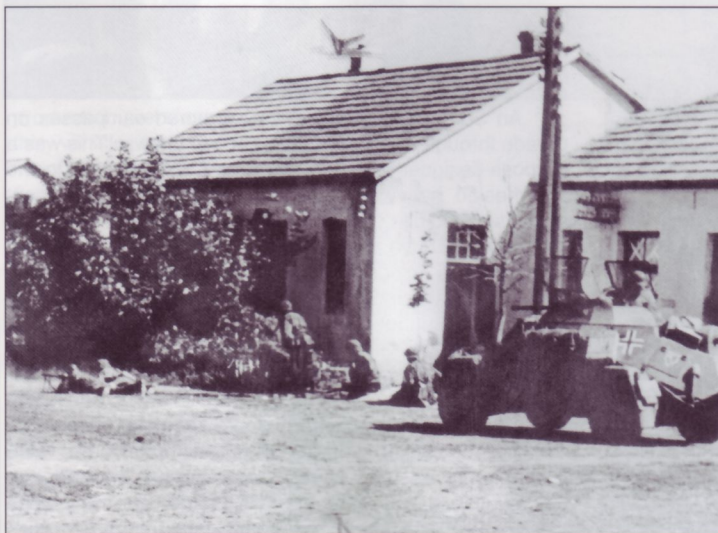
An Sd.Kfz.221 (converted into an armored radio car) makes its way along a muddy village street during the invasion of the Soviet Union. The upright "Y" insignia of the 7.Panzer-Division, in yellow, is seen on the front fender, as is a small stenciled white pennant indicating a battalion command group. The retro-fitted "Rahmenantenne" (frame antenna) is in a rather dilapidated state, indicating hard service. Note also the Notek black-out driving system head-lamp, mounted on the glacis plate, between the standard canvas covered head-lamps.

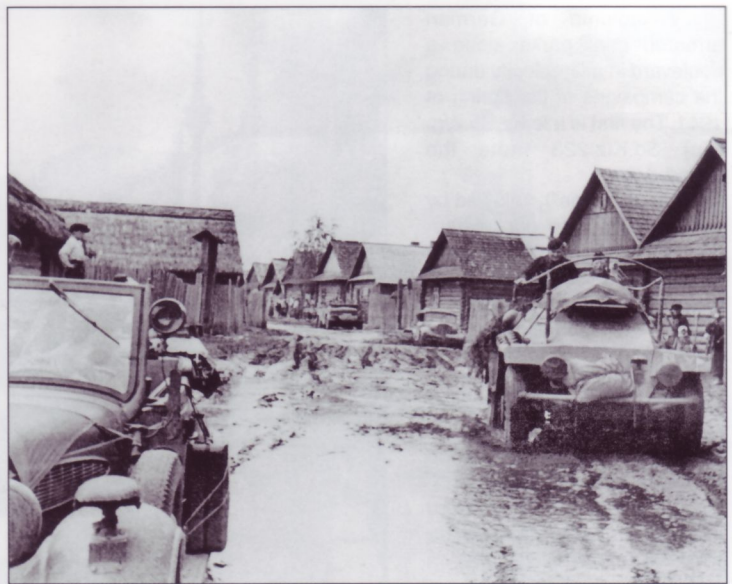
An Sd.Kfz.223 armored radio car stands on the side of a village street, while a column of trucks passes through. At left is a column of horse-drawn supply wagons. It is an Ausf.B as indicated by the style and placement of the vision ports on the turret. The '223 wears the segmented circle of a motorcycle reconnaissance unit on its left-rear fender (just above the Notek tail-lamp array, as well as a license plate on each fender (unfortunately obscured). The balkenkreuz national insignia, in black with a white outline, is painted on to an appliqué armor plate which was fitted to this series of armored cars to cover the radiator grill. This photo probably dates from the spring of 1941, during the campaigns for Greece and the Balkan states.

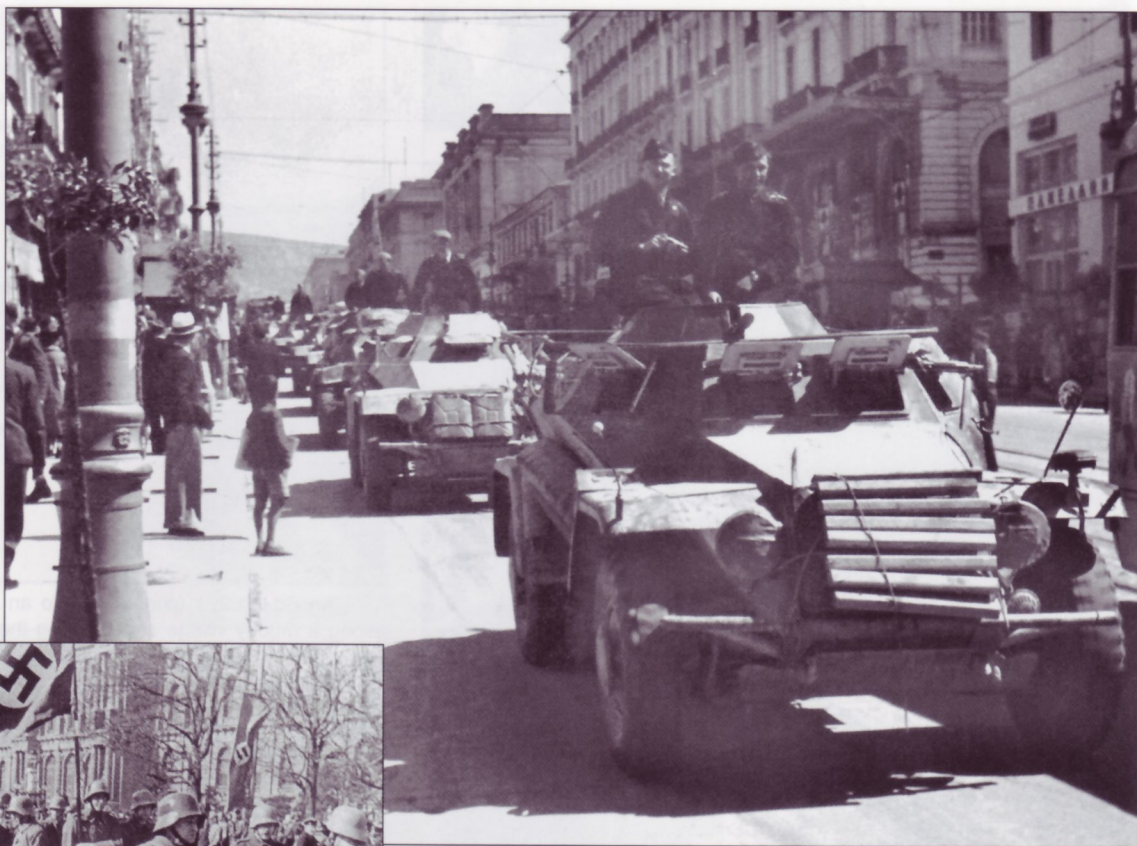
An Sd.Kfz.232 (6-Rad) heavy armored radio car stands idle on the streets of Vienna, Austria, during Hitler's annexation of that nation into his fledgling Third Reich. This ungainly armored car is built on a commercial Büssing-NAG chassis; others were built on Magirus chassis. This vehicle wears Wehrmacht Heeres license plates and is probably painted in the pre-war "Buntfarbenanstrich" (fireproof colorful pattern) camouflage scheme of Nr.17 edgelb-matt, Nr.28 grün-matt and Nr.18 braun-matt.

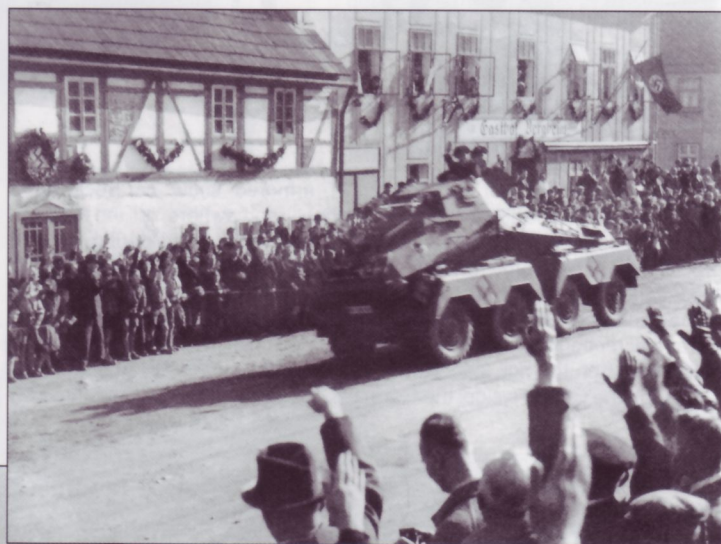
An Sd.Kfz.231 (8-rad) heavy armored car passes on parade through a German town, early in the war. This was a purpose-designed heavy armored car, as opposed to the six-wheeled heavy armored cars, which were expedient designs based on commercial chassis. The "eight-wheelers" had all-wheel drive and steering, and could be driven at the same speeds in both directions, thanks to a transmission with six forward and six reverse gears, as well as driver's stations fore and aft.

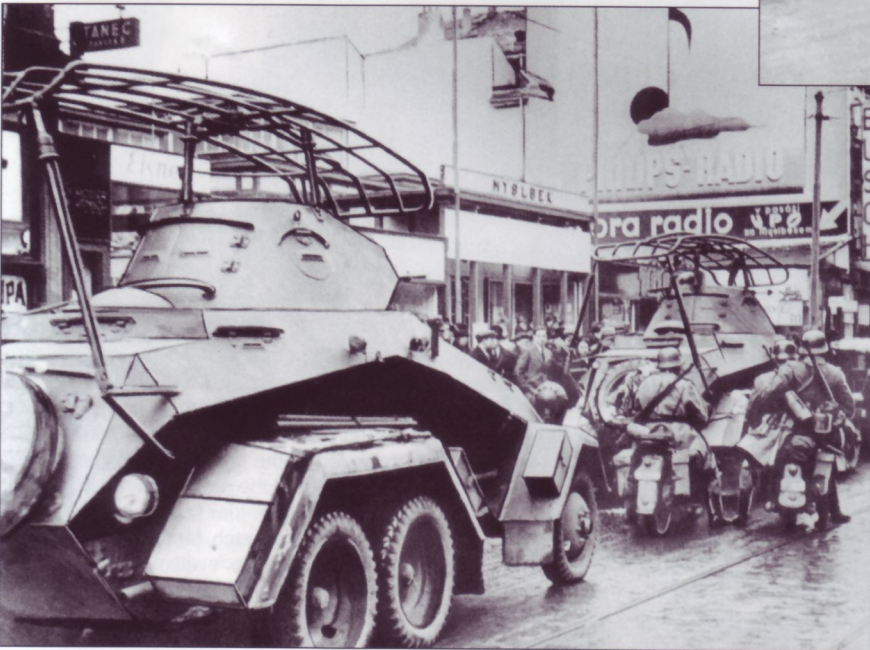
This heavily-retouched photo depicts a pair of Sd.Kfz.232 (6-Rad) heavy armored radio cars, also probably in Austria. These are built on the Magirus commercial chassis. Note the rain guards over the various hatches and view-ports, the dome over the rear driver's station and the covered spare wheel on the vehicle's rear. These vehicles have the same designations as the more familiar (and later) Sd.Kfz.232 (8-Rad) eight-wheeled armored cars, because they fulfilled the same tactical function.

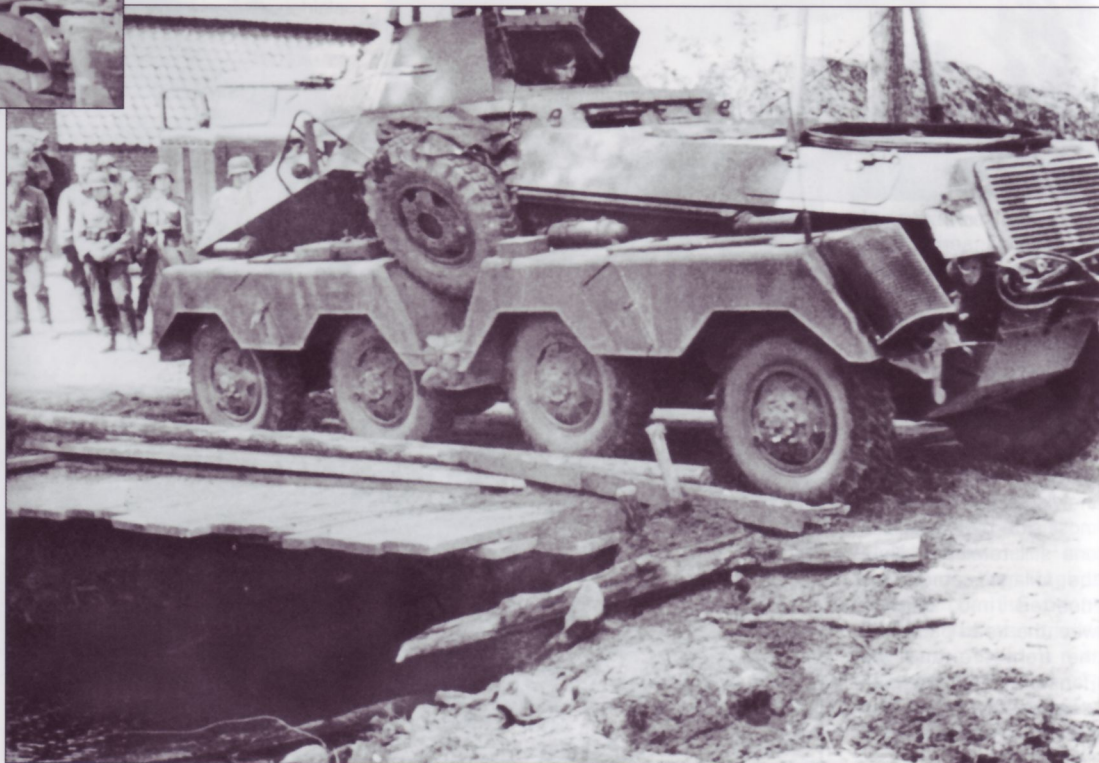
Although the original photographer could have used a lesson in composition, this image remains of interest for several reasons. The vehicle can still be identified as an Sd.Kfz.232, since the "Rahmenantenne" support bases can be seen on the turret and the hull. Also of interest is the storage of a spare wheel and tire on the hull side; later vehicles such as the Sd.Kfz.234 series, had a purpose-built rack added at the rear end. This armored car carries a thin white-outline balkenkreuz on the turret, which is an unusual location.

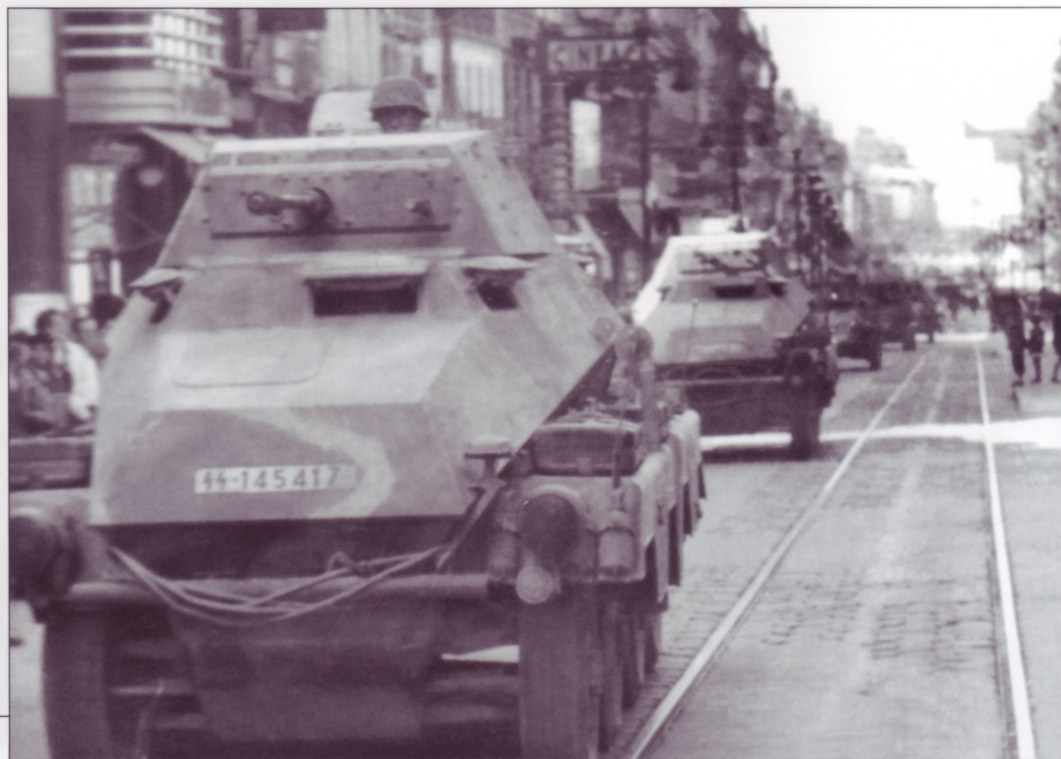
This Sd.Kfz.263 heavy armored radio car shows a rare view of the early-war two-tone camouflage, thanks to its pristine appearance and the angle of the sun. Note the canvas-covered "Kurbelmast" (telescoping antenna mast) behind the upper superstructure, and the un-covered standard headlamps. Note also the frame for a command pennant as well as the wire lead coming from the "Rahmenantenne" (frame antenna) to the superstructure, next to the split roof hatches.

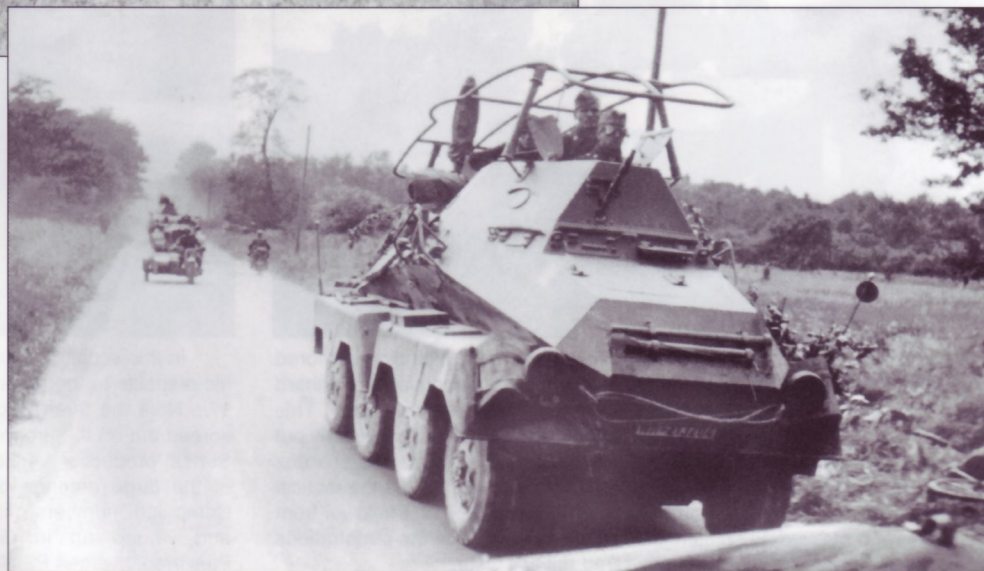
This Sd.Kfz. 263 contains later features, notably the visors, which were of a standardized, cast design that dispensed with the need for rain gutters above them. It is finished in a very worn white-wash over what should be a base of dunkelgrau. The tactical sign signifies a headquarters element from either a motorized infantry battalion or motorcycle reconnaissance battalion. An Sd.Kfz. 223 follows behind.

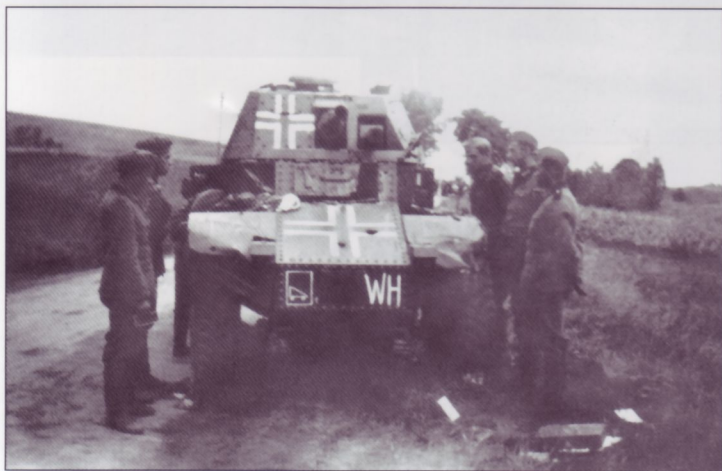
Germany used many captured wheeled vehicles, including armored cars. Here, an ex-French AMD (Auto Mitrilleuse de Decouverte) Panhard 178 2eme. Serie, has been knocked-out while in German hands. This armored car was captured during the French Campaign and immediately put to use against its former owners. Note the large white-outline balkenkreuz national markings on the glacis and turret front plate, as well as the tactical sign for a motorized anti-tank company, and the large "WH" on the lower front plate. A group of German soldiers inspect the vehicle; note the penetrations on the glacis plate as well as the shattered driver's visor.

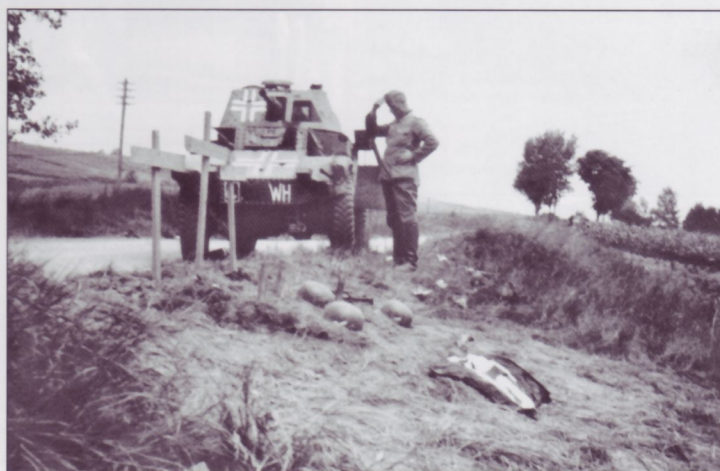
In this second photograph of the same vehicle, a German soldier pays his respects to the markers of the three Germans who died in the Panhard 178. Note the three wooden crosses, the three helmets and the Nazi flag spread out on the ground as a makeshift shrine. This is a 2eme Serie (2nd Series) production version of the Panhard 178, as can be seen by the lack of the large antenna bases fore and aft. After the end of the French Campaign, numbers of these well-designed armored cars were captured and wound up in German service where they were designated Panzerspähwagen P204(f)
