PANZER-DIVISION 1935-1945

(1) The Early Years 1935-1941

Robert Michulec

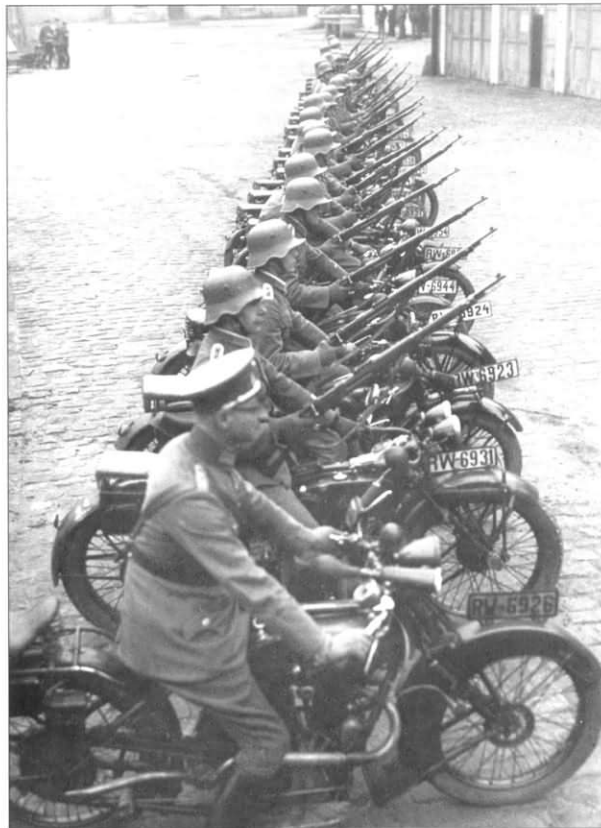
Motorcycle troops played the role of modern cavalry in the 1920s and 1930s Reichswehr as can be seen by these troops on their Victoria motorcycles, lined up in a kaserne in the manner typical of the cavalry. Cavalry helmets are worn by the troops who are also armed with Mauser K-98 rifles.

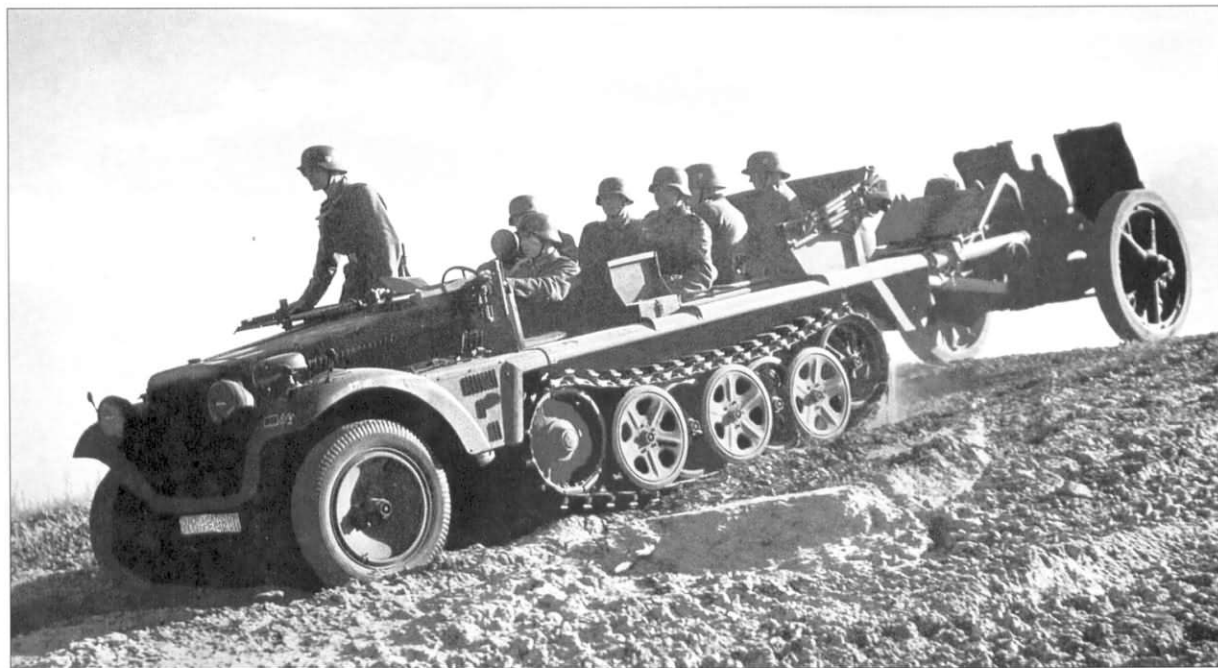
One of the most valuable additions to the Panzer-Divisions in the late 1930s was the half-track prime movers employed by the artillery troops. These vehicles enabled the Germans to move supporting artillery units across virtually any type of terrain allowing for frequent changing of firing positions. They also allowed the artillery batteries to keep up with the advancing Panzer companies and provide fire support when needed. This photo shows one of the most numerous of the light half-track prime movers, an Sd.Kfz.10, towing a 15cm sIG33 in Poland in 1939. It was used throughout the war to tow various light infantry and anti-tank guns.

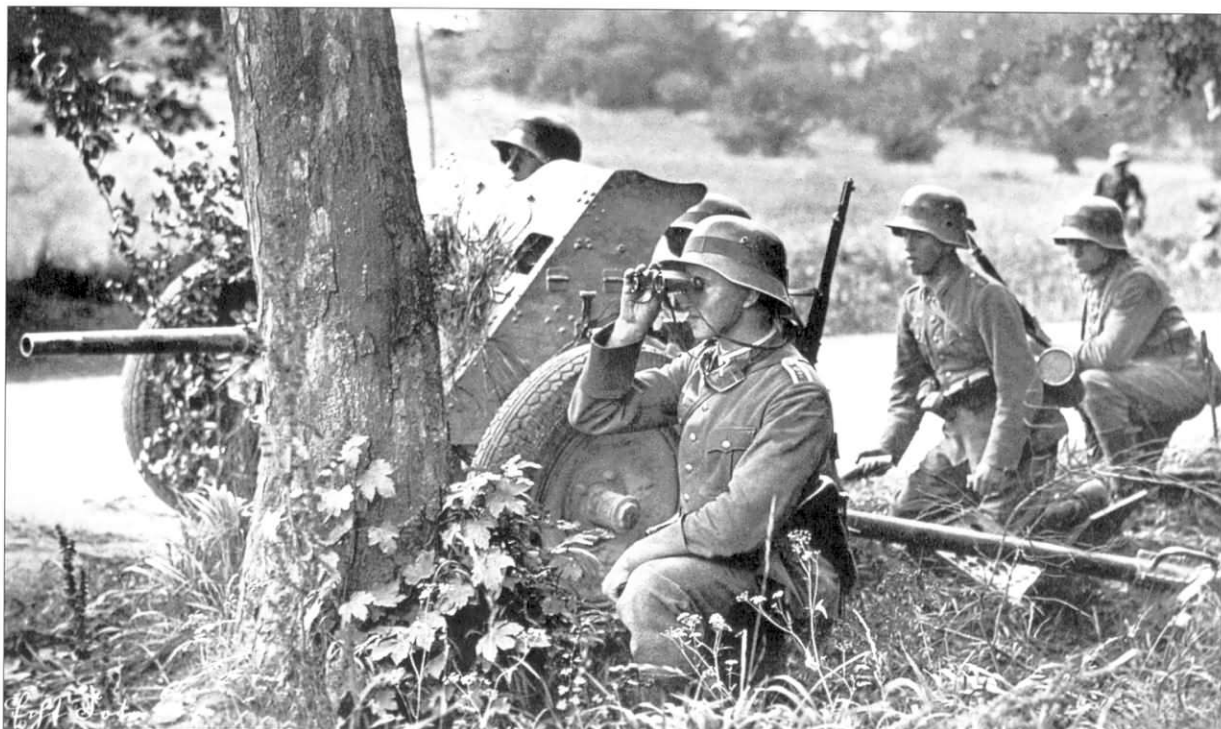
At the beginning of the war, the anti-tank defense of the Panzer Divisions was based on the 3.7cm PaK35/36. One of the best anti-tank guns of its day, it was produced in large numbers and was utilized in various forms during the entire war. This one is shown during field exercises in the late 1930s. During these exercises, the troops were identified as friendly or enemy forces by red or yellow bands around their helmets. Here, this gun crew are wearing red bands on their older style M1916 steel helmets. The Unteroffizier gun commander has a white metal Gothic script 'P' and a '2' on his shoulder strap denoting Panzer-Abwehr-Abteilung 2 of 1. Panzer-Division. His early M1928 uniform also features large, turned back cuffs and NCO braid on the top of the collar.

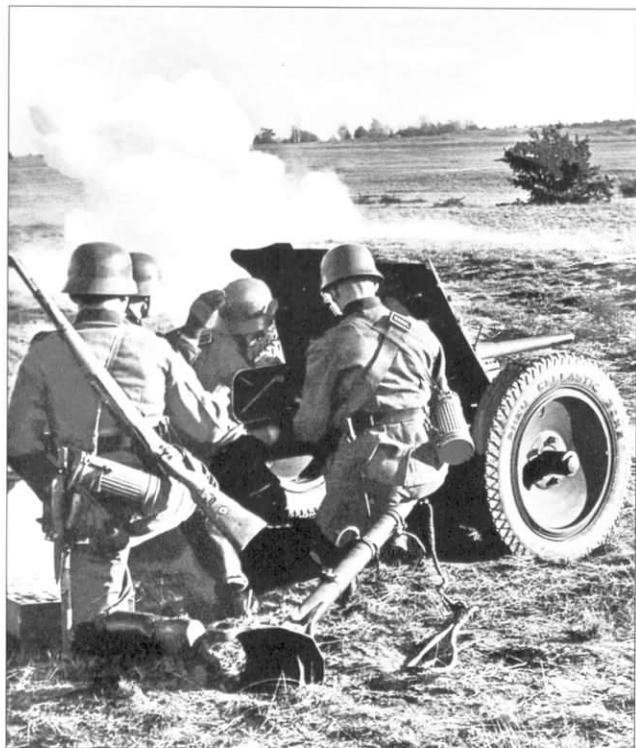
Another 3.7cm PaK35/36 anti-tank gun photographed during pre-war field exercises. The L/45 caliber gun using standard armor piercing ammunition could penetrate 38mm of armor at a range of 400 meters which was impressive for its time. This crew is wearing the standard M1935 uniform with the dark green collar. The man on the right has the wide leather bandoleer that was used by artillery crews to help manhandle their guns.

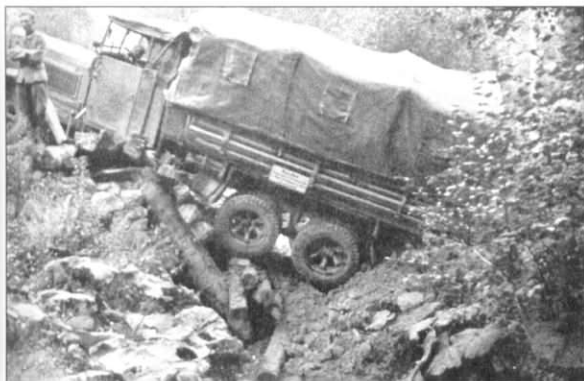
A primitive bridge has collapsed under the weight of this Henschel 33D1 truck. The roads in Poland were mainly constructed for horse drawn transport and such occurrences were not uncommon during the German Army's advance.

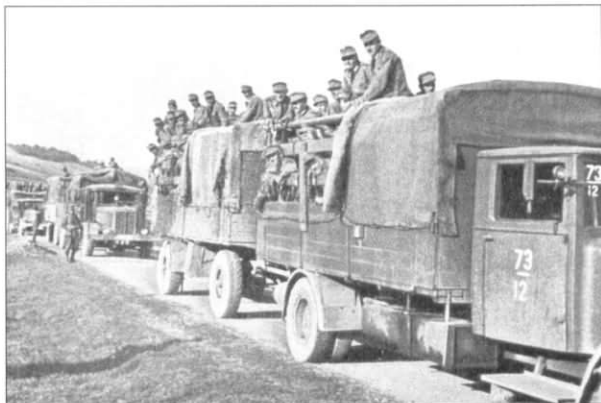
Lack of military transport in all the German divisions often forced commanders to use trucks borrowed from supply companies. Here, soldiers are transported in lorries towing trailers. The second vehicle is a Büssing NAG 6500 which is towing a 5-t trailer. The meaning of the numbers '73/12' on the first truck are unknown.

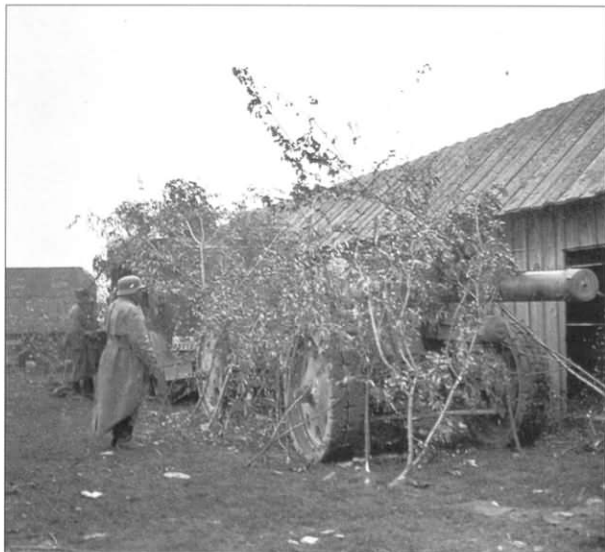
This half-track prime mover towing a 15cm sFH18 is so well camouflaged with foliage that it is impossible to recognize the type of vehicle. The divisional artillery regiment in 1939 was organized into 2 battalions with 3 batteries of light and heavy howitzers in each. There were 24 guns in the standard Panzer-Division, however, a few divisions were equipped with the 10.5cm IFH18 only. There were also about 150 trucks, cars and prime movers, but - again - in some divisions all the howitzers were towed by trucks.

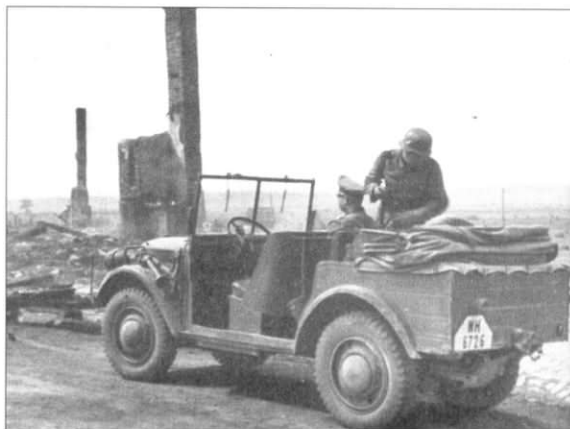
A light cross-country personnel car, Kfz.2 or 3, used by the staff troop at the platoon or company level, seen here in Poland in September 1939. This vehicle seems to have had the doors permanently removed as the pillar dividing them is missing.

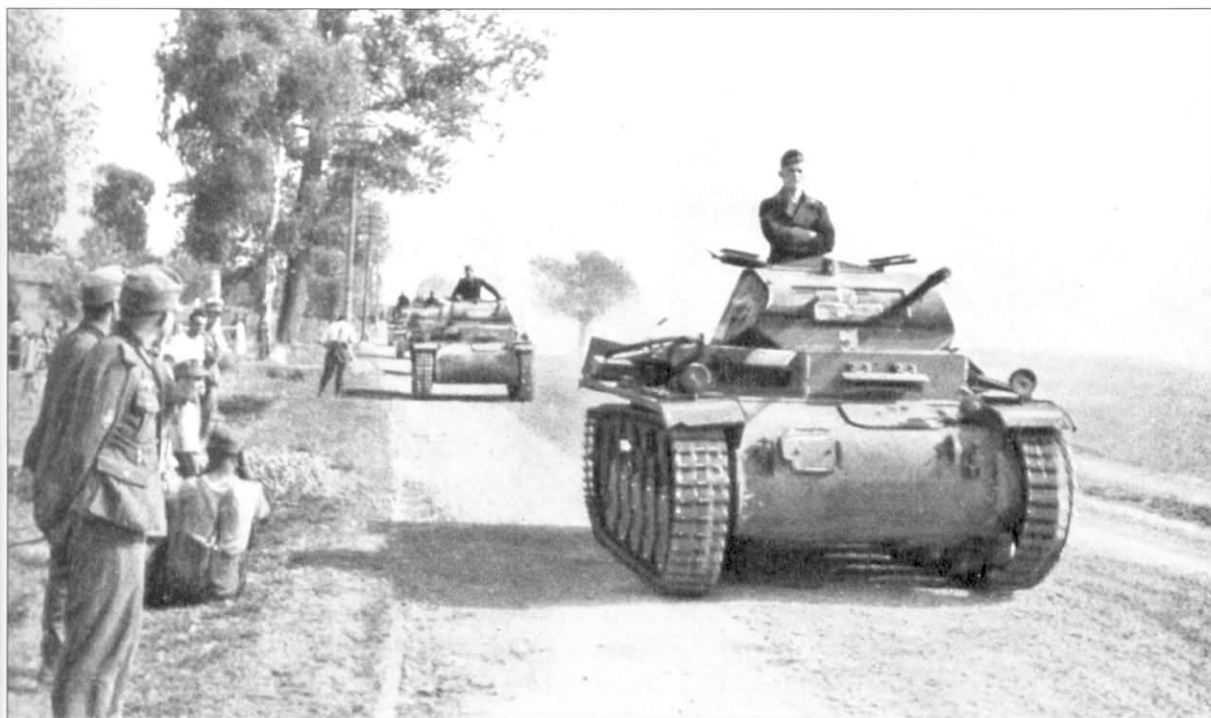
The battle over, these Pz.Kpfw.II Ausf.c-C head back to Germany for refitting and rest. After the defeat of Poland, the Pz.Kpfw.II was improved with additional 20mm armor plate on the front hull and turret. The white national cross that was painted on the front of this vehicle's turret has had mud or paint applied to make it less conspicuous to Polish anti-tank gunners.

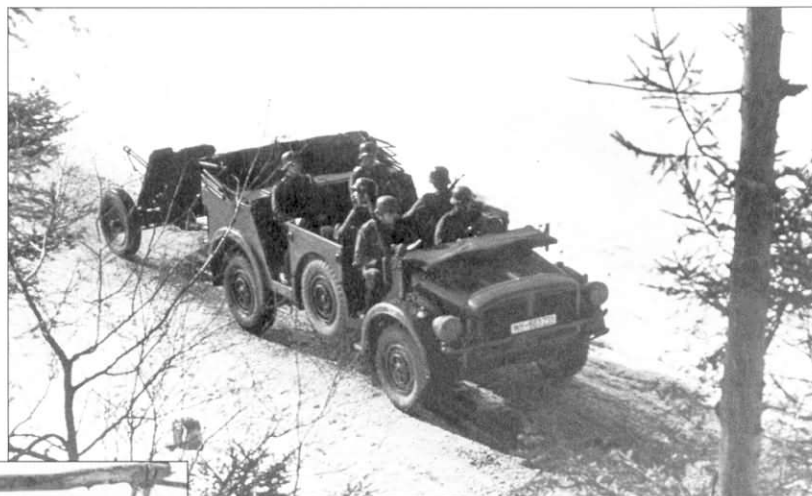
A Horch Kfz.69 heavy personnel car, seen here towing a 3.7cm PaK35/36 anti-tank gun in the winter of 1939-40. It was a rugged vehicle and performed many duties within the Panzer and Infantry Divisions. This one is finished in its dark gray base with no visible markings other than the vehicle registration plate.

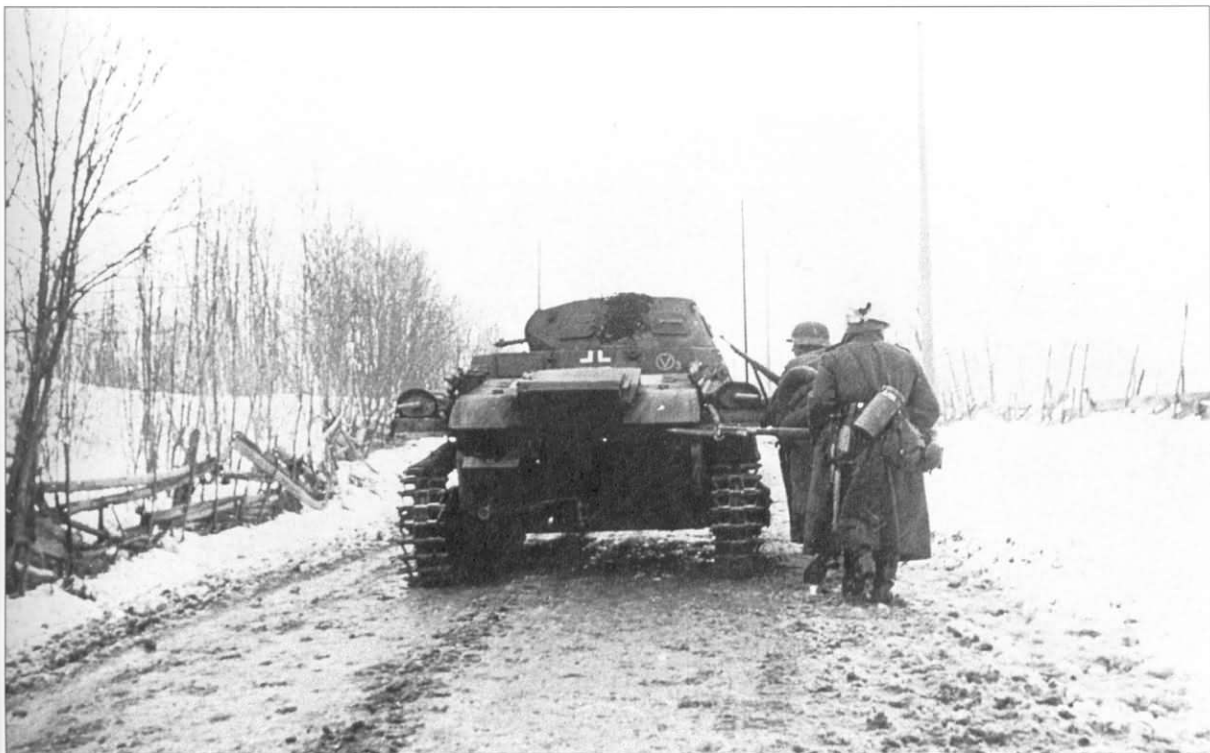
A Pz.Kpfw.I Ausf.A cautiously moves down a snow covered Norwegian road affording protection to the infantry who accompany it. The tactical markings on the rear hull and sides are painted in yellow with a white outline national cross. The tactical number on the turret has been removed by the censor, but is known to have been a white two digit number. There were no Panzer-Divisions involved in Operation 'Weseruebung', the invasion of Norway on April 9, 1940, but an independent armored battalion, Panzer-Abteilung z.b.V.40, was sent. It was equipped mainly with obsolete tanks, mostly Pz.Kpfw.I and II, because the Germans did not expect any armored resistance from the Norwegians. To bolster the force, Panzerzug Horstmann with three Neubau-Pz.Kpfw.IV arrived on April 19. Panzer-Abteilung z.b.V.40 was formed in March 1940 from three light tank companies from three Panzer-Regiments. On April 24, their reported strength was 29 Pz.Kpfw.I, 18 Pz.Kpfw.II, 4 Pz.Bef. and the 3 Nb.Pz.Kpfw.IV.

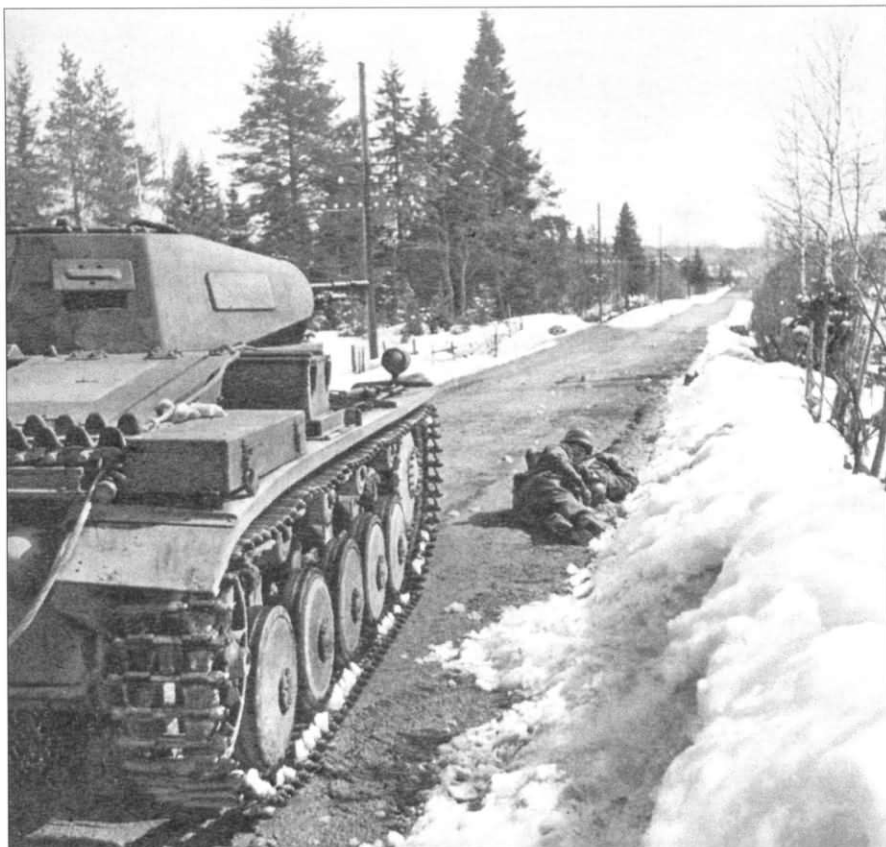
A Pz.Kpfw.II Ausf.A-C of Pz.Abt.z.b.V.40 provides cover fire for the accompanying infantry with its 2cm KwK30 gun. Unlike most other tanks in this unit, this one has no markings on the turret. There were 18 Pz.Kpfw.II in this unit when it was formed in March 1940.

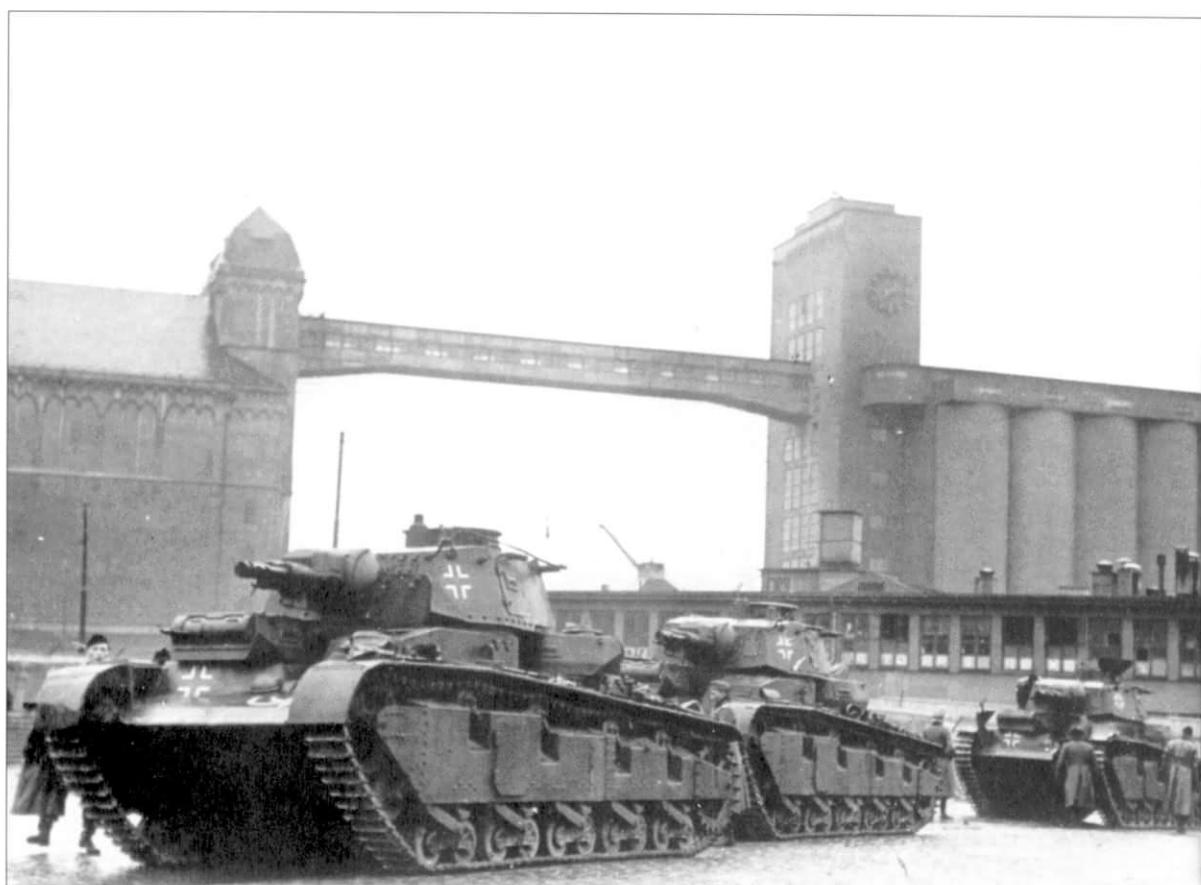
All three Neubaufahrzeug of Pz.Abt.z.b.V.40 shortly after arriving in the harbor at Oslo, Norway on April 19, 1940. The only visible markings are painted on the vehicles: white outline national crosses as well as a white elephant head emblem on the lead vehicle.

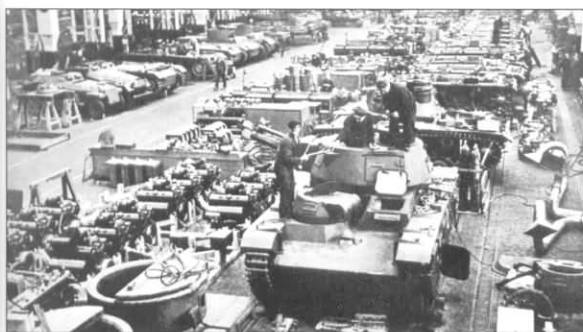
One of two Neubaufahrzeug mild steel prototypes manufactured by Rheinmetall-Borsig in 1934, seen here in the late 1930s. It is still fitted with the original Rheinmetall-Borsig rounded turret which was replaced on the three armored production vehicles with a turret manufactured by Krupp. Two Pz.Kpfw.III hulls can be seen in the foreground fitted with test weights to simulate the weight of the turret.

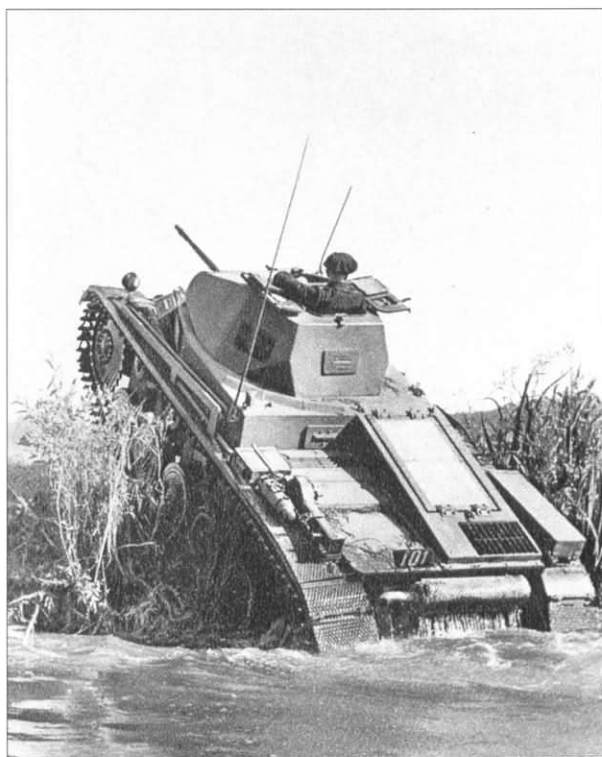
This Pz.Kpfw.III Ausf.A-C is unusual in that it has the tactical marking '101' indicating it is the vehicle assigned to the commander of I.Bataillon. In the normal organization chart of a Panzer-Division, this would normally have been a kl.Pz.Bef.Wg.I or Pz.Bef.Wg.III. There also appears to be a white air recognition band painted on the engine deck hatches.

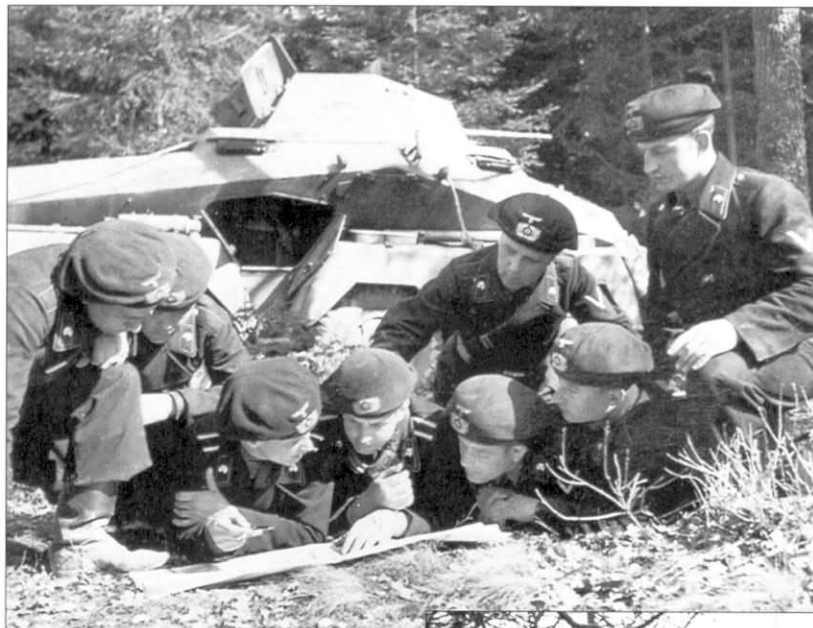
Armored car crews study a map prior to the invasion of France in May 1940. The vehicle in the background is a schwere Panzerspähwagen (Sd.Kfz.231) 8-Rad which formed the core of the German heavy reconnaissance companies. Each Panzer-Division was equipped with 61 light and heavy armored cars on May 10, 1940.

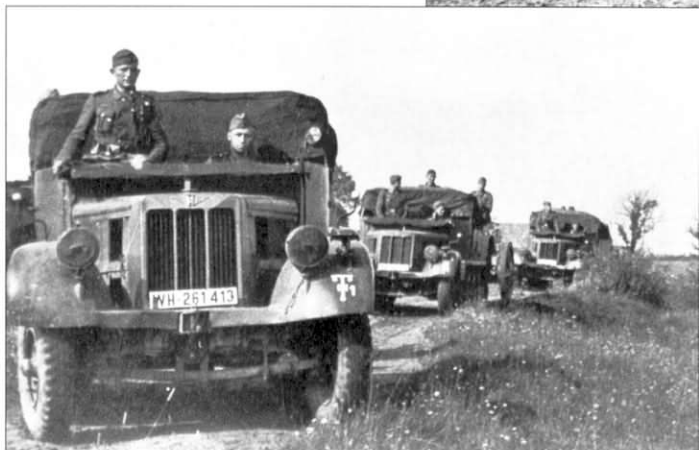
Three Sd.Kfz.11 half-track prime movers towing 10.5 cm IFH18 howitzers along a dirt road somewhere in France in 1940. The tactical sign on the mudguard of the first vehicle indicates they are attached to the first company of a towed artillery battalion. They are finished in overall dark gray with a heavy coat of dust. The Sd.Kfz.11 was used throughout the war to tow light and medium artillery and anti-tank guns.

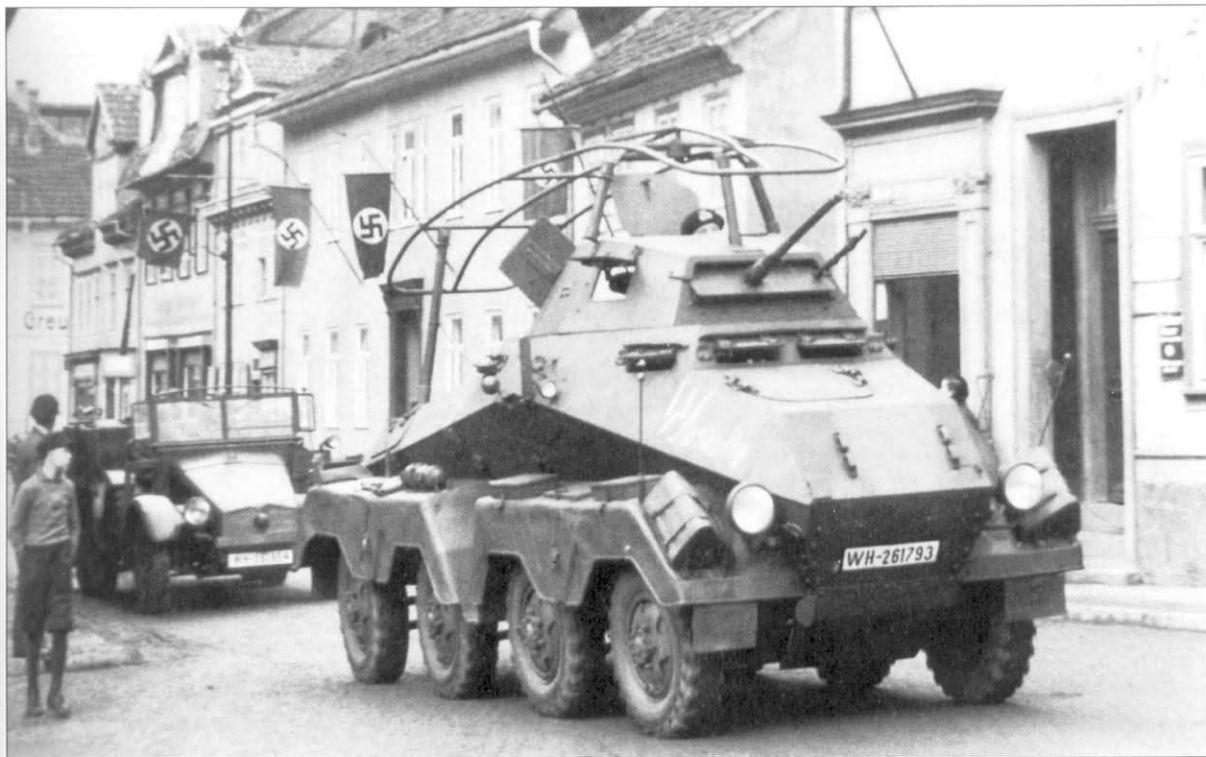
A schwere Panzerspähwagen (Fu) (Sd.Kfz.232) 8-Rad followed by a Krupp Protze light truck passing through a German city, probably in 1940. The vehicle registration number 'WH-261793' is painted in black on a white plate with a black border. Just above this can be seen a light patch where the white national cross has been painted over. On the side of the hull, the name 'Wiesbaden' has been applied, probably in red, with a white shadow, a practice that seems to have been common among armored car crews.

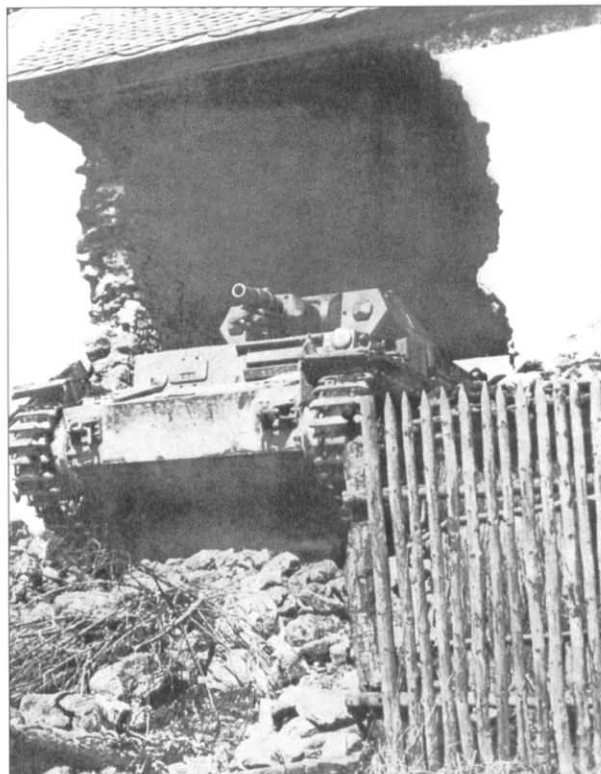
This photo appears to show a Pz.Kpfw.IV Ausf.B or C breaking through a building wall, but in fact it was taken during exercises during the winter of 1939-40. The hole was probably made by an artillery shell as there is no debris on the tank, so this was likely a propaganda photo.

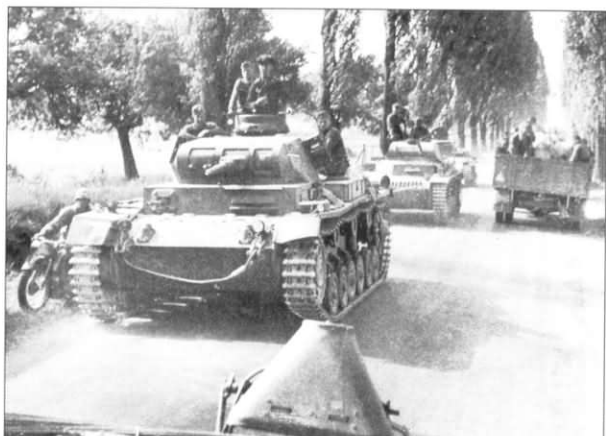
A Pz.Kpfw.III Ausf.F followed by a Pz.Kpfw.III Ausf.A-C and a Pz.Kpfw.I advance into France in May 1940. During the battle for France, the most numerous versions of the Pz.Kpfw.III were the Ausf.E and Ausf.F. Between December 1938 and July 1940, 531 vehicles of both types were manufactured. The cast air intakes on the glacis identify this one, otherwise they were very similar.

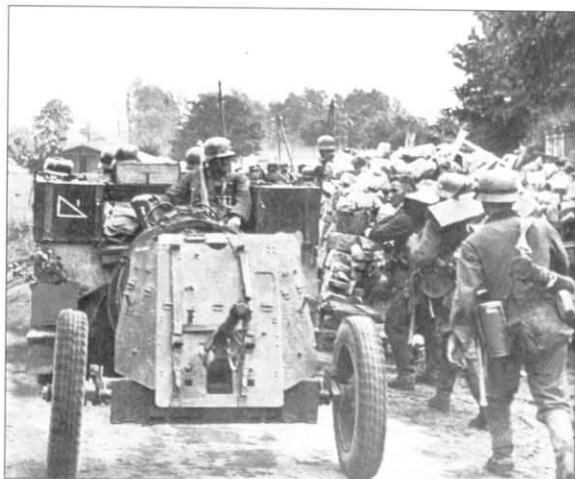
A Krupp Protze Kfz.69 towing a 3.7cm PaK35/36 past a barricade on a road in southern France in June 1940. This was not the only anti-tank gun used in the German divisions at this stage of the war as they also employed 4 companies of Czech-made 4.7cm anti-tank guns mounted on the Pz.Kpfw.I chassis. Nevertheless, the PaK35/36 was still the standard anti-tank gun in use although it was virtually obsolete by this time. The tactical sign painted on the back of the Krupp Protze indicates this unit belongs to the 1.Kompanie of an anti-tank battalion.

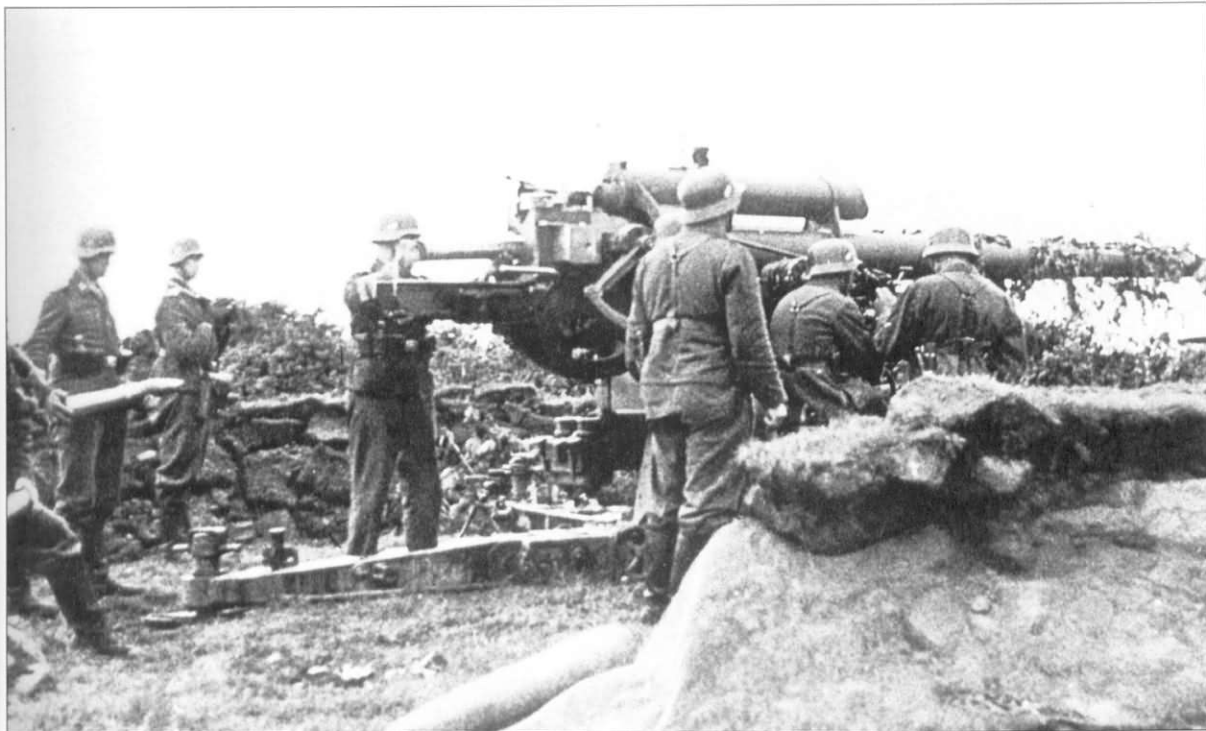
The '88' played a major part in the battle for France and was instrumental in bringing the British attack against Rommel's 7. Panzer-Division at Arras on May 21, 1940 to a halt. Here we see a Luftwaffe 8.8cm FlaK18 in action near Amiens in early June 1940. This was a new role for the Luftwaffe FlaK crews, but later it would become routine.

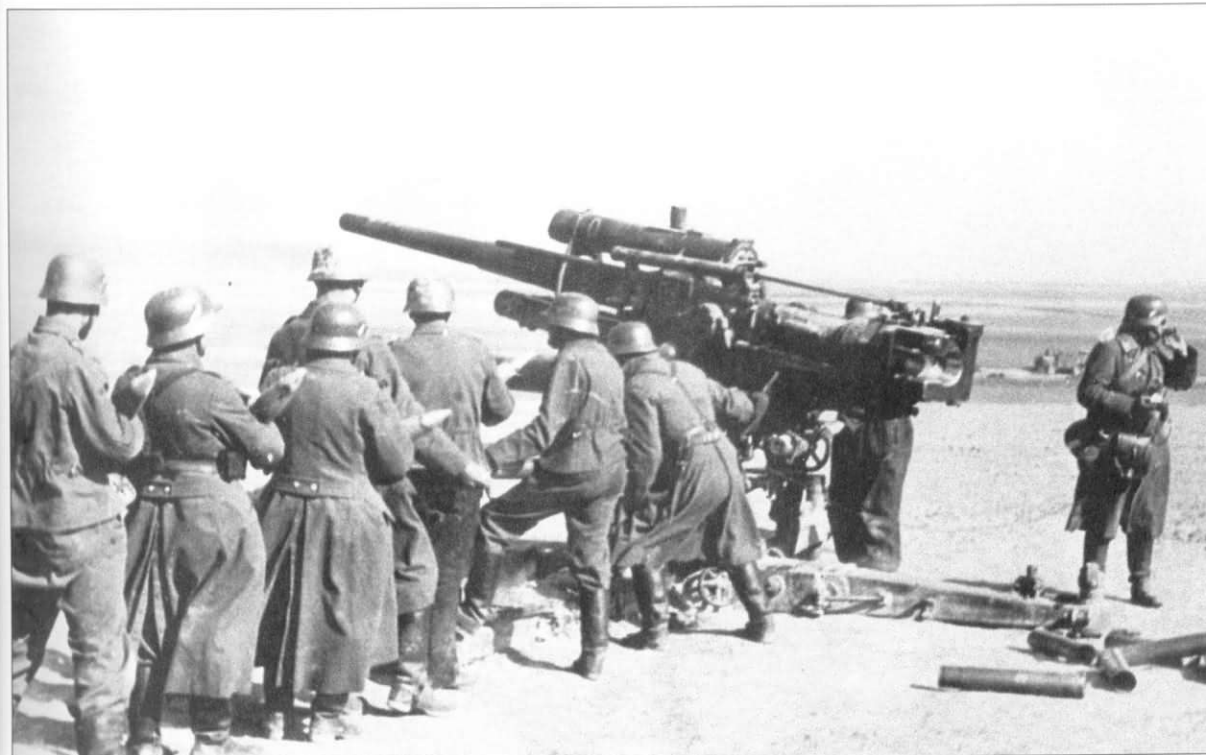
The gun crew queues up with rounds for their 8.8cm FlaK18 in northern France, late May 1940. Taken in the heat of battle, the gun is in full recoil and empty shell casings litter the ground around. The Pzgr.39 armor piercing round could penetrate 122mm of armor plate at a range of 1,000 meters, so no Matilda or KV crew was safe from it. The letter 'O' is painted in white on the recuperator housing.

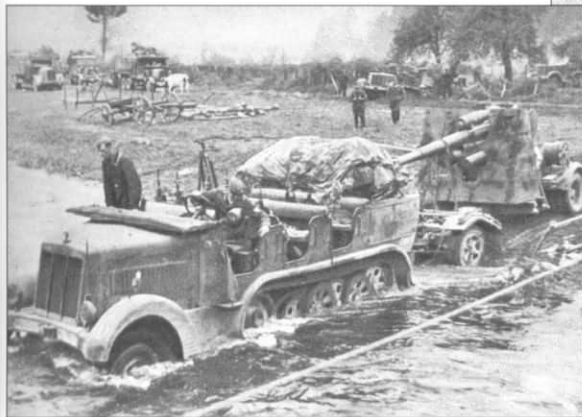
An early model Luftwaffe Sd.Kfz.7 towing an 8.8cm FlaK18 across a shallow river. Originally built by Krauss-Maffei as the KM m 10 in 1936, it was also built by Hansa-Lloyd as the HL m 10 and is easily recognizable by its shorter track run which has two less road wheels than the later and more common version. There are two license number plates painted on the front bumper which are repeated on side of the body at the rear of the vehicle. There is also a tactical sign painted on the left front mudguard, a white circle with a line through it.

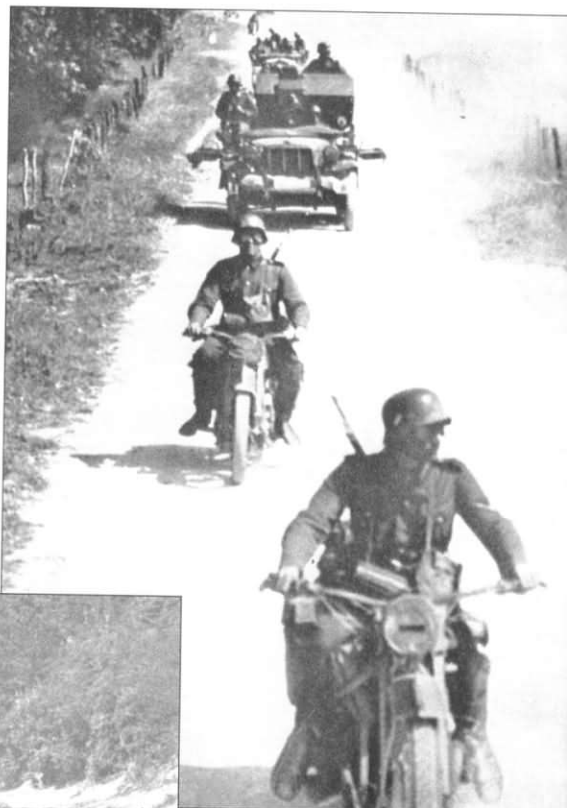
Two motorcycles lead a column of vehicles across the French countryside, including Sd.Kfz.10/4 armed with the 2cm FlaK30 FlaK38 anti-aircraft gun. In addition to its anti-aircraft duties, the FlaK30/38 was also used against light armored targets on the ground using armor piercing ammunition. Later models were provided with an 8mm armored cab.

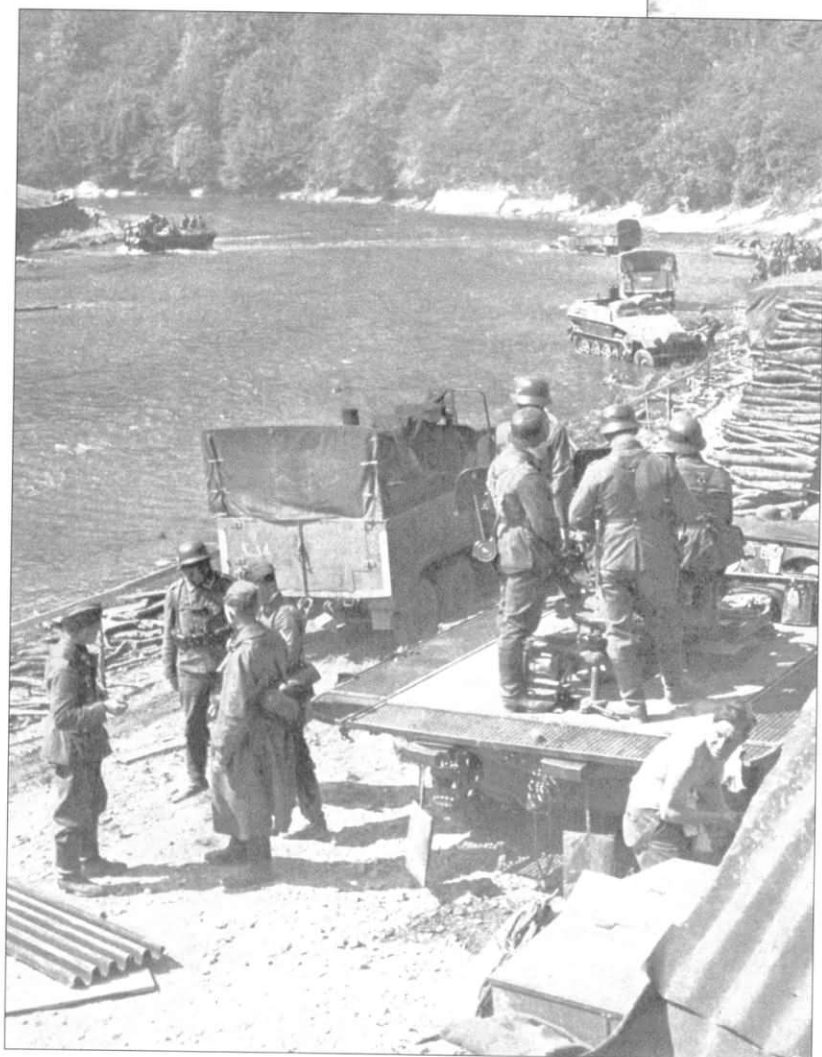
Another Sd.Kfz.10/4 provides anti-aircraft defense while German troops cross a shallow river. In the background, the crew of a Sd.Kfz.251/1 Ausf.B are using the opportunity to wash the dirt and grime off their vehicle. Visible on the rear of the truck passing on the left is the white divisional oakleaf emblem of 1.Panzer Division above a white outline rhomboid with a black floor while painted beside it.

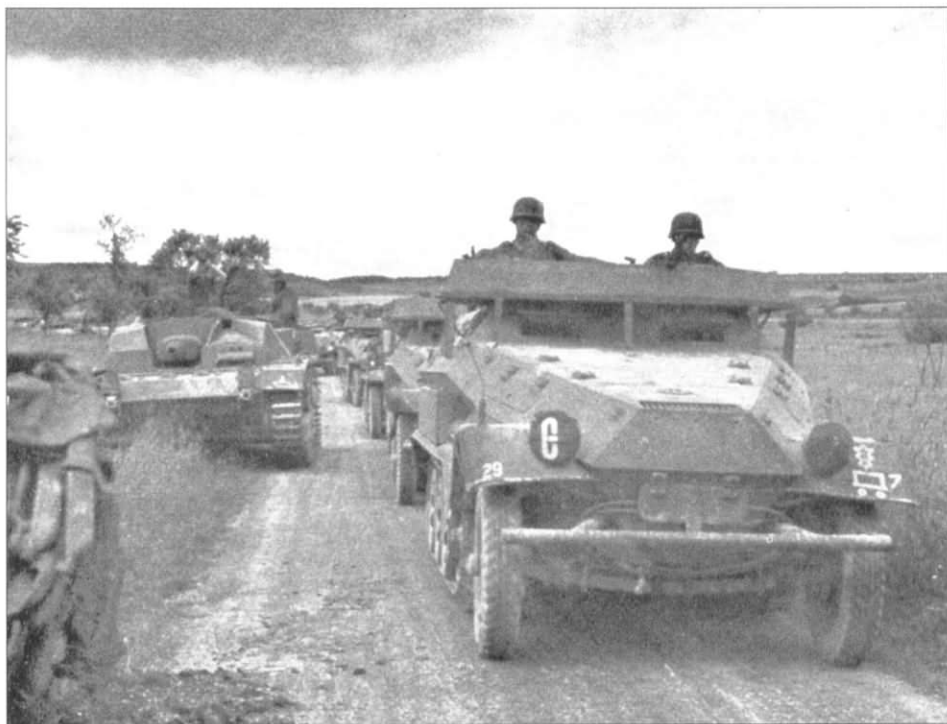
A trio of Sd.Kfz.251/18 Ausf.A mittlere Beobachtungspanzerwagen from 1.Panzer-Division in France, May 1940. They are fitted with a map table that extends over the driver's compartment roof and were utilized as an observation vehicle by headquarters staff. The white divisional oakleaf emblem is painted on the left mudguard above the tactical sign for the seventh company of a motorized infantry regiment. On the right mudguard, a number '29' is painted, which may indicate the vehicle number within the unit. The headlights have canvas covers over them, the right one of which, has the letter 'G' painted on it, signifying Guderian's XIX.Panzer-Korps. On the left, we see one of the few StuG.III Ausf.A, from Sturmgeschütz-Batterie 640, that took part in the battle. Instead of the standard tactical sign for a self-propelled gun unit, it has the earlier sign consisting of a white outline Panzer rhomboid with a small arrow on top, painted on the left mudguard.

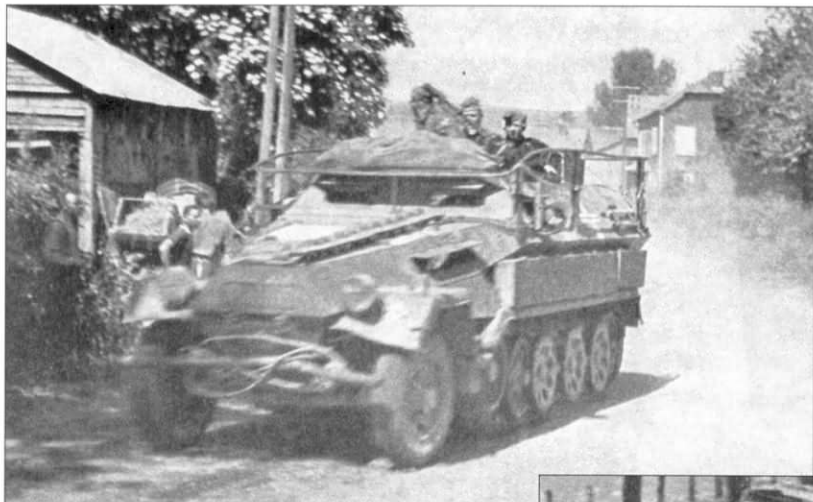
This Sd.Kfz.251/6 Ausf.A command half-track is fitted with an early style of frame antenna. The divisional emblem for one of the Panzer Divisions using a 'Y' is barely visible on the right mudguard.

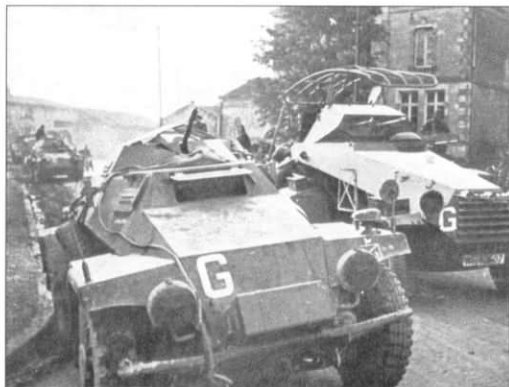
A schwere Panzerspähwagen (Sd.Kfz.232) (Fu) 6-Rad passes an Sd.Kfz.221 of 2.Panzer-Division in France in June 1940. Both vehicles carry the white letter 'G' for Guderian's XIX.Panzer-Korps, prominently displayed on the front. The Sd.Kfz.221 also has the tactical sign of a motorized reconnaissance unit with a '2' in the lower right corner, painted on the left mudguard. Beside that can be seen the two yellow dots representing 2.Panzer-Division. An unrecognizable inscription has been painted under the driver's side visor as well.

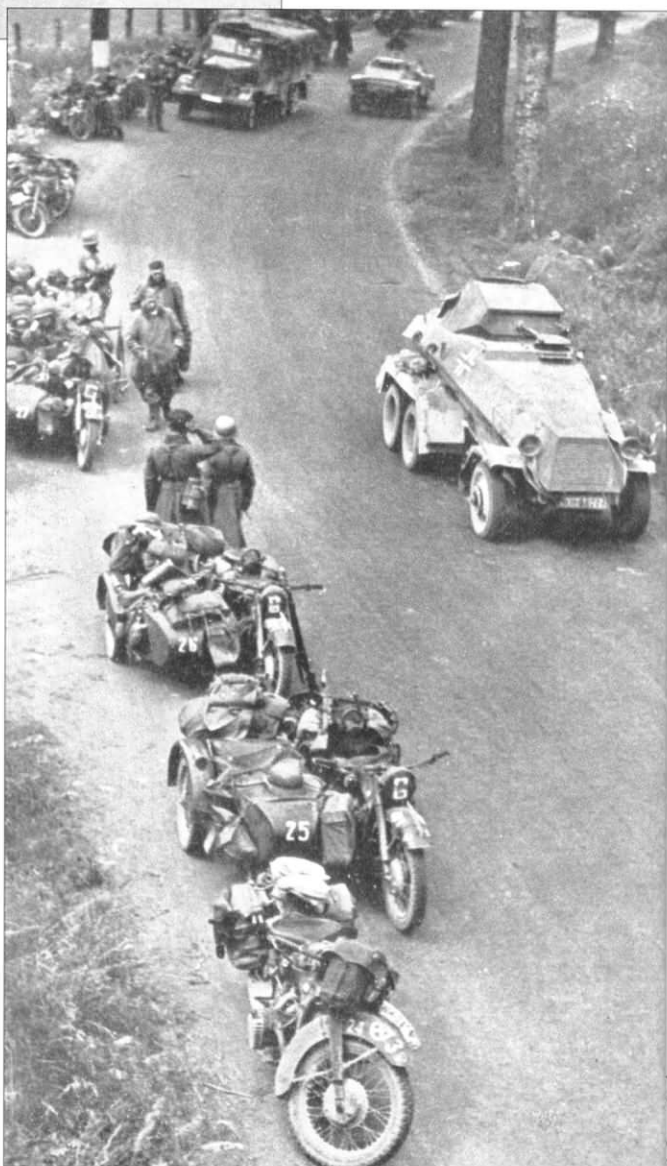
An Sd.Kfz.231 6-Rad armored car followed by an Sd.Kfz.221, passes a motorcyclist column on a road in France in May 1940. By this time, the Sd.Kfz.231 6-Rad was already obsolete and was withdrawn from service by the end of the year. The motorcycles all display standard tactical markings including the symbol for a motorcycle company followed by the company number, in this case, a '3'. Each machine is also numbered starting with '24' and it is interesting to note that they are lined up in order. The headlight covers also have the letter 'G' painted on them for Guderian's XIX.Panzer-Korps. Also of interest is the cavalry saddlebag carried by the lead BMW R12.
