PANZER-DIVISION 1935-1945

(1) The Early Years 1935-1941

Robert Michulec

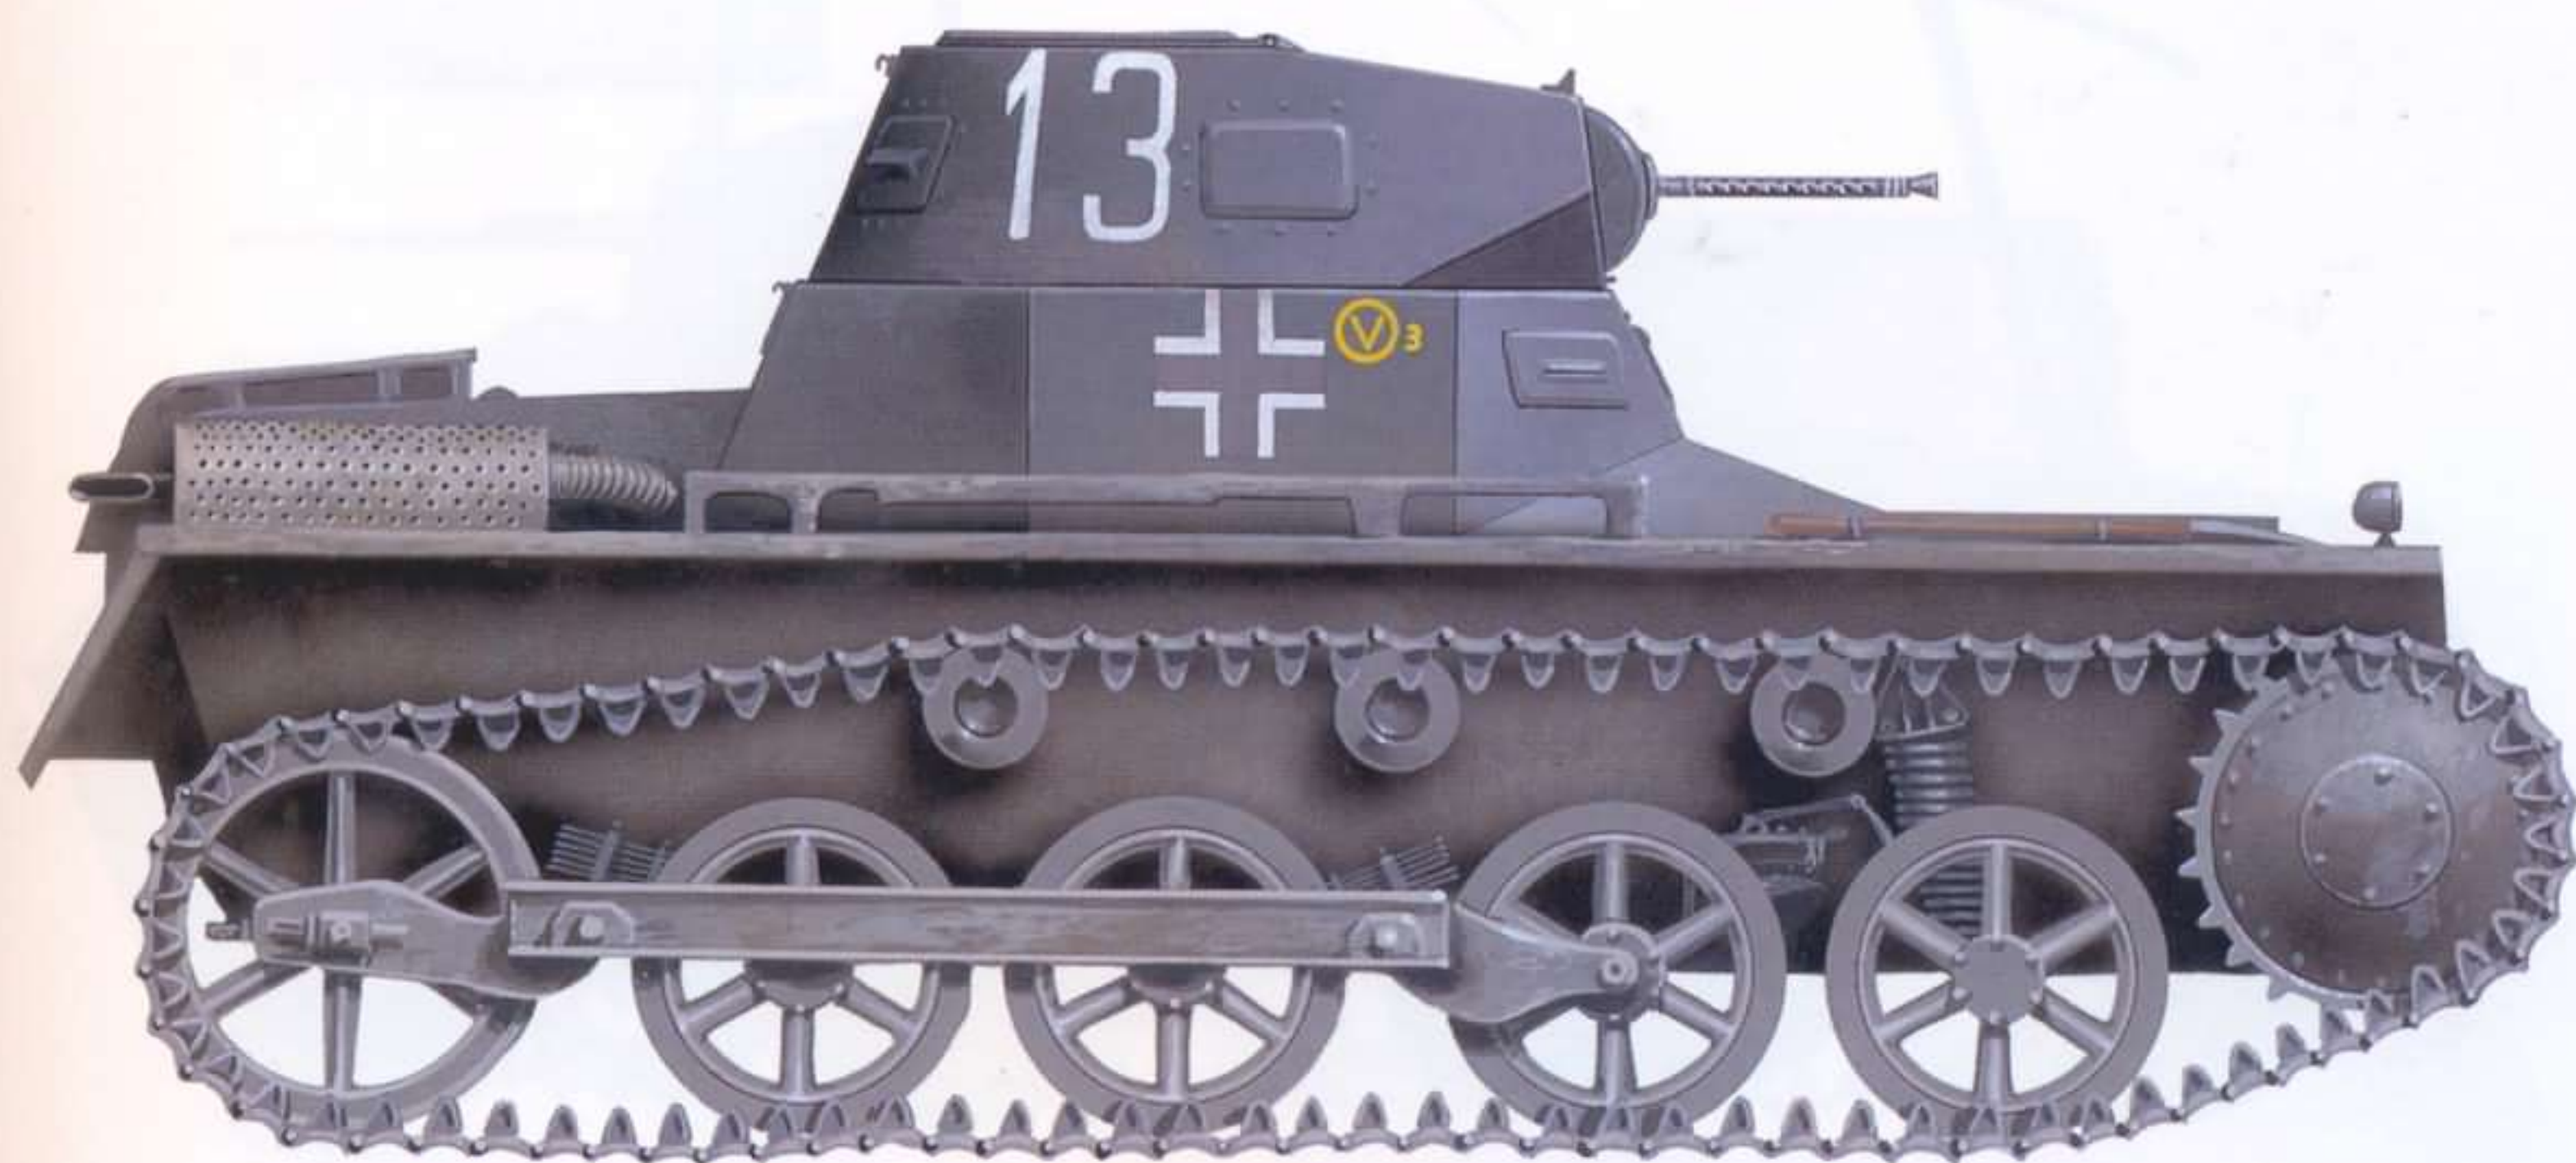
Pz.Kpfw.I Ausf.A, 3.Kompanie/Pz.Abt.z.b.V.40, Norway, April 1940

This vehicle is finished in overall dark gray and displays the unit emblem with a number '3' indicating it is from 3.Kompanie, both painted in yellow. It still has the tactical number, '13', painted in white on the turret, from the unit that was used to create it, 5.Kompanie/Pz.Rgt.15 of 5.Panzer-Division.

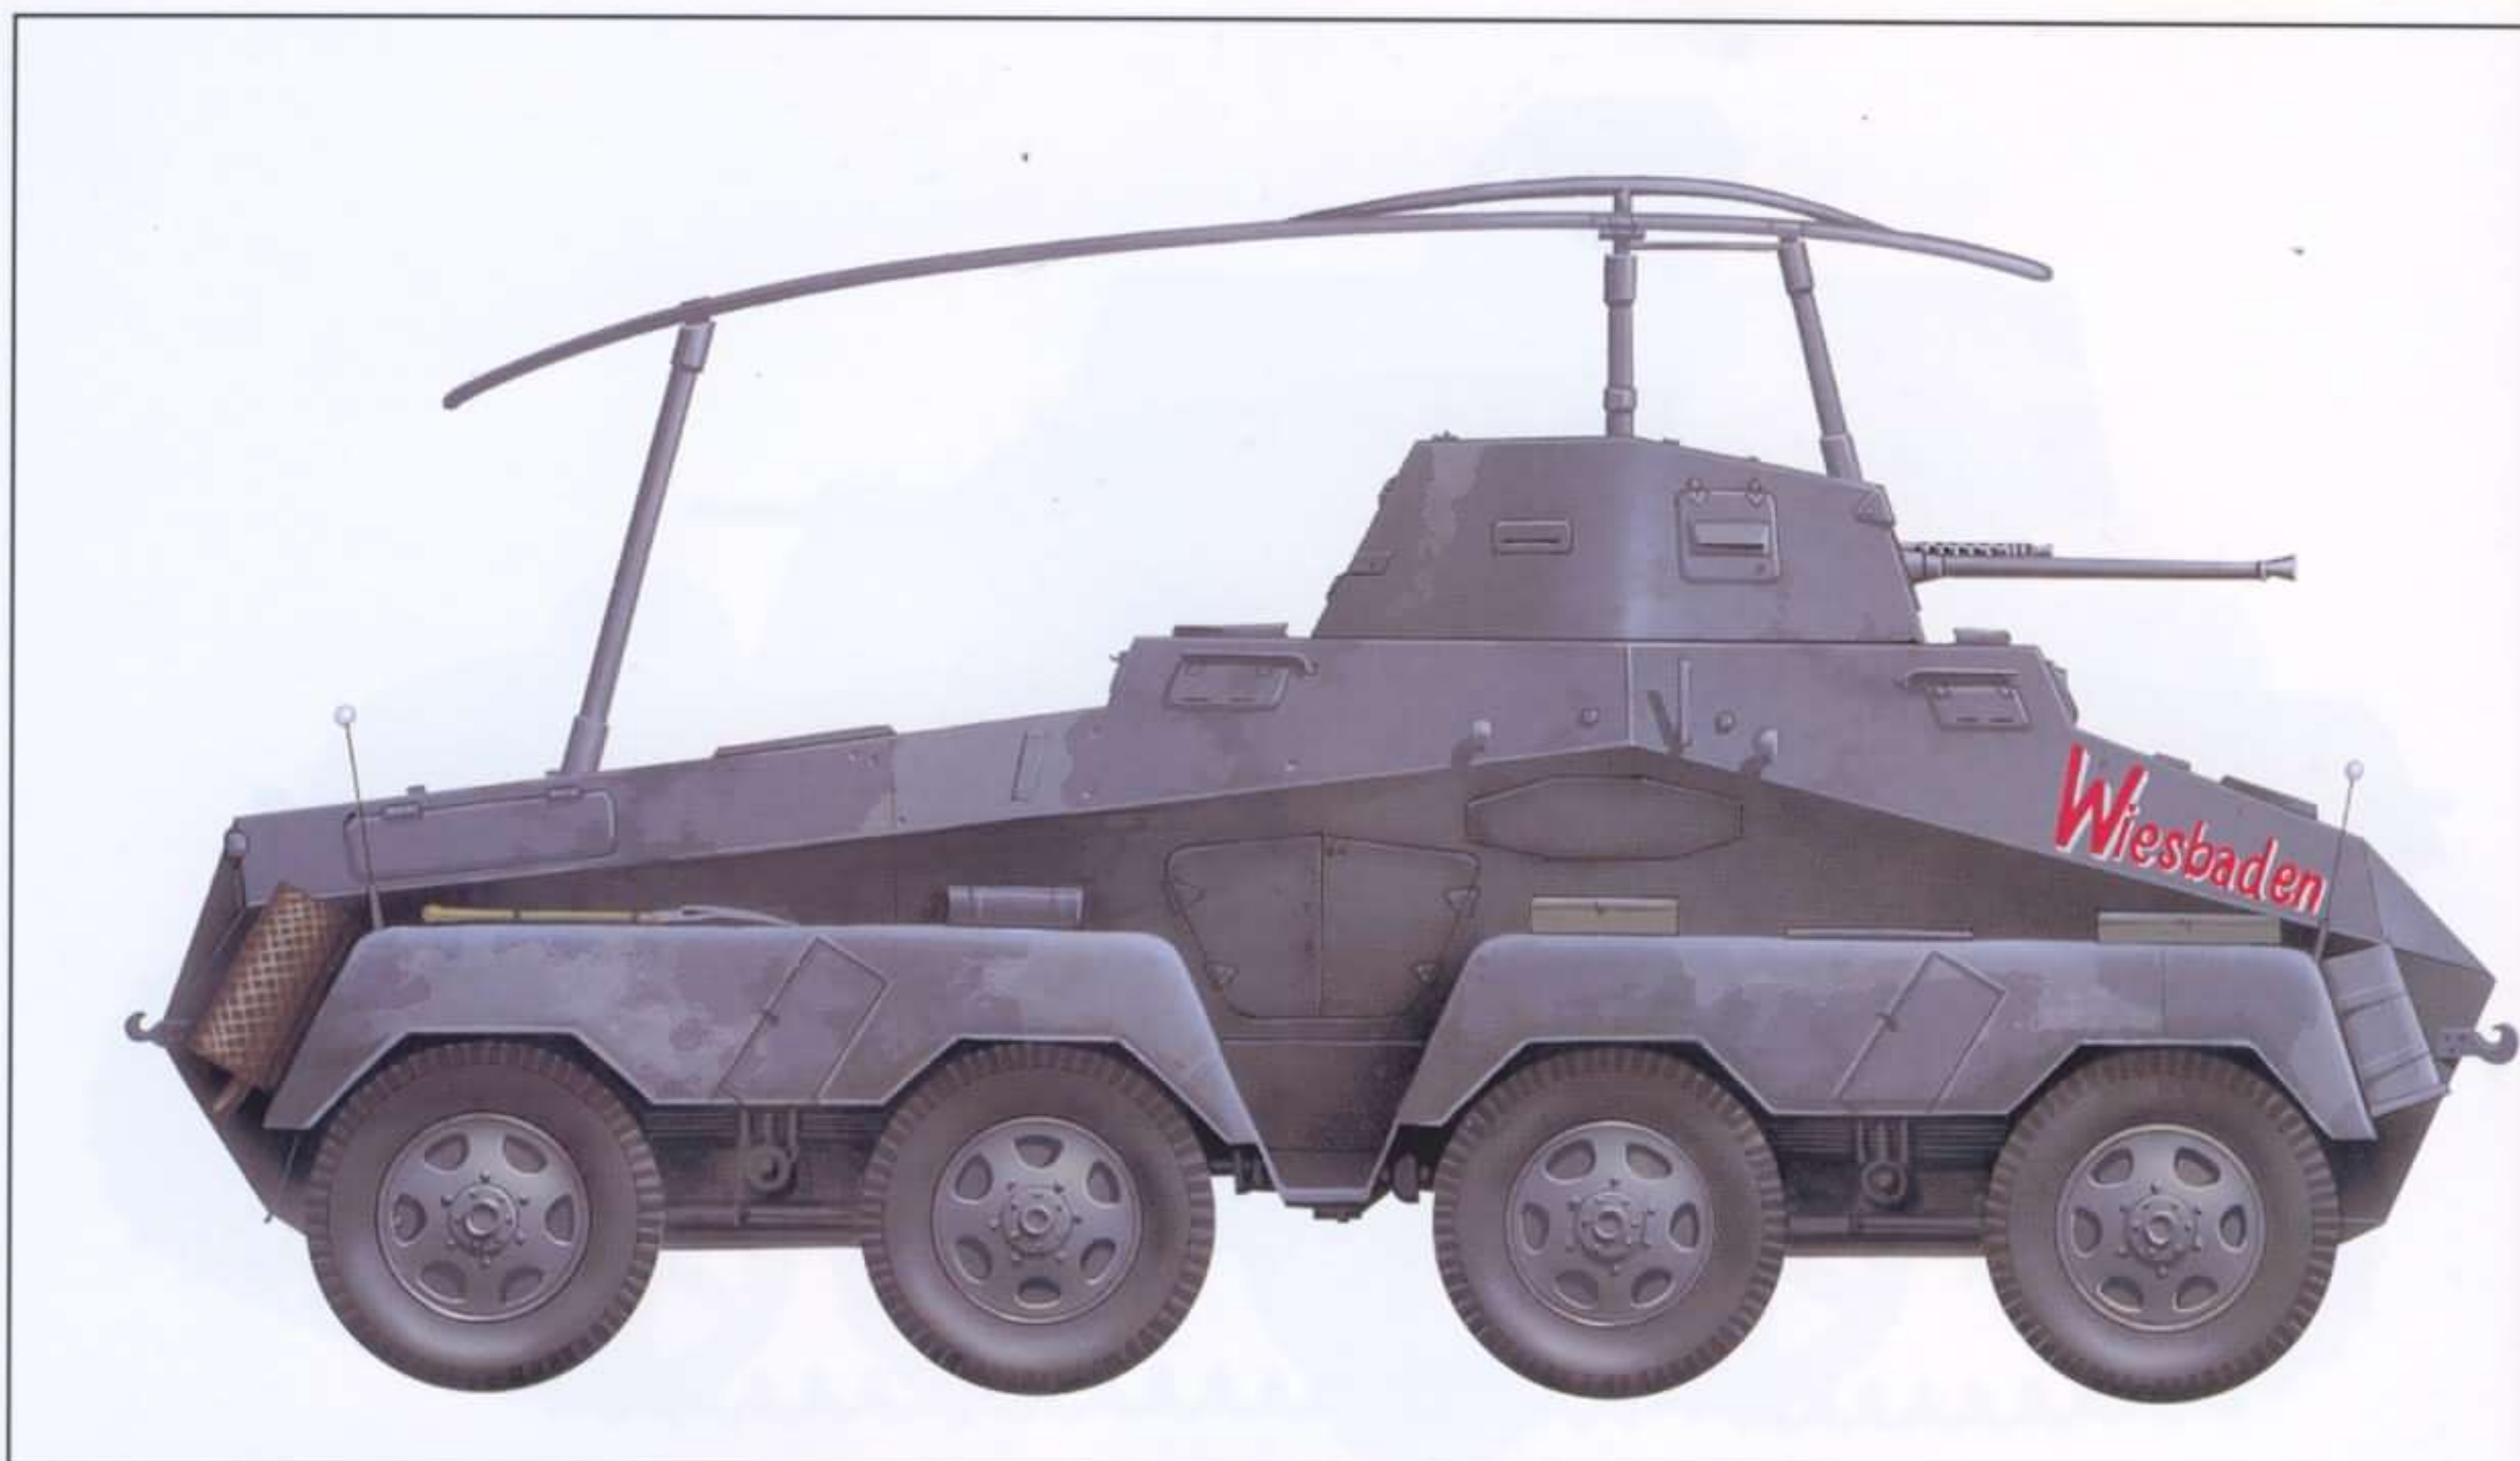
Sd.Kfz.232, unknown Pz.Aufkl.Abt., Germany, spring 1940

The vehicles of this unit carried the names of cities on their vehicles, in this case 'Weisbaden', probably in red, with a white shadow. It was painted in the standard dark gray but seems to have had a camouflage spray of another color, possibly a lighter gray, covering the national battlefield crosses and in a random spot pattern over the rest of the vehicle. The standard Wehrmacht license plate number 'WH-261793' is painted in black outline on a white background with a black border.

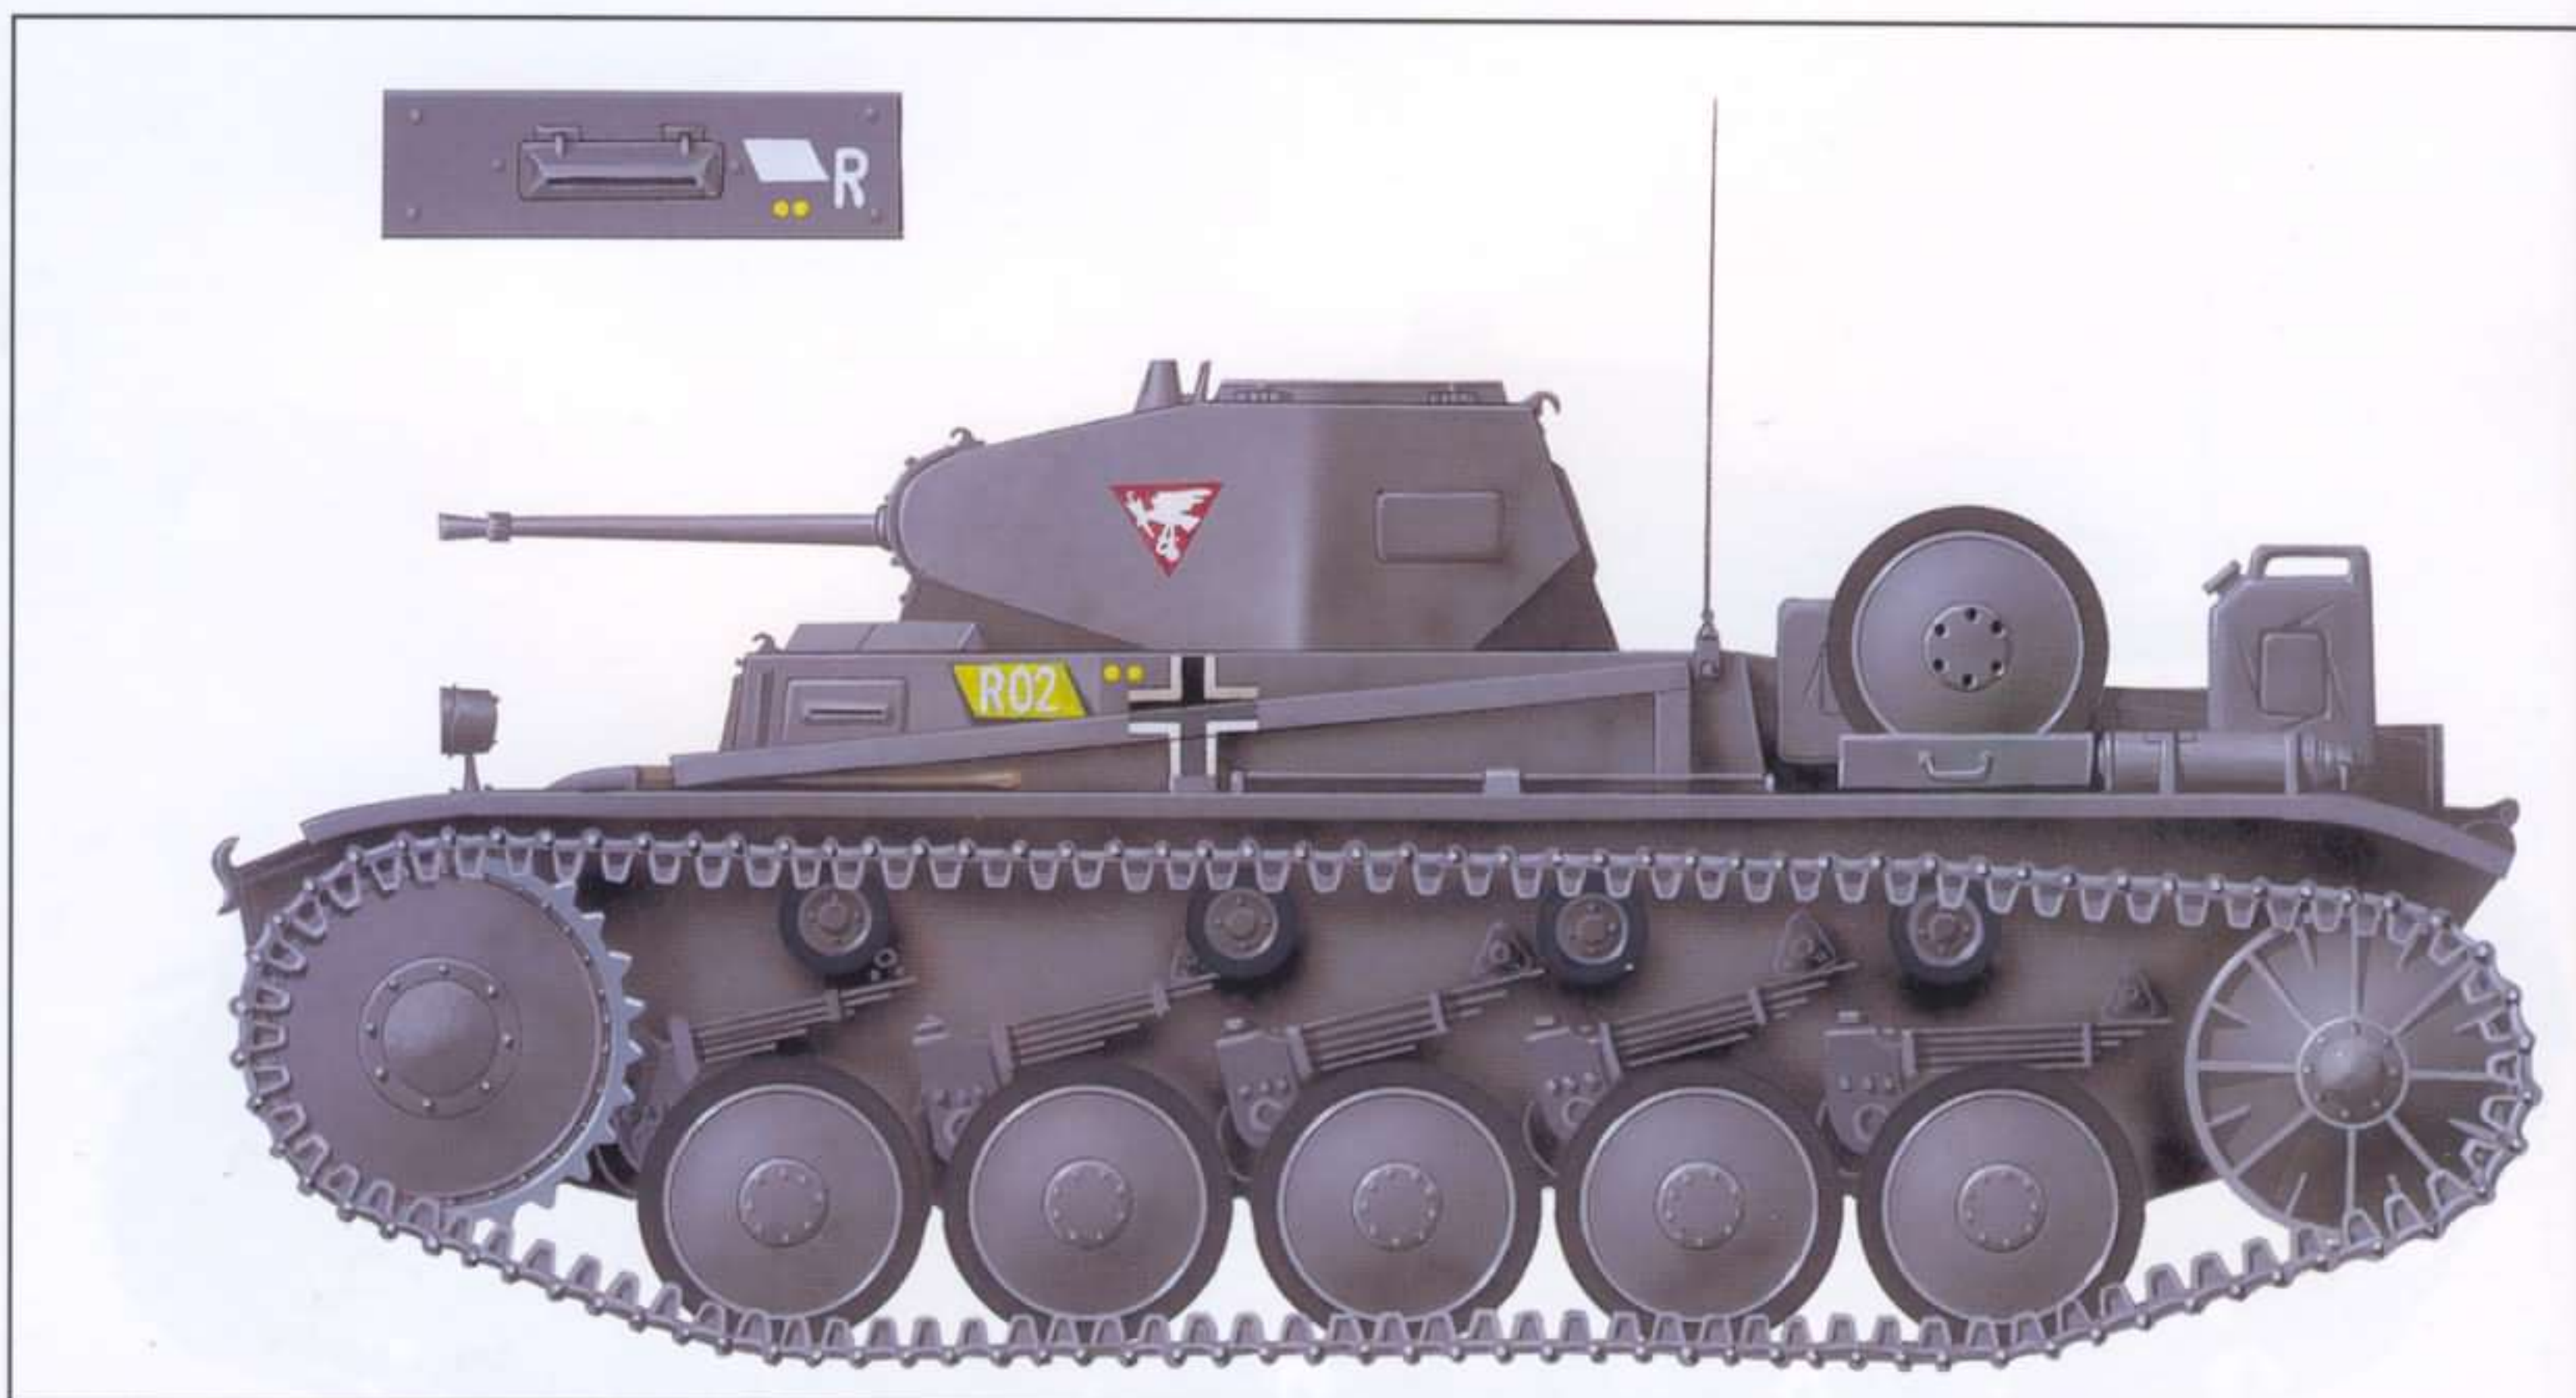
Pz.Kpfw.II Ausf.A-C, Pz.Brig.2, 2.Panzer-Division, France, spring 1940

This tank belongs to the regimental staff of one of 2.Panzer-Division's two Panzer-Regiments, either Pz.Rgt.3 or Pz.Rgt.4. It carries a full set of regulation markings including two dark yellow dots, which was the tactical sign for 2.Panzer-Division, and the tactical number 'R02' painted white on a dark yellow rhomboid metal plate. A white rhomboid tactical sign for a Panzer-Division has been painted on the front plate with the regimental 'R' beside it. A unit emblem is painted on the side of the turret, a white eagle in flight carrying a top hat in its talons and an umbrella in its beak, painted on an alternate color triangle, possibly red. The national cross is unusual in that it has a thin black outline painted outside the white.

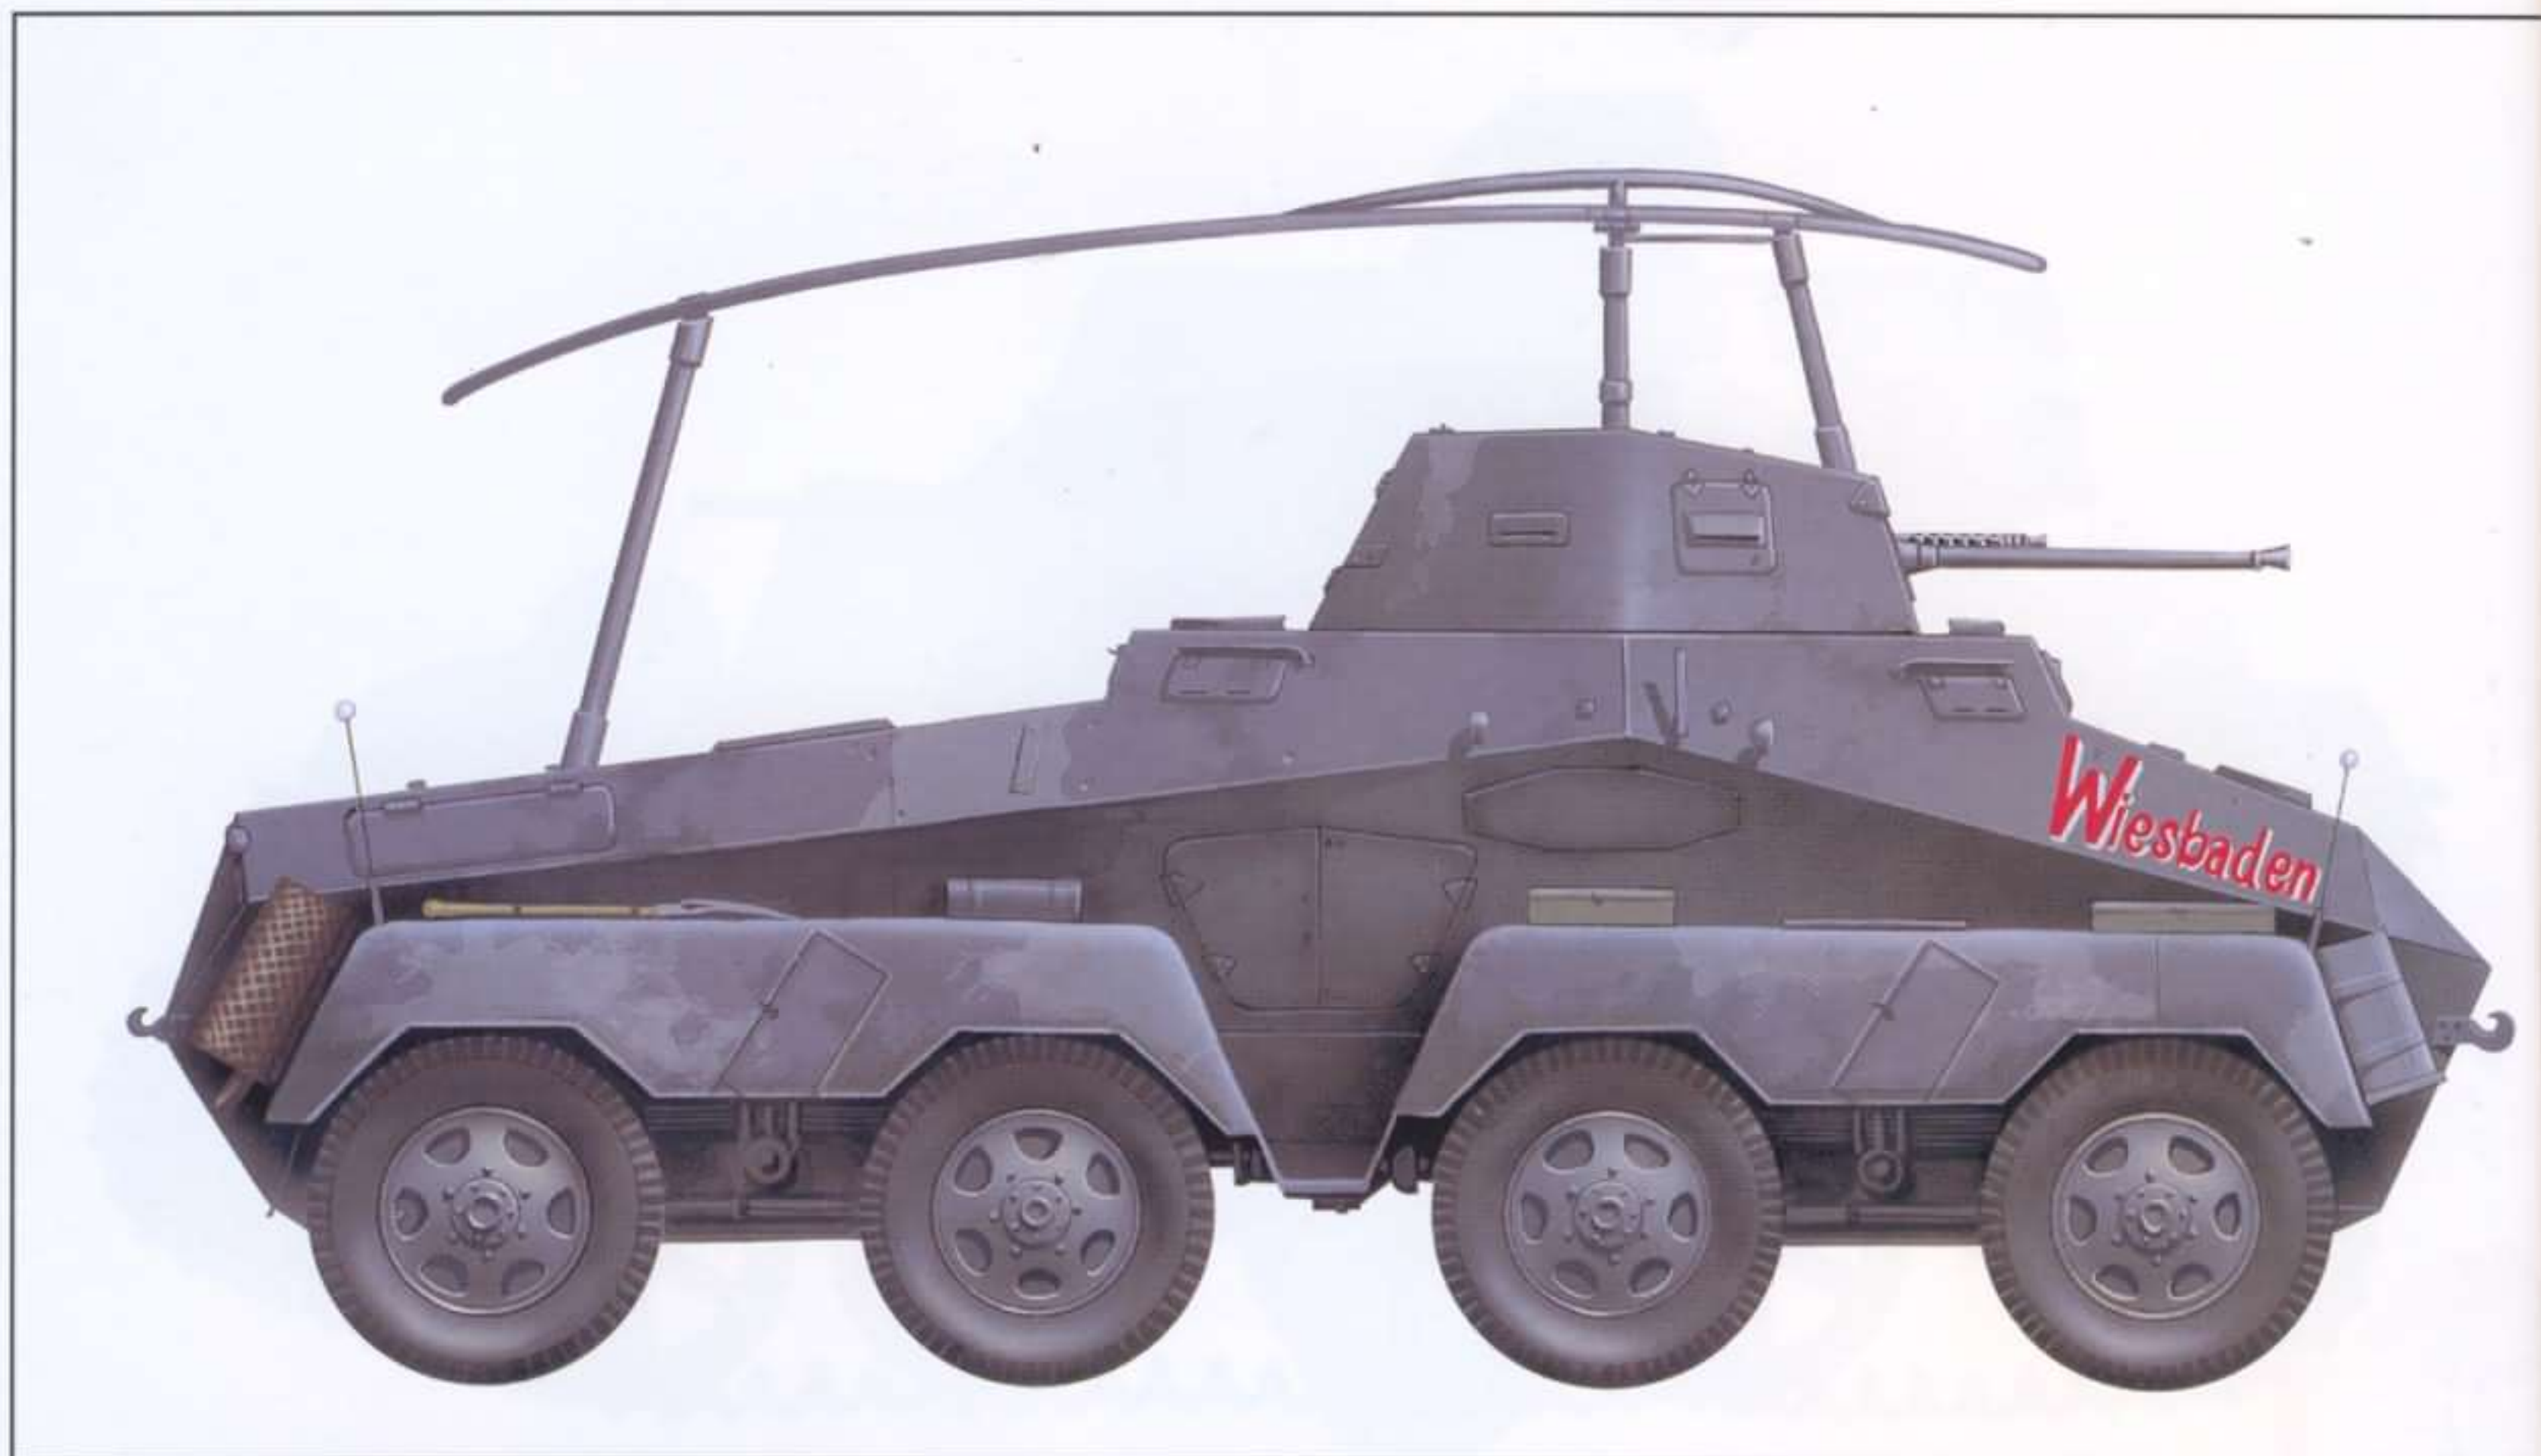
Sd.Kfz.232, unknown Pz.Aufkl.Abt., Germany, spring 1940

The vehicles of this unit carried the names of cities on their vehicles, in this case 'Weisbaden', probably in red, with a white shadow. It was painted in the standard dark gray but seems to have had a camouflage spray of another color, possibly a lighter gray, covering the national battle crosses and in a random spot pattern over the rest of the vehicle. The standard Wehrmacht license plate number 'WH-261793' is painted in black outline on a white background with a black border.

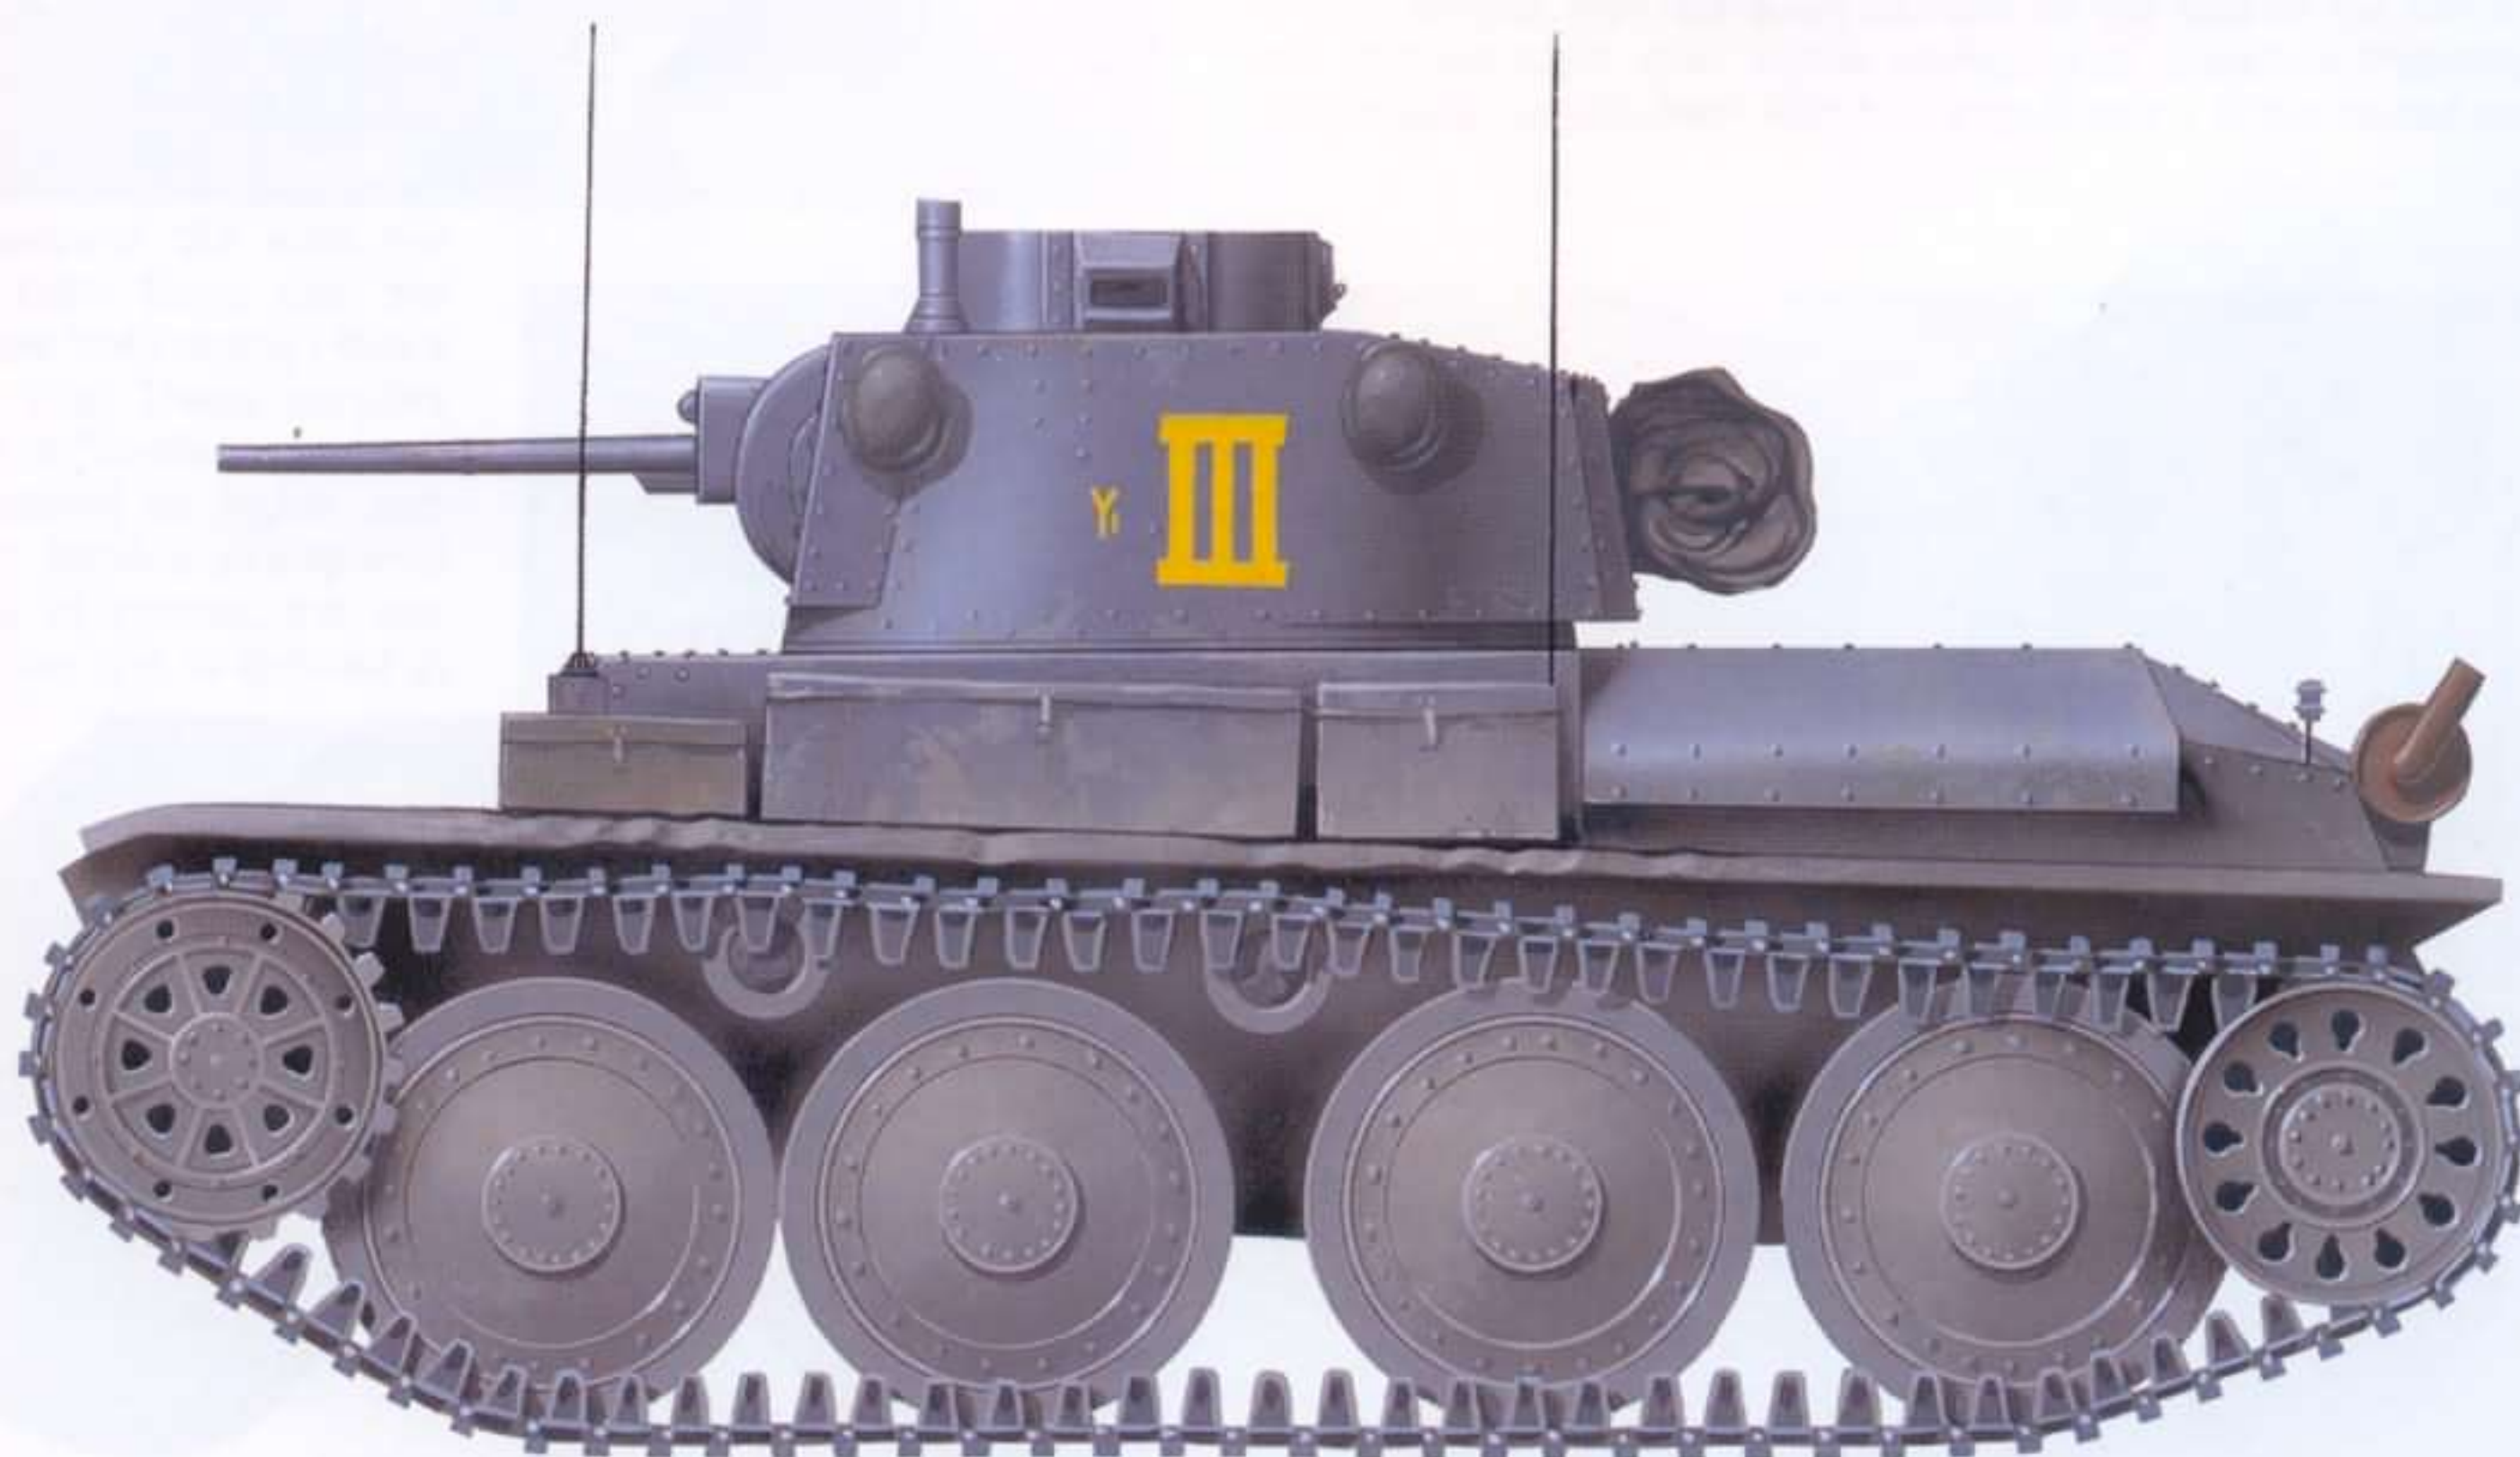
Pz.Kpfw.38(t) Ausf.B, III/Pz.Rgt.10, 8.Panzer-Division, Russia, summer 1941

This tank, used by III.Battalion staff, was finished in overall dark gray and carried large, colorful Roman numeral tactical markings, typical for Operation 'Barbarossa'. The divisional emblem, also in yellow, was painted in front of the tactical number and was repeated on the plate over the former location of the bow machine gun.

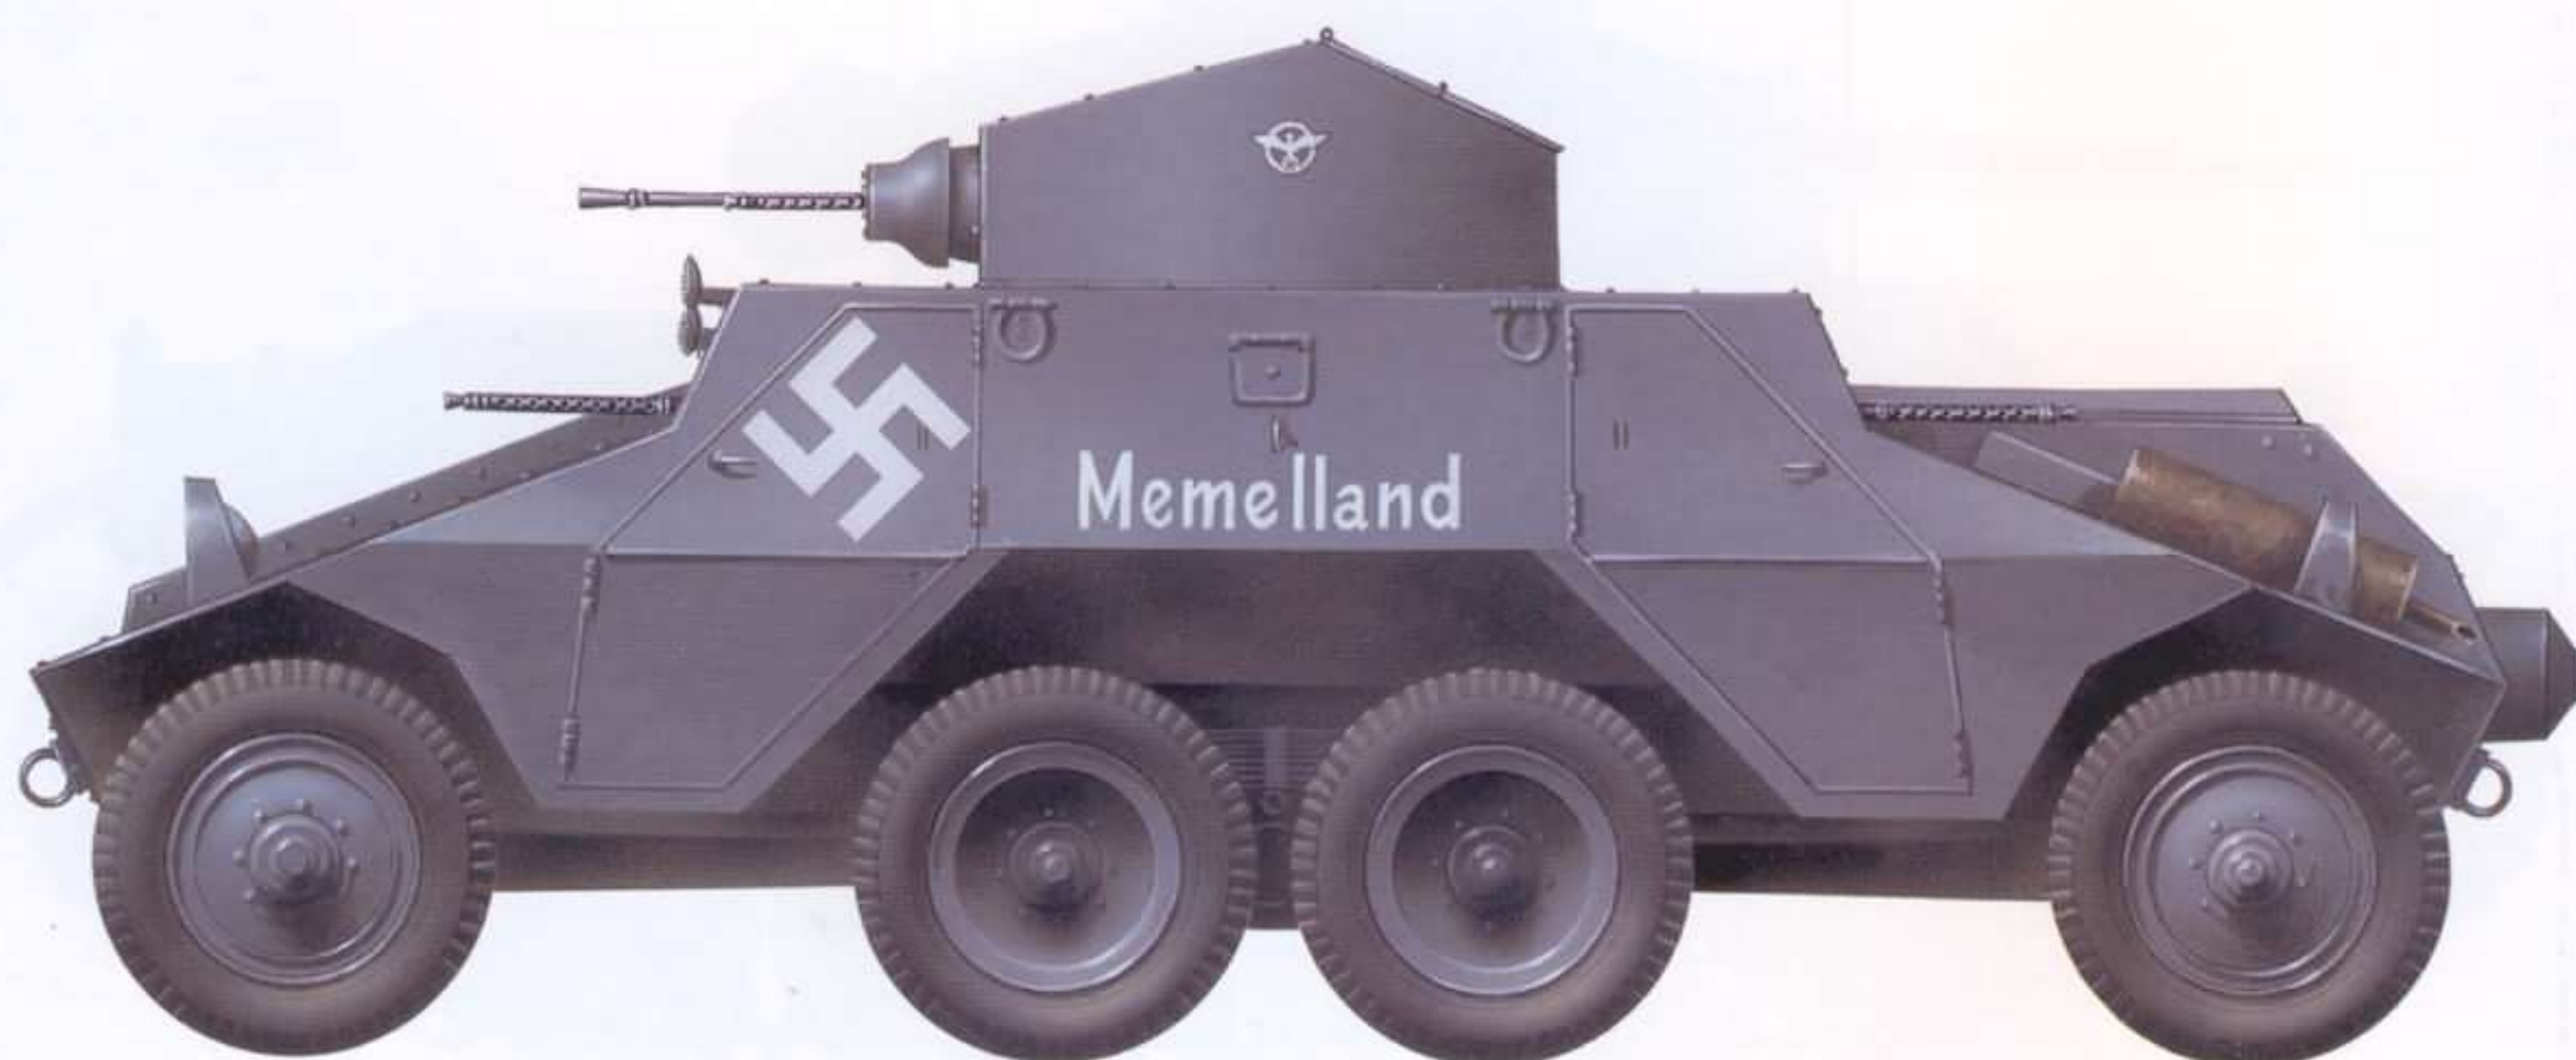
Polizei-Panzerkampfwagen ADGZ, Pol.Rgt.Mitte, Russia, summer 1941

This overall dark gray Steyr ADGZ armored car carried large swastikas and the name 'Memelland' painted in white on each side. The ORPO emblem was painted on the side of the turret, typical for most combat vehicles of this service during this period.

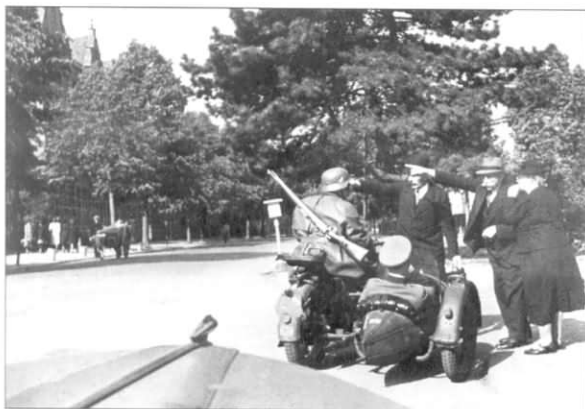
German soldiers on a BMW R11 motorcycle combination get directions from Dutch civilians in Amsterdam, June 1940. The sidecar, though distinctly civilian in appearance, has a WH number painted on the back side, though the number is indistinguishable. The censor has thoughtfully obliterated the license number from the rear of the motorcycle, but has left a marking that appears to be a dark colored 'X' in a light colored rectangle of unknown meaning, painted on the bottom of the mudguard.

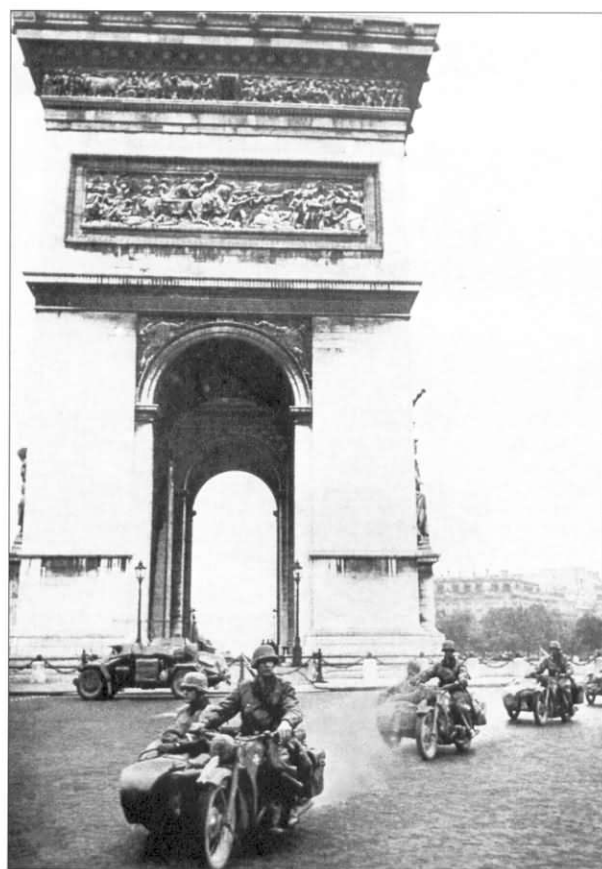
A motorcycle reconnaissance troop on Zündapp KS600 motorcycle combinations pass the Arc de Triomphe in Paris in mid-June 1940. An illegible tactical sign has been painted on the side of the frame below the fuel tank on each one. In the background, a leichte Panzerspähwagen (Sd.Kfz. 223) can be seen with its frame antenna in the raised position.

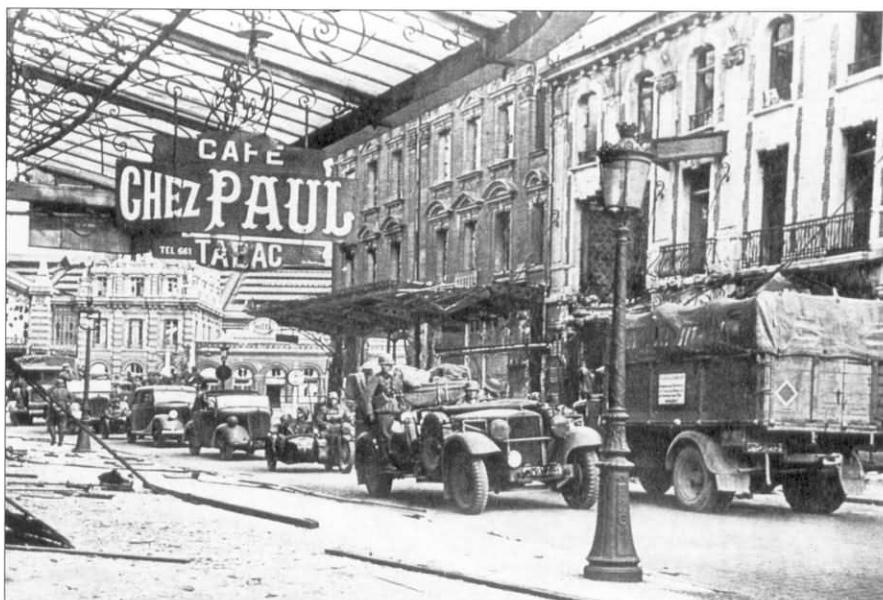
A column of various soft-skin vehicles led by a Wanderer Kfz. 11 travels through the damaged streets of Arras in May 1940. The vehicle on the right is an Opel Blitz S-type 3-ton truck.

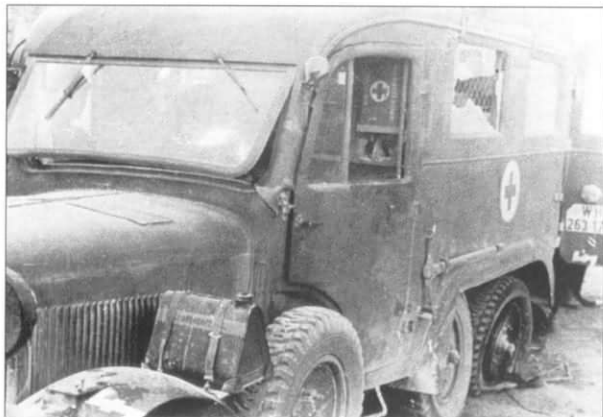
A German Steyr 640 Kfz.31 ambulance shot up by French troops in early June 1940. The Red Cross signs on sides and rear door are not very prominent which probably contributed to the mistaken identity. The front mudguard and rear door carry the emblem of Pz.Rgt.8 which at that time was one of the two Panzer-Regiments attached to 10.Panzer-Division.
