PANZER-DIVISION 1935-1945

(1) The Early Years 1935-1941

Robert Michulec

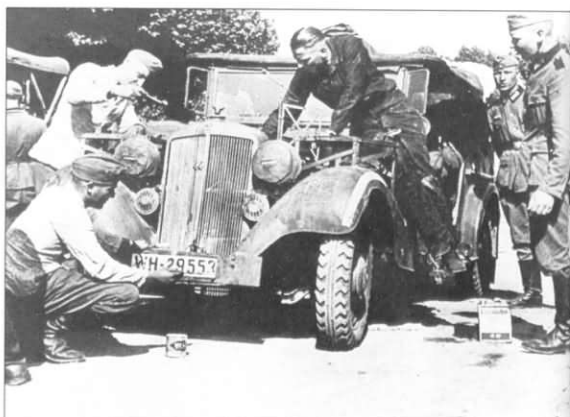
Vehicle maintenance and repairs being carried out in a field workshop at Montceau-les-Mines in July 1940. The tactical sign painted in yellow on the left mudguard indicates the vehicle belongs to the 5.Batterie of a tow artillery regiment. White road width markings are also painted on each mudguard and the vehicle registration number, 'WH-29553', is being repainted on the front. The purpose of the metal frames on top of the mudguards is not clear, however, they may have been for stowing additional fuel cans. This car is a Horch 830 B1 Kfz.15.

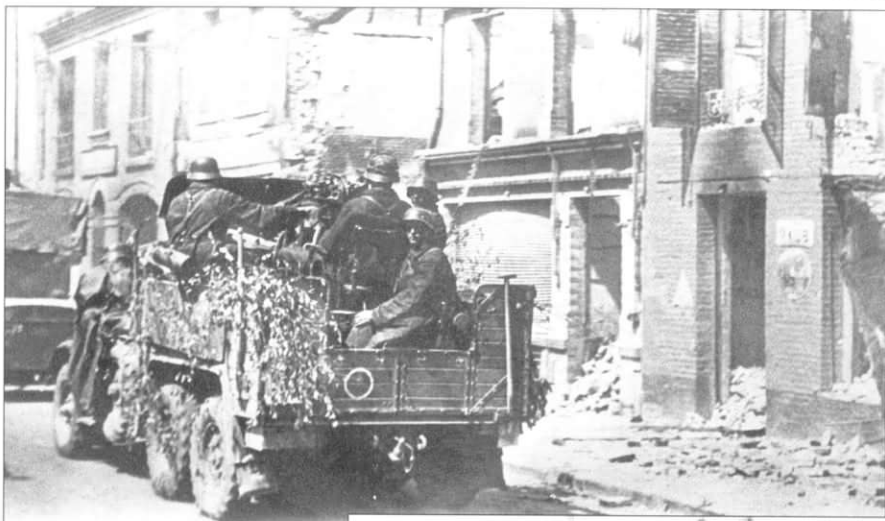
A Krupp Protze L2H143 Kfz.1 light truck mounting a 2cm FlaK30, Regiment 'General Göring' passing through the ruins of Montcornet at the beginning of June 1940. The Regiment had its beginnings in 1933 as a police unit. It took part in the Austrian Anschluss in 1938 and after that, was reorganized as primarily an anti-aircraft unit until a rifle battalion was added in April 1940. The white circle on the rear of the truck indicates it is attached to the regimental staff.

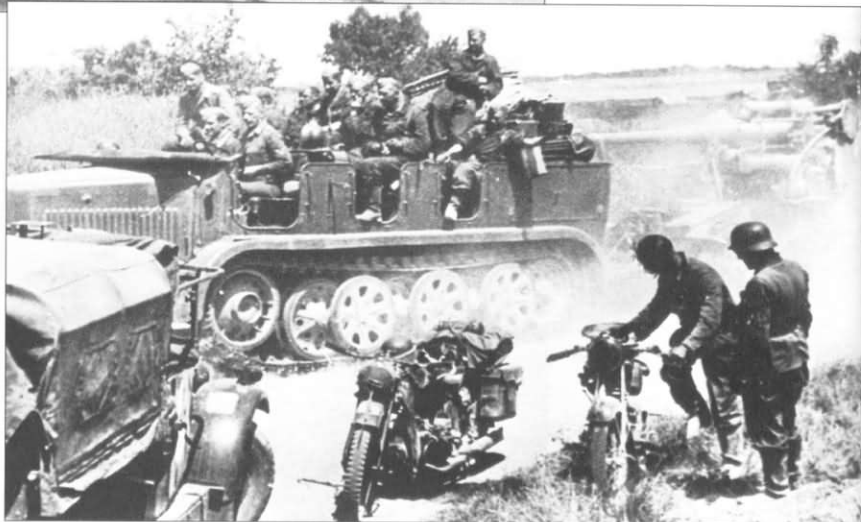
An Sd.Kfz.7 half-track prime mover towing an 8.8cm FlaK18, negotiates a tight corner on a narrow, dirt road in France. Traffic control in the rear areas in support of a major offensive was a great challenge where the passage of several thousand vehicles necessitated strict control. Pre-war field exercises were very useful and lessons learned under actual battle conditions in Poland were to prove beneficial during the battle for France. Here the soldier in the rear of the half-track appears to be signaling oncoming traffic to halt.

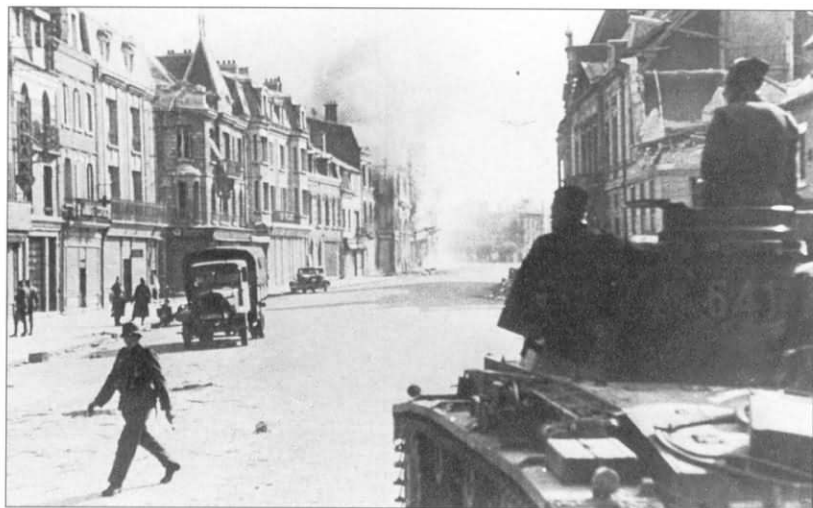
A column of German tanks passing by the remains of a French motorized column which has been demolished by Luftwaffe attacks during their retreat at the end of May 1940. Both the lead tanks are Pz.Kpfw.III Ausf.E while in the background, a Pz.Kpfw.II is visible. From the visible part of the directional sign, the location would appear to be in the vicinity of Arras.

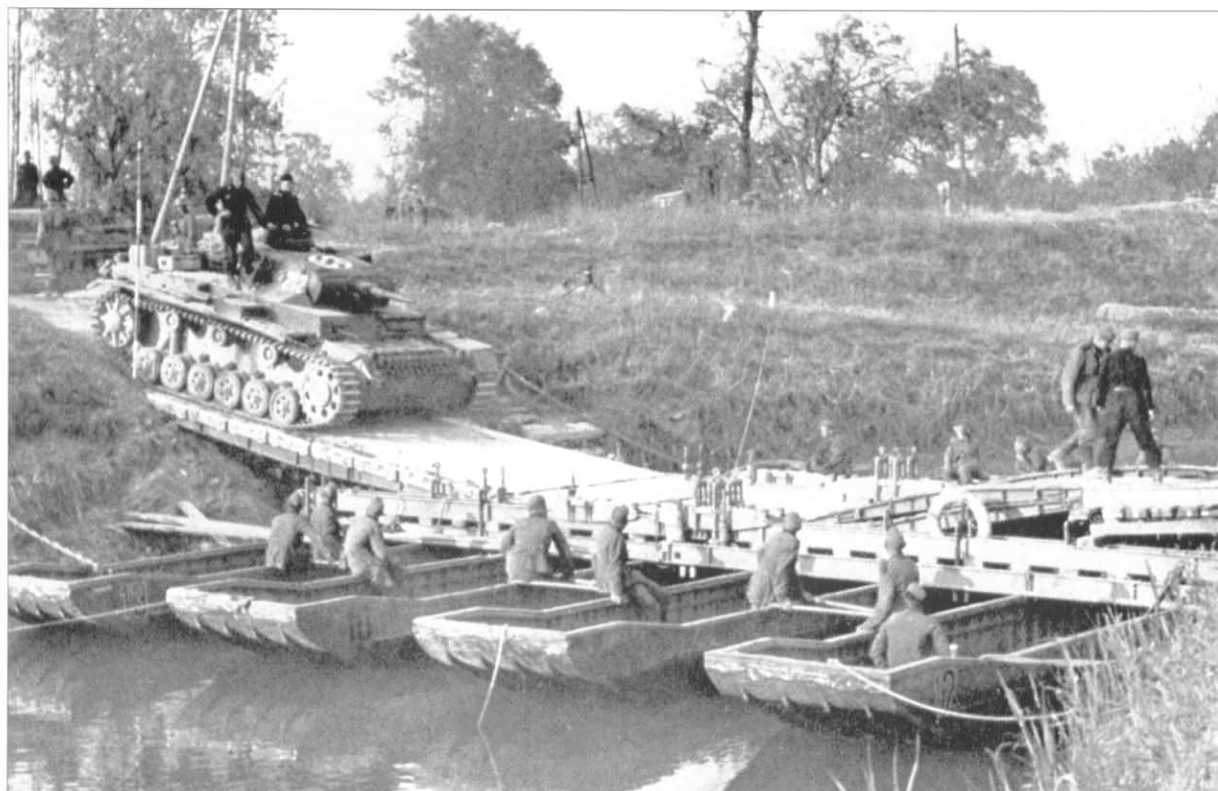
A Pz.Kpfw.III Ausf.E crossing a river on a temporary engineer's bridge in France, June 1940. The tactical number '212' is painted in white on the turret and it also carries a German flag for aerial identification. This practice was used for the first time in France and proved to be useful in helping identify German units to their own low-flying reconnaissance planes.

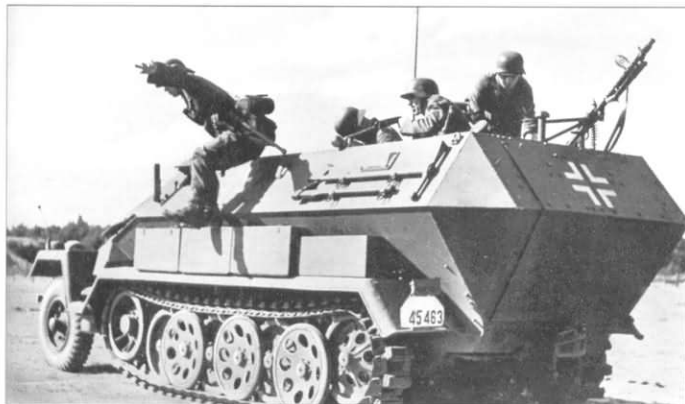
Panzergranadiere dismount from an Sd.Kfz.251/1 Ausf.A during training in 1940 in this photo taken from a German postcard. This was a relatively rare vehicle in the Panzer-Divisions at this period of the war and only seven companies of 12-14 vehicles in all ten Panzer-Divisions were equipped with them. The censor has removed the 'WH' from the vehicle registration plate.

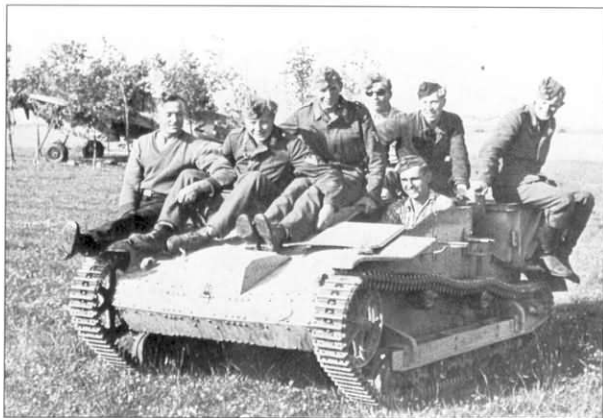
It is interesting to note that the French Army was more extensively motorized during the 1930s than the German Army was. Approximately 6,000 lightly armored and tracked tractors, like this UE with trailer, were employed by the French Army in 1940. This one has been captured by the Germans and put to use but still carries the original French markings on the front plate, the serial number, or matricule, and a small white grenade shaped bridging sign with a '1' inside.

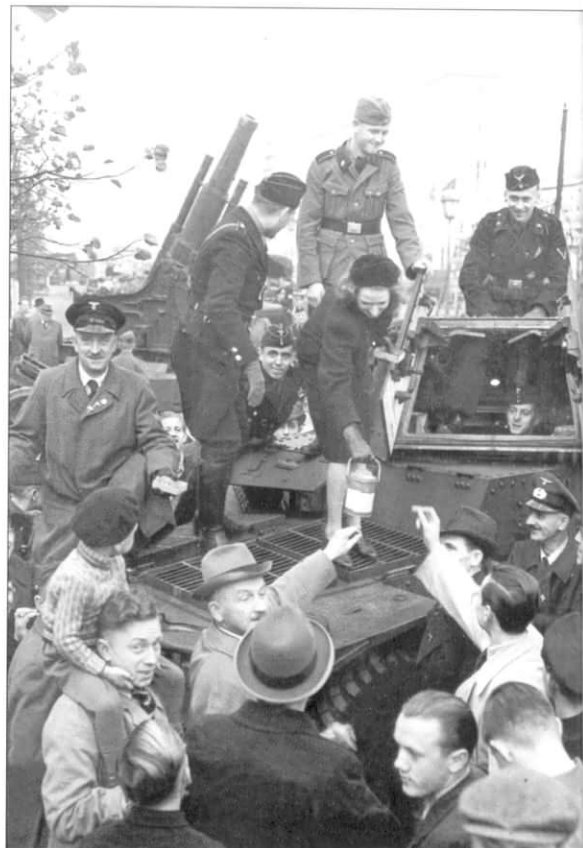
Captured French equipment on display on the Unten der Linden in Berlin in the middle of October, 1940. Large numbers of Panhard 178 armored cars were captured and placed into German service as the Panzerspähwagen Panhard 178-P204(f). Most were issued to armored reconnaissance units.

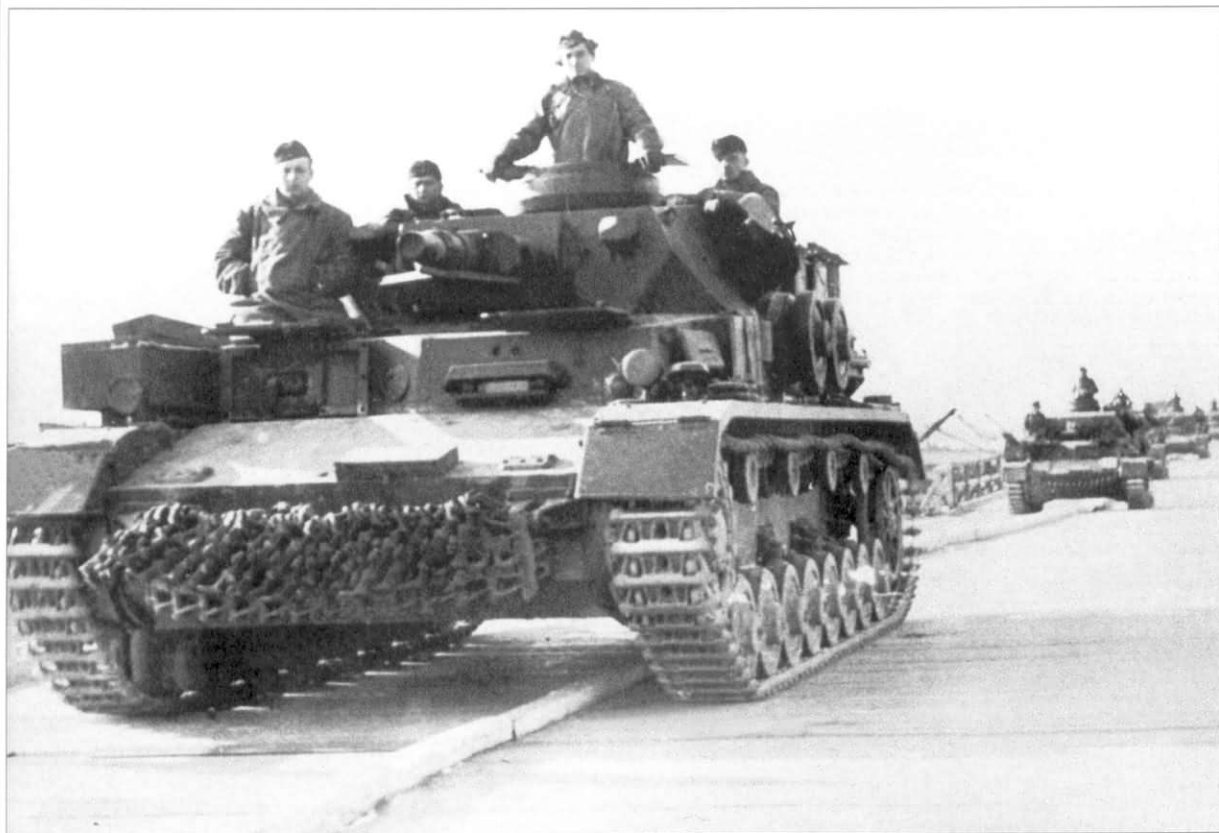
A column of Pz.Kpfw.IV Ausf.E from Pz.Rgt.33 of 9.Panzer-Division enter Bulgaria over the Danube bridge. Visible around the MG ball mount is the bracket for attaching the 30mm additional armor plate that was fitted to many of these vehicles. This crew have also suspended several rows of extra track links from the front tow hooks.

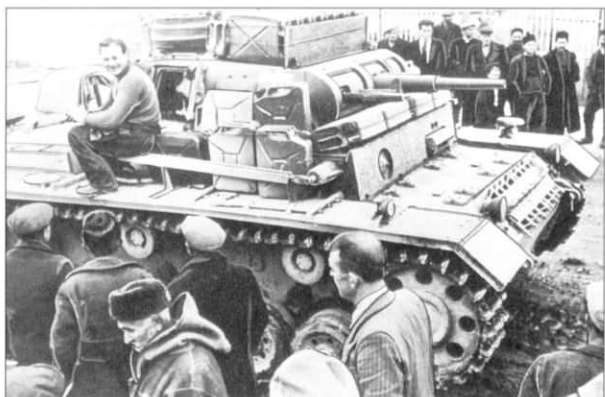
This retouched photo shows a Pz.Bef.Wg.III Ausf.H at rest in a Bulgarian village in mid-March 1941. The vehicle has been heavily stowed with additional fuel cans secured to the turret roof and along the front and side of the hull. The name 'Haster', probably painted in red or black with a white outline, has been painted on the side of the turret while the inscription 'fu 6 u. 8', likely referring to the radio equipment carried, has been painted in white on the front plate beside the former MG ball mount location, now replaced by a pistol port.

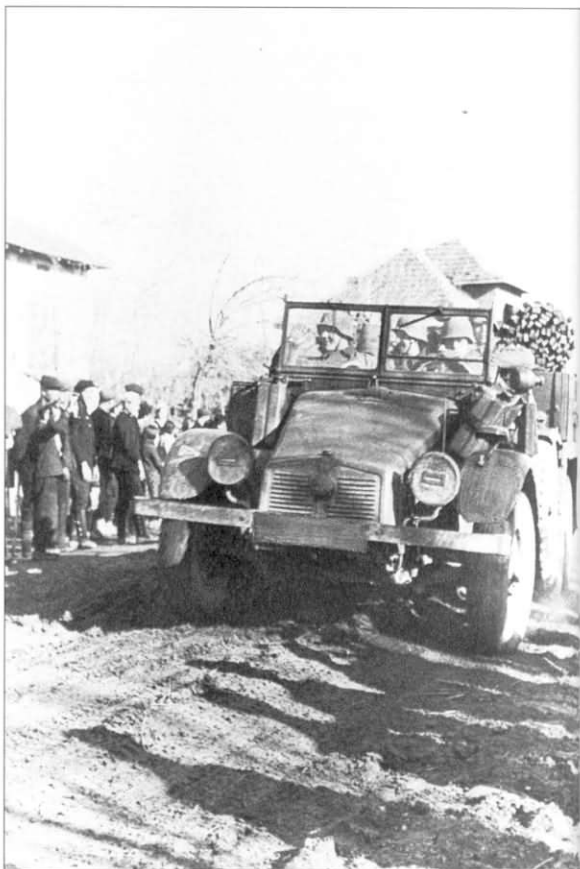
A Krupp Protze Kfz.69 passing through a Bulgarian village in March 1941. The vehicle registration number and unit emblem have been painted out by the censor but the tactical sign for the first company of a motorized anti-tank battalion is still visible on the right mudguard. What appears to be a camouflage pattern painted on the front of the vehicle is actually shadow cast from trees lining the roadside.

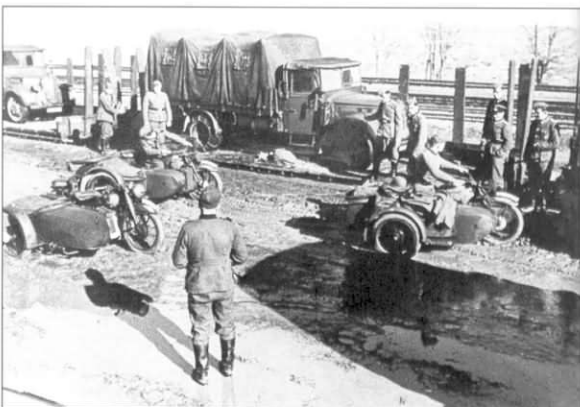
Another shot of vehicles being loaded onto trains. The two motorcycle combinations in the background are Zündapp KS600's. The one in front is a BMW R61 that has been fitted with an unusual sidecar. The two trucks are Ford G 917 T or G 997 T 3-ton lorries. The two types were identical externally, the only difference being the engine.

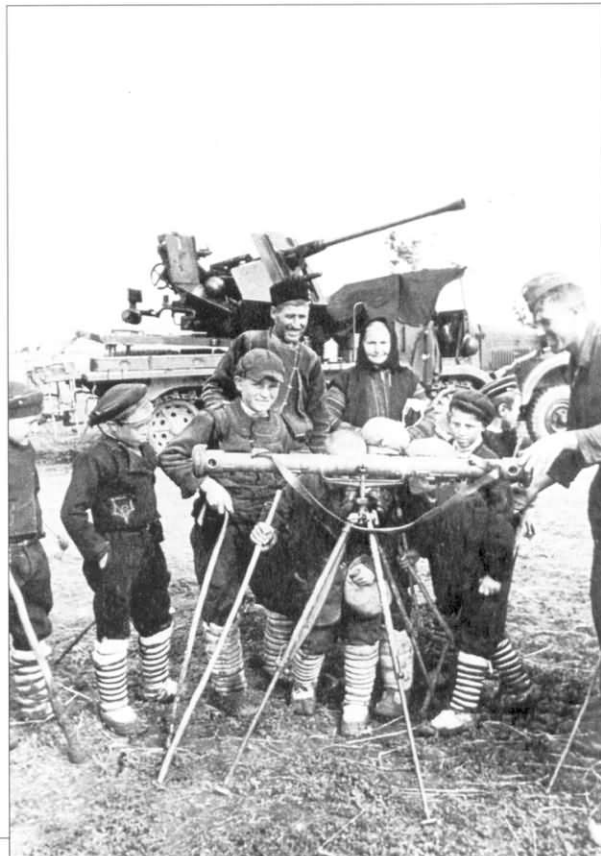
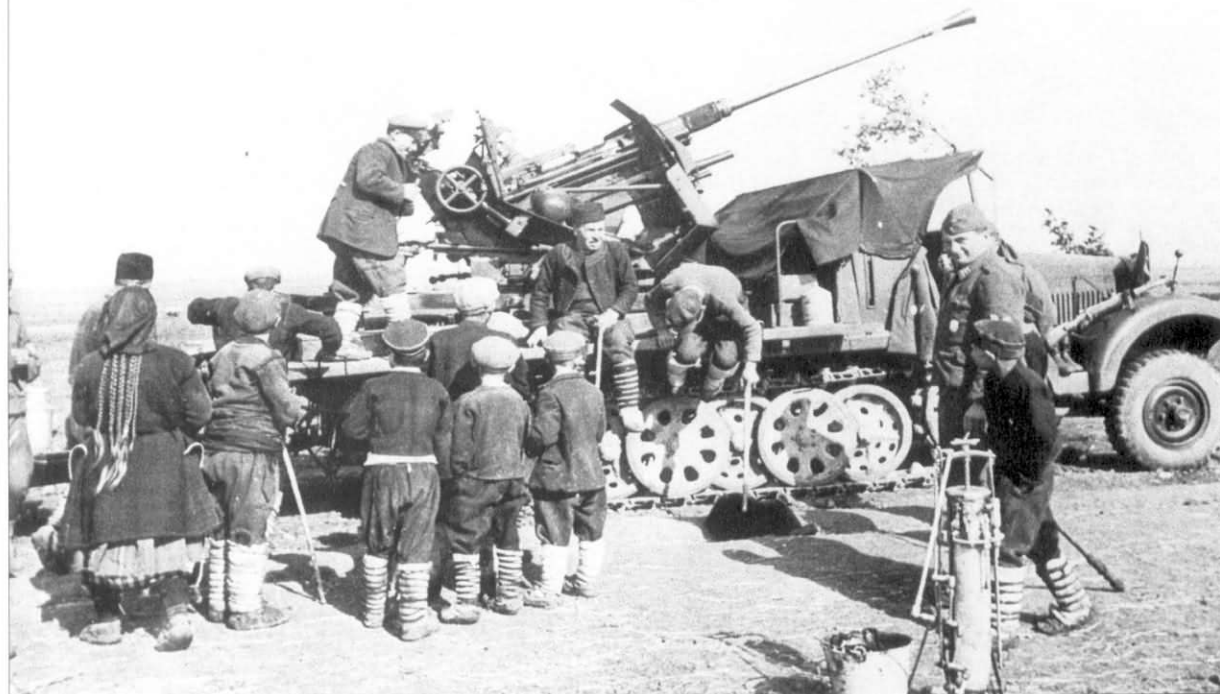
Two photos of an Sd.Kfz.6/2 anti-aircraft vehicle armed with a 3.7cm FlaK36 gun which is assigned to a Luftwaffe anti-aircraft unit. The Bulgarian peasants seem to be very interested in it, especially the children who are being shown the view of the countryside through the range finder. The 3.7cm FlaK36/37 became the standard defense weapon against low-flying aircraft and were fitted to a variety of self-propelled mounts including the Sd.Kfz.7 and sWS. A total of 339 of the Sd.Kfz.6/2 were built up to 1943.

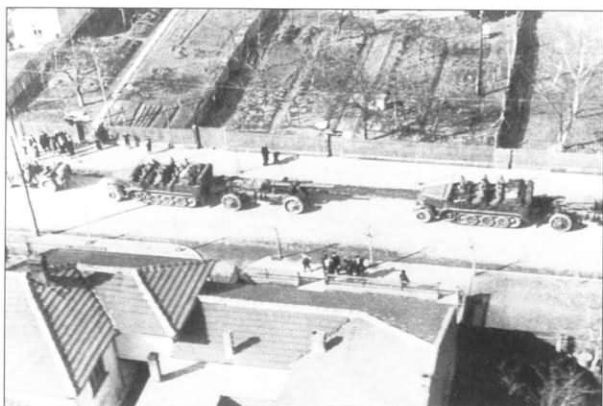
An Sd.Kfz.7 half-track prime mover towing a 15cm sFH18 howitzer in Bulgaria in March 1941. The letter 'A' indicating the battery the gun was assigned to, is painted in white on the right equilibrating wheel and just below that, is the tactical sign for a towed artillery battalion and the emblem of the 9. Panzer-Division.

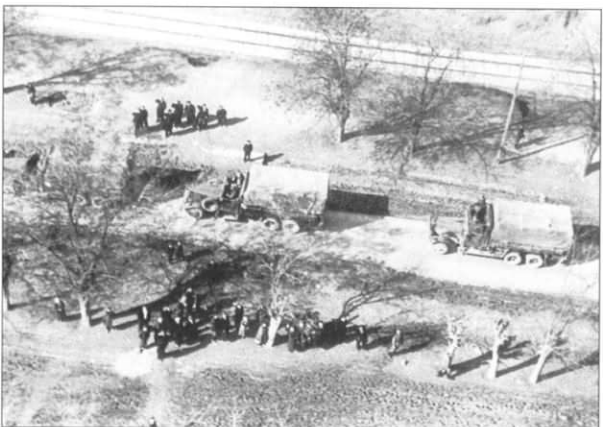
Part of the same column showing some of the division's transport. A rarely seen vehicle, the Sd.Kfz.254 m.g.p. Beob.Kw (Saurer RK-7) to the right seems to have attracted much attention. A total of 128 of these combination wheeled and tracked vehicles, originally developed by the Austrian Army, were incorporated into the Wehrmacht Panzerartillerie Regiments as observation and radio vehicles.

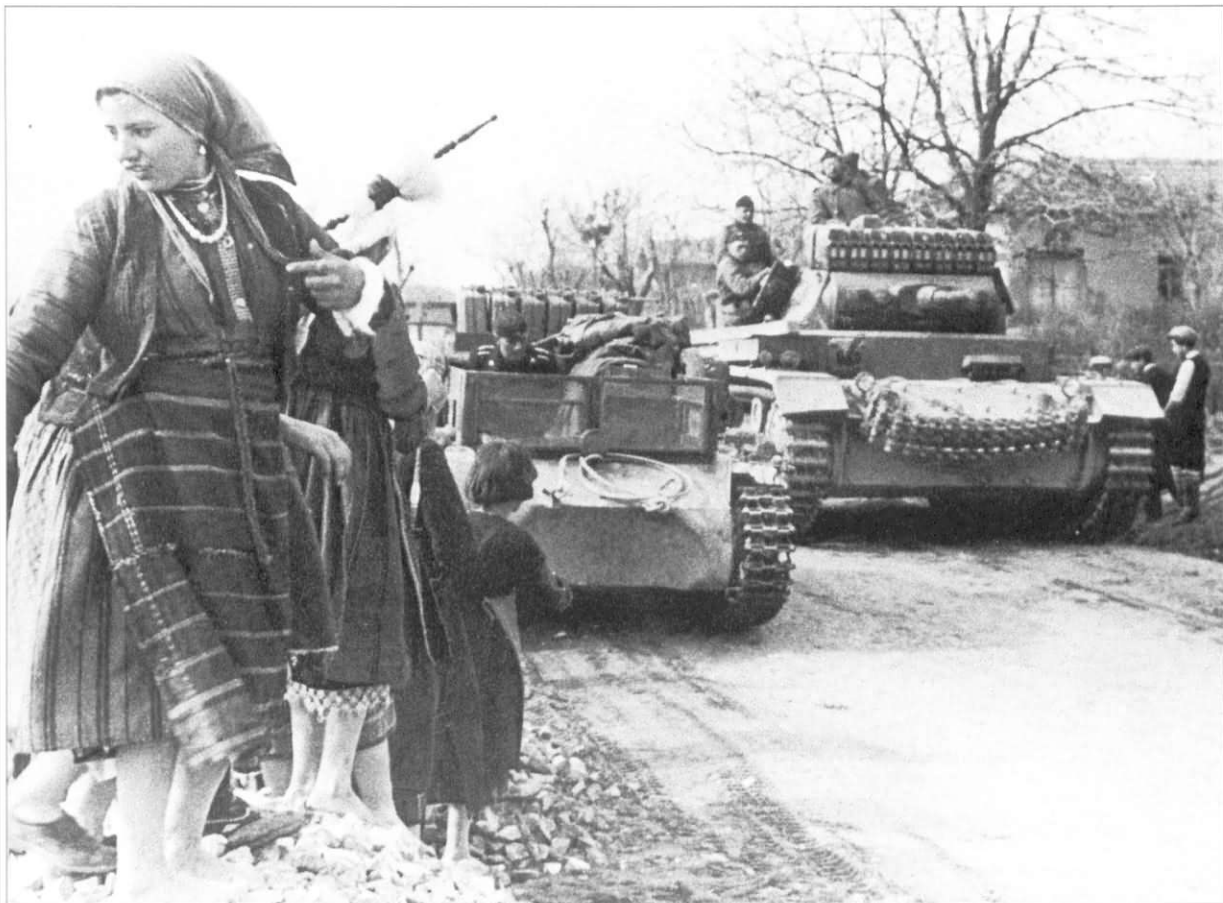
A Pz.Kpfw.III Ausf.G passing by another rare vehicle, an Instandsetzungskraftwagen I, an open, turretless Pz.Kpfw.I Ausf.B used as a repair and recovery vehicle. Unusually, this one features a glass windscreen. 164 of them were produced up to November 1938. They were used up to 1941 when they were found to be too small and after that served as training vehicles. The emblem of 9.Panzer-Division is just visible to the right of the driver's visor on the Pz.Kpfw.III. This photo was taken in Bulgaria in late March 1941.

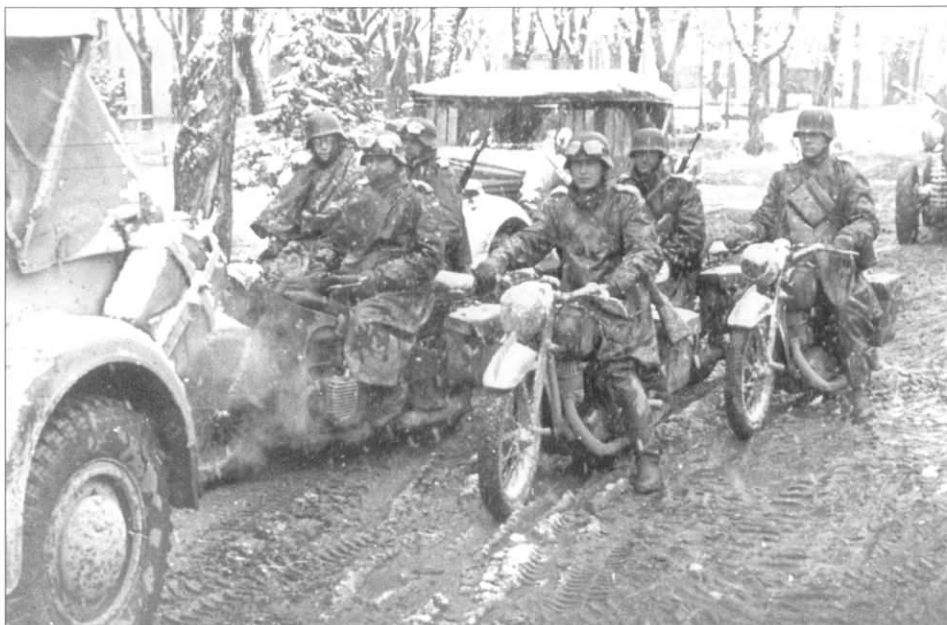
German motorcycle troops and light personnel cars make their way along a muddy, forest road in Bulgaria. The two motorcycles in front are NSU 601 OSL solo machines while the one behind is a BMW R12 combination. Of special interest though, is the Sd.Kfz.254 m.gep.Beob.Kw (Saurer RK-7) running on its wheels in the background.

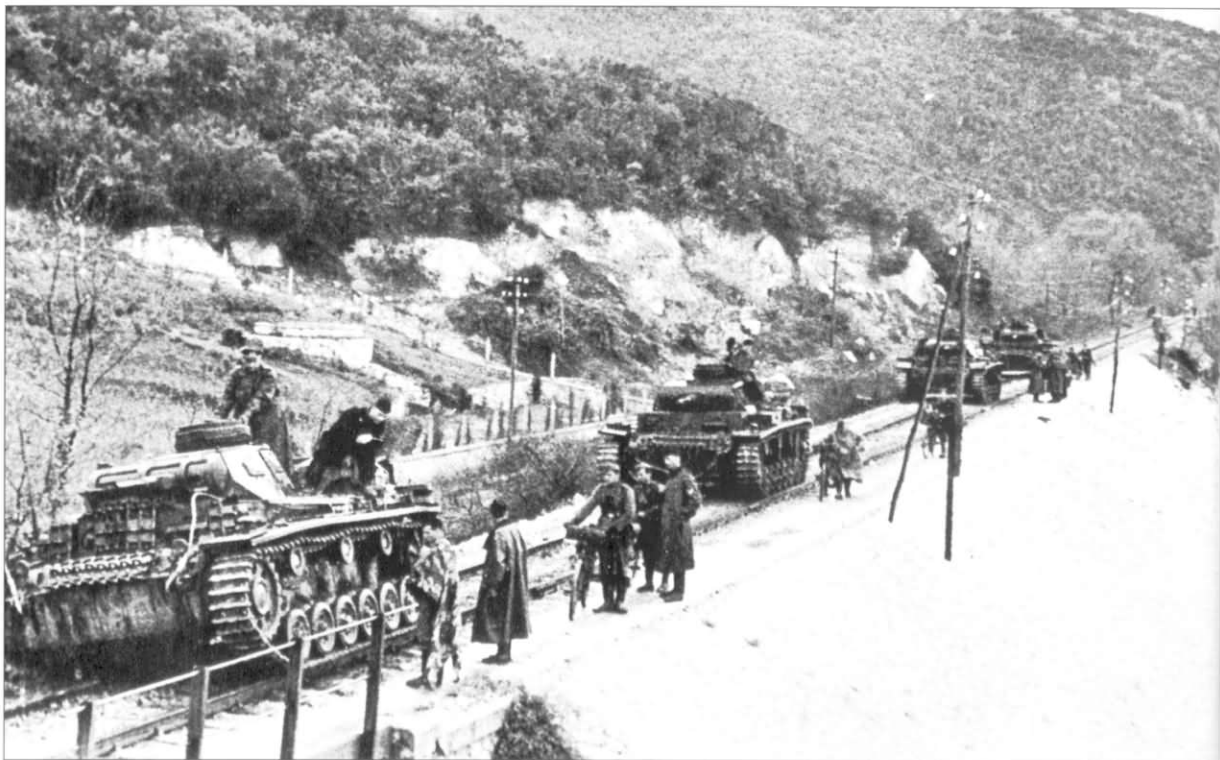
Traveling on railroads is not the most sensible thing to do for any type of vehicle, including tanks, because of the risk of damage to the tracks and suspension. Nevertheless, there are occasions when no other choice was available as with this column of Pz.Kpfw.III's near Larissa, Greece, in April 1941. On the left, a Pz.Bef.Wg.III Ausf.H seems to have climbed up onto the rail and is being carefully guided off with the assistance of the soldiers on the ground. It is followed by three Pz.Kpfw.III Ausf.G which appear to have been uparmored with the additional 30mm plates welded and bolted to the front.

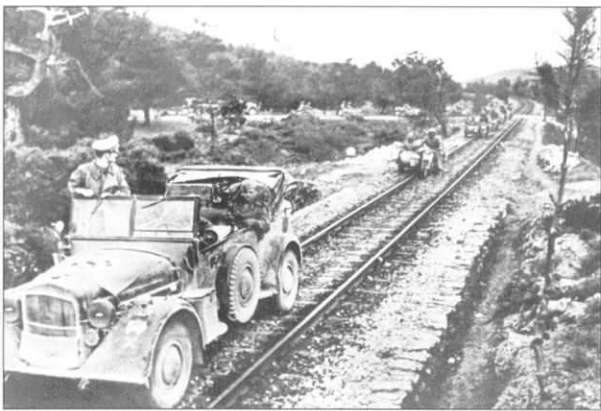
A Horch Kfz.15 leads a column of motorcycle combinations along a railroad in Greece, April 1941. The emblem of 5.Panzer-Division, an 'X', has been painted in yellow on the left mudguard and the tactical sign of a motorized reconnaissance company is painted in white above it. A German national flag has been tied across the engine compartment for aerial recognition.

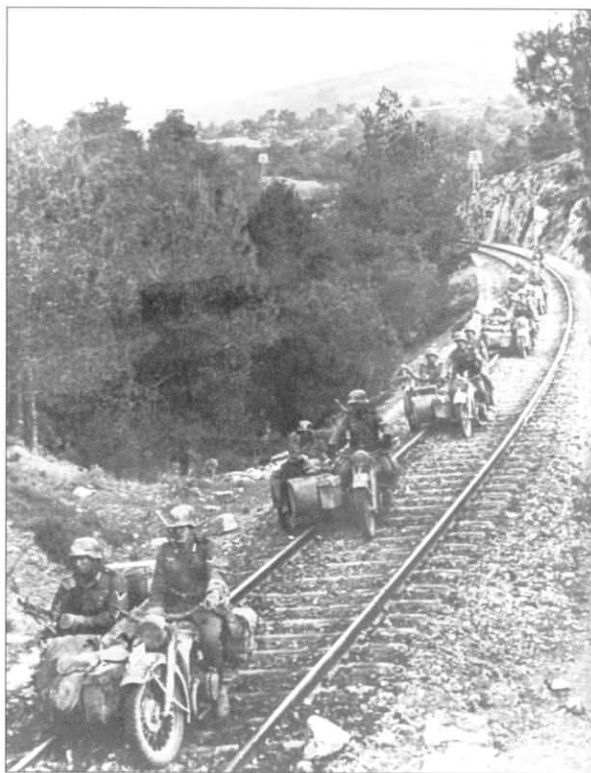
The same column moves slowly along the railroad. The first three machines are BMW R12s and the one on the left displays the 5.Panzer-Division emblem and the tactical sign for a motorized reconnaissance company on its mudguard.

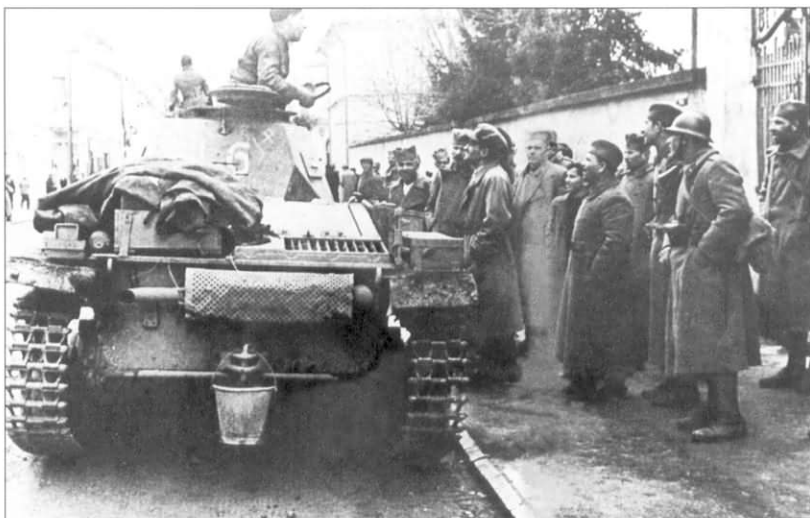
The driver of an Sd.Kfz.252 leichte Gepanzerter Munitionskraftwagen, light armored ammunition carrier, probably from StuG.Abt.184, writes a report or letter after the battle in Yugoslavia in April 1941. The Sturmgeschütz-Abteilungen first saw action in France in 1940, but the real battles were yet to come. This vehicle is finished in overall dark gray and is covered with a layer of dust. Part of the white outline national cross is visible just to the left of the vision flap.

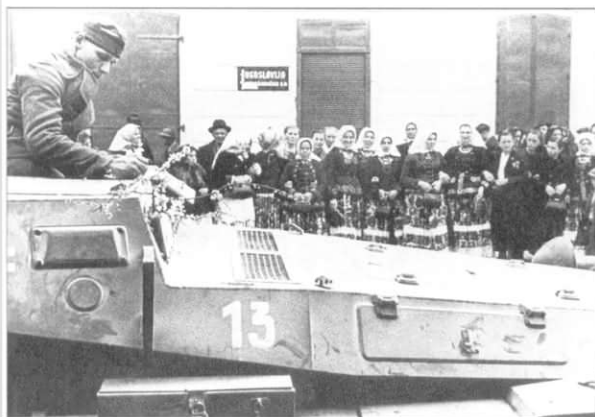
A StuG.III Ausf.B of StuG.Abt.184 parked in front of the Sd.Kfz.252 in the left photo. Clearly shown are some details not usually noticeable such as the hinge and lock detail on the inspection hatches and the bullet splash ridges lining the gun sight aperture. The white or yellow tactical sign for a self-propelled artillery unit is visible to the right. Three Heeres StuG.Abt. took part in the fighting in the Balkans in 1941. The other two, StuG.Abt.190 and 191 fought in Greece.

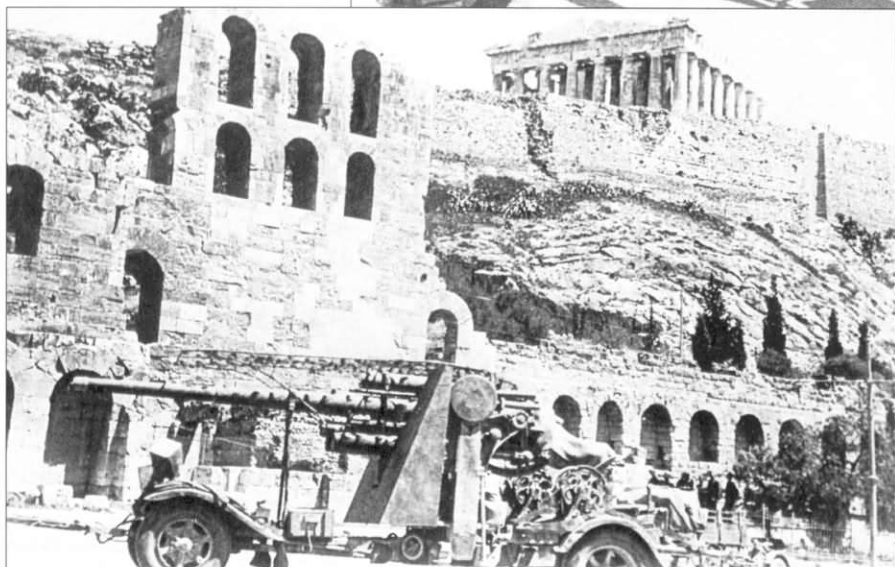
An 8.8cm Flak 18 stands before the ruins of the Acropolis, dominated by the Parthenon, in Athens after the Greek surrender in early May 1941. An elaborate frame supporting a camouflage net has been installed over the gun, the shadows from which create the impression of painted spots on the barrel. The gun is finished with overall dark gray which is lightened with a coating of dust.

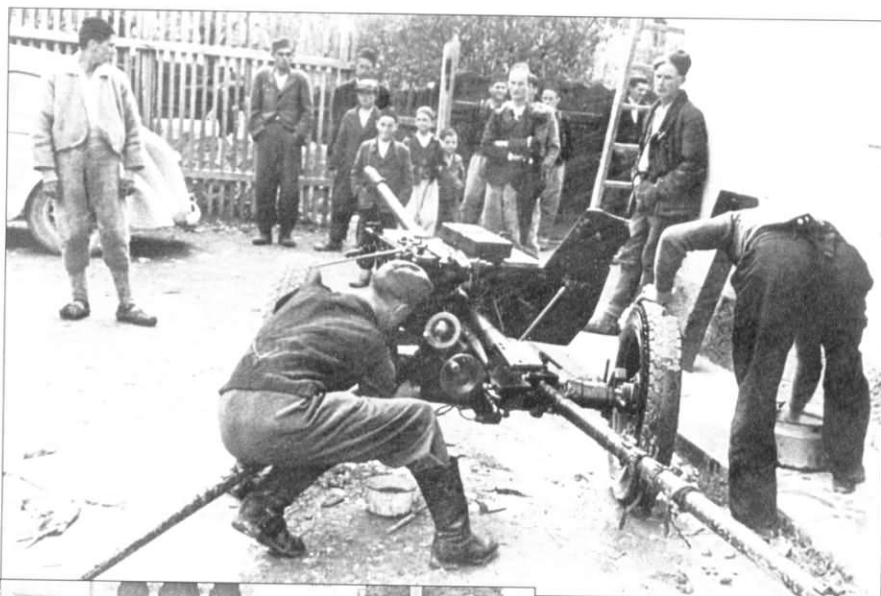
Curious onlookers watch as the crew of this 3.7cm PaK35/36 anti-tank gun wash off the accumulated dust and dirt from the short campaign. This photo illustrates how the hinged gun shield could be folded down.

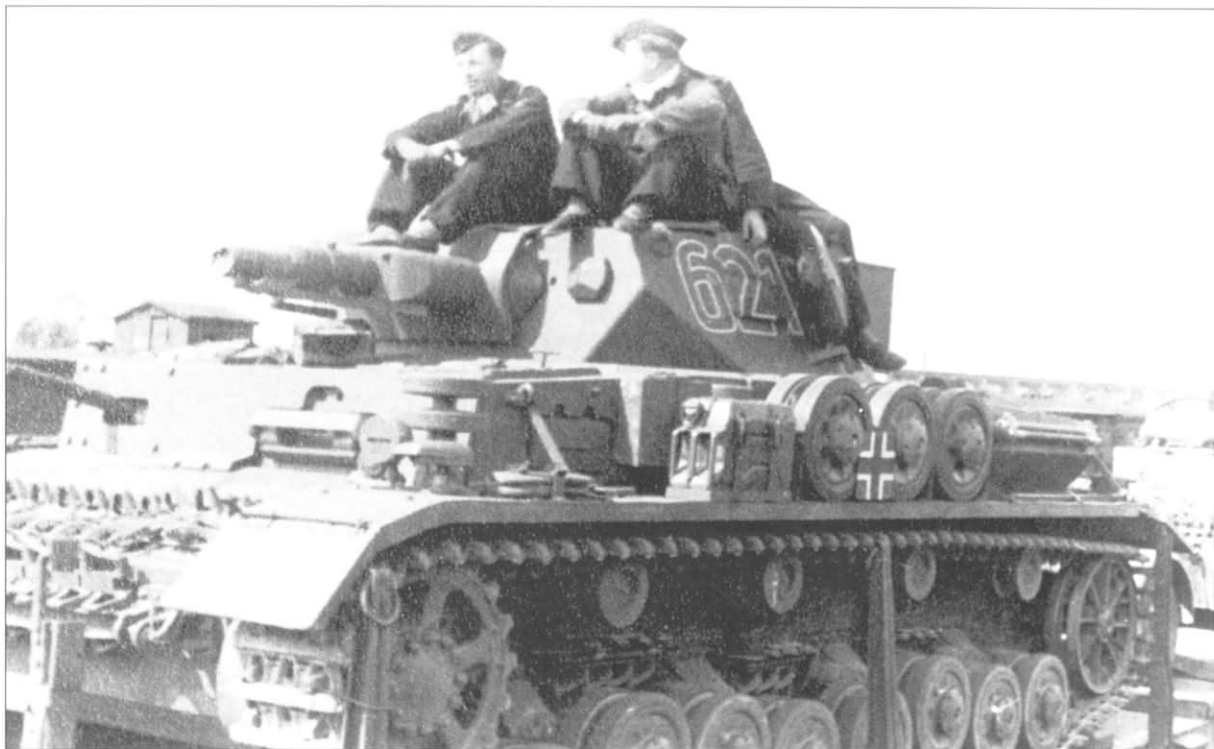
Crew members of this Pz.Kpfw.IV Ausf. E relax and enjoy the scenery while being transported by rail. The additional 30mm front plates and 20mm side plates were a common feature on the Ausf. E. The vehicle is well stowed with additional roadwheels and spare track links including extra links attached to the side of the hull above the roadwheels. Spare return rollers are even mounted near the front corner of the hull. Markings include a national cross painted on a small square plate attached to the mudguard in front of the spare roadwheels and a large tactical number '621' painted in white outline on the turret. A Pz.Kpfw.I is visible in the background on the following rail car.

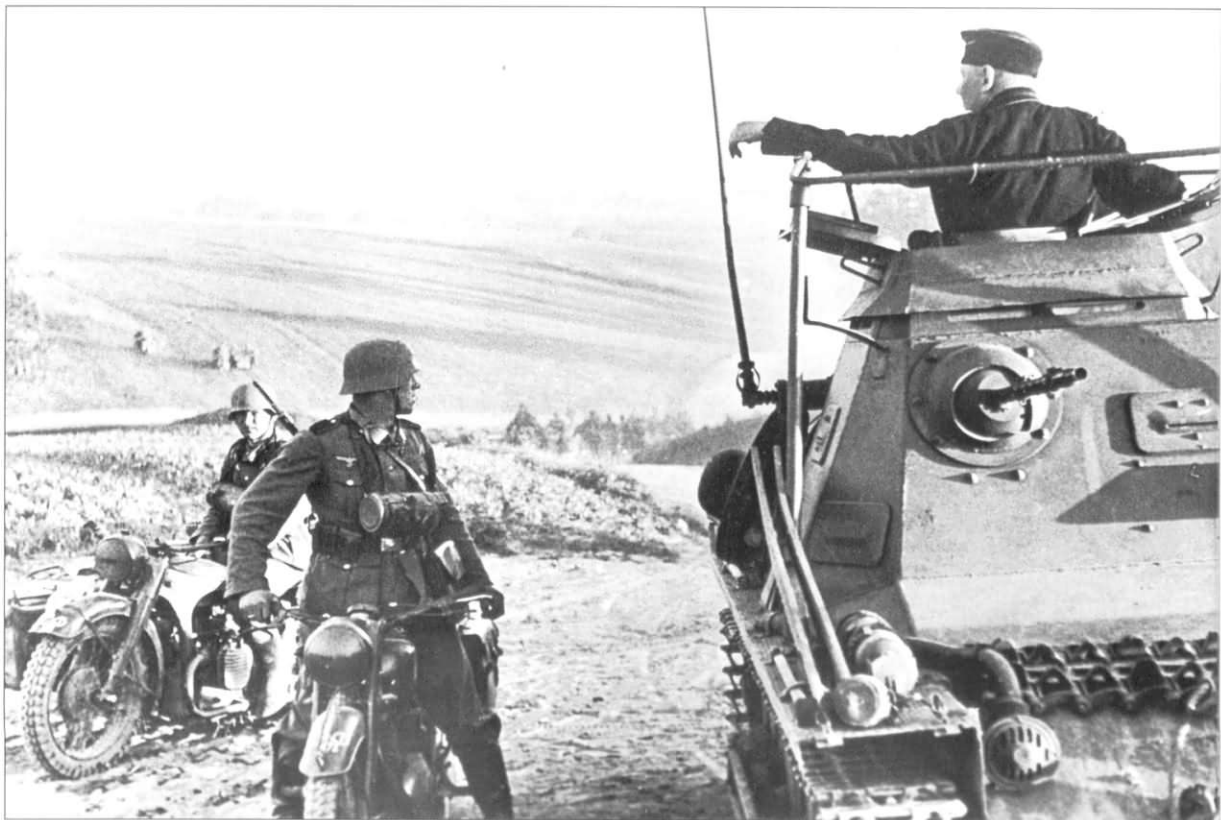
Motorcycle troops report to a battalion commander in his *Kfz.Bef.Wg.I*. These vehicles were equipped with a *FuG2* and *FuG6* long range radio for communications between battalion headquarters and subordinate units. Their thin armor protection was unsuitable for frontline duties and made their crews vulnerable to most enemy tank guns of the time. The motorcycle combination on the left is a *BMW R12* while the solo machine on the right is a *DKW NZ350*. They both carry the white tactical sign for a motorcycle company with the company number beside it, in this case a '3' on the *BMW* and a '2' on the *DKW*. Both also display the emblem for *11.Panzer-Division*.

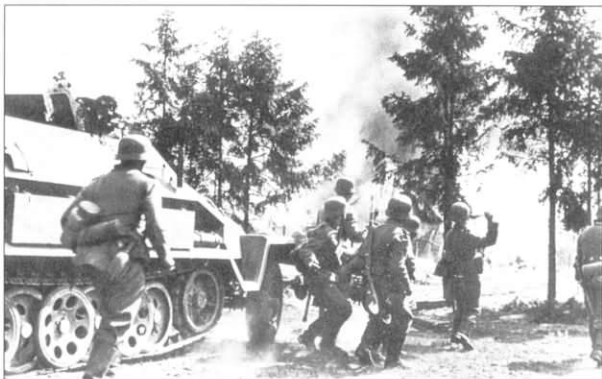
Motorized infantry attack a burning Russian village with stick hand grenades in the early days of Operation 'Barbarossa'. They have been transported into battle by their *Sd.Kfz.251/1 Ausf.B* armed with a single *MG34*, which has been back fitted with the armored shield, for support. There were no major differences in the construction of the *Ausf.A* to *Ausf.C*, most changes being minor simplifications in the front end.

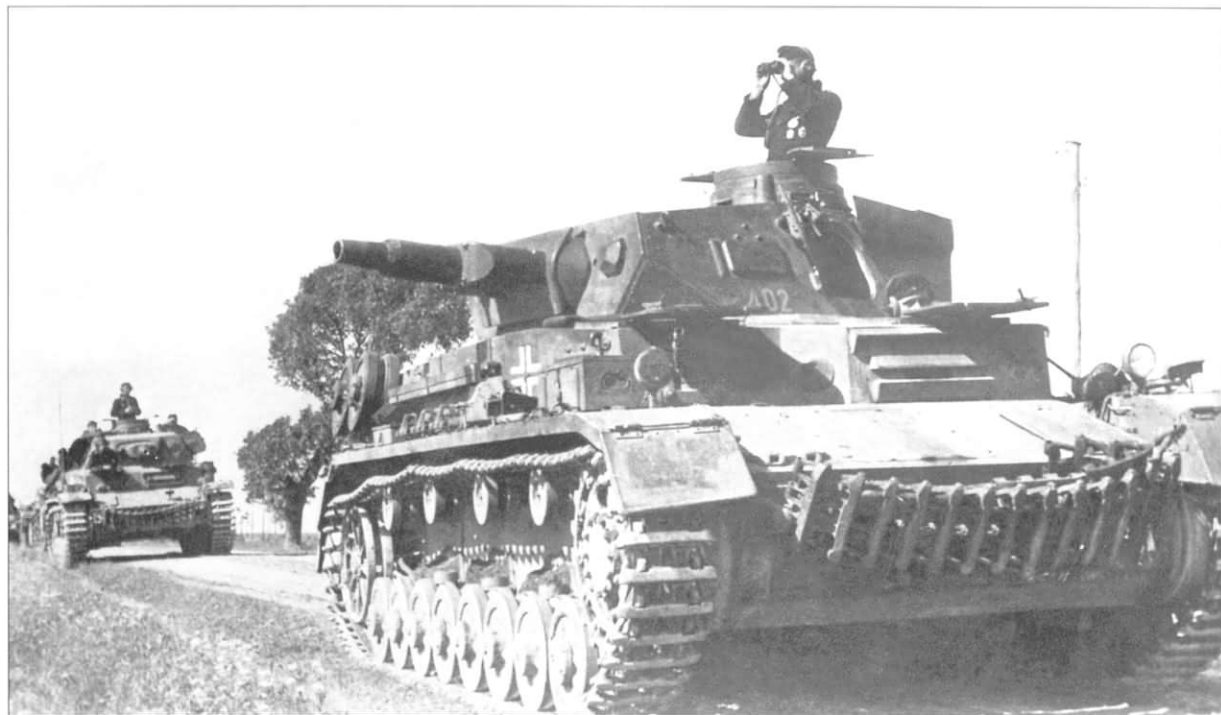
A column of tanks led by a Pz.Kpfw.IV Ausf.D marching across northern Russia in 1941. The tank belongs to 6.Panzer-Division and was assigned to 4th company staff, which was issued with two such vehicles. The tactical number, '402', seen on the side of the turret under the vision flap, was painted in yellow, as was the divisional emblem, 'XX', visible next to the driver's visor. The front roadwheel and one of the spares mounted on the side of the hull are fitted with the later production hub introduced on the Pz.Kpfw.IV Ausf.E.

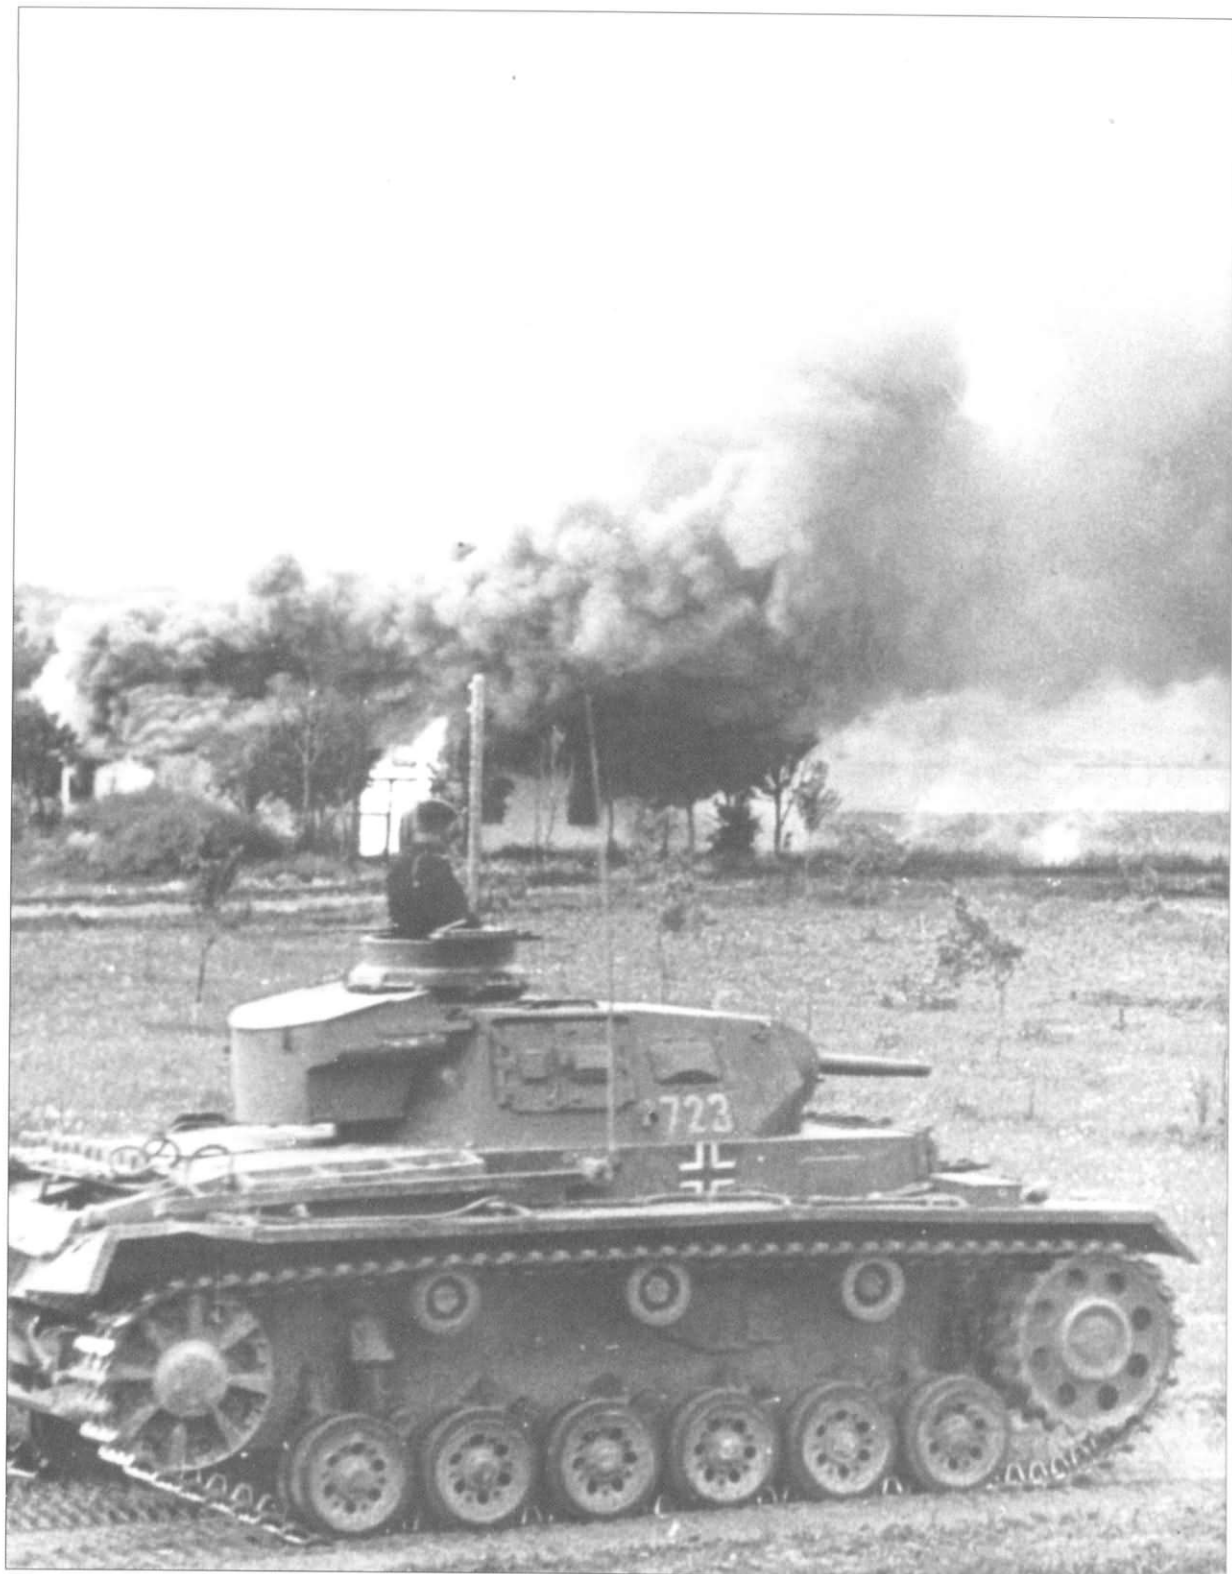
A Pz.Kpfw.III Ausf.E passes the same farmhouse. The tactical number '723', painted in yellow, is plainly visible on the side of the turret, as is the black and white national cross on the side of the hull. Turret stowage bins were introduced on the Ausf.G but were fitted to many early vehicles in the field workshops.

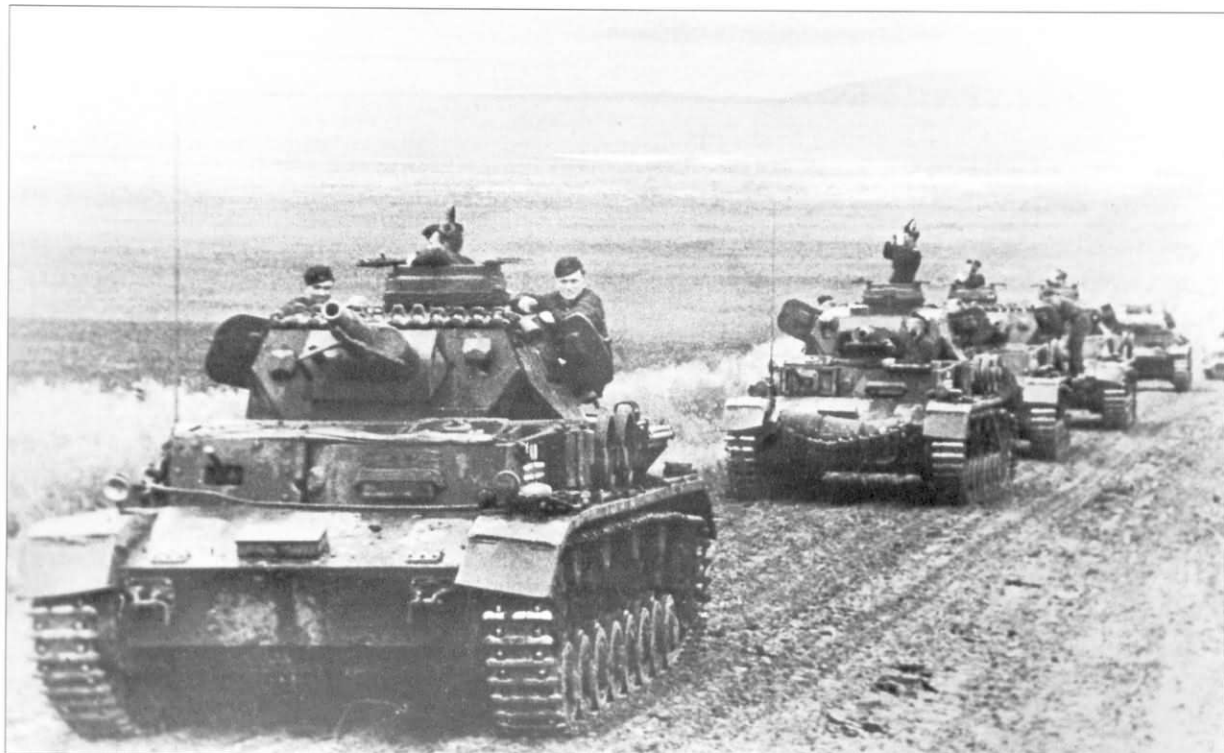
A column of tanks and softskin vehicles led by a platoon of Pz.Kpfw.IV Ausf.E carrying the emblem of 9.Panzer-Division beside the driver's visor. At the time, the Pz.Kpfw.IV was the heaviest tank in the German arsenal. Compare these vehicles to the photo of the ones crossing the Danube into Bulgaria seen earlier in this book. Unusually, the spare roadwheels carried on the first vehicle are two single wheels and not pairs. Also, the second vehicle in line does not have the additional 30mm armor plate installed on the front of the hull although the mounting brackets for it have been.

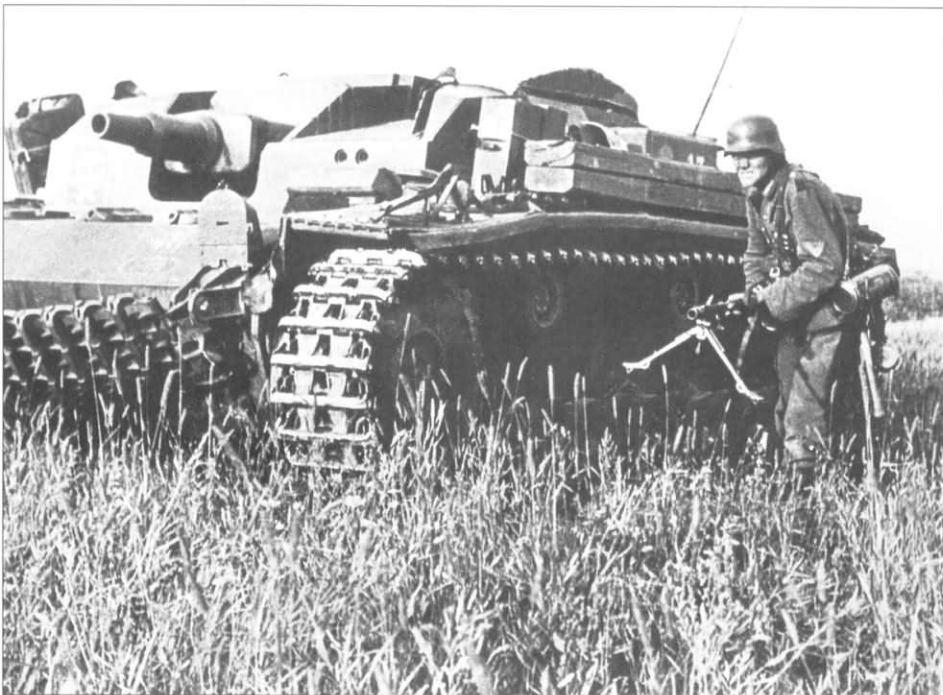
Experiences during Operation 'Barbarossa' proved the importance of Sturmartillerie on the modern battlefield. Similar to the Tiger battalions, most Sturmgeschütz were organized into independent Sturmgeschütz-Abteilung and Brigades. This one, with the tactical number '13', is a StuG.III Ausf.B from StuG.Abt.192 which carried a very prominent unit emblem on its vehicles. The emblems were painted red for the first battery, yellow for the second and green for the third. The platoons in each battery were numbered the same so it is almost impossible to determine the battery a vehicle belonged to by its number. The exceptions are the battery commander's vehicles which carried a single digit number. The tactical sign for self-propelled artillery is painted in yellow on the glacis with the battery and Abteilung numbers. '1/192', inside.
