PANZER-DIVISION 1935-1945

(1) The Early Years 1935-1941

Robert Michulec

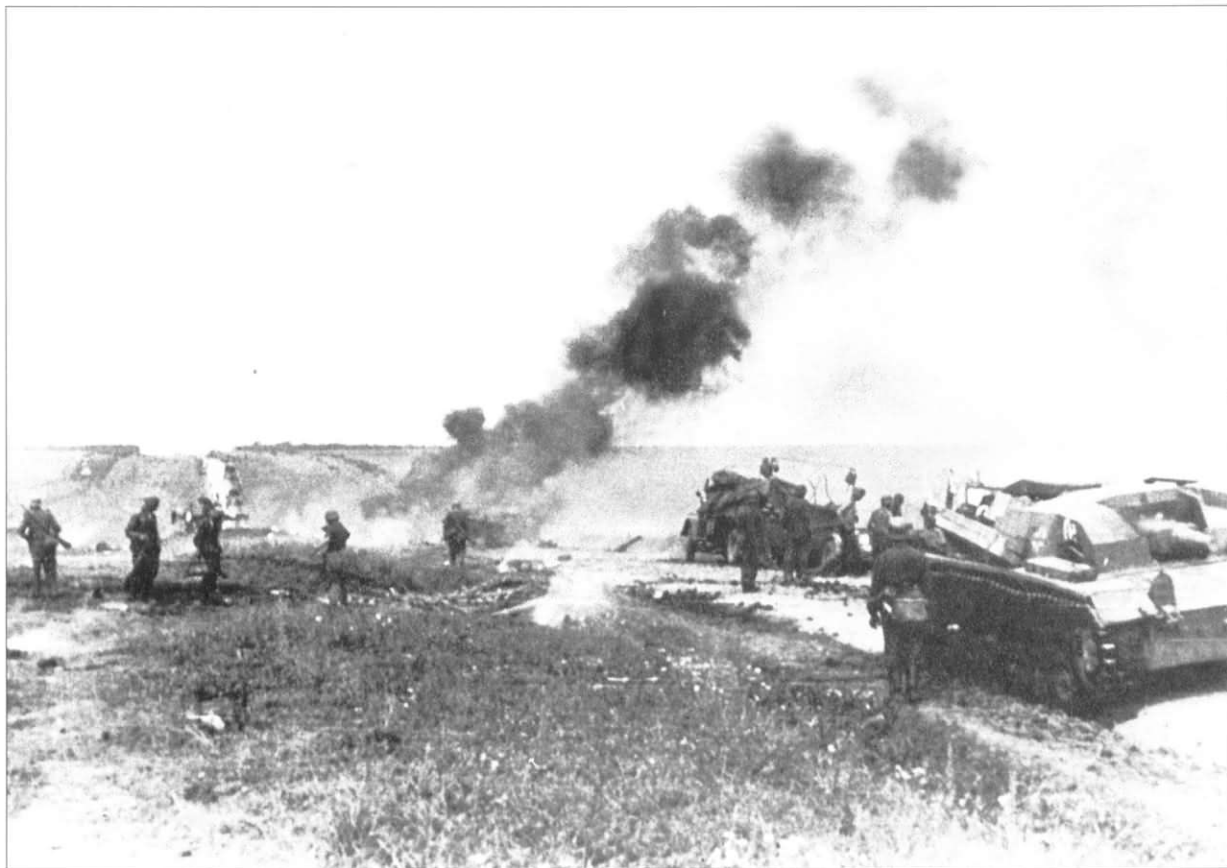
This photo of a German column was taken just after a Soviet artillery barrage, which has destroyed one of the vehicles. The StuG.III Ausf.B on the right carries an unidentified marking on the side of the superstructure just in front of the national cross.

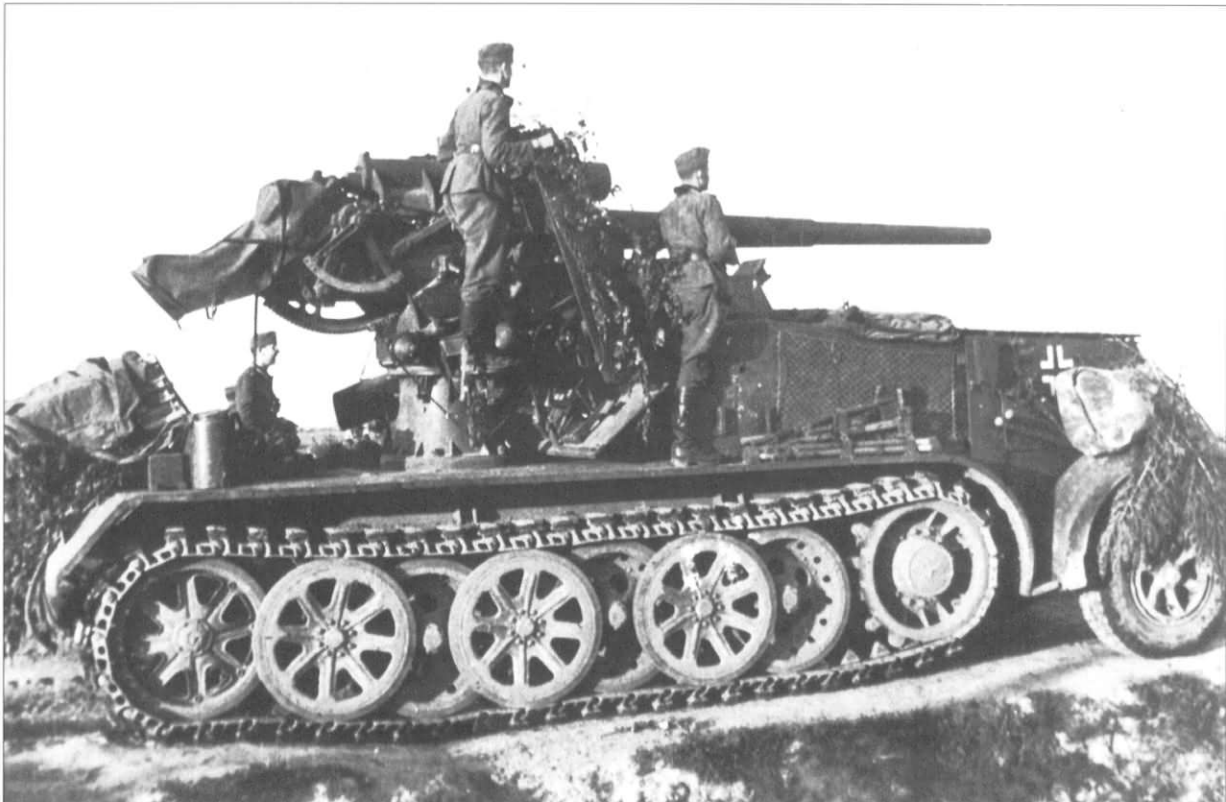
The 8.8cm FlaK18(Sfl) auf Zugkraftwagen 12t (Sd.Kfz.8) was used mainly as a heavy anti-tank vehicle in Poland and France. Only 25 were produced in 1939 and 1940 and they were issued to s.Pz.Jg.Abt.8. Subsequent versions were built on the 18t FAMO and were also intended for use in an anti-aircraft role.

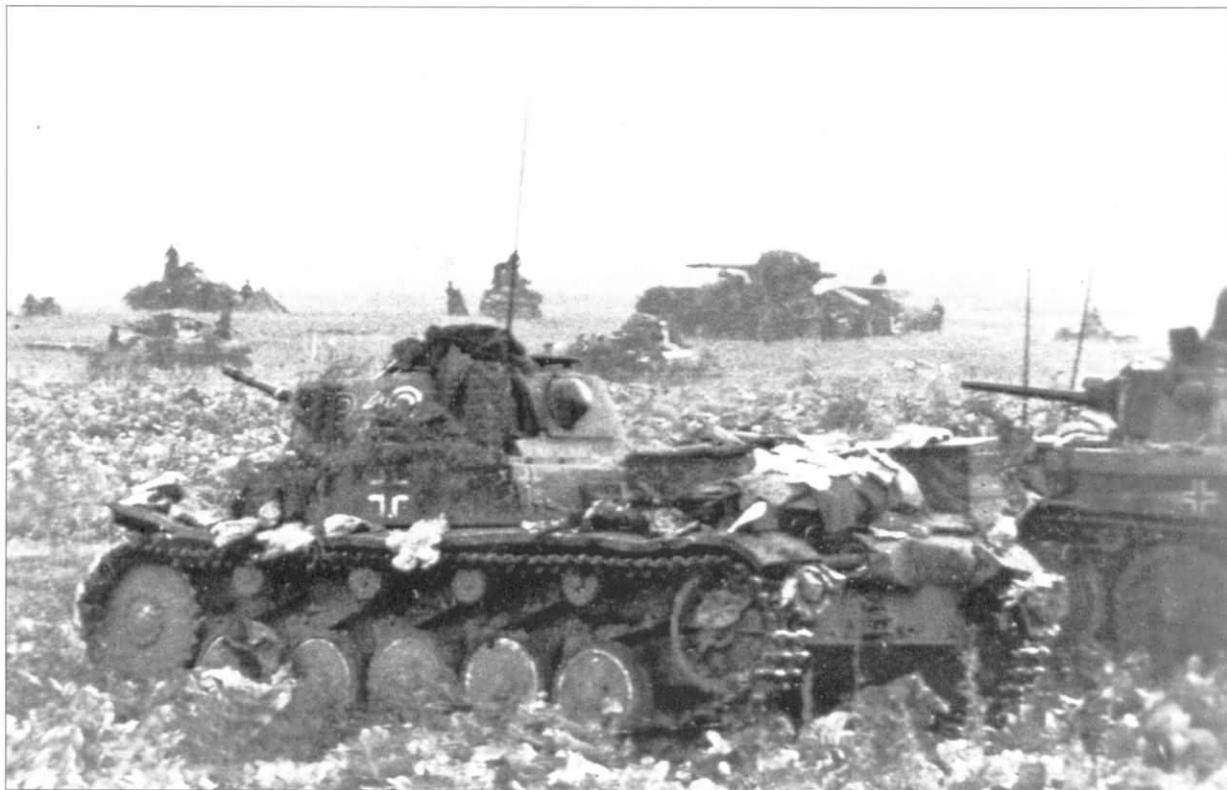
Regimental staff vehicles of a Panzer-Division halt in a field in Russia in late summer, 1941. Visible in the background are two 8.8cm FlaK18(SII) auf Zgw 12t (Sd.Kfz.8) and several other vehicles that have made some attempt at camouflaging themselves in the open ground. The Pz.Kpfw.II Ausf.A-C in the foreground has the tactical number 'R12' painted on the turret, possibly red with a white outline, while only the first letter of the tactical number can be seen on the Pz.Kpfw.38(t) behind it.

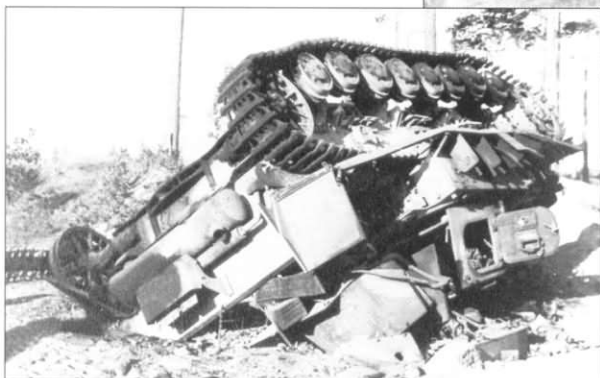
This Pz.Kpfw.IV Ausf.E has been completely demolished and burned out as a result of a Soviet bombing attack. During the summer battles in the Soviet Union, the Panzer-Divisions lost 125 Pz.Kpfw.IV while only receiving 10 replacements.

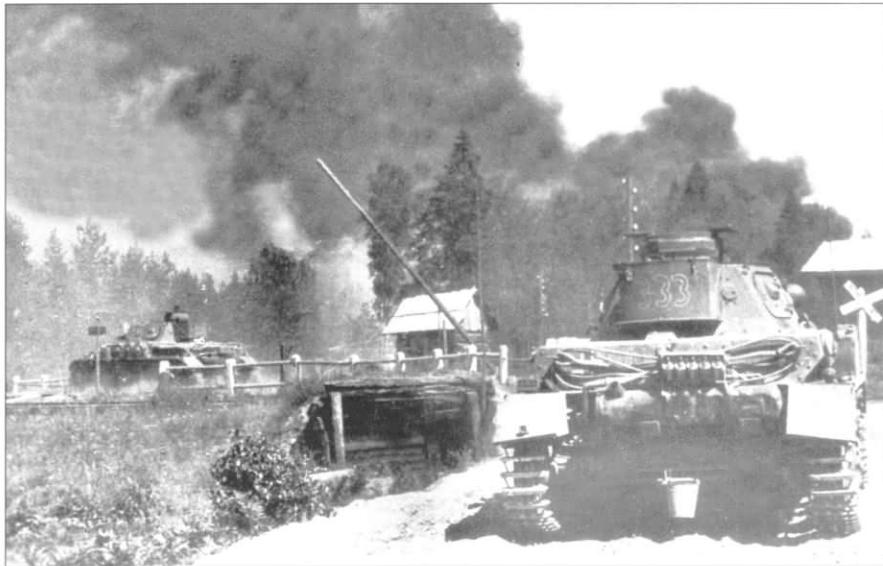
A pair of Pz.Kpfw.IV Ausf.E from the same Panzer-Division as those in page 69 cross a railway line somewhere in the Soviet Union. The tactical number '333' indicates this vehicle is the third vehicle of the third platoon in the third company.

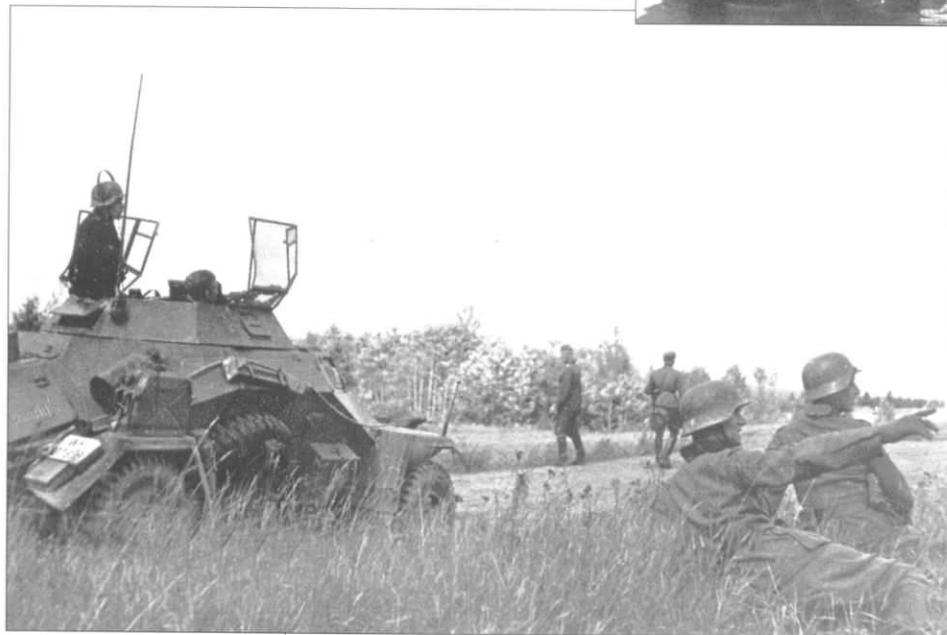
A late model Sd.Kfz.222 armored car waits at the side of the road while two officers reconnoiter the road ahead on foot. Compared to the above photo, this vehicle carries little in the way of additional equipment and displays no national markings. It does, however, have the name 'Danzig', probably in black with a white shadow, painted on the engine access hatch.

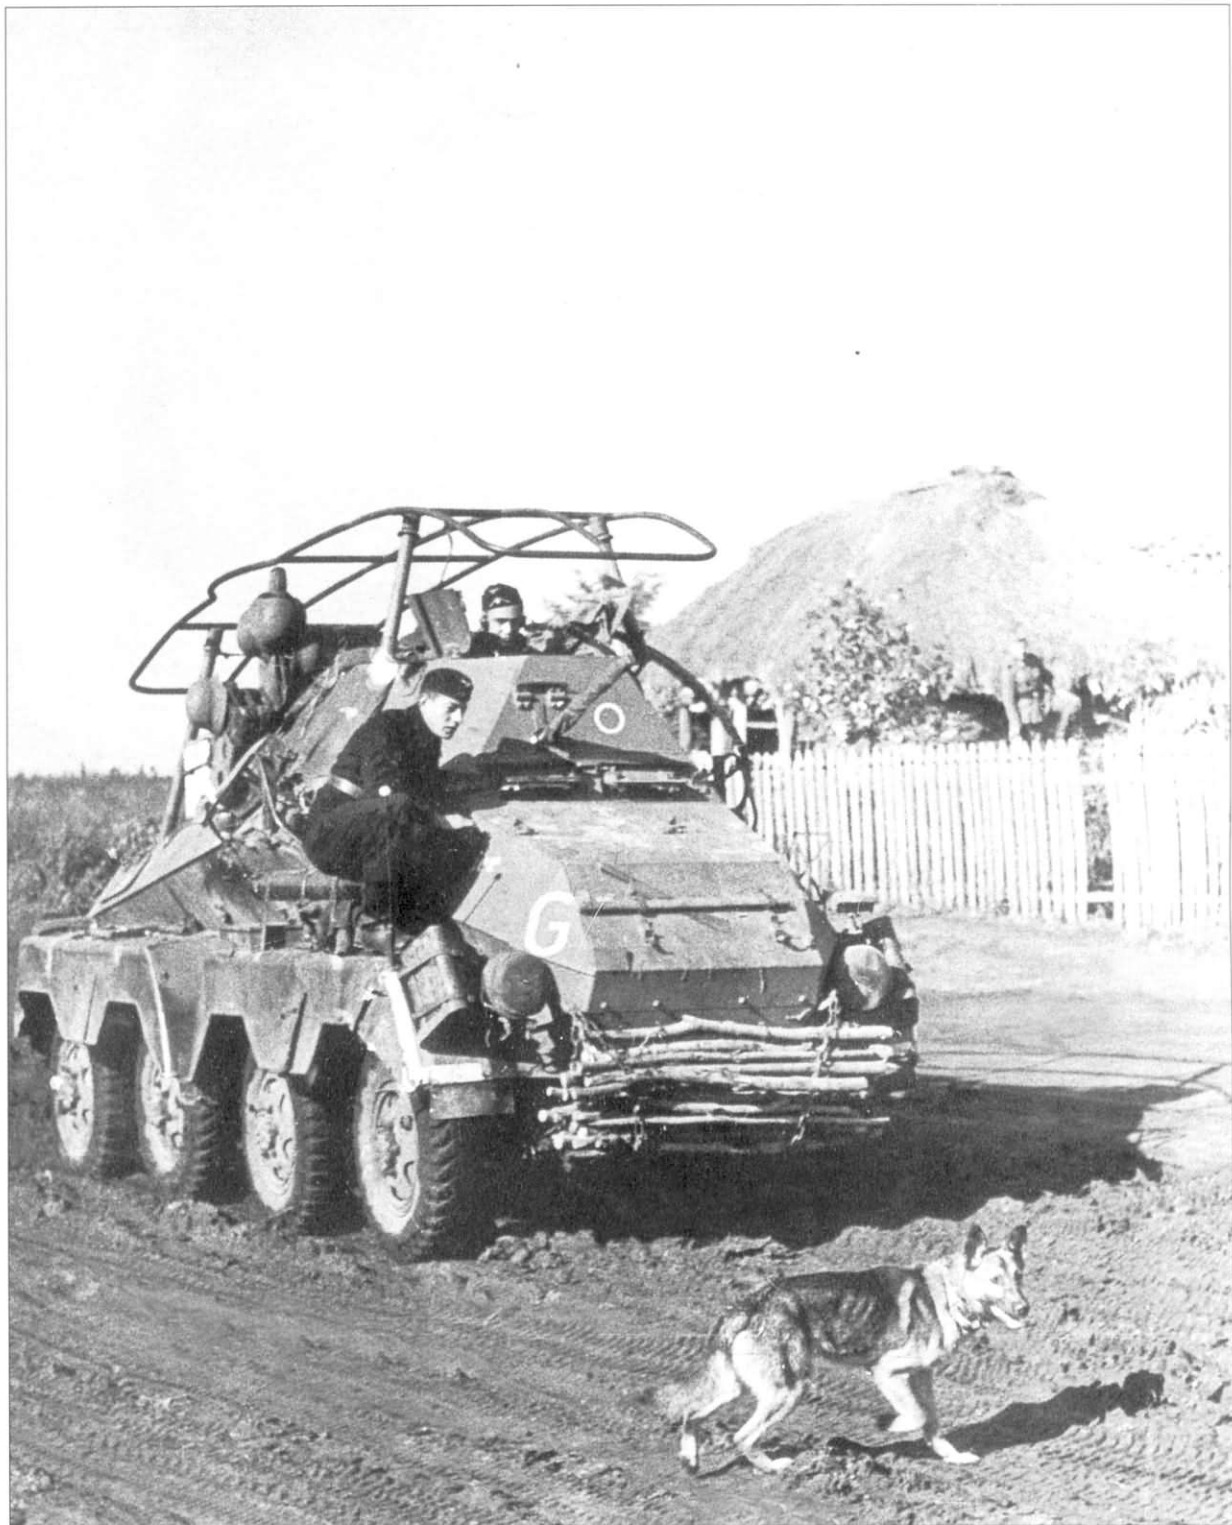
A heavily laden Panzerfunkwagen (Sd.Kfz.263) 8-Rad of an unidentified unit, patrols a village in early autumn, 1941. The crew warily eye the dog on the road as the Soviets were known to train dogs with explosives strapped to their backs to run under armored vehicles. A simple lever switch on top would then detonate the device. The letter 'G' painted in white on the front indicates the vehicle belongs to one of the Panzer-Divisions in Panzer-Gruppe Guderian. White road width markings are painted on the corners of the mudguards and part of a name can be seen behind the knee of the crewman outside the vehicle. The meaning of the white circle is unknown.
