Panzerkampfwagen III

Medium Tank 1936-44

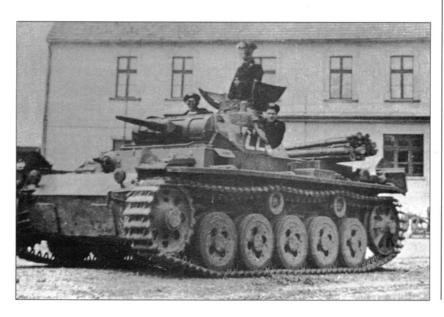
PzKpfw III Ausf. A photographed in Poland, 1939. The Ausf. A – D were fitted with a circular hull machine gun mounting. Note yellow turret cross; see Plate A1 and commentary. (Bundesarchiv)

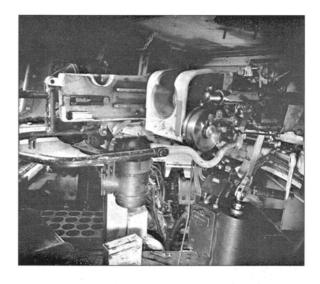
Balancing the L/60 gun of the later Ausf. J posed a more serious problem, which was sometimes solved by a compression spring mounted in a cylinder and attached to the gun. This can be seen on the right of the picture, and in the foreground to the right of it is the supplementary traverse handle fitted to some vehicles; this enabled the loader to assist the gunner, to whose controls it was linked under the gun. (Imperial War Museum)

longer L/60 model was fitted, and to compensate for this a small compression spring in a cylinder was mounted on the forward offside corner of the turret ring and attached to the gun. This arrangement was found on the Ausf. J, but on later Marks a torsion bar was bolted across the turret roof and connected to the upper part of the gun mounting. On later Marks, too, the recoil shield arms were 4½in. longer, providing additional compensation but reducing clearance to the turret ring to 17½in.

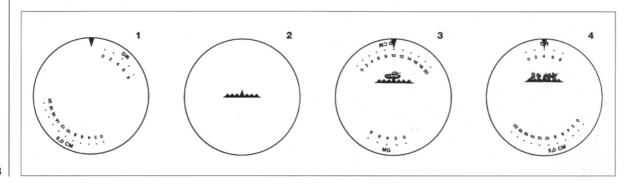
The 'sight picture' of a PzKpfw III with 50mm gun: (1) Range plate (2) Sighting plate (3) Main armament engaging hard target at I,000m (4) Co-axial MG engaging infantry at 400m.

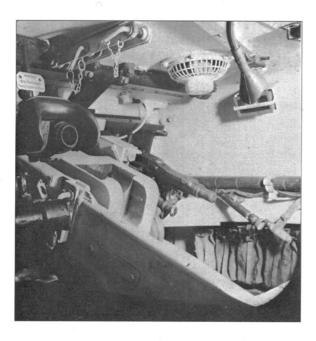
Gunner's view of the turret of an L/60-armed Ausf. J. Note commander's voice-tube, and immediately below it a case for spare MG barrels stowed on the turret ring. (Martin Windrow)

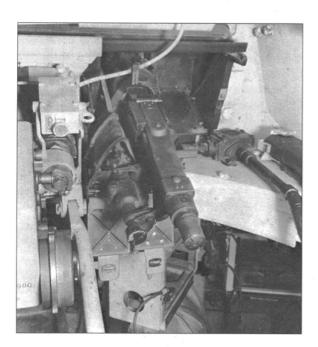
Looking forward from the loader's position in the same turret; note details of co-axial MG mounting. (Martin Windrow)

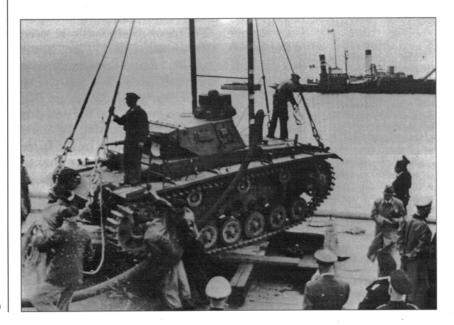
The Tauchpanzer, or Diving Tank, seen here during trials for Operation 'Sea Lion'. Vehicles of this type were used successfully in the crossing of the River Bug during the initial stages of 'Barbarossa' in June 1941. (Bundesarchiv)

The intention was for the tanks to launch themselves from lighters and then motor ashore along the seabed, direction being maintained by instructions passed through a radio link from the parent vessel. The design was, on the whole, successful and found a practical application at the crossing of the River Bug during Operation 'Barbarossa'. The crews were drawn from volunteer battalions, which were later formed into the 18th Panzer Regiment.

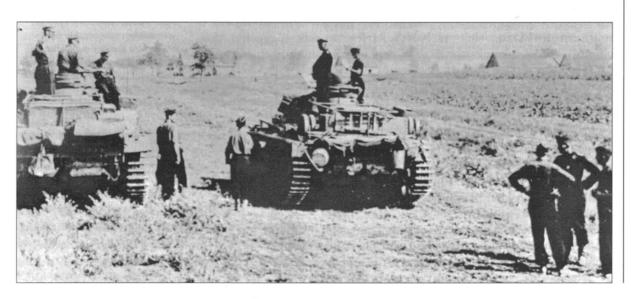
The German Army relied on verbal orders to a greater extent than other armies, thus accelerating the command process considerably. Here two Panzerbefehlswagen III have met for an orders group in Russia; while senior officers confer with maps, lesser mortals such as drivers remove themselves to a respectful distance. (Bundesarchiv)

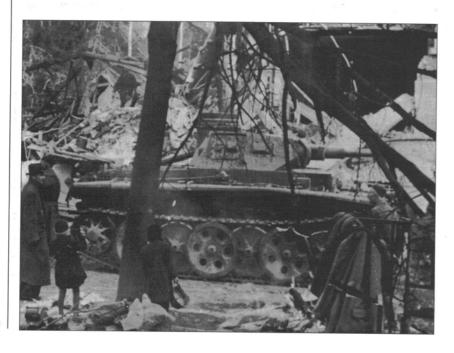
A well-camouflaged Panzerbeobachtungswagen III (armoured observation vehicle), used by the Panzer division's artillery forward observation officers to control the fire of their guns. The vehicle is identified by its dummy gun offset to the right. Armament consisted of a ball-mounted machine gun in the centre of the mantlet. (RAC Tank Museum)

Until 1943 Panzerartillerie Forward Observation Officers performed their duties from a light half-track which, because of its vulnerability, was not entirely suitable for the task. However, in that year numbers of PzKpfw III gun tanks were specially converted for the role, their title being **Panzerbeobachtungswagen** ('armoured observation vehicle') **III**. In this version the main armament was stripped out and replaced by a single ball-mounted machine gun in the centre of the mantlet, a dummy gun being installed to its right. The interior contained an artillery board and duplicate radios, one netted to the main operational frequency, the other providing a rear link to the guns. The crew consisted of the FOO, his technical assistant, two radio operators and the driver, all of whom would have been artillery personnel.

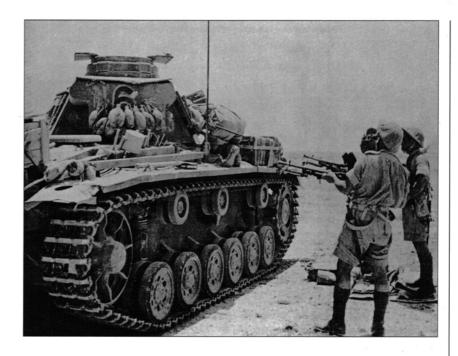
A posed photograph of British infantry inspecting a broken-down PzKpfw III in the desert. To the right of the single turret number, the palm tree insignia of the DAK can just be made out, above a cluster of water canteens. This obviously experienced crew had acquired all kinds of useful impedimenta: but far more serviceable for water stowage would have been British-style chagals, the canvas bags which kept water cool by evaporation. (Imperial War Museum)

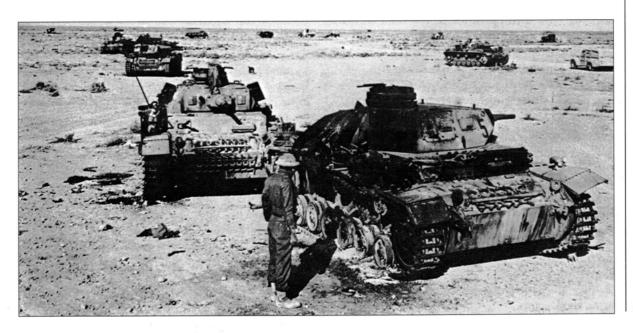
Another view of the desert strewn with brewed-up armour during the 'Crusader' battles: the PzKpfw III on the left bears the 15.Panzer-Division sign in red and the DAK palm in white to the right of the driver's visor. (Martin Windrow)

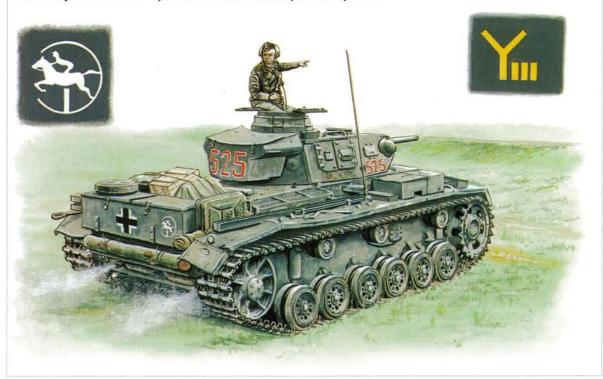
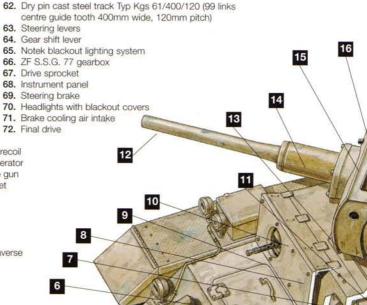
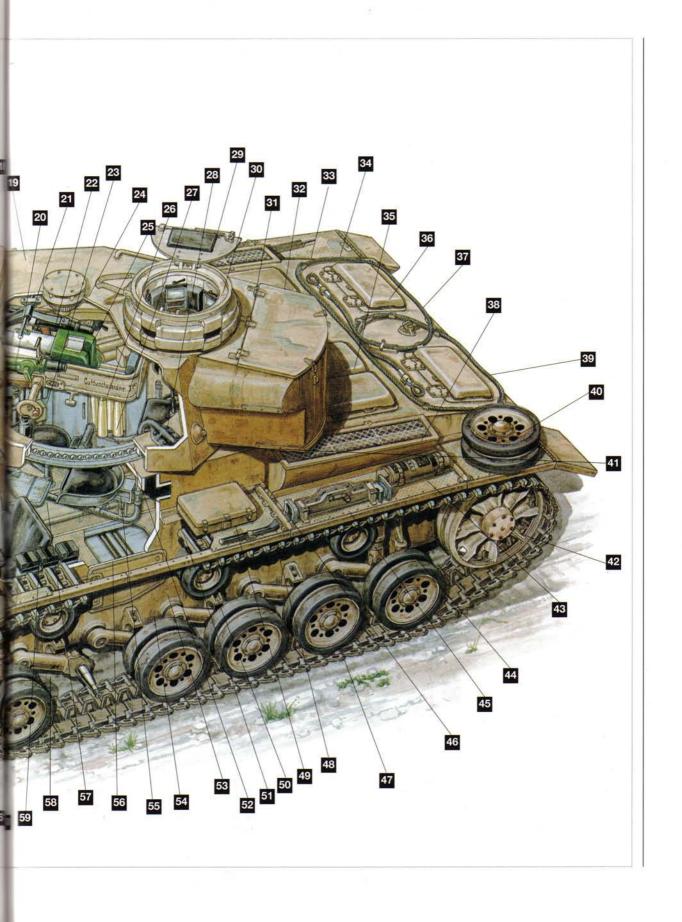
PANZERKAMPFWAGEN III **AUSF. J**

D: CUTAWAY OF PZKPFW III AUSF. J, See the cutaway key for details

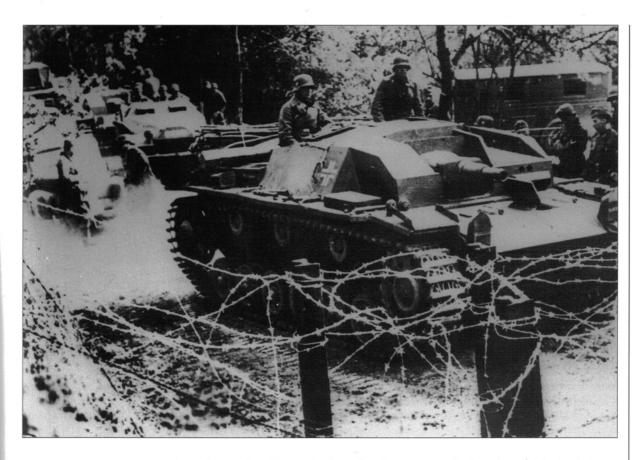
The PzKpfw III's most famous derivative, the Sturmgeschütz (assault gun). This early example, armed with a L/24 75mm howitzer, was one of only four batteries employed during the 1940 campaign in France. (RAC Tank Museum)

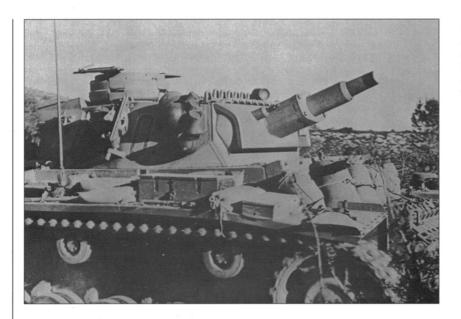
Close-up of an Ausf. N. The colour scheme appears to be the darker yellow used on some German tanks in the last stages of the African fighting. (Martin Windrow)

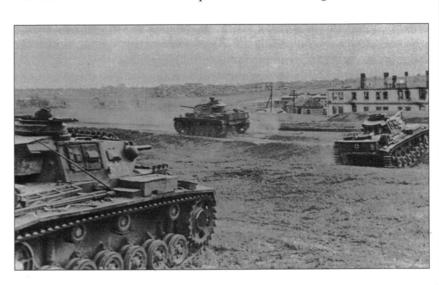
Nice study of PzKpfw III Ausf. Js of 24.Panzer-Division moving into a forward zone during the 1942 Russian campaign. This formation favoured large rear stowage boxes, on which were marked the divisional sign, commemorating its origins in the old 1.Kavallerie-Division – see Plate C. 24.Panzer-Division was lost at Stalingrad, but reformed several months later. (Bundesarchiv)

C2: PZKPFW III AUSF. J, 24.Panzer-division, Russia, 1942

In common with many tanks of this division photographed in Russia, this L/60 Ausf. J has a large stowage bin fixed across the rear of the engine deck, and on this can be seen the black and white national cross and the division's distinctive sign. A log has been lashed below the bin, doubtless as an unditching beam. The turret number '525' in red, outlined white, identifies the 2nd Zug, 5th Company. The origins of this formation, raised from the old 1.Kavallerie-Division, are recalled in the yellow uniform piping which contrasted with the rose-coloured Waffenfarbe of the rest of the Army tank units.

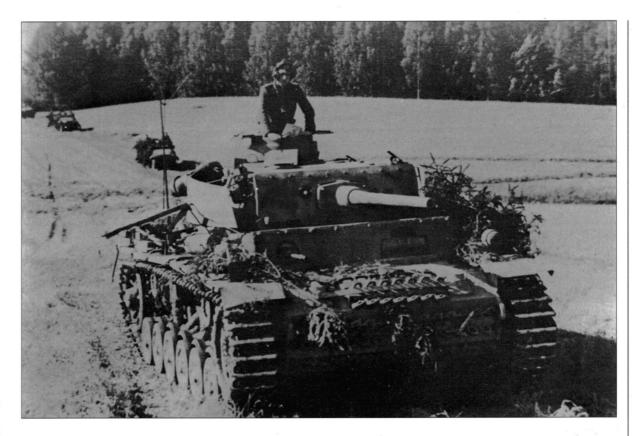
Later versions of the Panzerbefehlswagen III dispensed with the frame aerial and employed a branched antenna instead, as carried by this example working with a Panzergrenadier unit. (Bundesarchiv) and from the Arctic to the North African desert. This achievement has, perhaps, been overshadowed in recent years by the study of later and more dramatic German designs, but the fact remains that it was the PzKpfw III that brought Hitler closest to achieving his wildest dreams.
