# Panzers in the Gunsights

German AFVs in the ETO 1944-45 in US Army Photos

Steven J. Zaloga

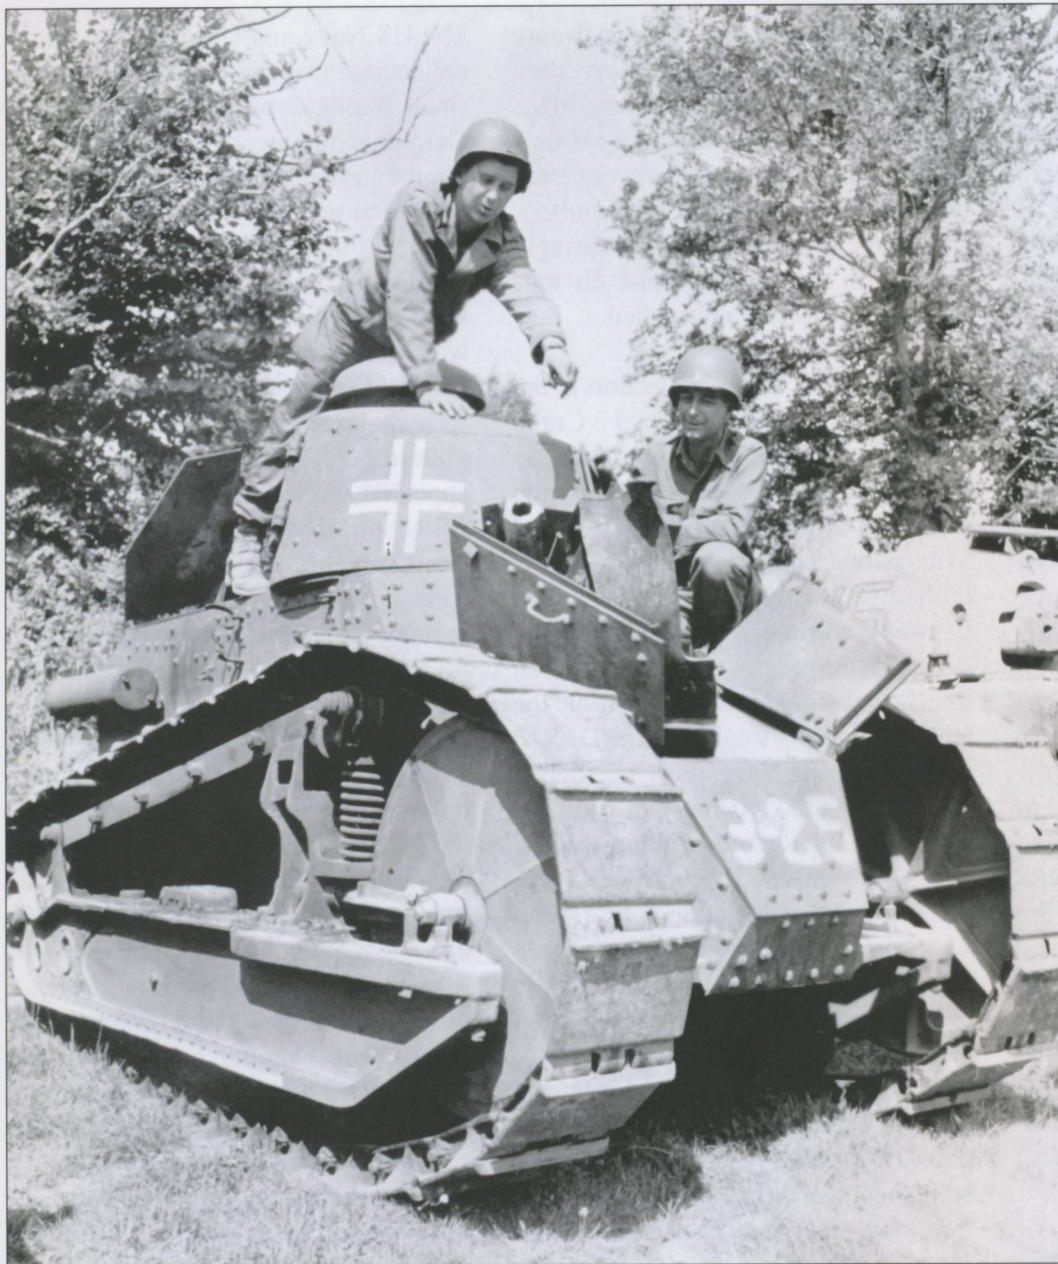
Obsolete French tanks like this Renault FT were used by German occupation units in France. This example was photographed in Normandy on 7 August 1944.

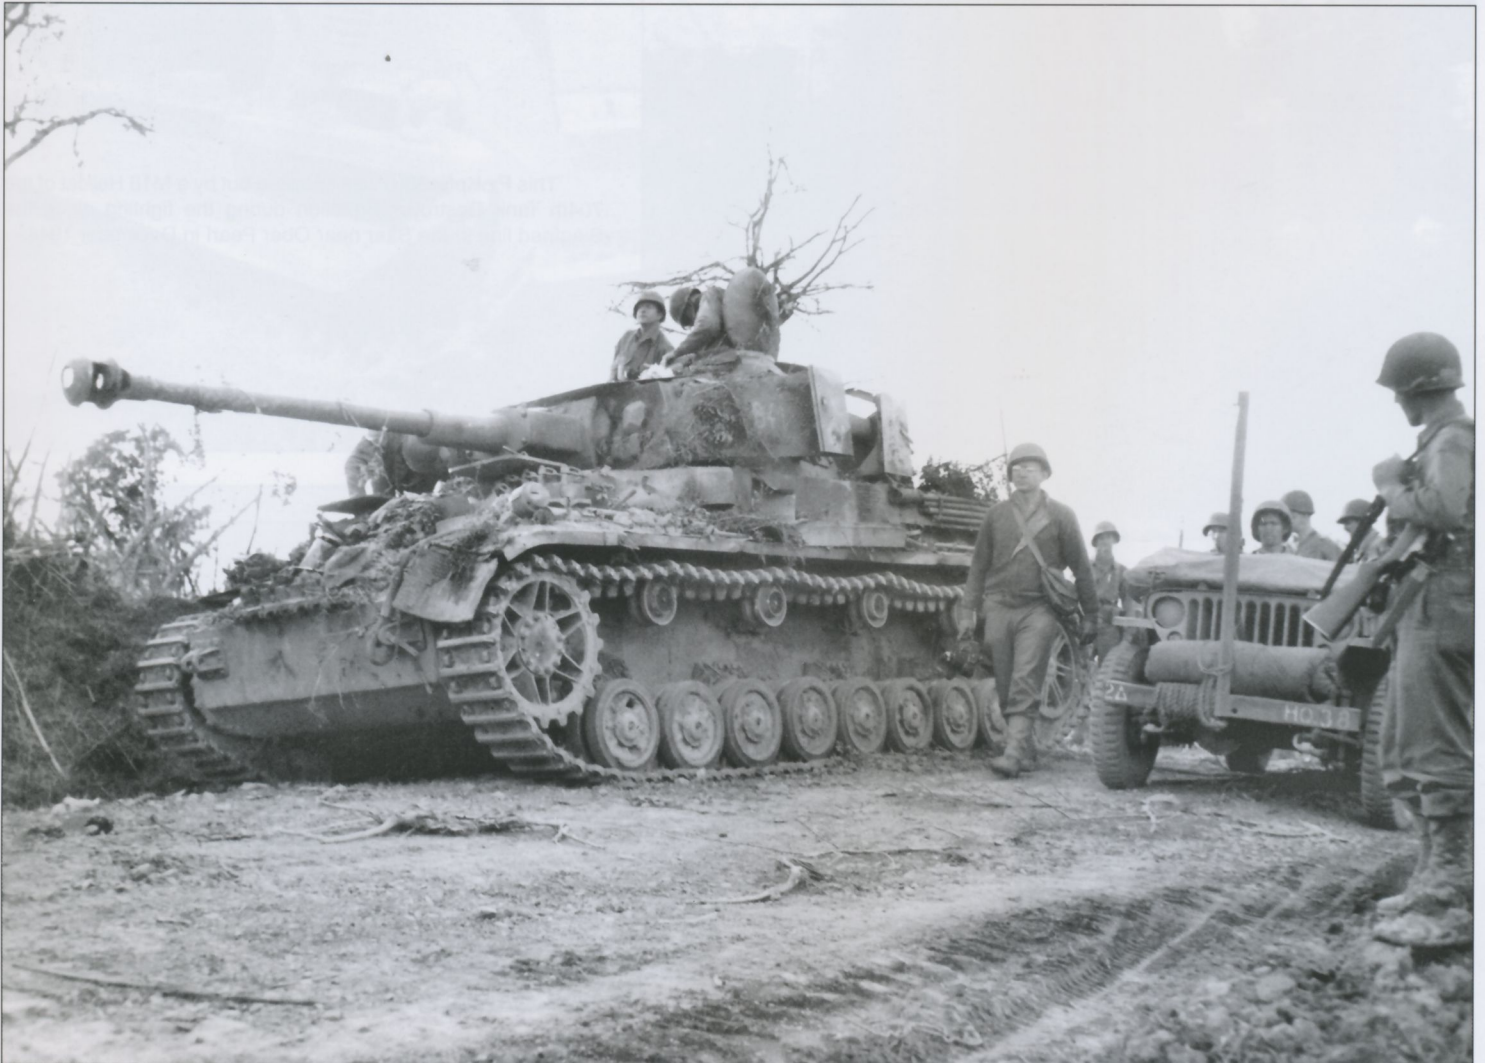
A Pz.Kpfw.IV with tactical number "841" is passed by troops of the 2nd Armored Division during the opening phase of Operation Cobra in late July 1944.

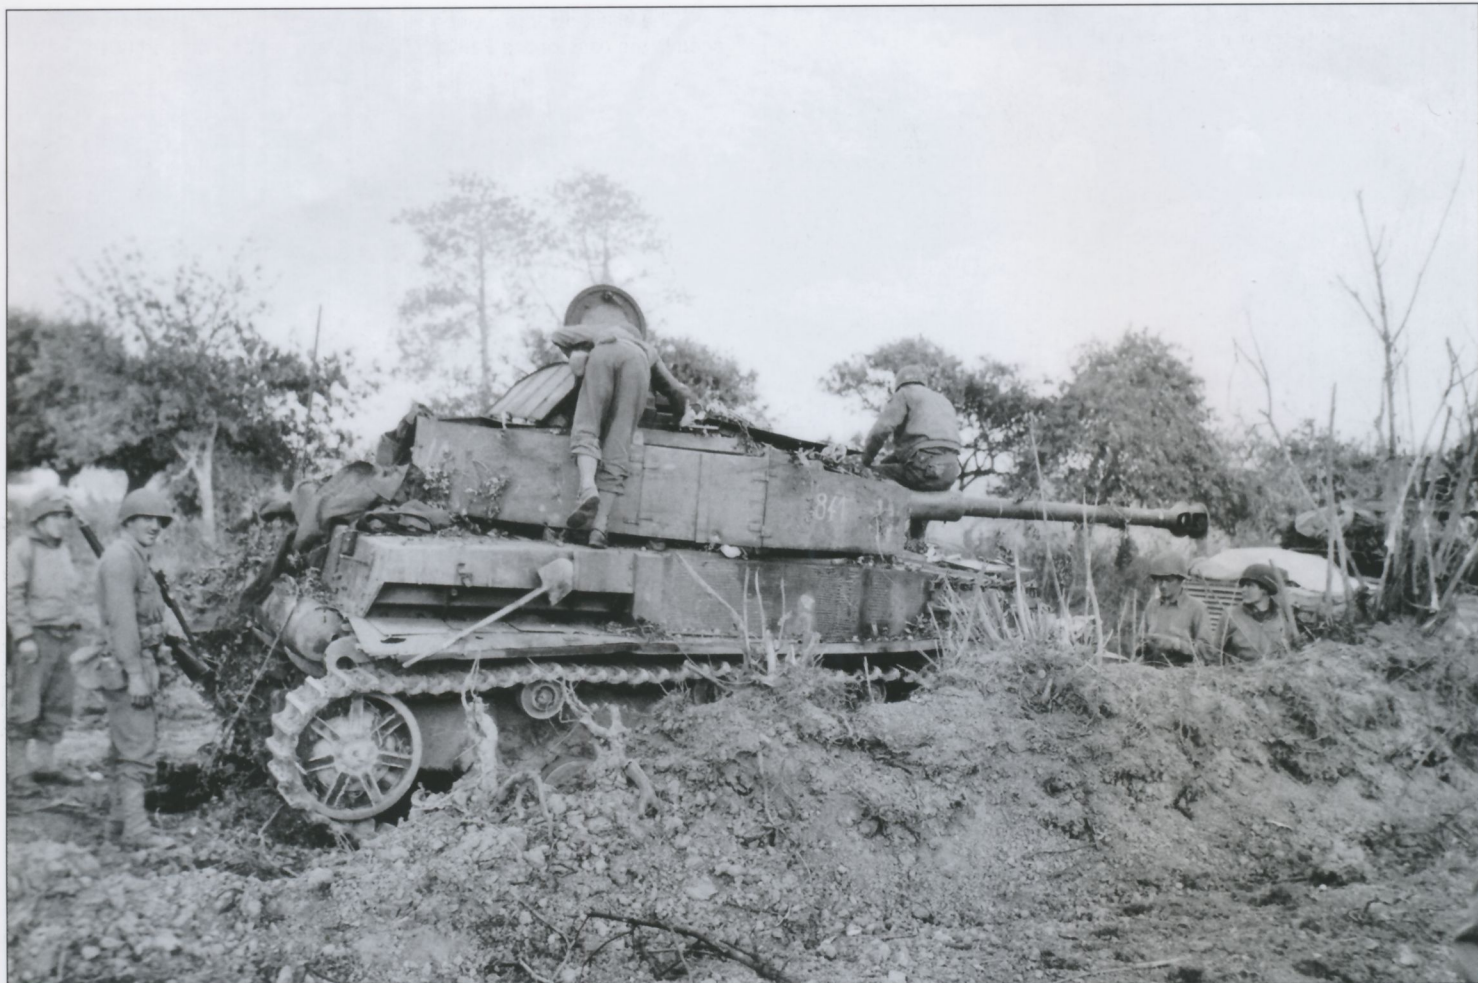
A view of the same Pz.Kpfw.IV from the opposite side as a column from the 2nd Armored Division passes by.

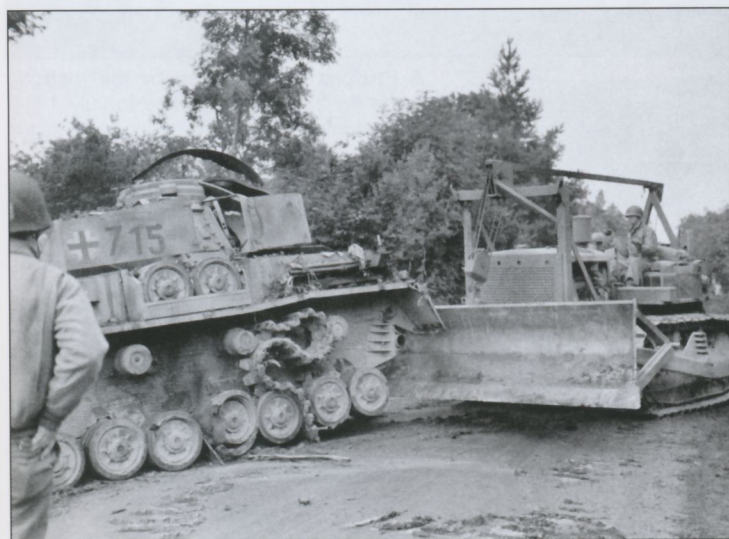
A US Army bulldozer pushes a wrecked Pz.Kpfw.IV off the road in the 1st Infantry Division sector during Operation Cobra in late July 1944.

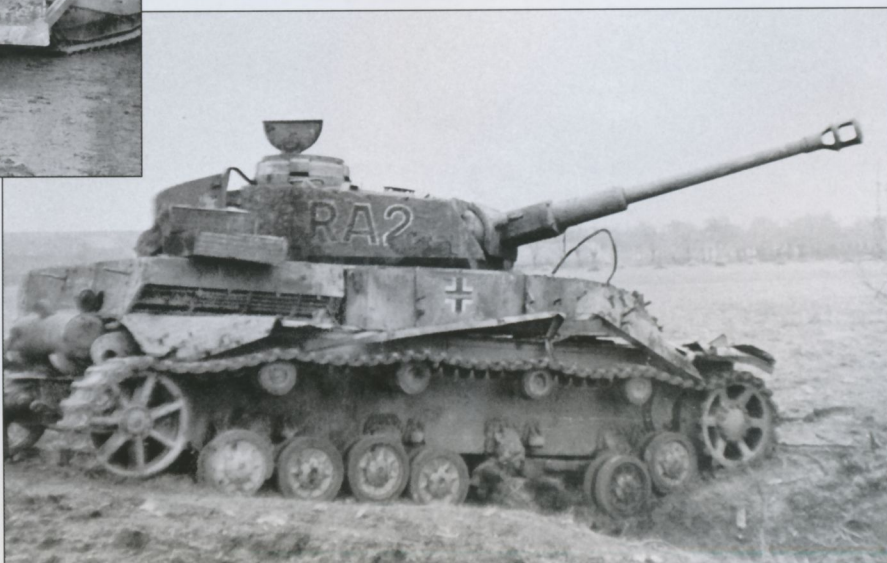
This Pz.Kpfw.IV was found in the Falaise pocket in August 1944. The tactical number is not common and may indicate a tank assigned to the divisional artillery regiment.

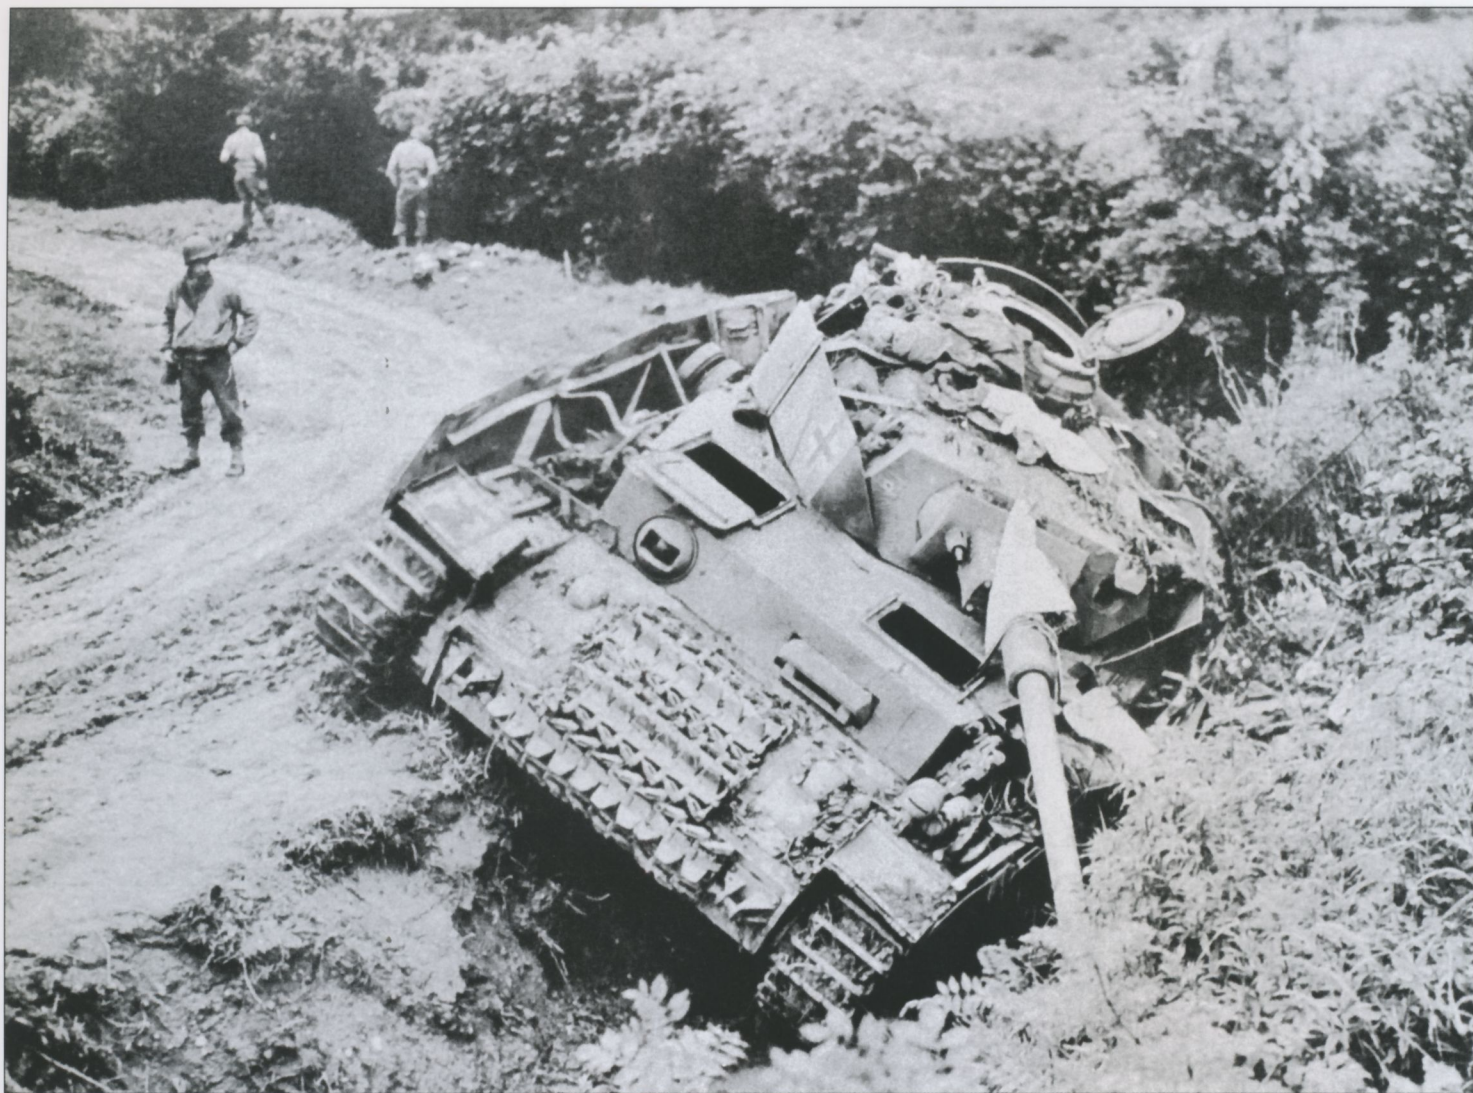
A Pz.Kpfw.IV abandoned by the roadside during the fighting in the bocage in July 1944. Often, abandoned tanks were pushed off roads to clear the path for following vehicles.

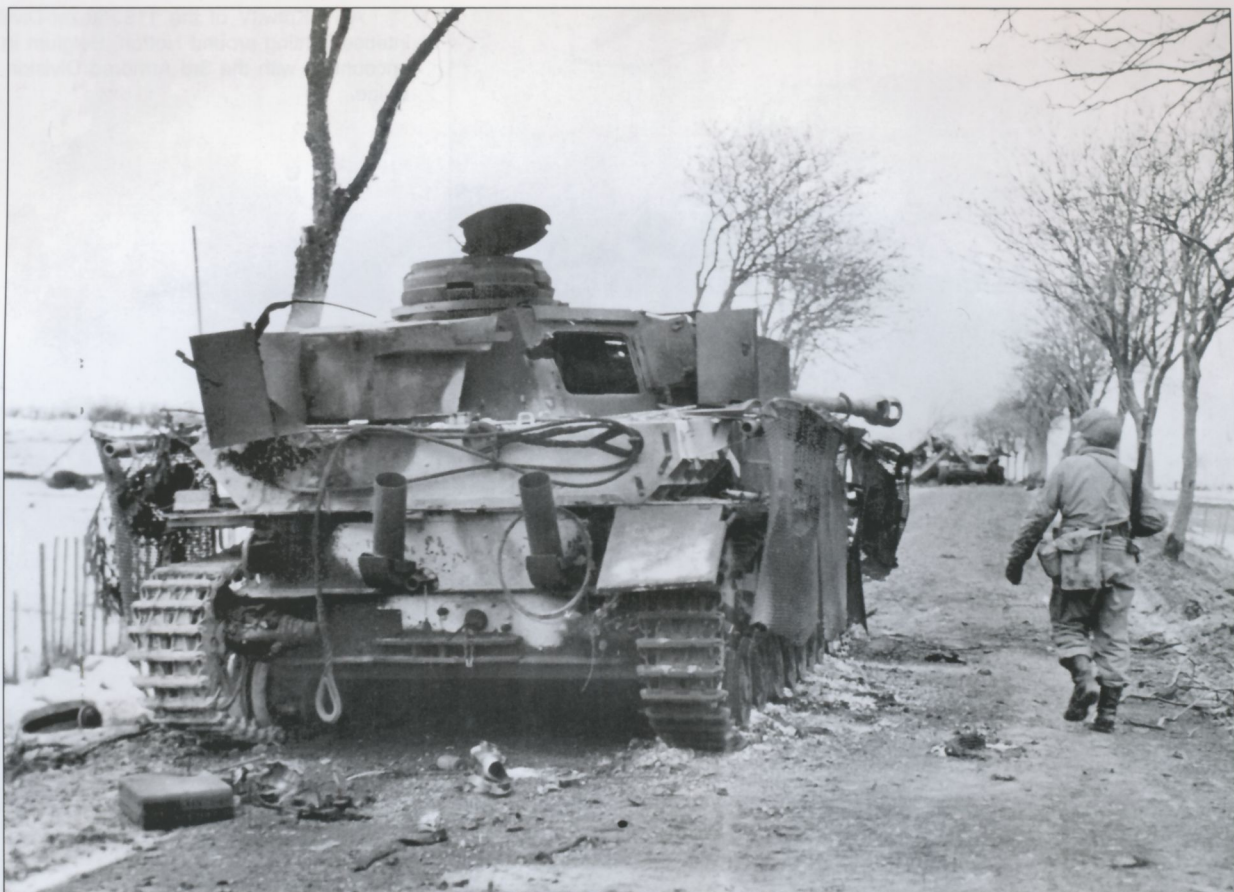
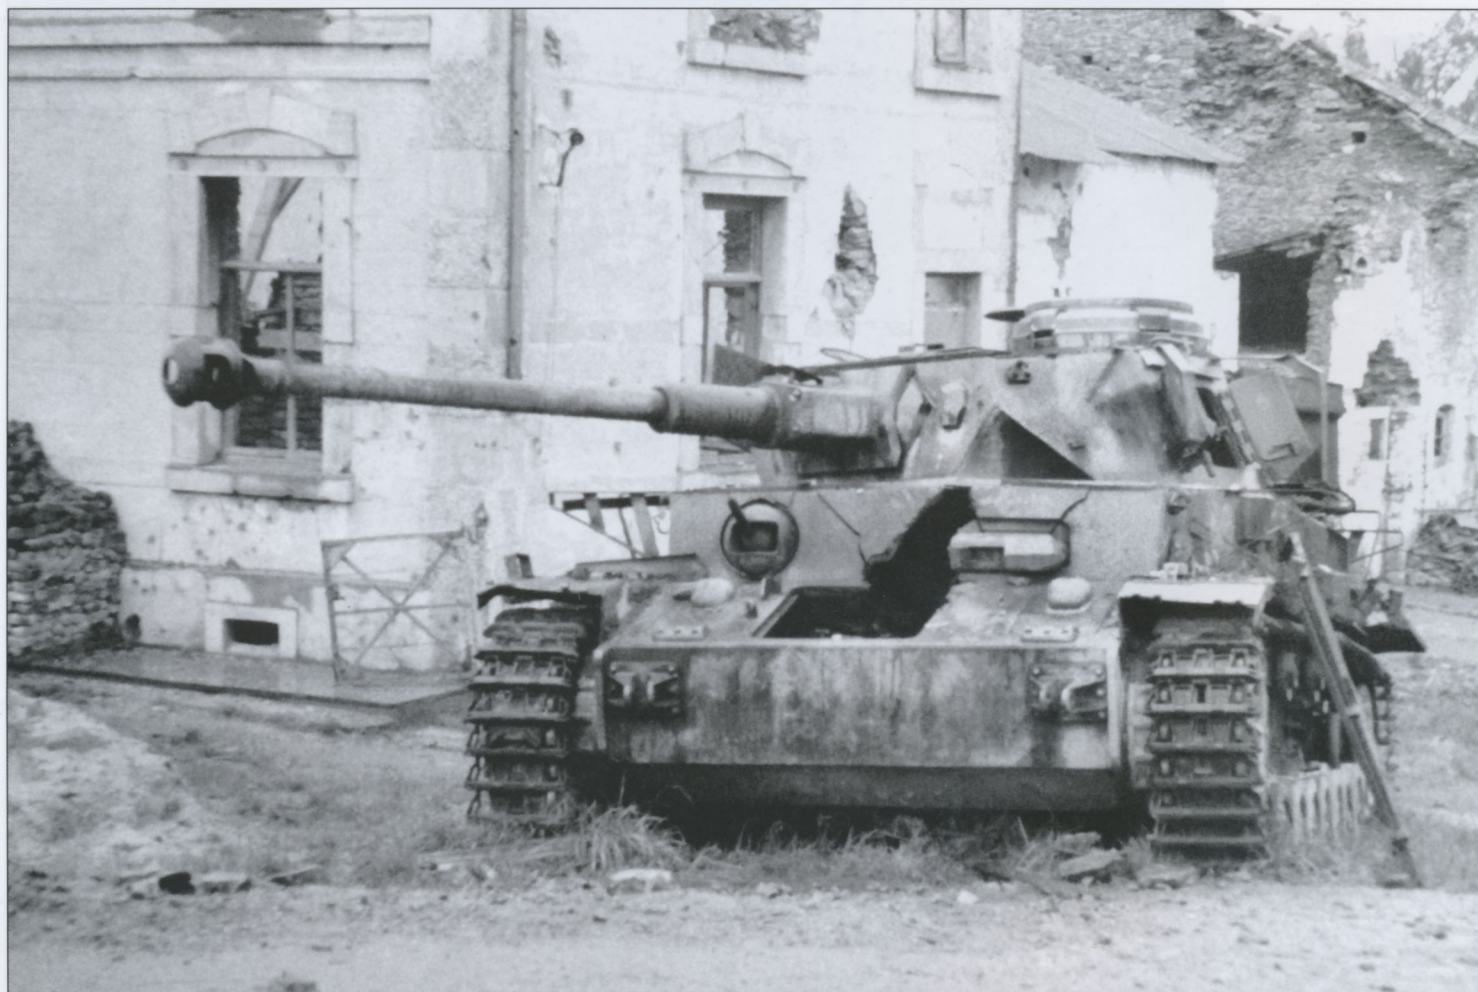
A Pz.Kpfw.IV knocked out in the fighting near Bastogne during the Battle of the Bulge and photographed the following summer. It has suffered a catastrophic failure of the front armor, probably a direct hit by an artillery round.

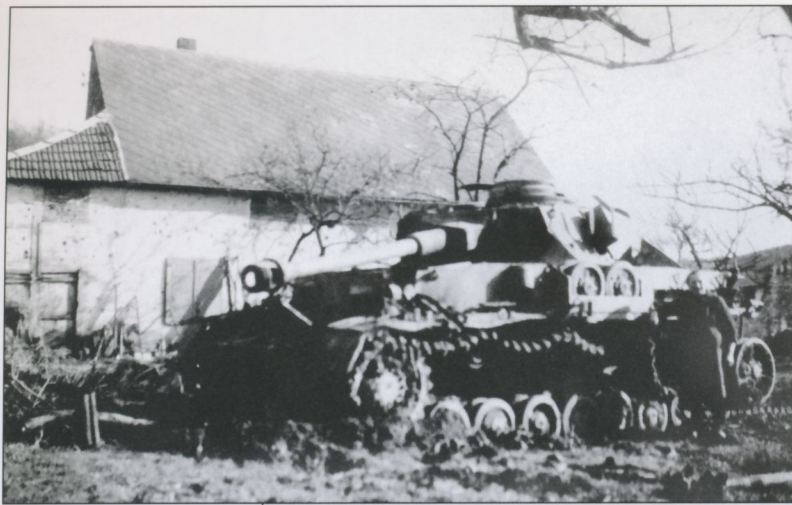
A Pz.Kpfw.IV of the 116.Panzer-Division knocked out in the intense fighting around Hotton, Belgium in late December 1944 in encounters with the 3rd Armored Division during the Battle of the Bulge.

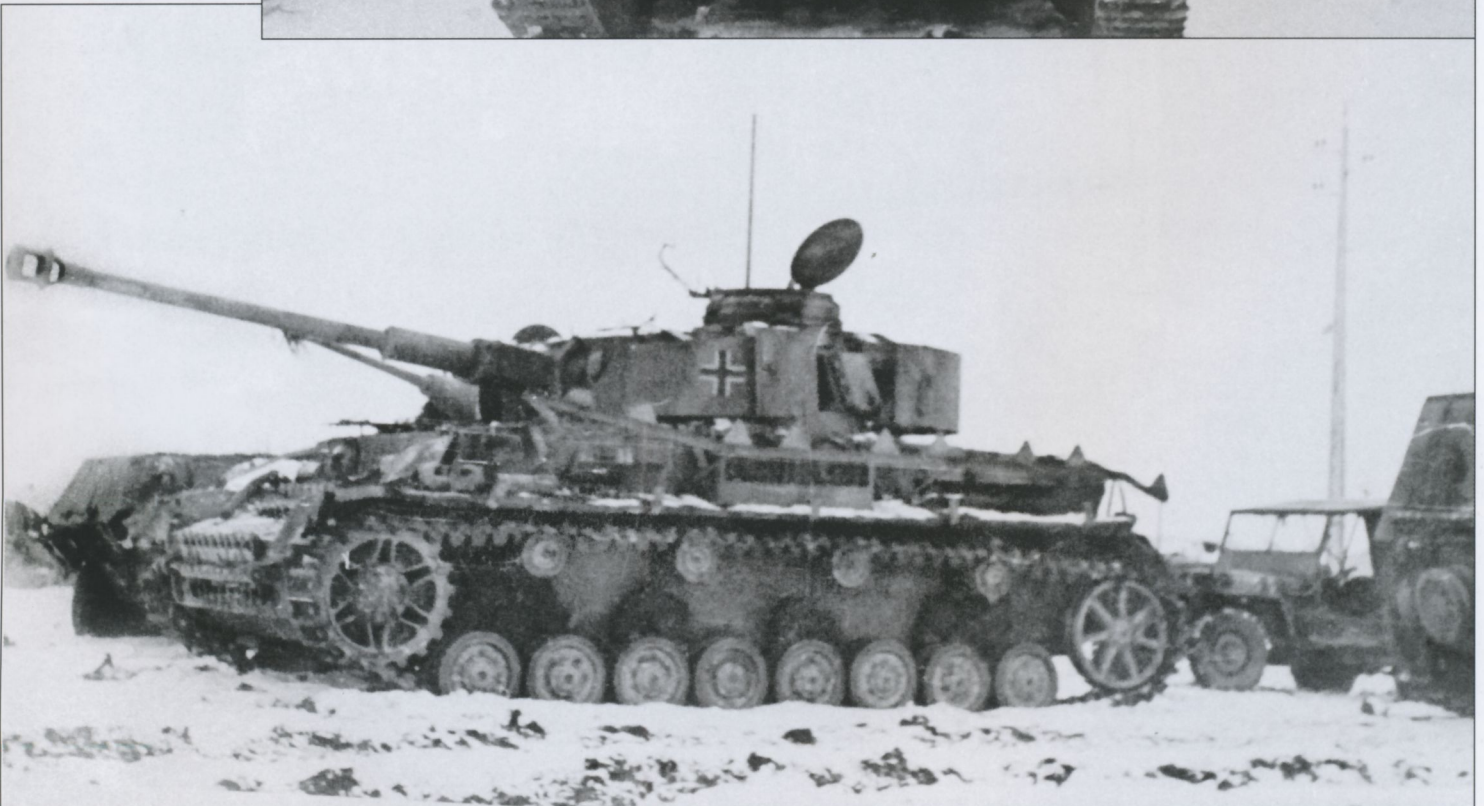
Another view of the same Pz.Kpfw.IV in the US First Army holding area in Belgium.

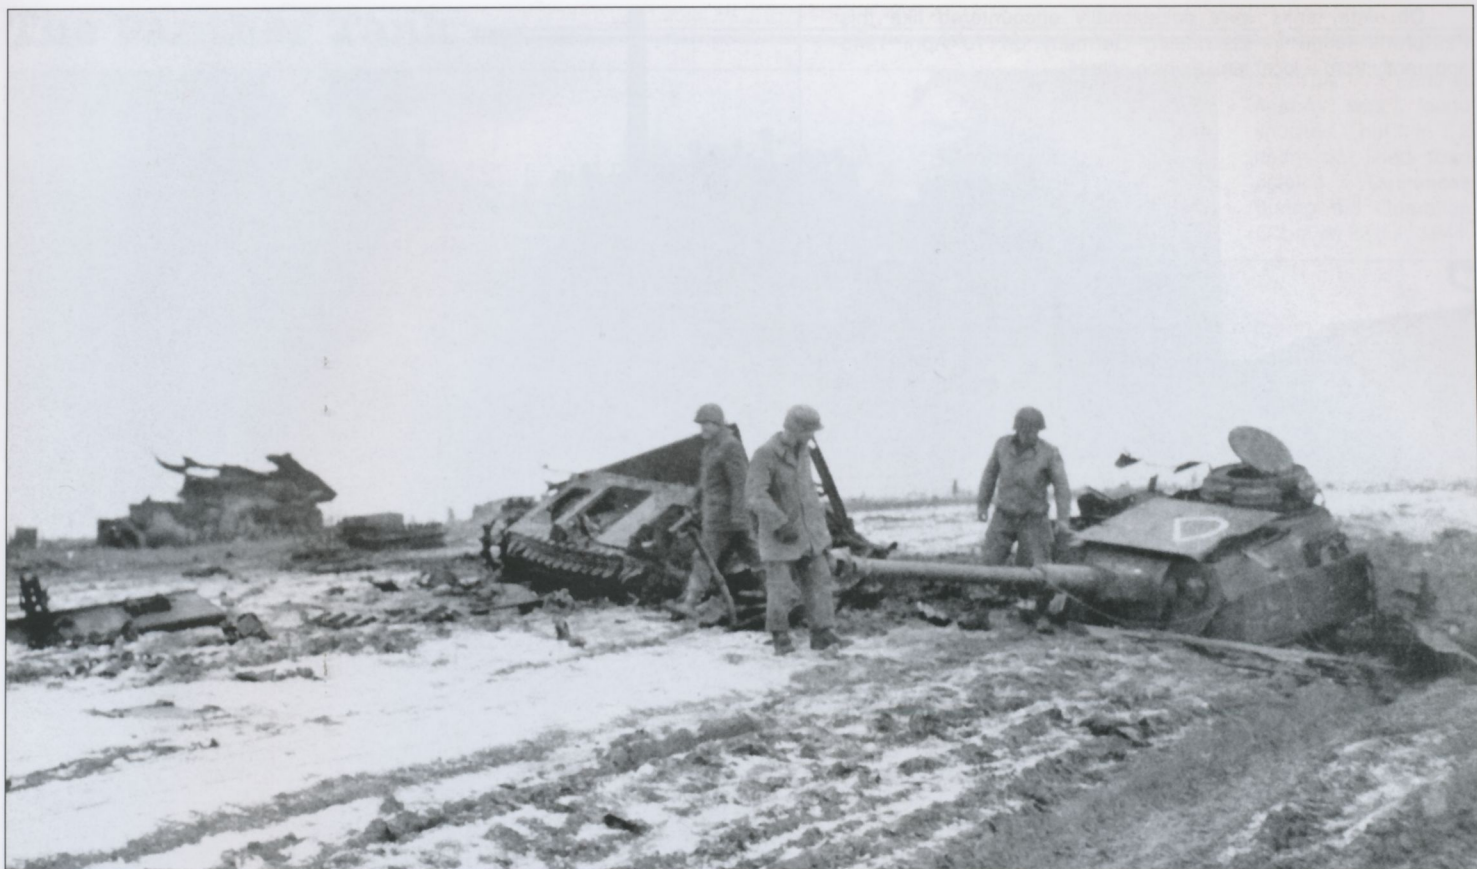
US engineers from the 102nd Division blow up derelict German tanks to prevent their recovery near Apweiler, Germany on 6 January 1945. The turret of the Pz.Kpfw.IV to the right seems to have a panel of appliqué armor on the roof.

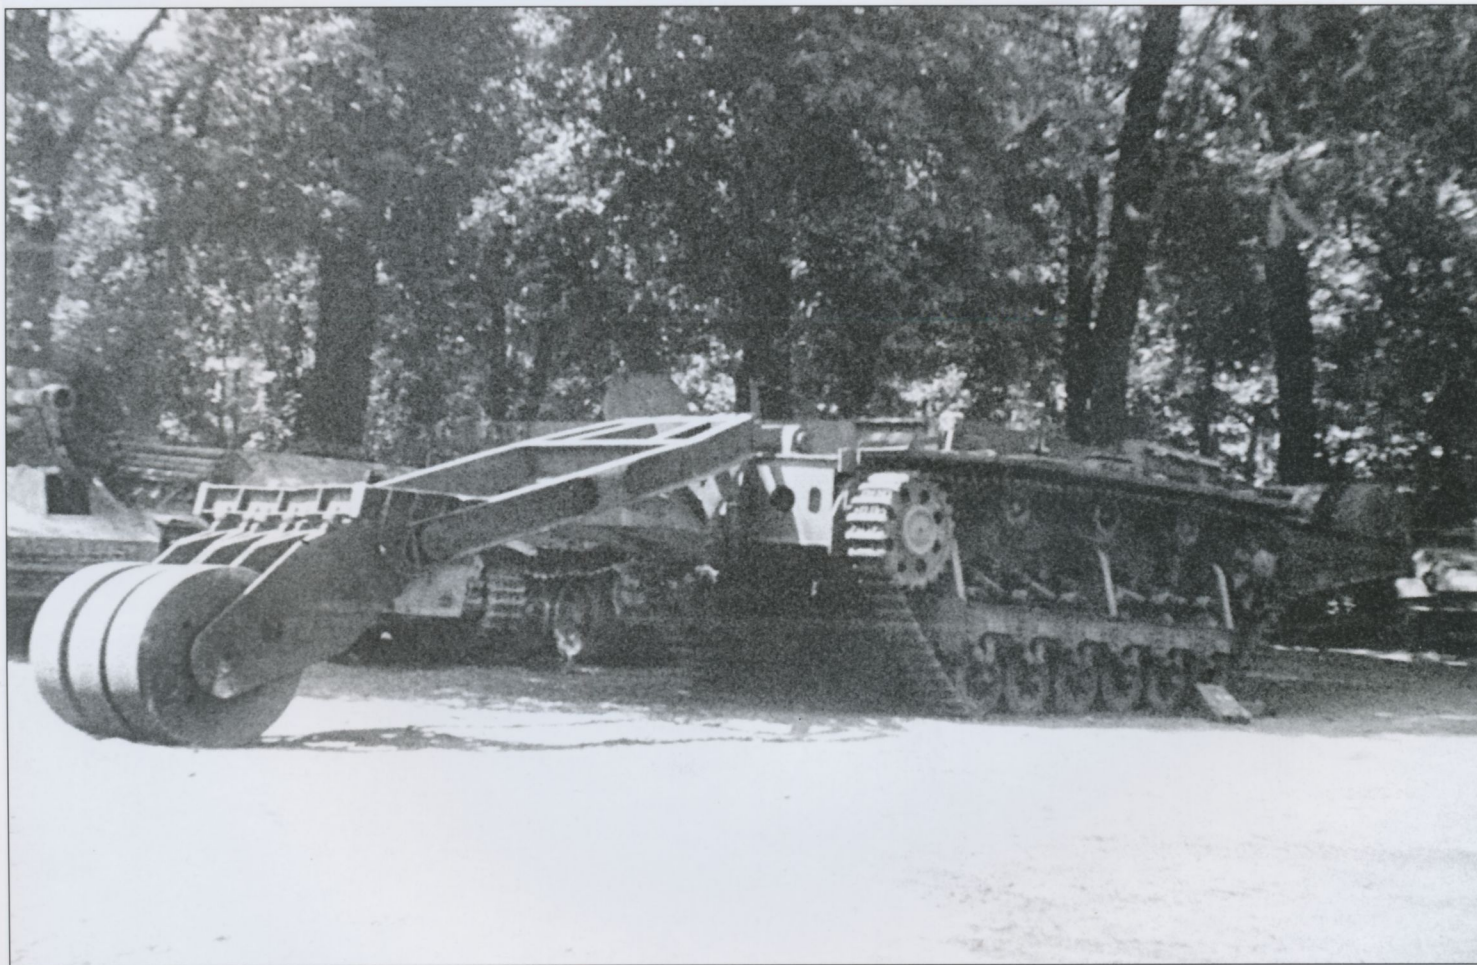
One of the rarer versions of the Pz.Kpfw.III was the Minenraumerpanzer III, an experimental mine-roller vehicle. One of the prototypes is seen here at a US Army ordnance holding area near Paris.

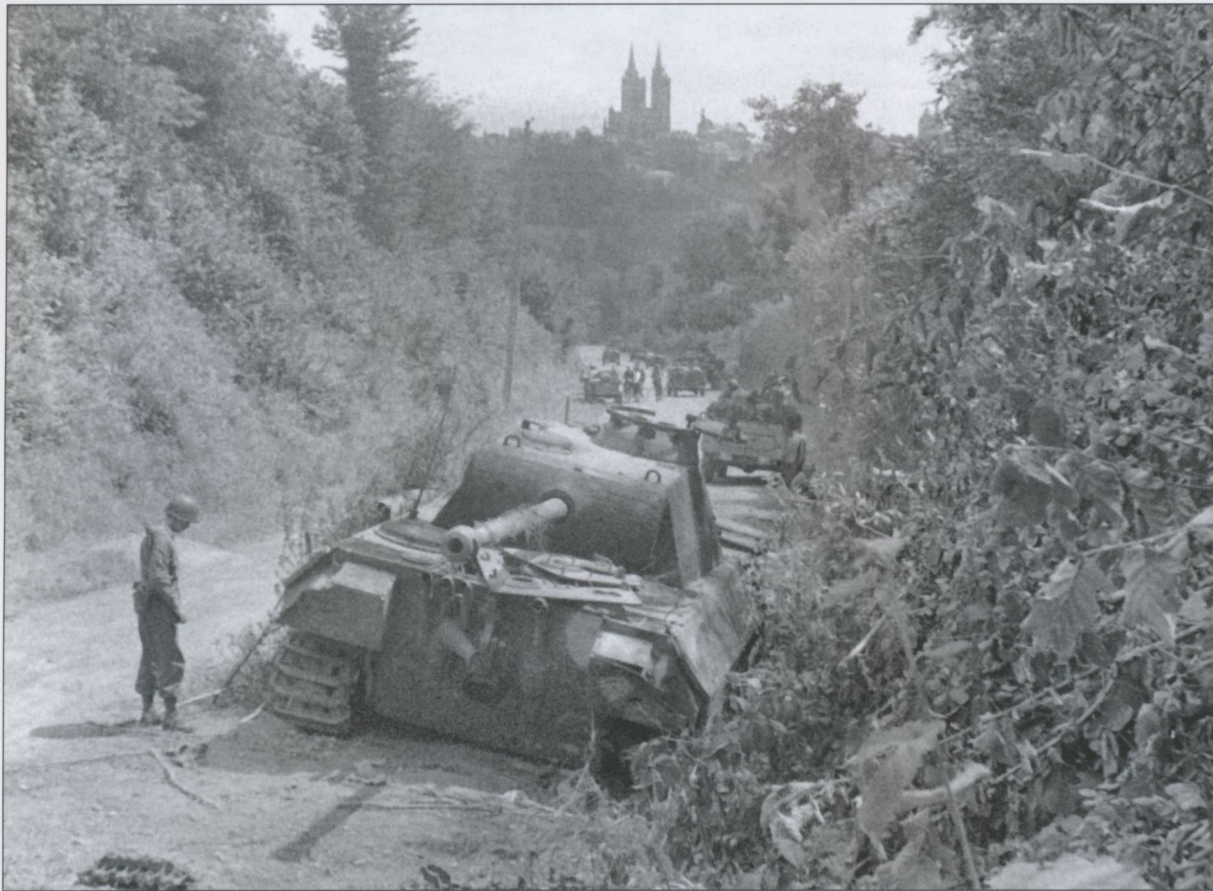
This Panther Ausf.A was found knocked out in a hedgerow lined road outside Coutances during the Operation Cobra on 28 July 1944.

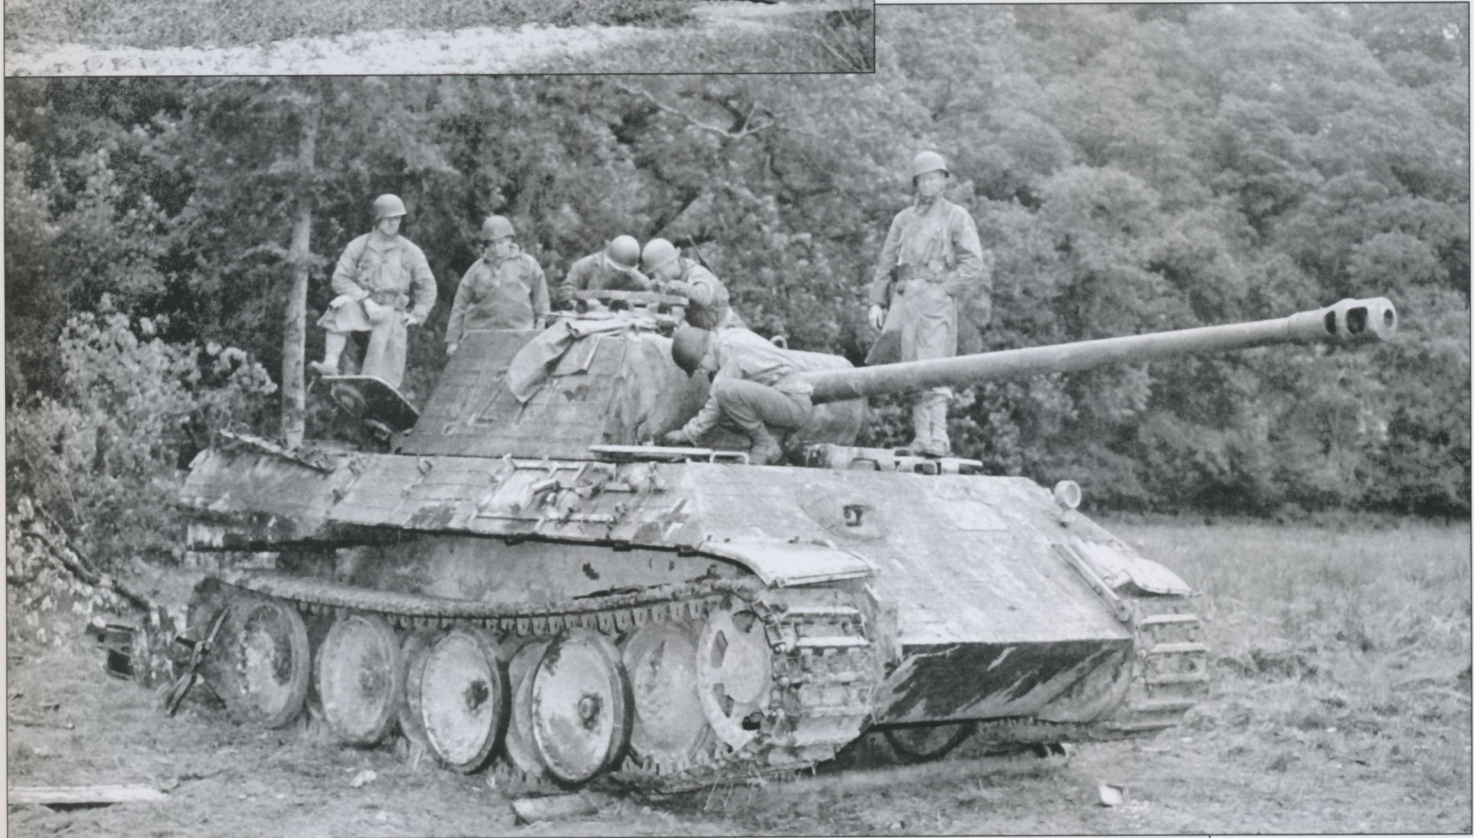
A 2. Panzer-Division Panther Ausf.A is examined by US troops after its capture in August 1944. The division's characteristic trident emblem is painted on the turret side in front of the tactical numbers.

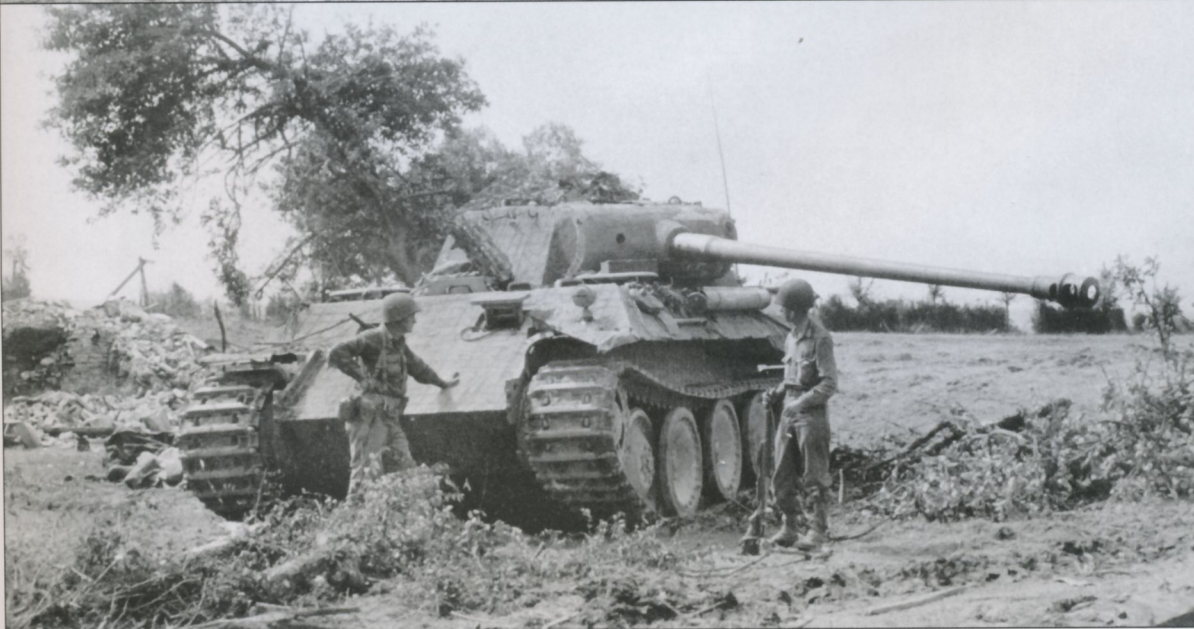
GIs inspect a Panther Ausf.A of I/Pz.Rgt.33, 9. Panzer-Division knocked out on the road between Argentan and Chambois during the fighting in August 1944.

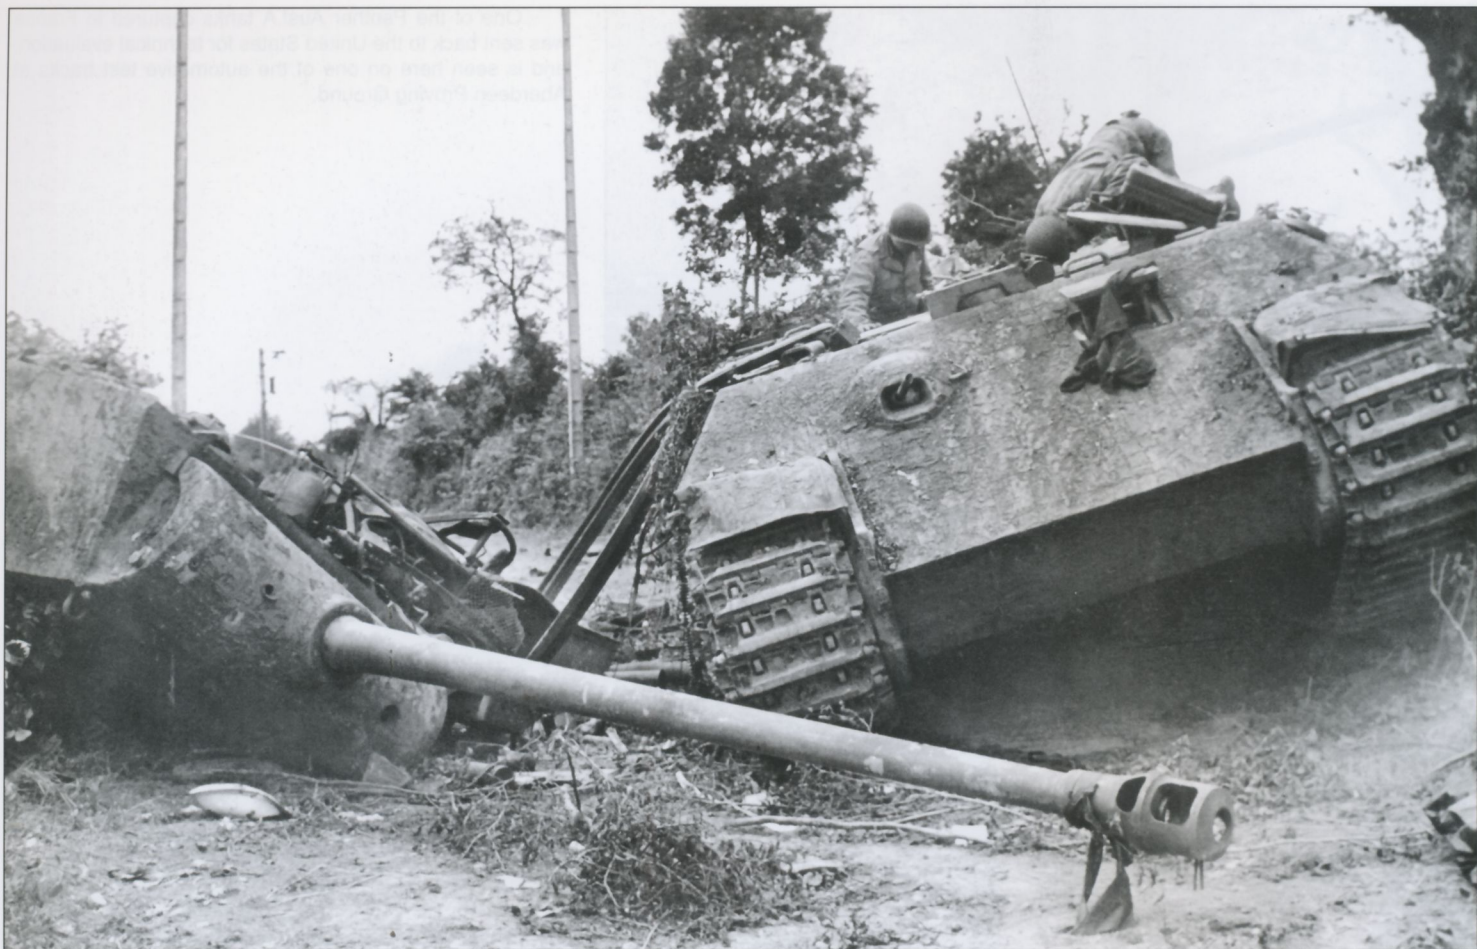
GIs inspect a Panther which lost its turret during the fighting around Coutances in August 1944.

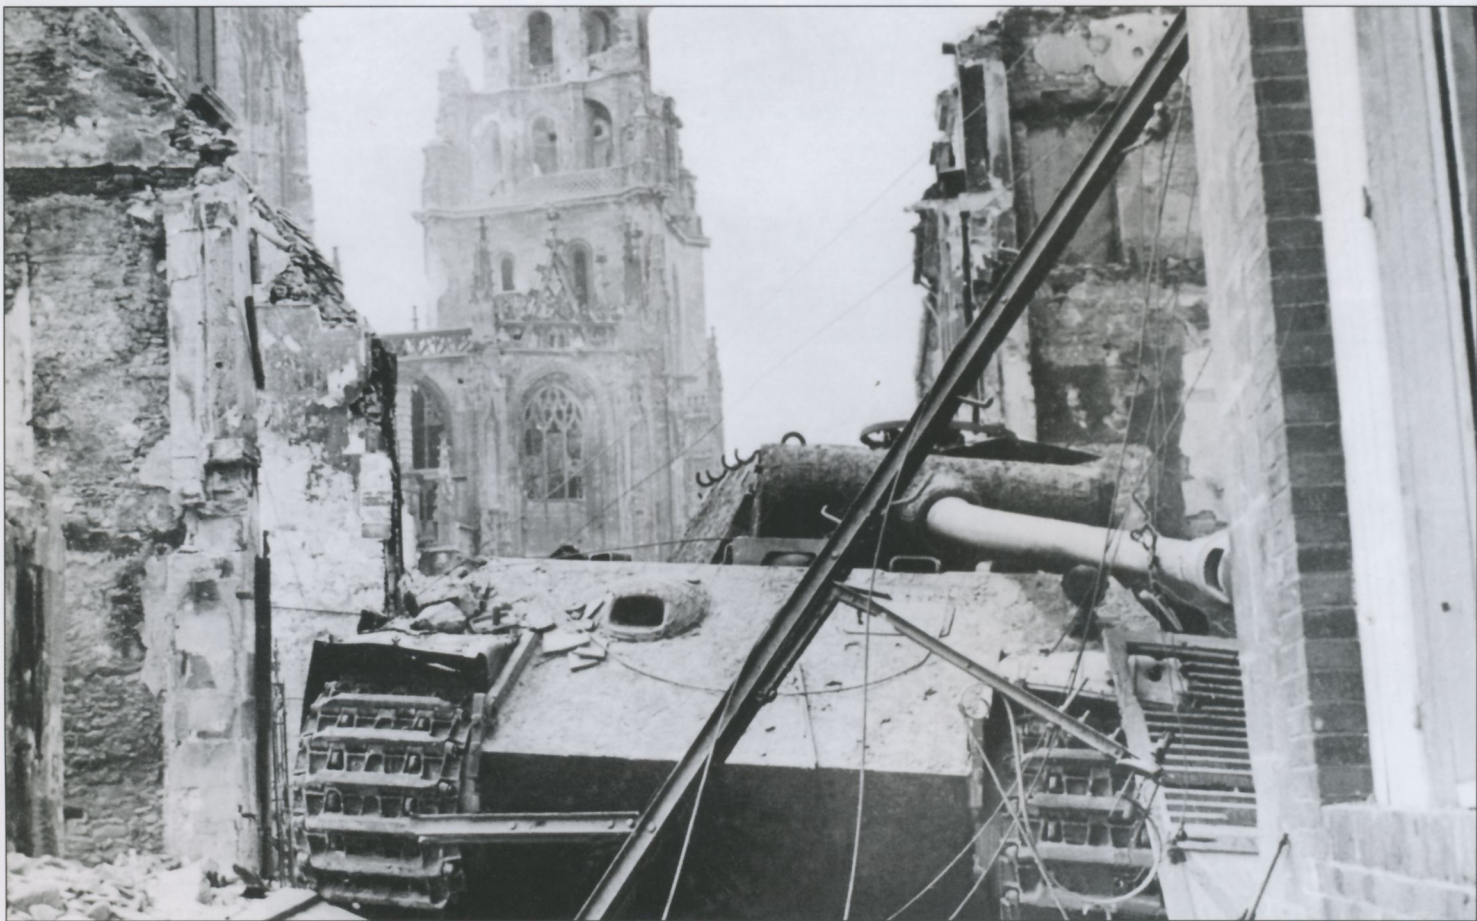
A Panther of II/Pz.Rgt.33, 9.Panzer-Division knocked out by artillery of the 5th Armored Division on rue de la Poterie in Argentan during the fighting there in August 1944.

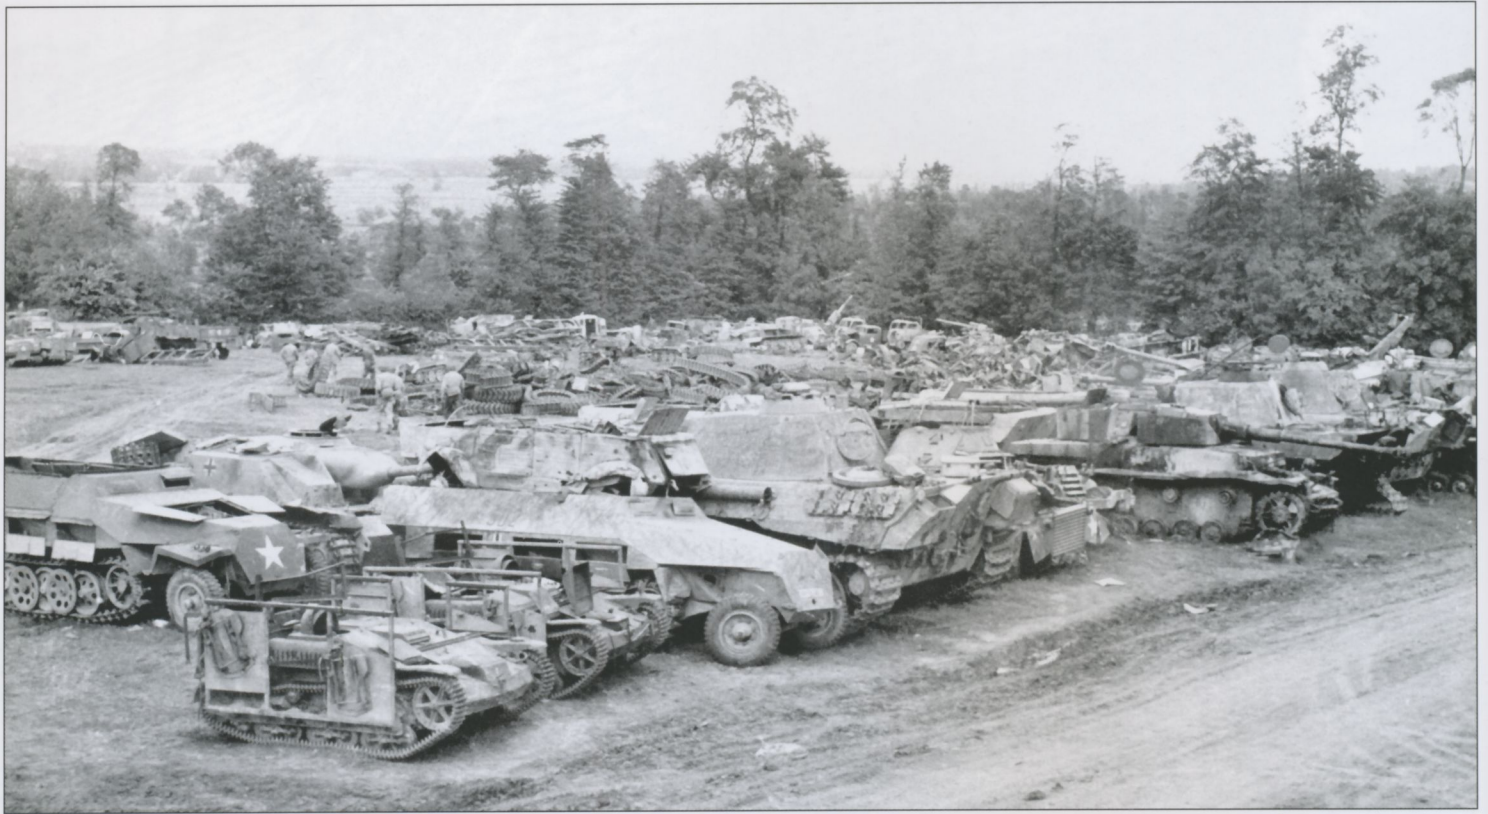
A large holding area for captured German equipment was created near Isigny in Normandy as seen here. Numerous types of armor are visible including obscure types such as captured Renault UE tractors fitted with Nebelwerfer rocket launchers in the left foreground, as well as more common types such as Panthers, StuG III, and Sd.Kfz.251 half-tracks.

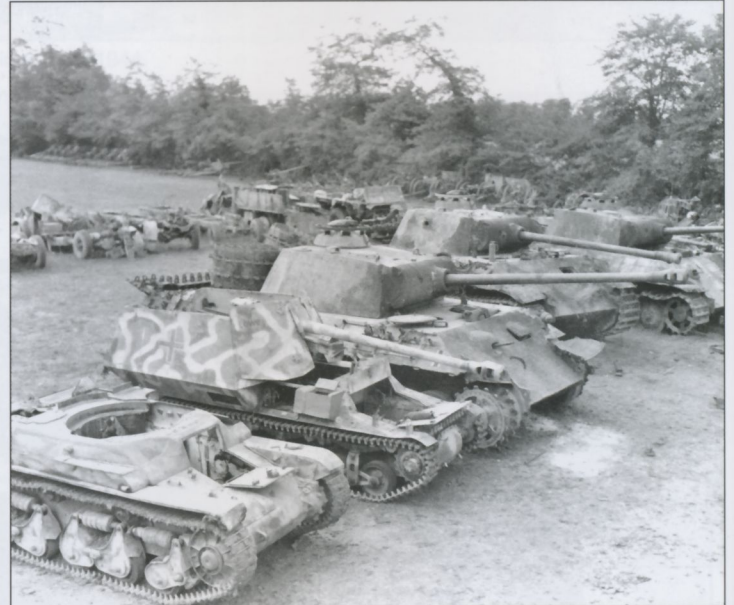
Another ordnance yard was created near Isigny at Trevieres in Normandy and this is a view of some of its holdings on 4 September 1944. Aside from the three Panther tanks, there is a Renault R-35 which had been converted to carry a 4.7cm anti-tank gun but with the superstructure subsequently removed. To its left is a Chenillette Lorraine converted into a tank destroyer with the addition of a 7.5cm PaK 40 anti-tank gun, and named Lowe (lion).

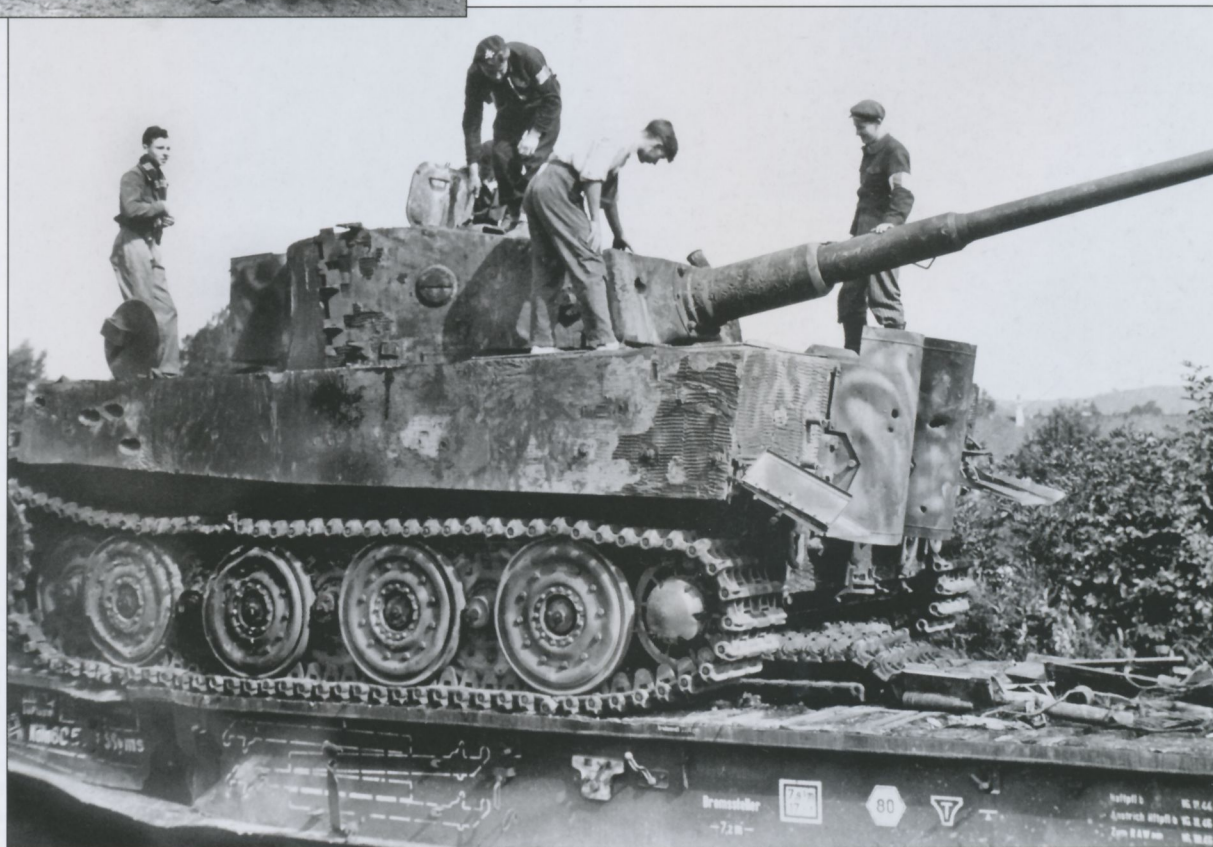
The Tiger I was seldom encountered by the US Army in France. A number were captured aboard a transport train near Braines, France on 8 September 1944 by the 468th AAA Battalion and here one is seen being inspected by members of the French resistance.
