# Panzers in the Gunsights

German AFVs in the ETO 1944-45 in US Army Photos

Steven J. Zaloga

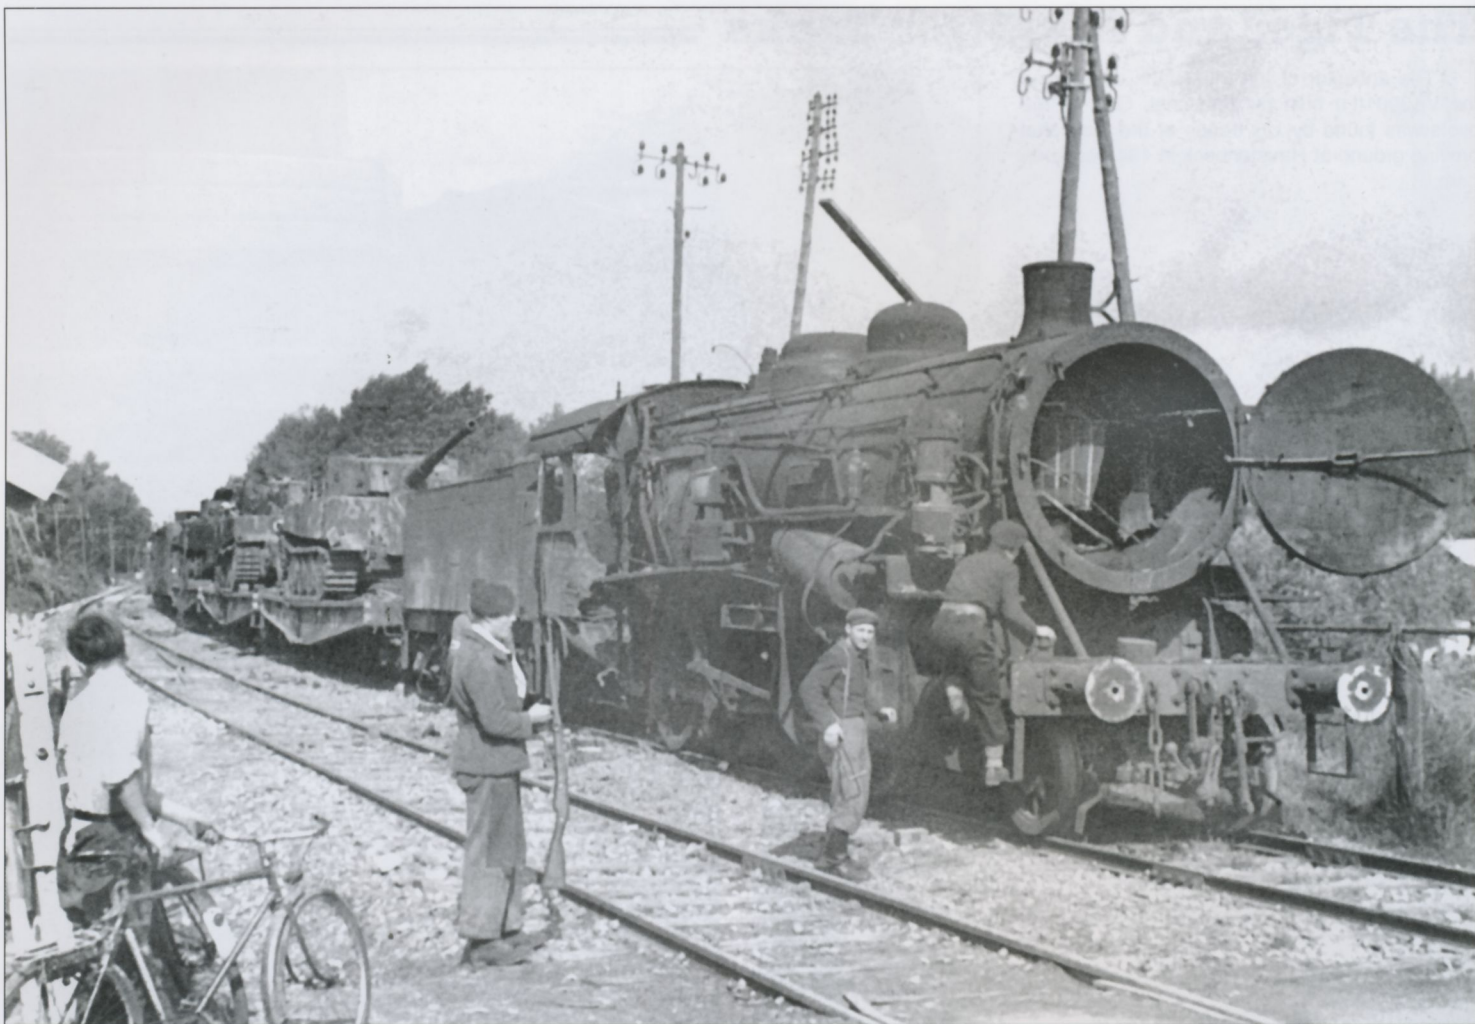
A view of the train at Braines carrying a number of Tigers.

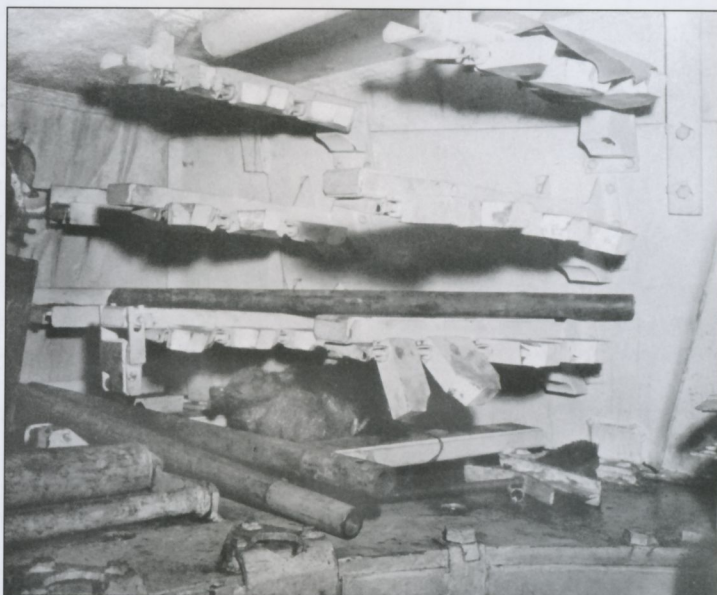
An interior view of the left rear of the turret showing the ammunition racks.

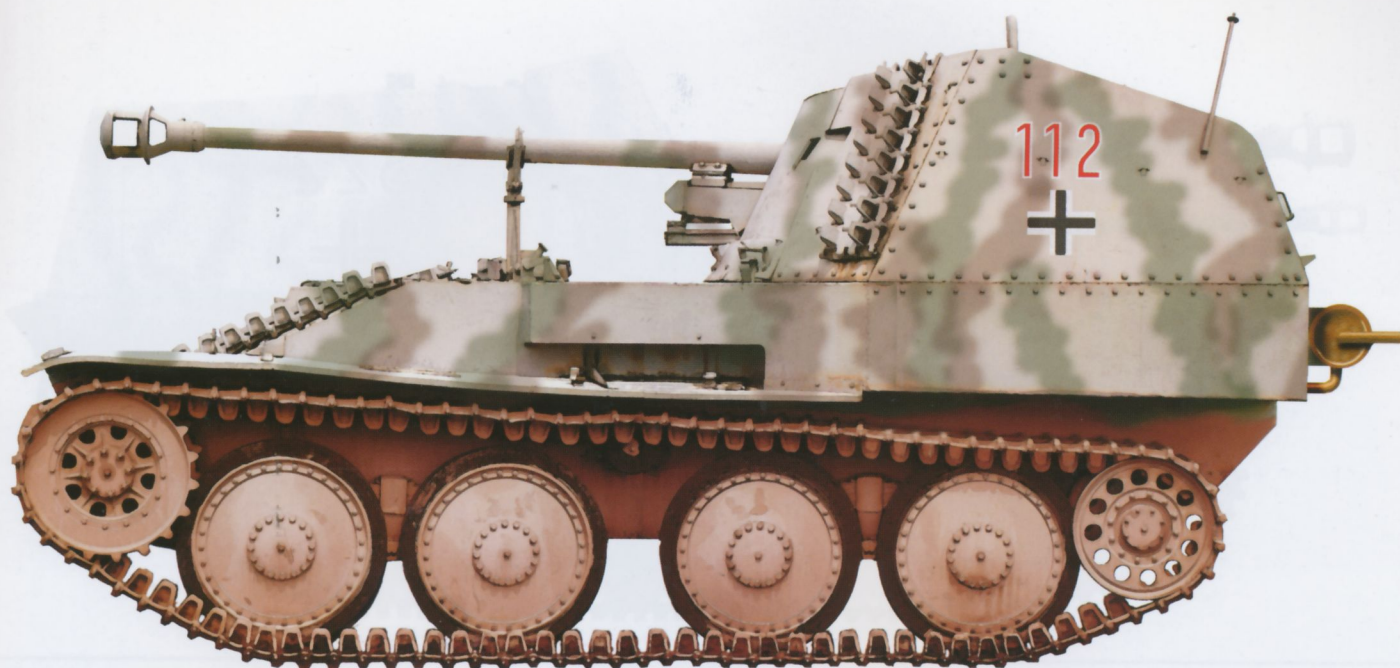
**Panzerjäger 38(t) Ausf.M Sd.Kfz.138, Pz.Jg.Abt.243, Normandy, June 1944**

This is another example of the typical summer 1944 paint scheme of factory applied RAL 7028 dark yellow with field applied patterns of RAL 6003 olive green and RAL 8017 dark brown. Once again, the camouflage pattern has been applied with field mixed paint, and the results are somewhat muted, no doubt subdued even further by the usual coat of dust.

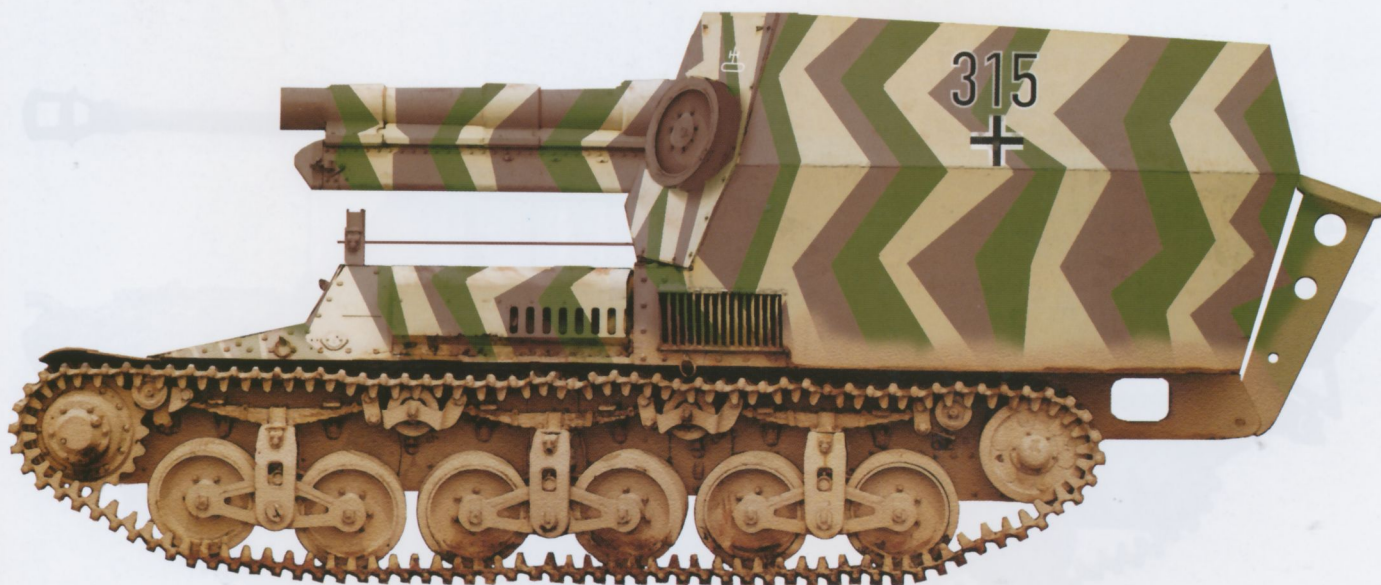
**15cm sFH13/1(Sf) Sd.Kfz.135/1, Pz.Art.Rgt.155, 21.Panzer-Division, Normandy, July 1944**

The artillery regiment of the 21.Panzer-Division had two batteries of self-propelled 15cm howitzers on the Lorraine chassis in Normandy. When delivered from Germany in 1943, they were finished in overall dark grey, but were repainted in 1944 prior to the invasion. The scheme as seen here is quite distinctive and not the usual amorphous sprayed pattern so common on German AFVs in Normandy. Besides the Balkan cross and tactical number on the superstructure side, the self-propelled gun battery tactical symbol can be seen in white on the front superstructure plate.

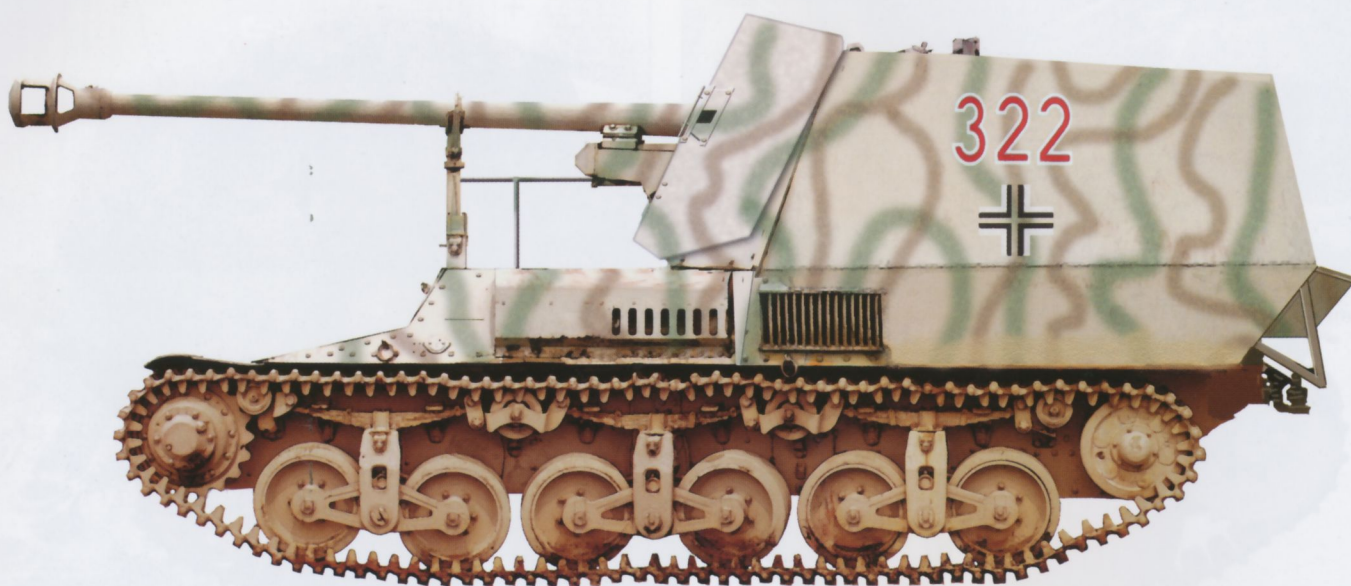
**7.5cm PaK 40/1 Sd.Kfz.135, 21.Panzer-Division, France, July 1944**

The camouflage schemes on the Becker self-propelled gun conversions of the 21.Panzer-Division were often quite distinctive as seen here. These tank destroyers were deployed in the division's panzer-grenadier battalions and the camouflage seems to have varied from battery to battery. In this case, the dark green and dark brown have been sprayed in wavy bands over the usual dark yellow, somewhat obscured by the usual summertime dust. The style of Balkan cross is not typical.

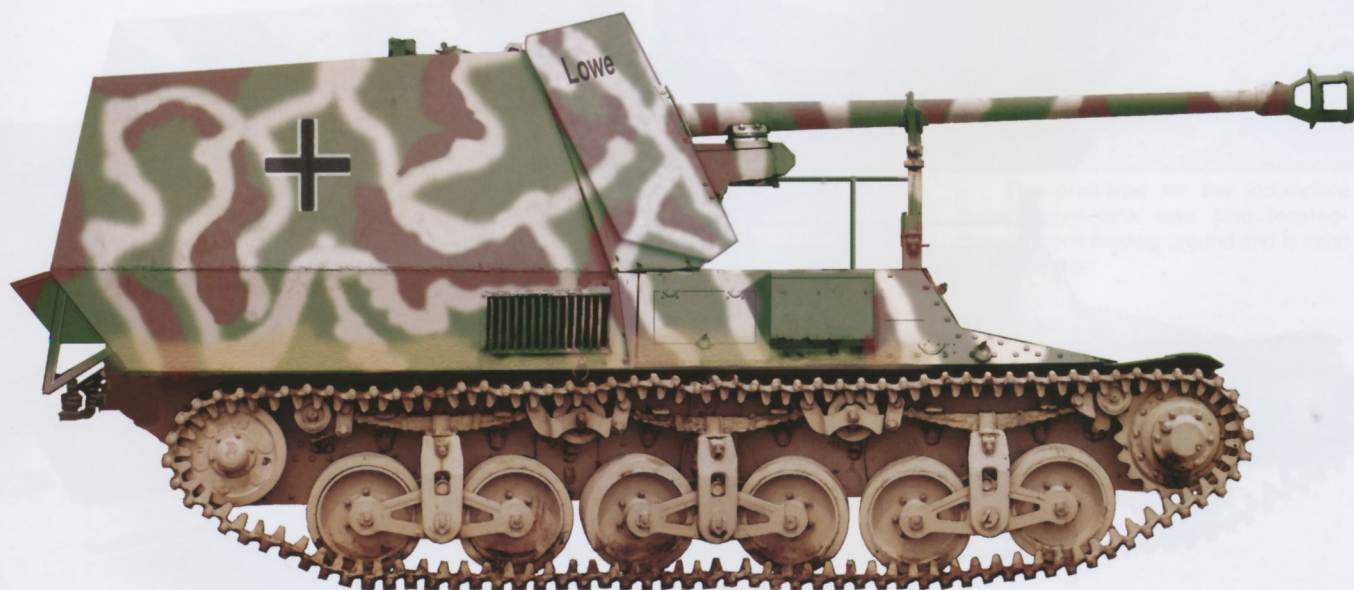
**7.5cm PaK 40/1 Sd.Kfz.135, 21.Panzer-Division, France, July 1944**

This provides another example of the variety of schemes applied to the Becker self-propelled gun conversions in France. This particular example is named Lowe (Lion). Since these vehicles were originally finished in overall dark grey, the unit has used the opportunity to repaint the vehicle with a larger percentage of dark green than was usually found in the summer 1944 patterns in Normandy.

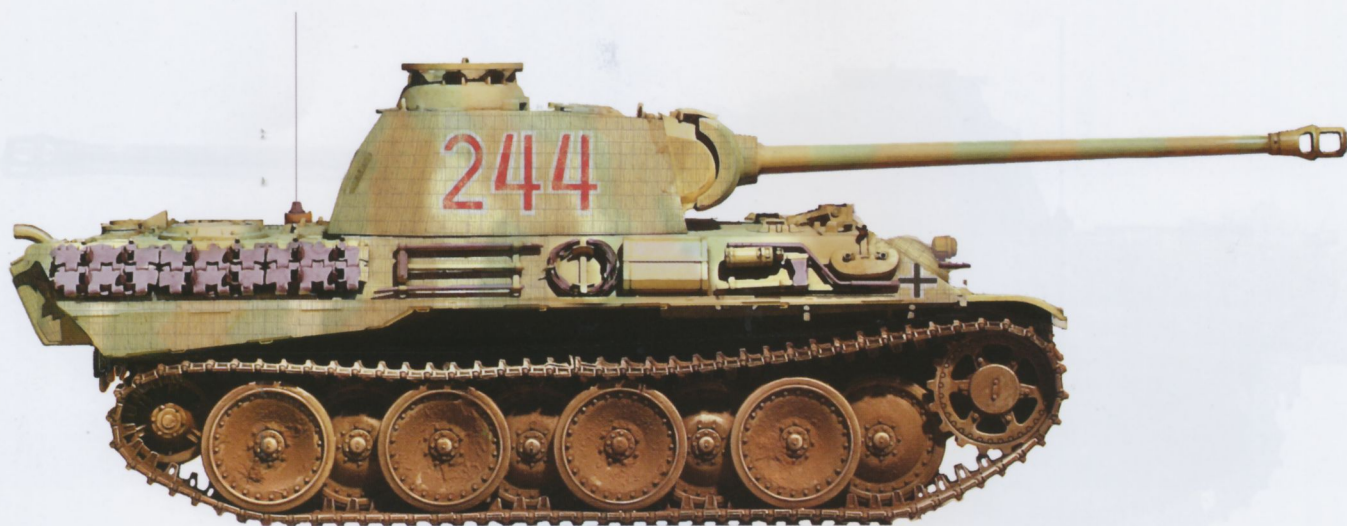
**Panther Ausf. A, 2./Pz.Rgt.6, Panzer Lehr Division, Normandy, July 1944**

This is a good example of the typical German AFV scheme in Normandy of factory applied RAL 7028 dark yellow with field applied patterns of RAL 6003 olive green and RAL 8017 dark brown. The field application and dust makes the pattern indistinct and much lighter than would be expected considering how dark the green and brown colors are in the original paste form. Panzer Regiment 6 tended to apply very large tactical numbers on the turret, and these were repeated on the turret rear as well. This particular Panther was captured by US forces and later sent to Aberdeen Proving Ground for trials.

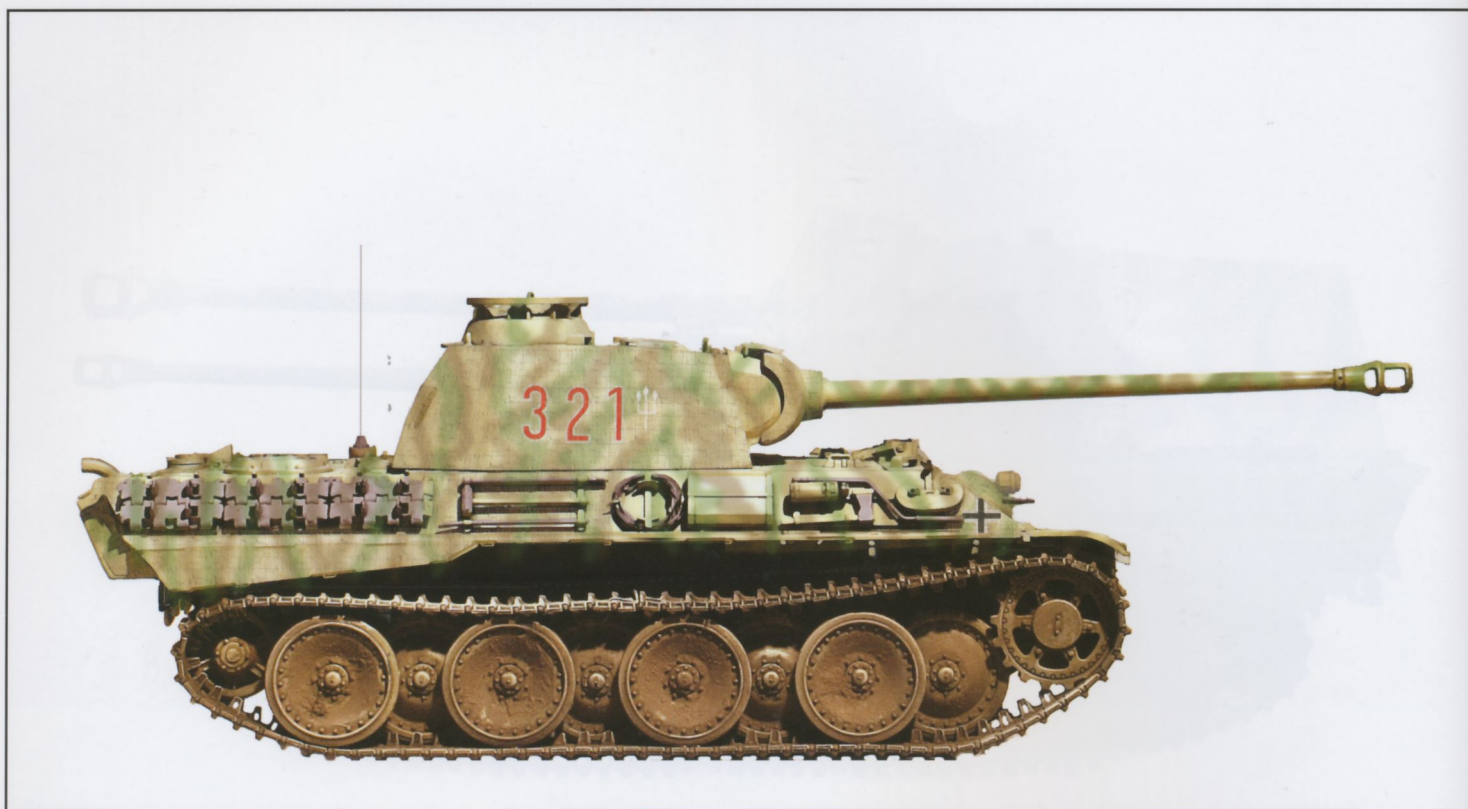
**Panther Ausf. A, 3./Pz.Rgt.3, 2.Panzer-Division, Normandy, August 1944**

This is a good example of typical German AFV camouflage in the summer of 1944 consisting of the usual German scheme of factory applied RAL 7028 dark yellow with field applied patterns of RAL 6003 olive green and RAL 8017 dark brown. The two latter colors were provided to the crew in the form of a pigment paste which was thinned with any available solvent and spray-painted on at the discretion of the unit. As a result, there were no standard patterns and the scheme varied from tank to tank. Since the paint was created in the field using available solvents, it was often not very opaque. The 2.Panzer-Division used a trident as the divisional tactical symbol, and it is seen here on the turret side in front of the tactical number.

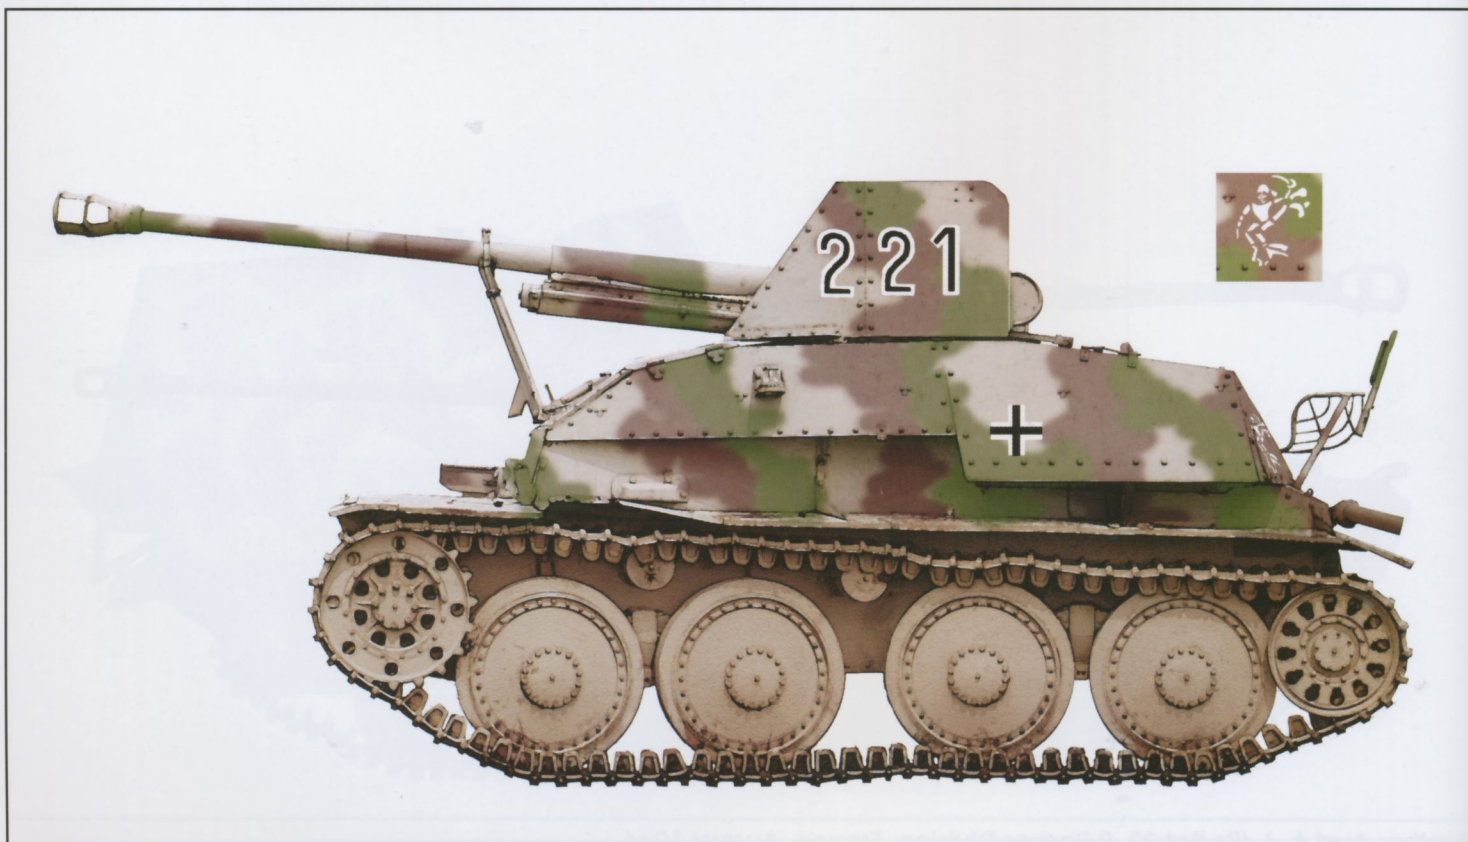
**Panzerjäger 38(t) Sd.Kfz.139, Pz.Jg.Abt.61, 11.Panzer-Division, Montelimar, France, August 1944**

This is a fairly good example of the summer 1944 camouflage scheme applied in a more distinctive pattern than seen in other units. The 11.Panzer-Division's "galloping ghost" tactical insignia was stenciled on the rear corners of the hull and is seen in more detail in the inset drawing above.

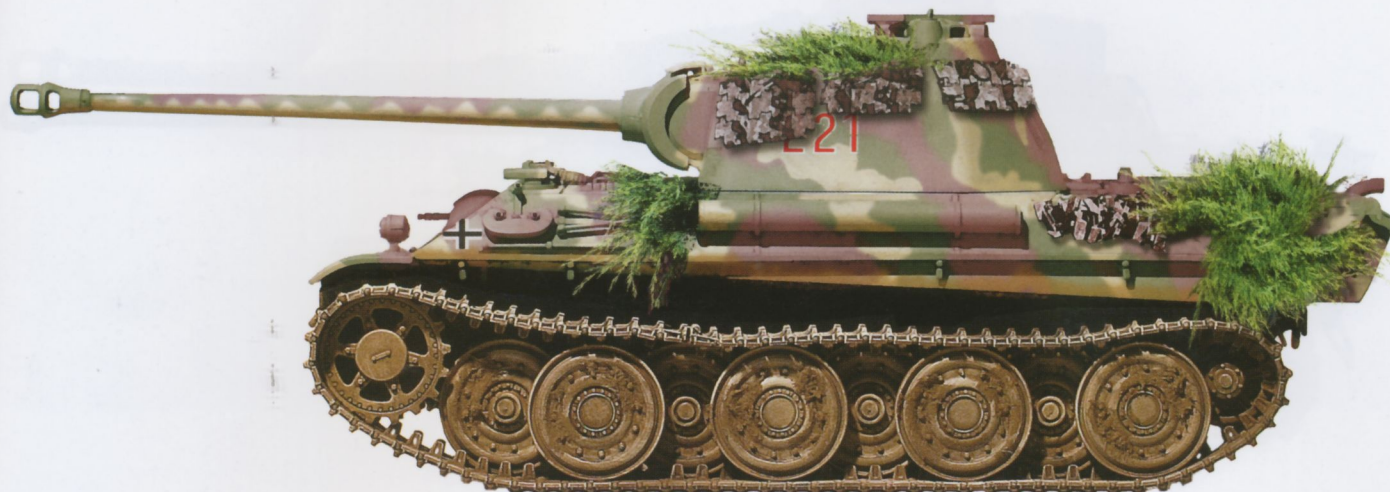
**Panther Ausf. G, 2./Pz.Rgt.1, Kampfgruppe Peiper, 1.SS-Panzer-Division, La Gleize, Belgium, December 1944**

The improvised nature of camouflage painting of German AFVs was abandoned in the autumn of 1944 in favor of factory applied camouflage patterns. Due to paint shortages, the initial plan in September 1944 was to use the existing coating of red lead primer as the base color, with a pattern of dark yellow and green applied to this to conserve paint. The camouflage scheme here is typical of factory-painted Panthers manufactured in September-October 1944.

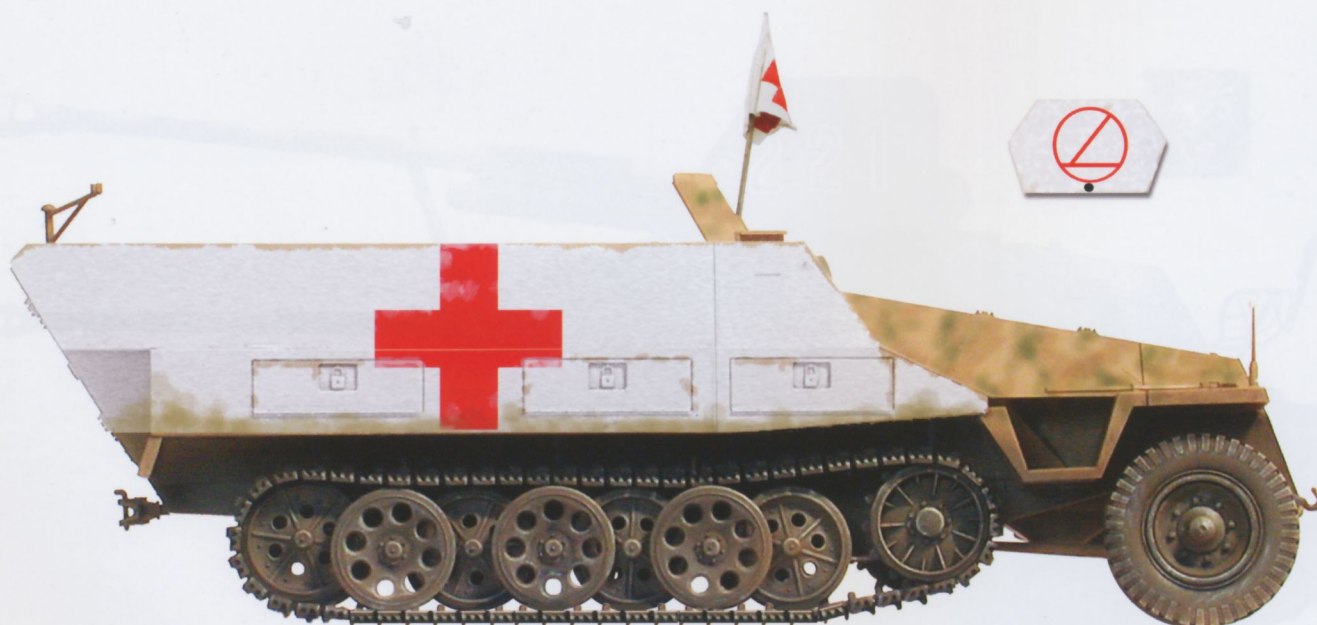
**Sd.Kfz.251 Ausf.D, US Army 84th Division, Germany, December 1944**

Captured German half-tracks were sometimes used by US Army infantry divisions, and in this particular case, it has been attached to a medical unit of the 84th Division during the fighting along the German frontier in December 1944. The rear sides have been painted white and a prominent Red Cross applied. The bow plate has also been repainted as seen in the inset drawing, and the divisional insignia, a simplified version of the division's "rail-splitter" arm patch, has been painted on to it.

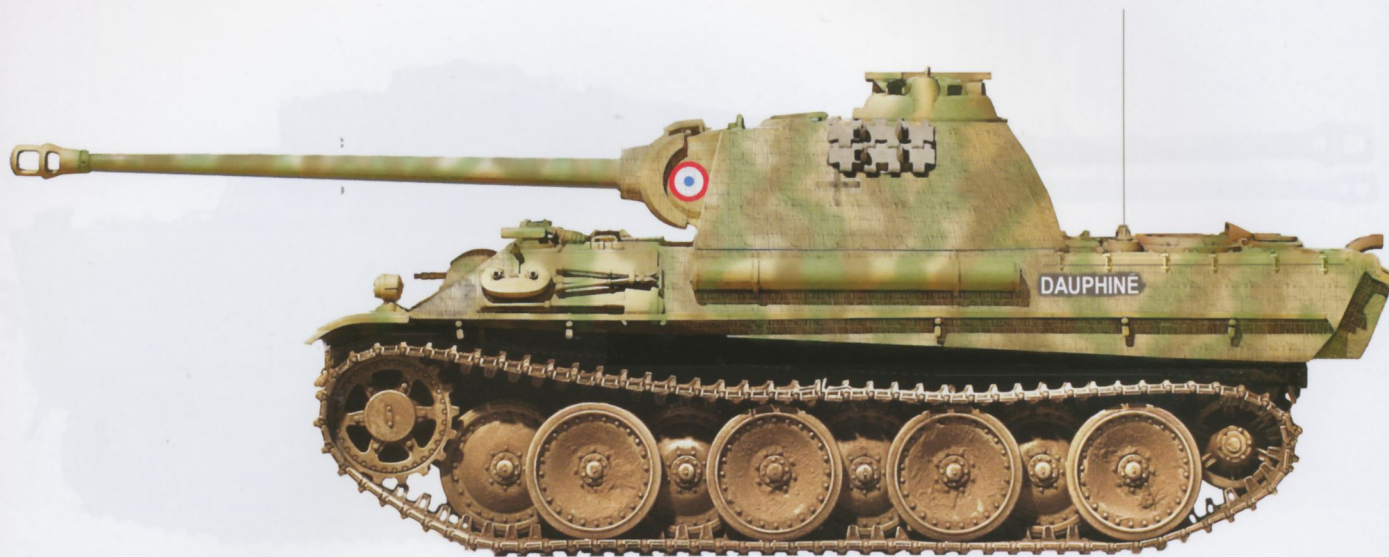
**Panther Ausf.G, French 1er Groupe Mobile de Reconnaissance FFI, St. Nazaire, March 1945**

The 1st GMR/FFI also found a single functional Panther in US Army ordnance yards in Normandy, which they christened "Dauphine". There are still traces of the German Balkan cross on the turret side, and a prominent French tri-color cocarde has been painted on the side of the gun trunnions

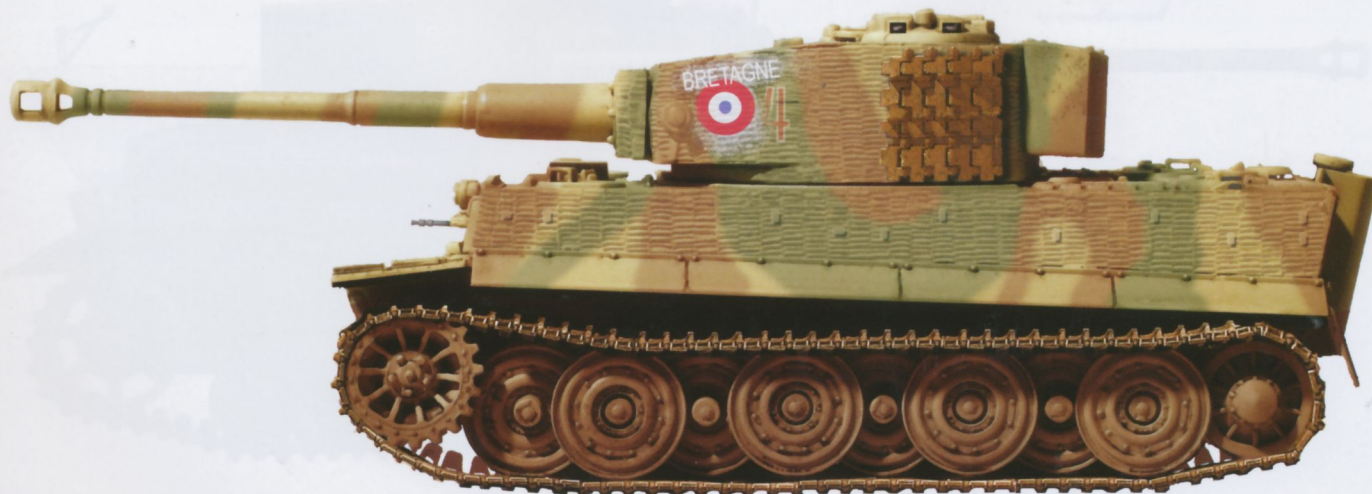
**Tiger I, French 1er Groupe Mobile de Reconnaissance FFI, St. Nazaire, March 1945**

The 1st GMR/FFI had two Tigers in March 1945, a Tiger I and a Kingtiger. The Tiger I was renamed "Bretagne" as seen here and the French tricolor cocarde painted on the turret side. There is slight evidence of the original German tactical number on the turret side, ending in "4". These vehicles were mostly left in their original German colors.

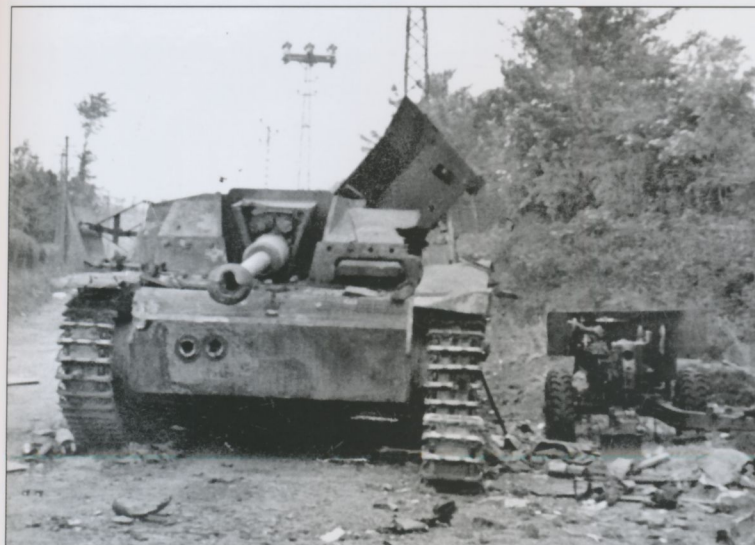
A StuG III Ausf.G knocked out while supporting the Grenadier Regiment 1058 attacks on US paratroopers in St. Mere Eglise following the D-Day landings. This one was hit no fewer than four times, but from the size of the gouges on the bow, it was probably a victim of M4 tanks of the 746th Tank Battalion. An airborne 57mm anti-tank gun sits beside it.

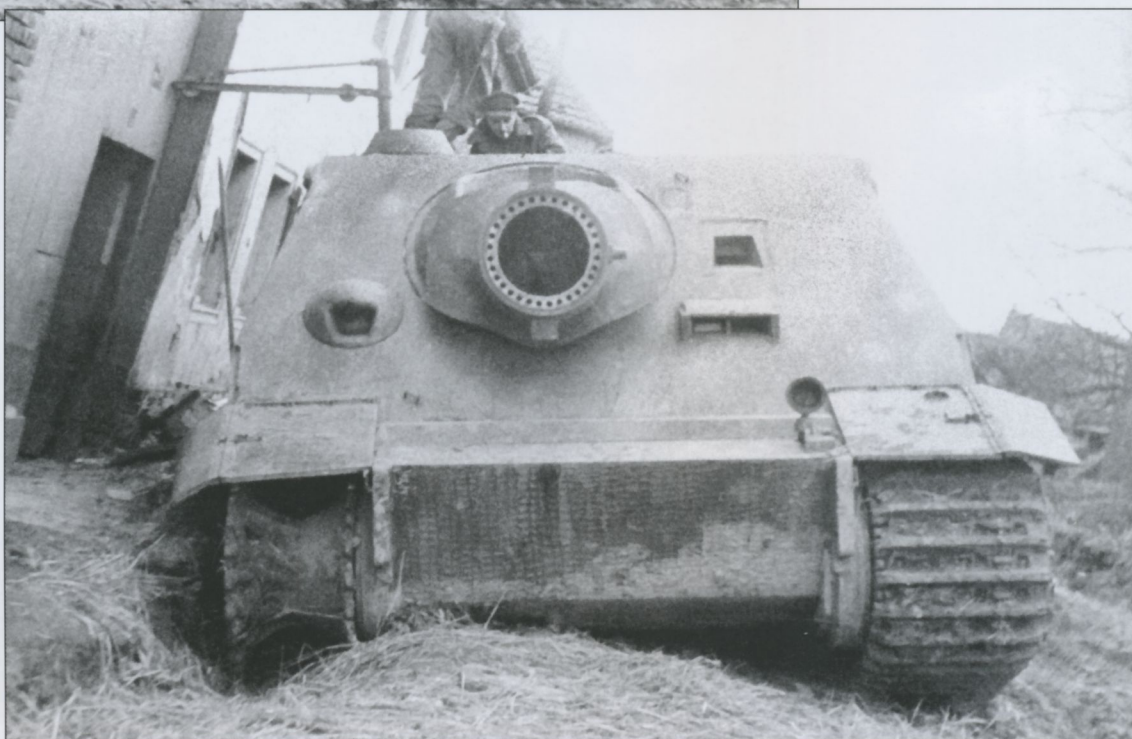
Another view of the Sturmtiger in Duren from the front.

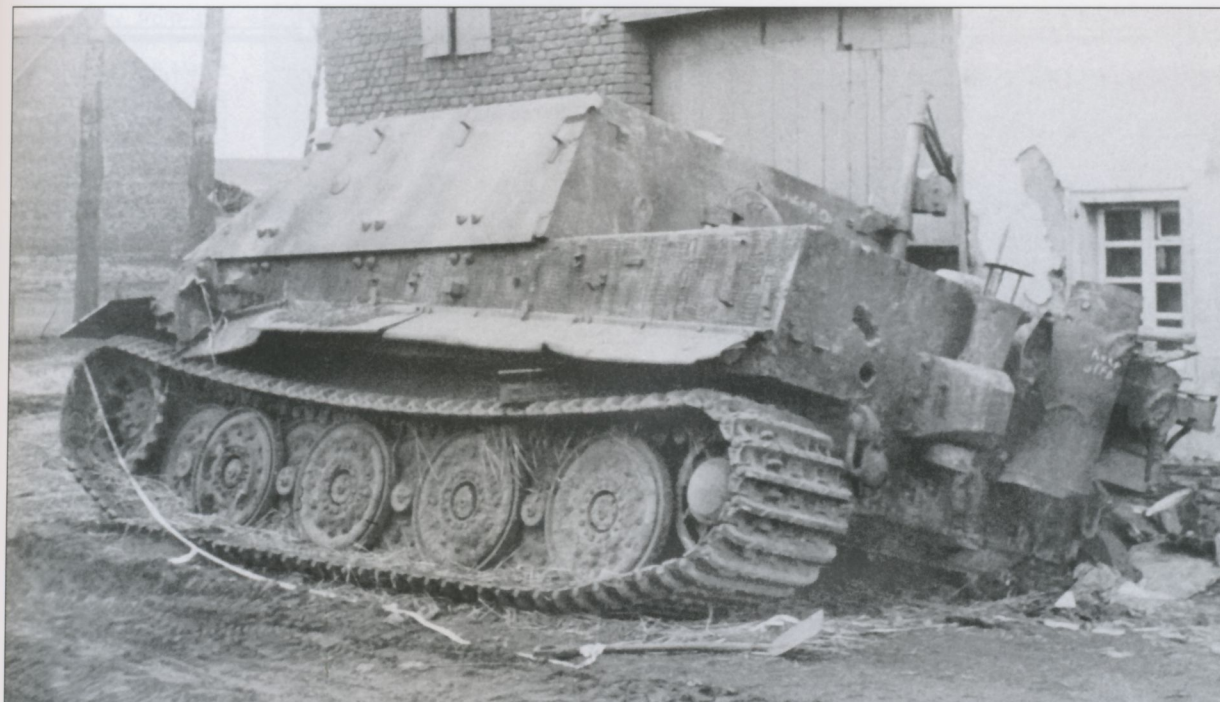
Another rear detail view of the Duren Sturmtiger.

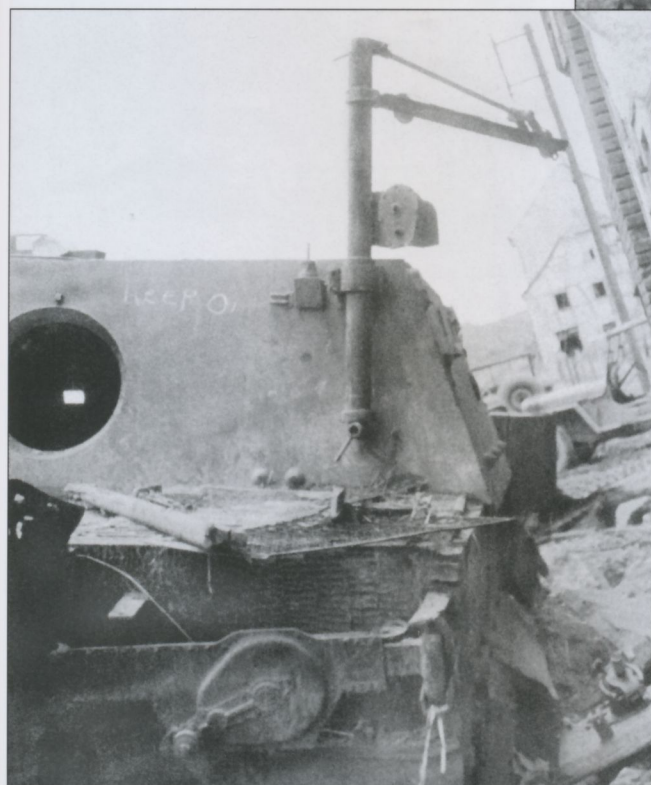
A detailed rear view showing the ammunition loading crane of the Duren Sturmtiger.

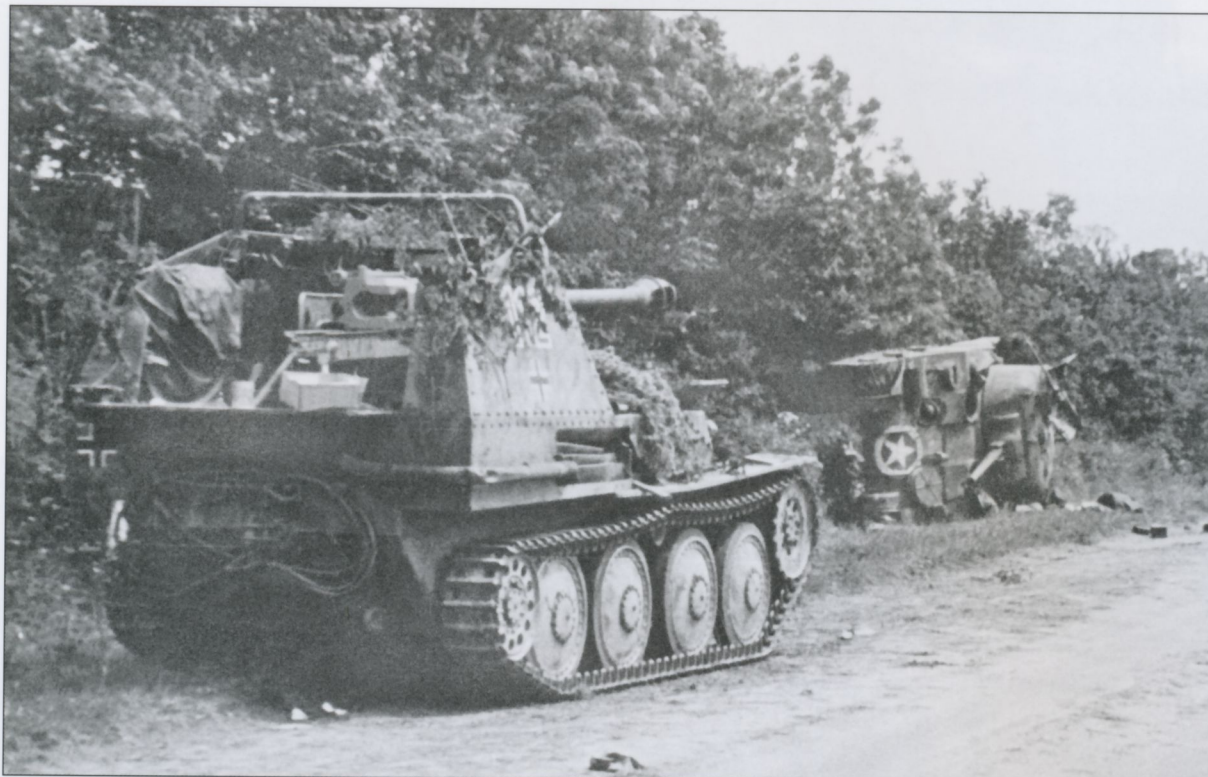
This Marder III Ausf. M from Pz.Jg.Abt.243 was captured by the 82nd Airborne Division during the fighting on the Cotentin peninsula in Normandy in June 1944, and a knocked out M4 medium tank can be seen in front of it.

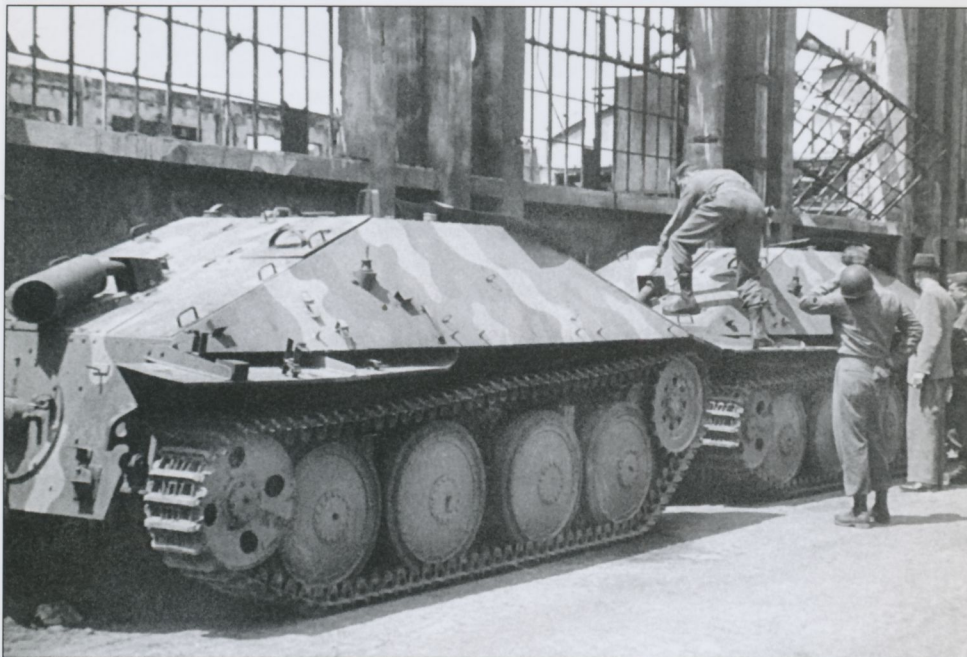
The US Army ordnance team inspects some Hetzers outside the plant in the final Skoda pattern camouflage.

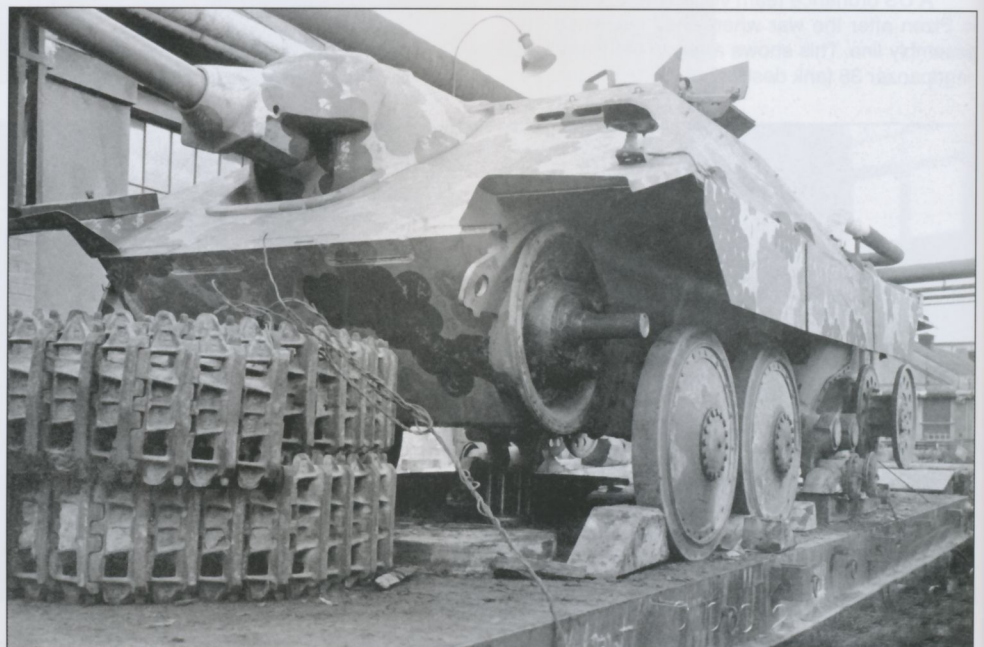
This Jagdpanzer 38 was also found at the Skoda plant but is from the initial summer 1944 production batches with the typical Skoda pattern ambush camouflage.

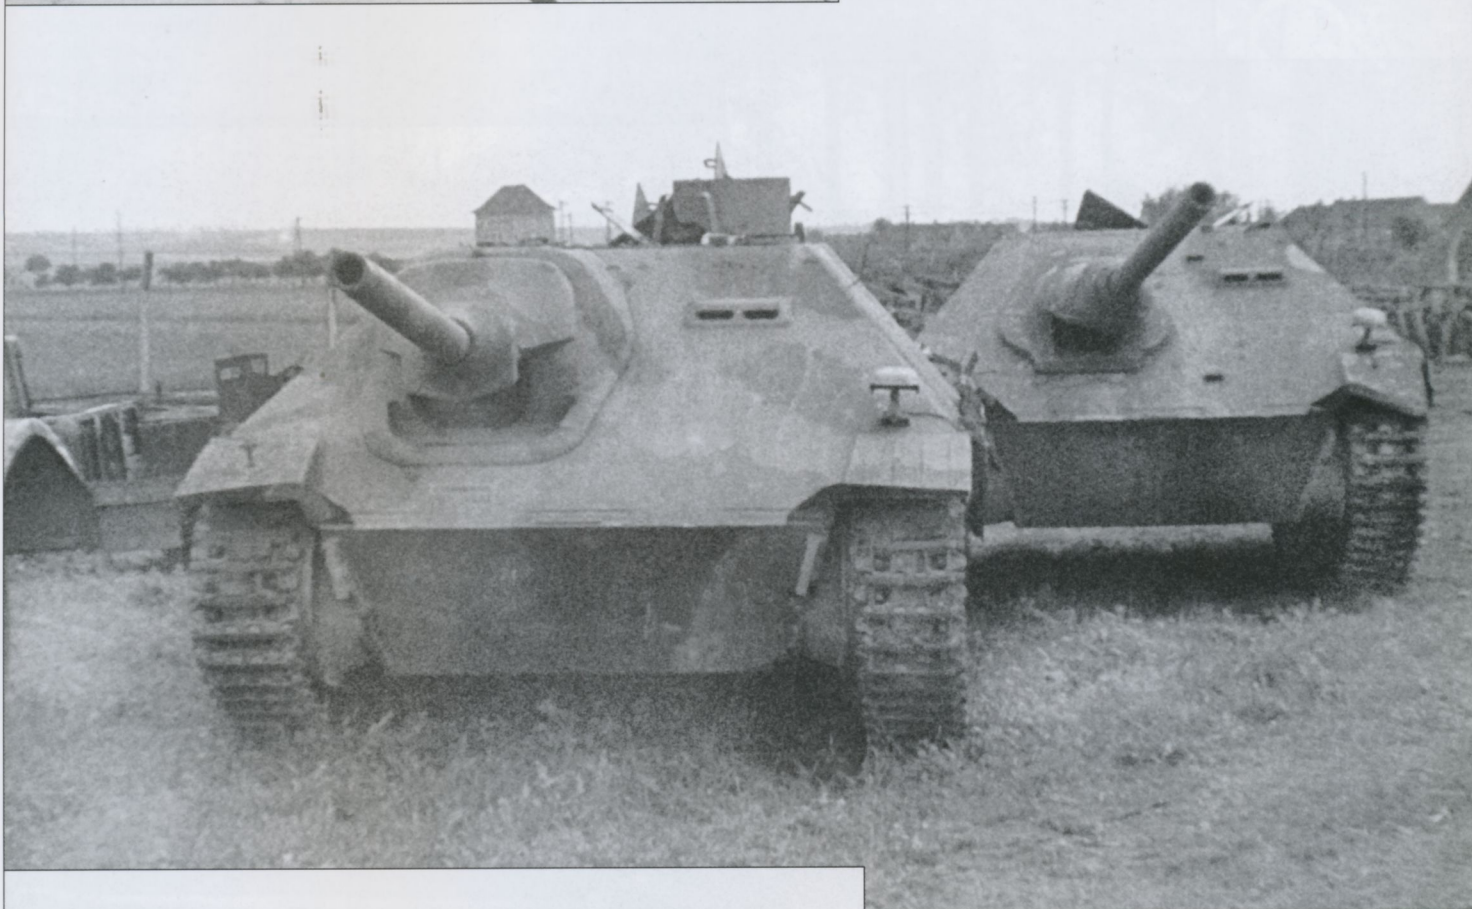
This pair of Jagdpanzer 38 were found at the Rheinmetall proving ground at Hillersleben and the vehicle to the right is one of the rare Jagdpanzer 38 Starr with its unique mantlet. This photo is doubly rare, as few Starr vehicles ever left Czech territory.

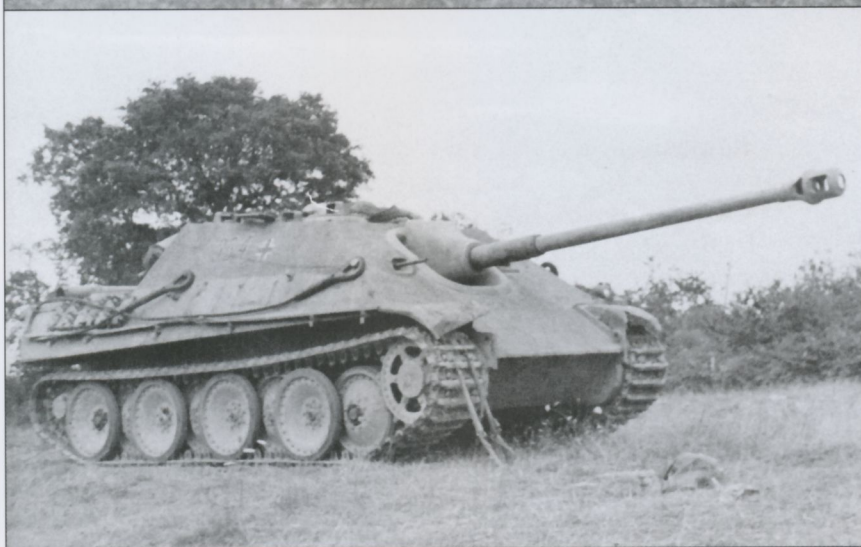
The Jagdpanther was first encountered in Normandy, serving with a company from s.Pz.Jg.Abt.654. As a result, when the first few were captured, they were the source of considerable interest by US Army technical intelligence. This photo was taken by a technical intelligence team of the US First Army.

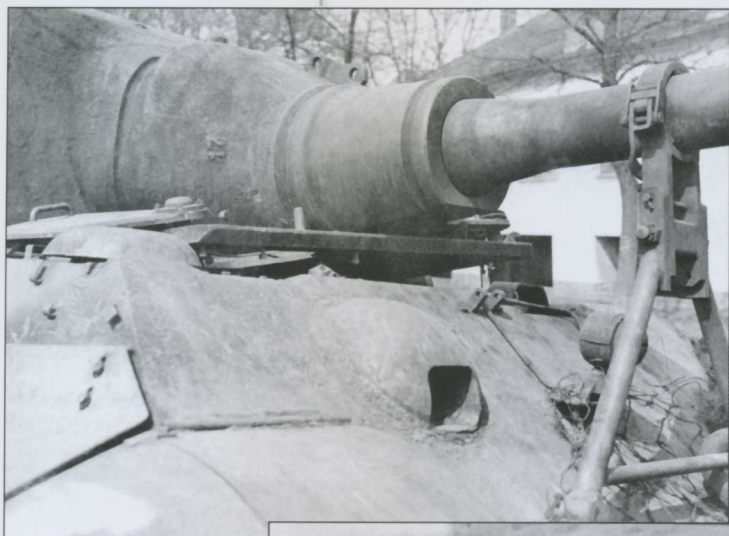
Another view of one of the Paderborn Jagdtigers showing a close-up of the mantlet and the heavy barrel travel lock.

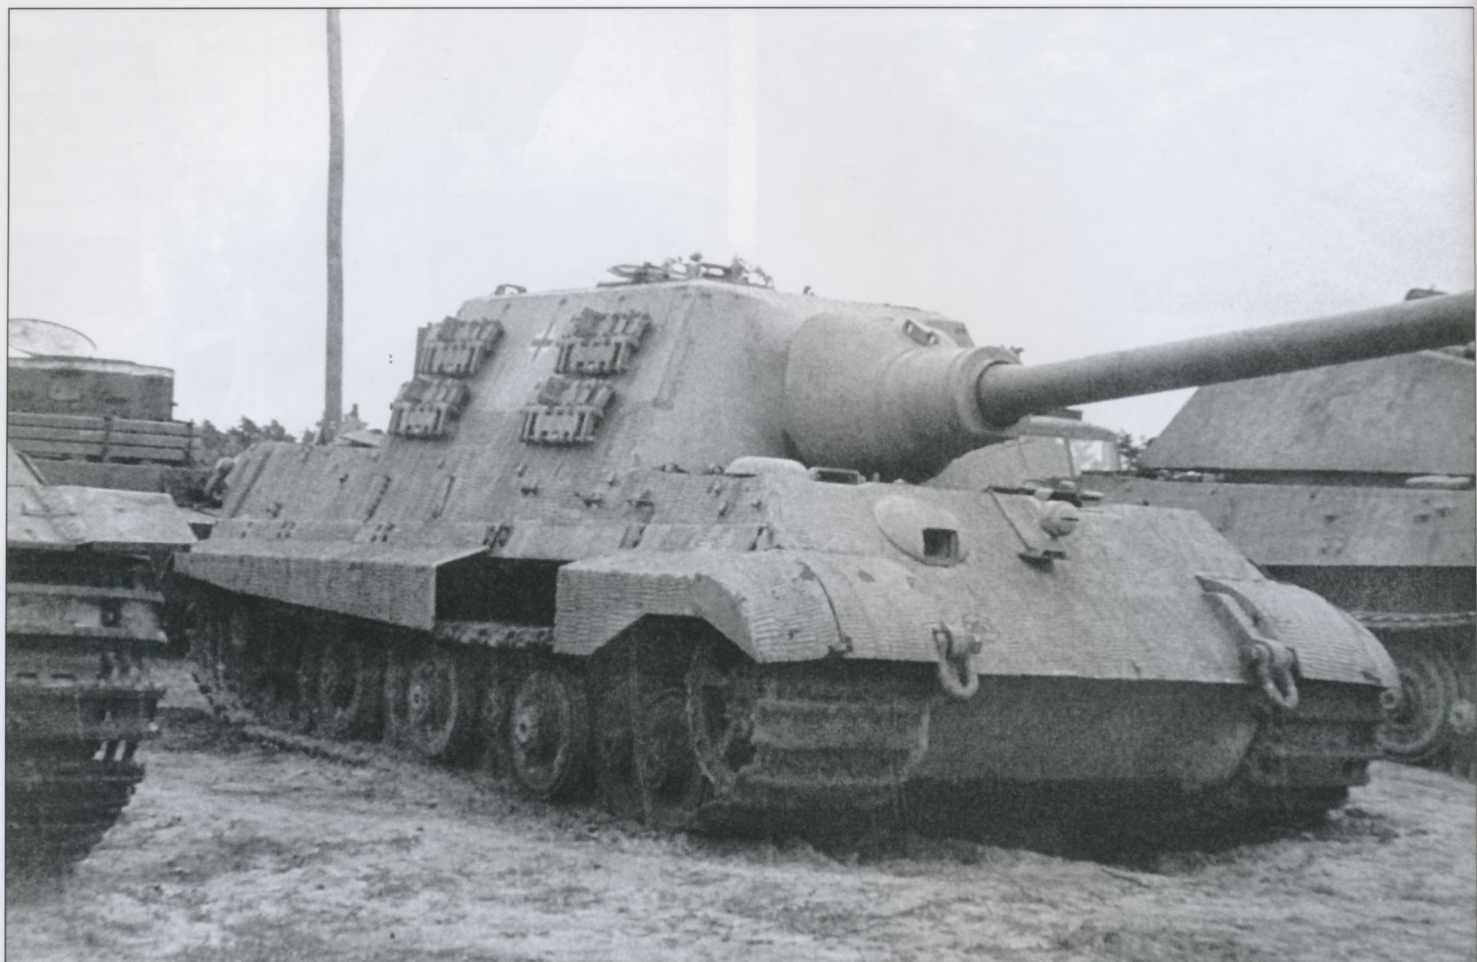
A US technical intelligence team after the fighting photographed this pilot Jagdtiger at the Henschel proving ground at Haustenbeck near the Henschel and Wegman plants in Kassel. It is one of the two initial vehicles built with the Porsche suspension.
