# Panzers in the Gunsights

German AFVs in the ETO 1944-45 in US Army Photos

Steven J. Zaloga

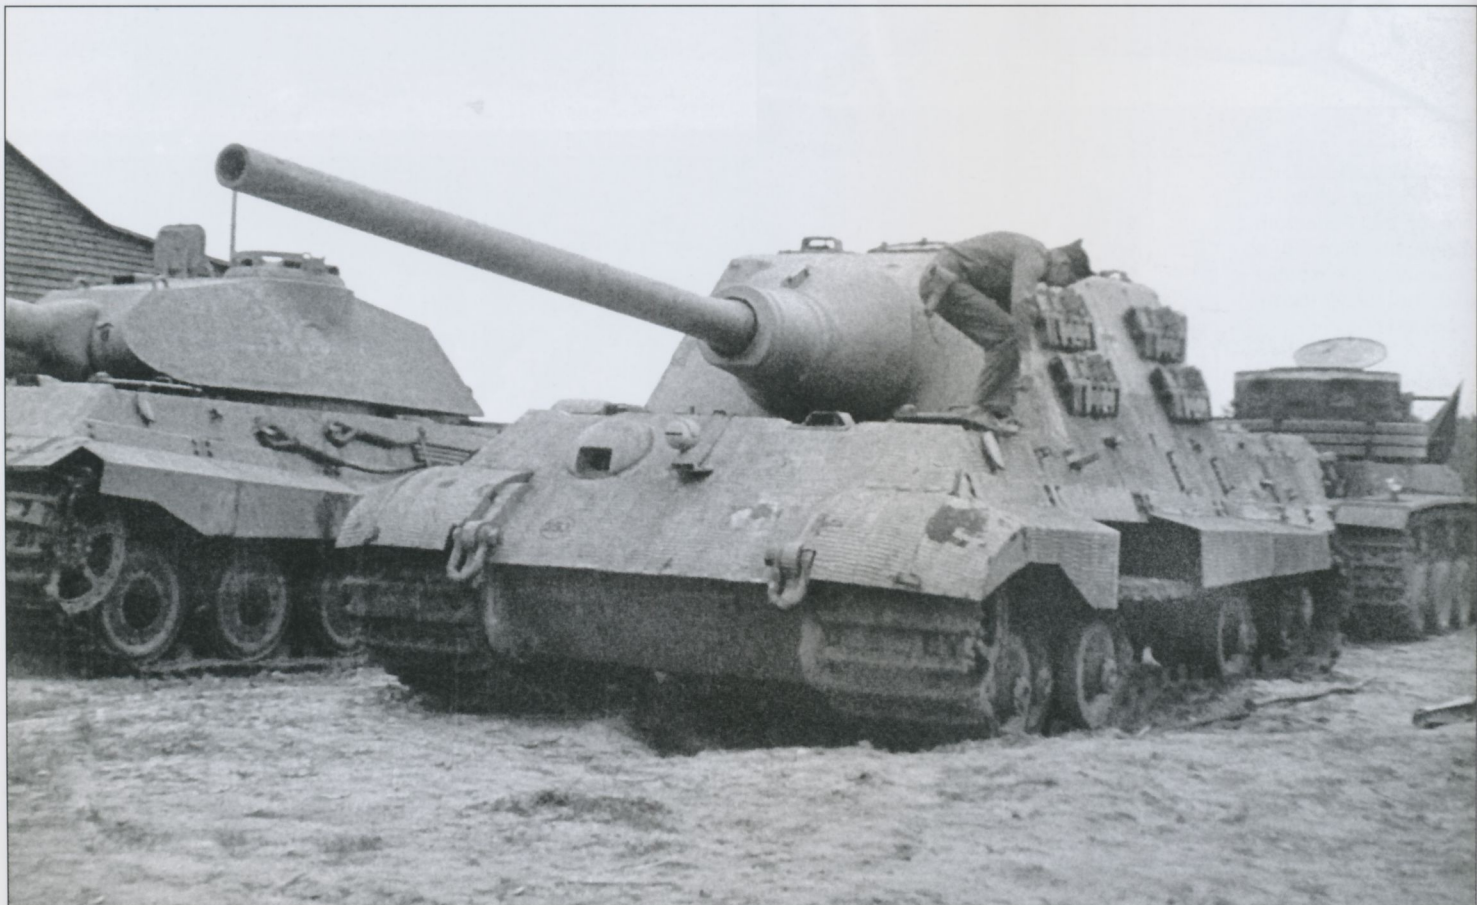
Another view from the left hand side of the Haustenbeck Jagdtiger pilot.

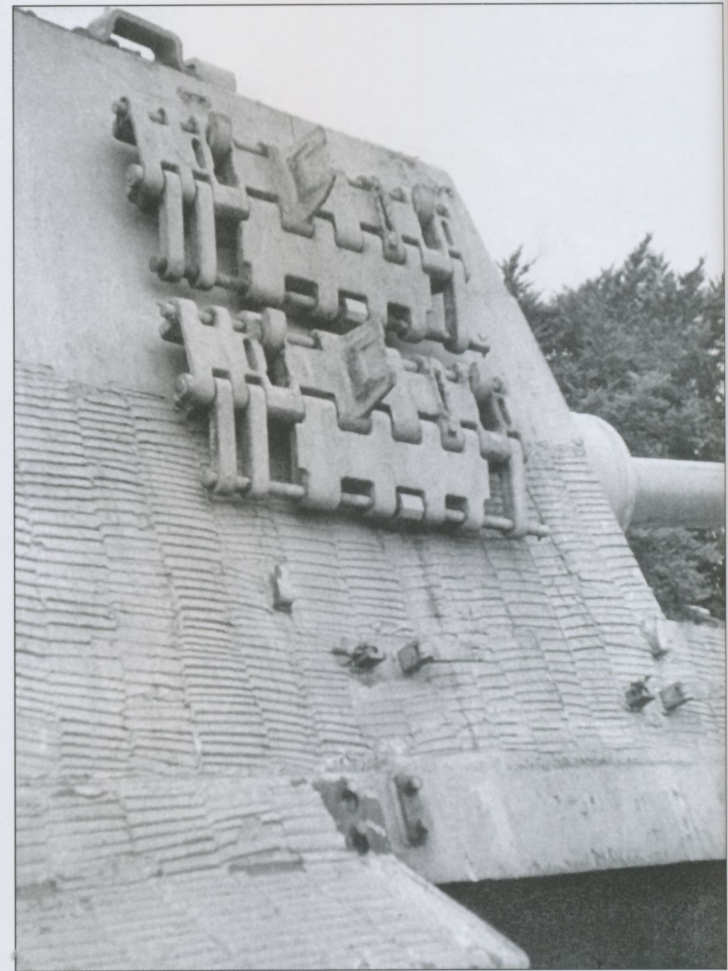
A detail view of the Haustenbeck Jagdtiger showing the spare track link stowage on the right hull side.

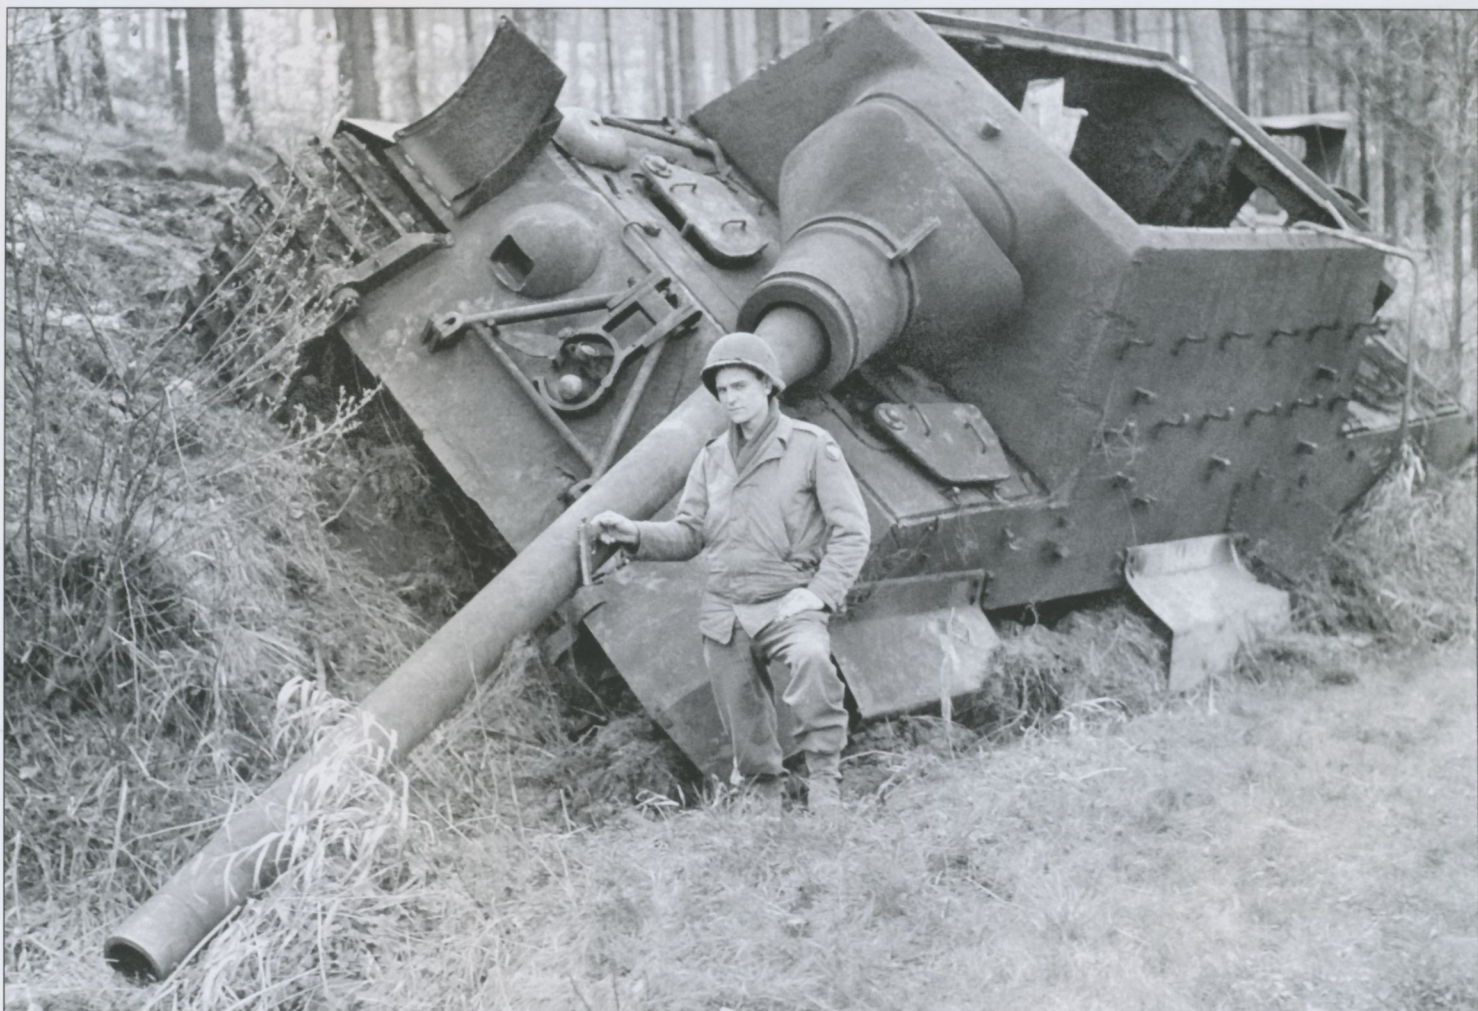
A Jagdtiger of s.Pz.Jg.Abt.512 claimed by a Sherman of the 750th Tank Battalion seen here after it was pushed off a road near Offensen, Germany on 9 April 1945. An internal ammunition fire has blown off the roof.

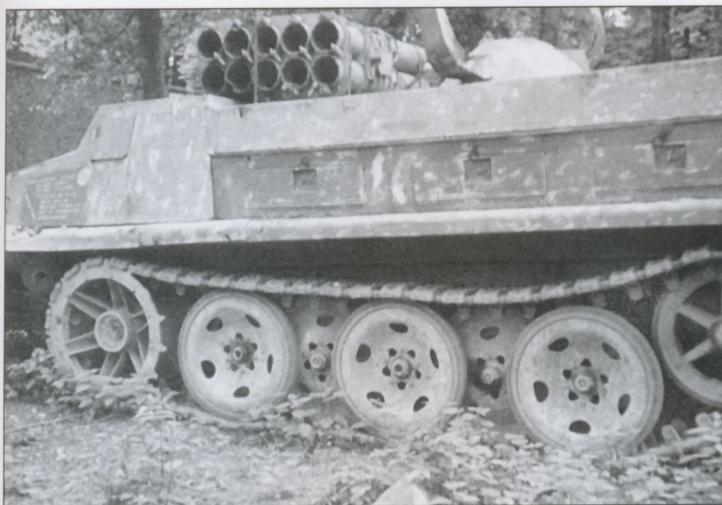
A closer view with the rocket rack off the trunnion.

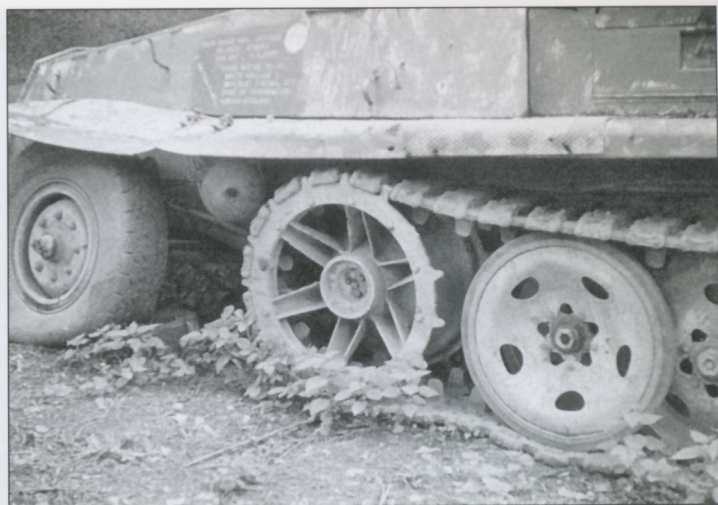
A close-up photo of the drive sprocket and suspension detail of Thorn.

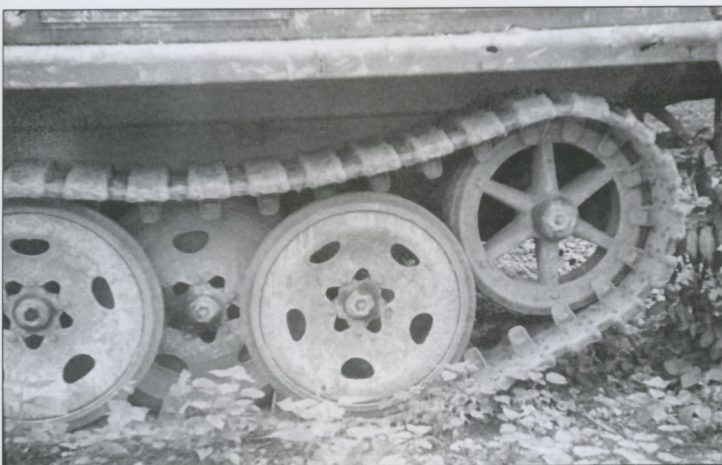
A close-up of the rear road-wheels and idler wheel of Thorn.

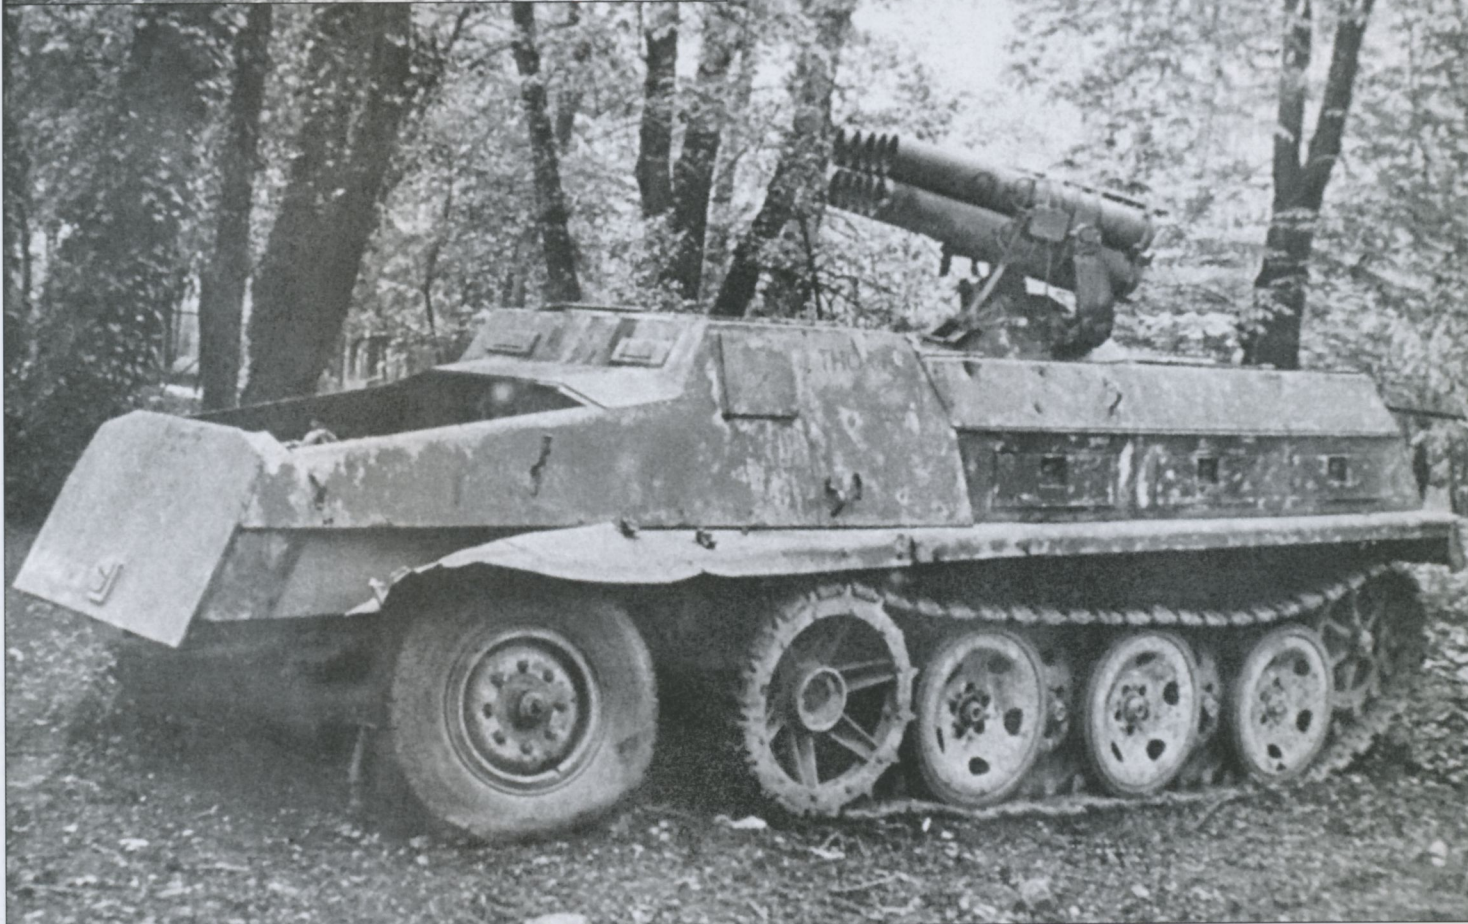
Another view of Thorn with the rocket rack in place.

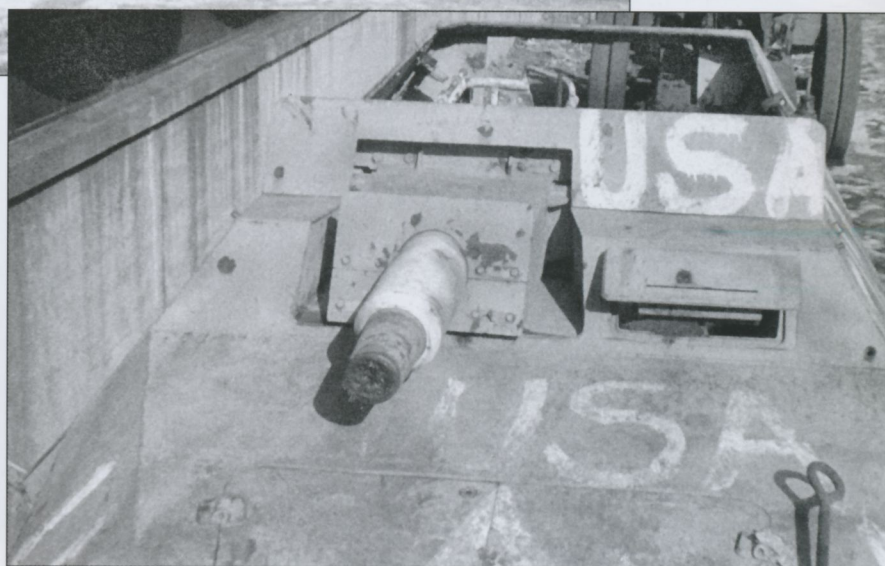
Another view of the 2.Panzer-Division Stummel providing a more detailed version of the original configuration of the 7.5cm howitzer mounting on the Sd.Kfz.251/9.

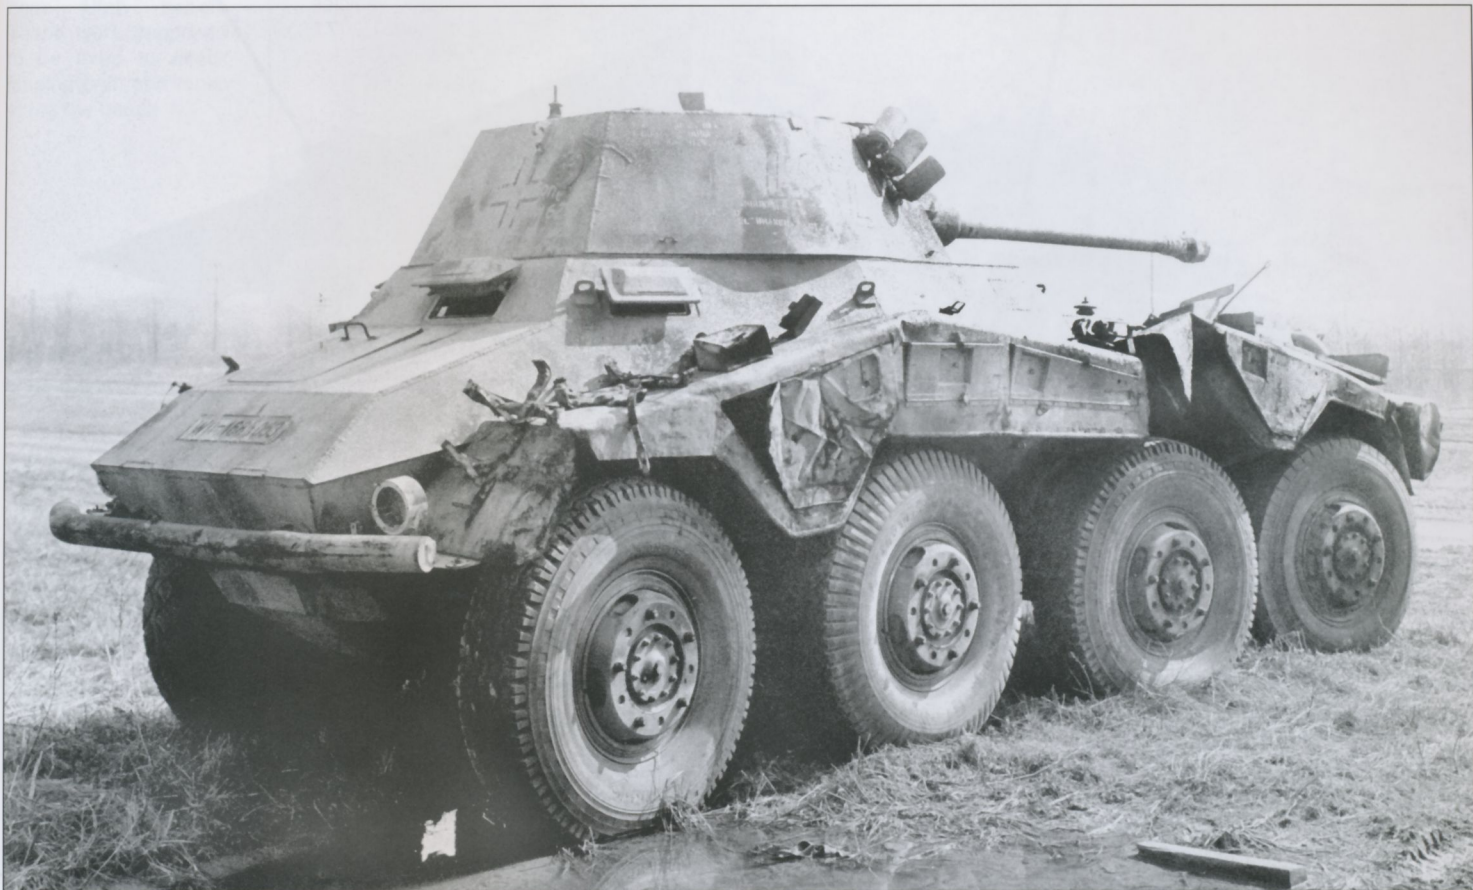
This Sd.Kfz.234 Puma armored car was the example shipped back to Aberdeen Proving Ground for trials. It was subsequently scrapped.

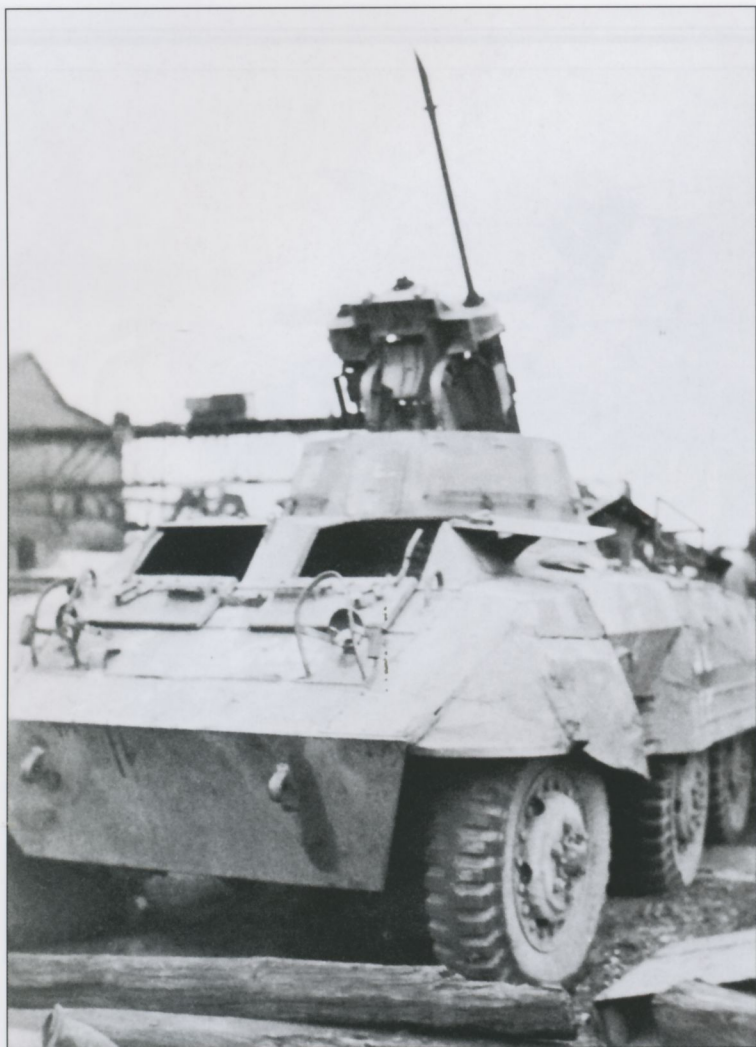
While captured US M8 armored cars were not particularly rare, this version certainly was. It has been reequipped with a 1.5cm Drilling anti-aircraft cannon mount instead of its usual 37mm gun.

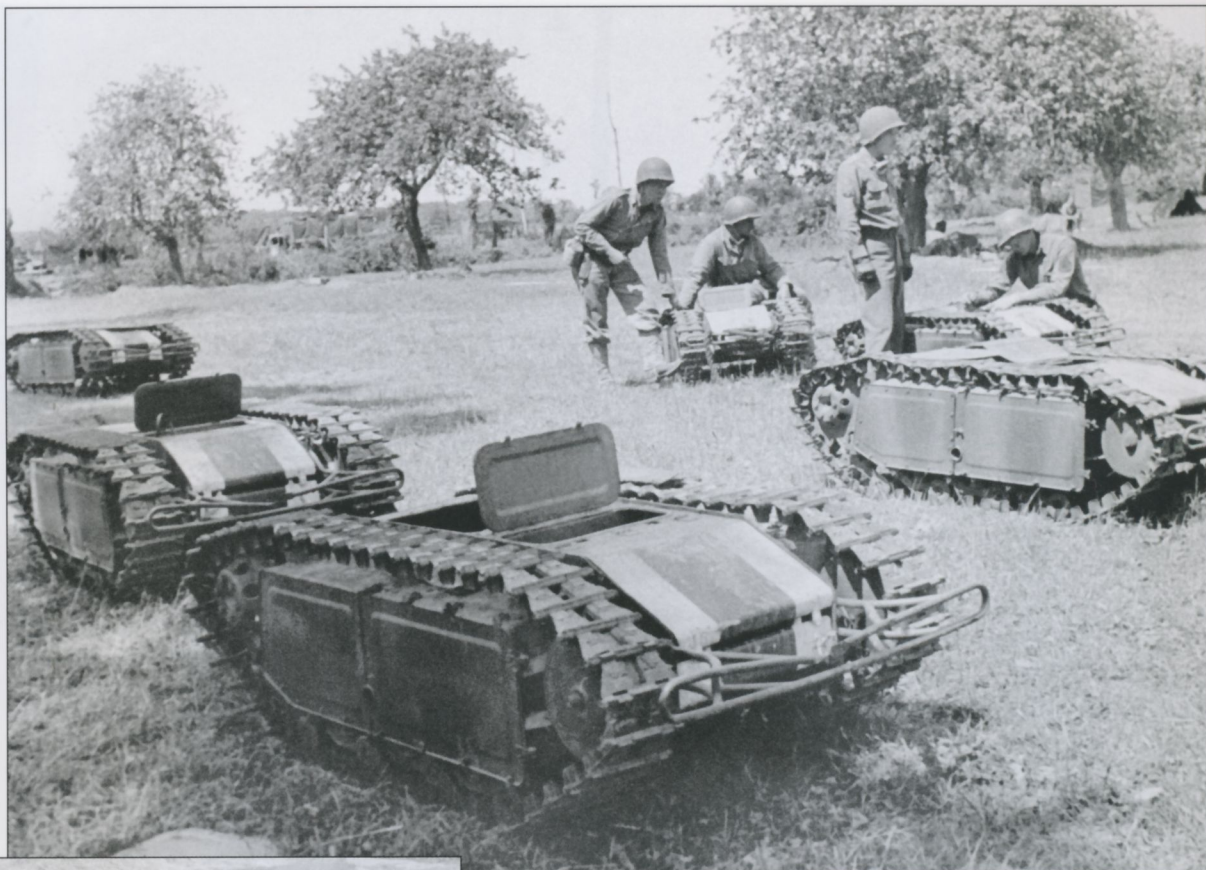
The Goliath remote control mines were deployed with several German static defense divisions on the Normandy coast in the weeks prior to the D-Day landing. They were not widely used in combat, often due to the disruption of the wire control link. These were found by US troops near Utah Beach.

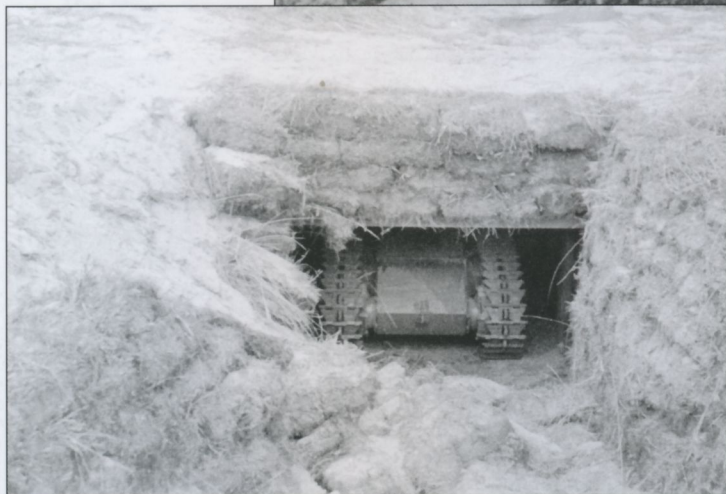
Another view of a group of Goliath mines near Utah beach. These were supposed to be used to attack landing craft and tanks along the beach.

The Goliaths were deployed in small hidden caves along the beach. Attempts by the WN 5 strongpoint at Utah Beach to use their Goliaths failed when the Allied preparatory bombardment severed the wire control lines leading to the command bunker.

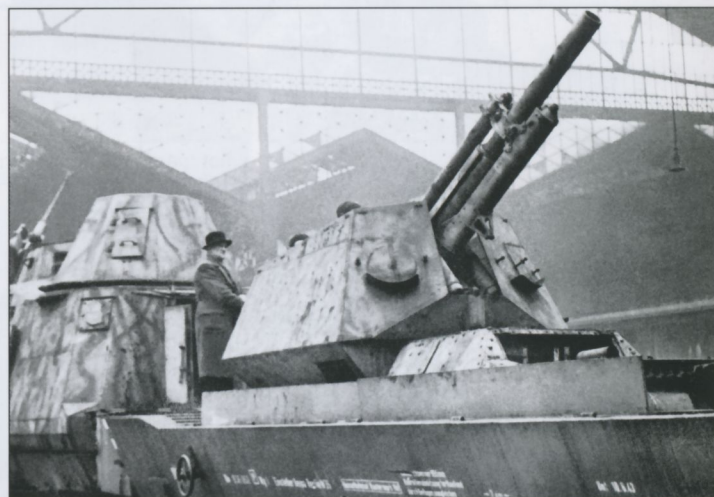
This is Panzerzug 32, a German armored train captured on 7 September 1944 by French troops in the station of St. Berain-sur-Dheune. This artillery car carries a Chennillette Lorraine converted into a self-propelled howitzer using a Soviet 122mm M30 howitzer.

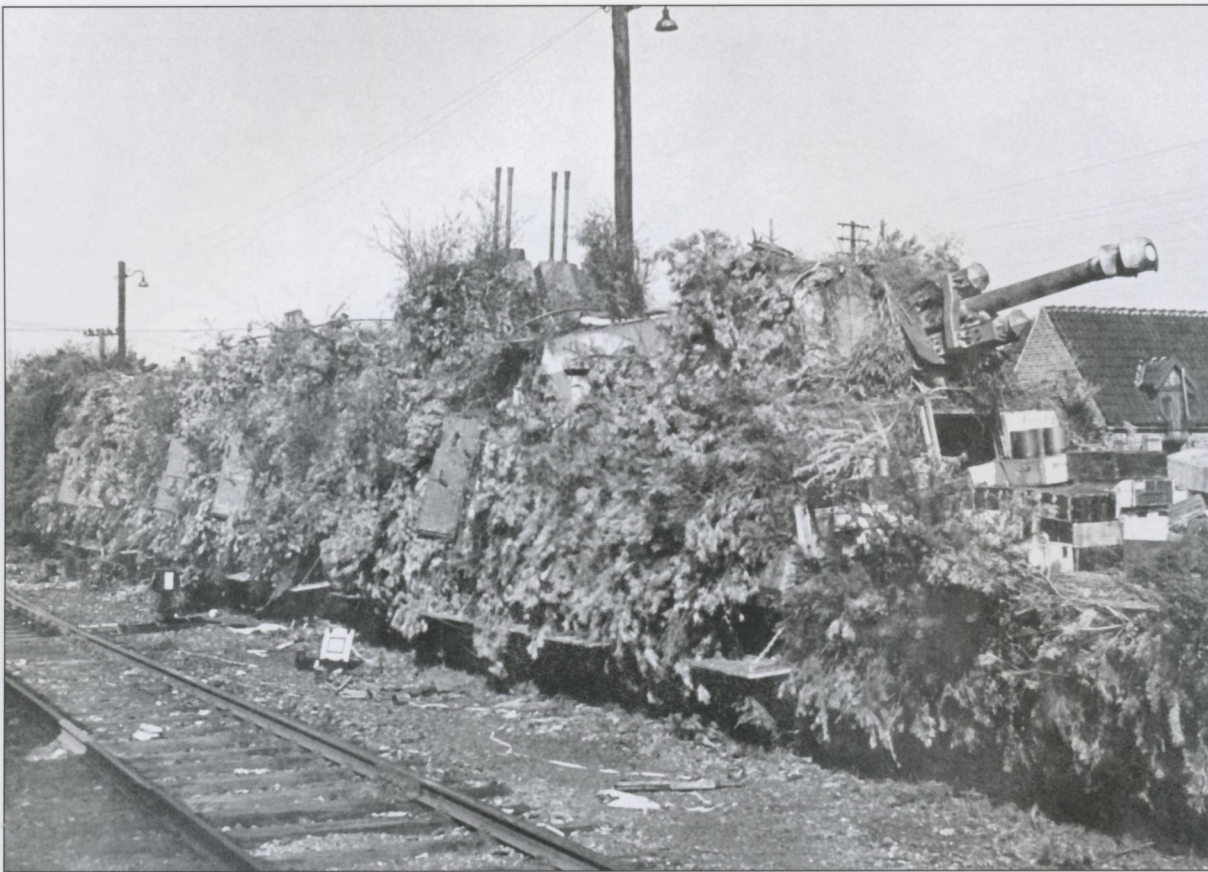
Another view of Panzerzug 32 after its capture. This train became famous after the war as one of the elements in the film "La Bataille du rail" in which it was blown up.

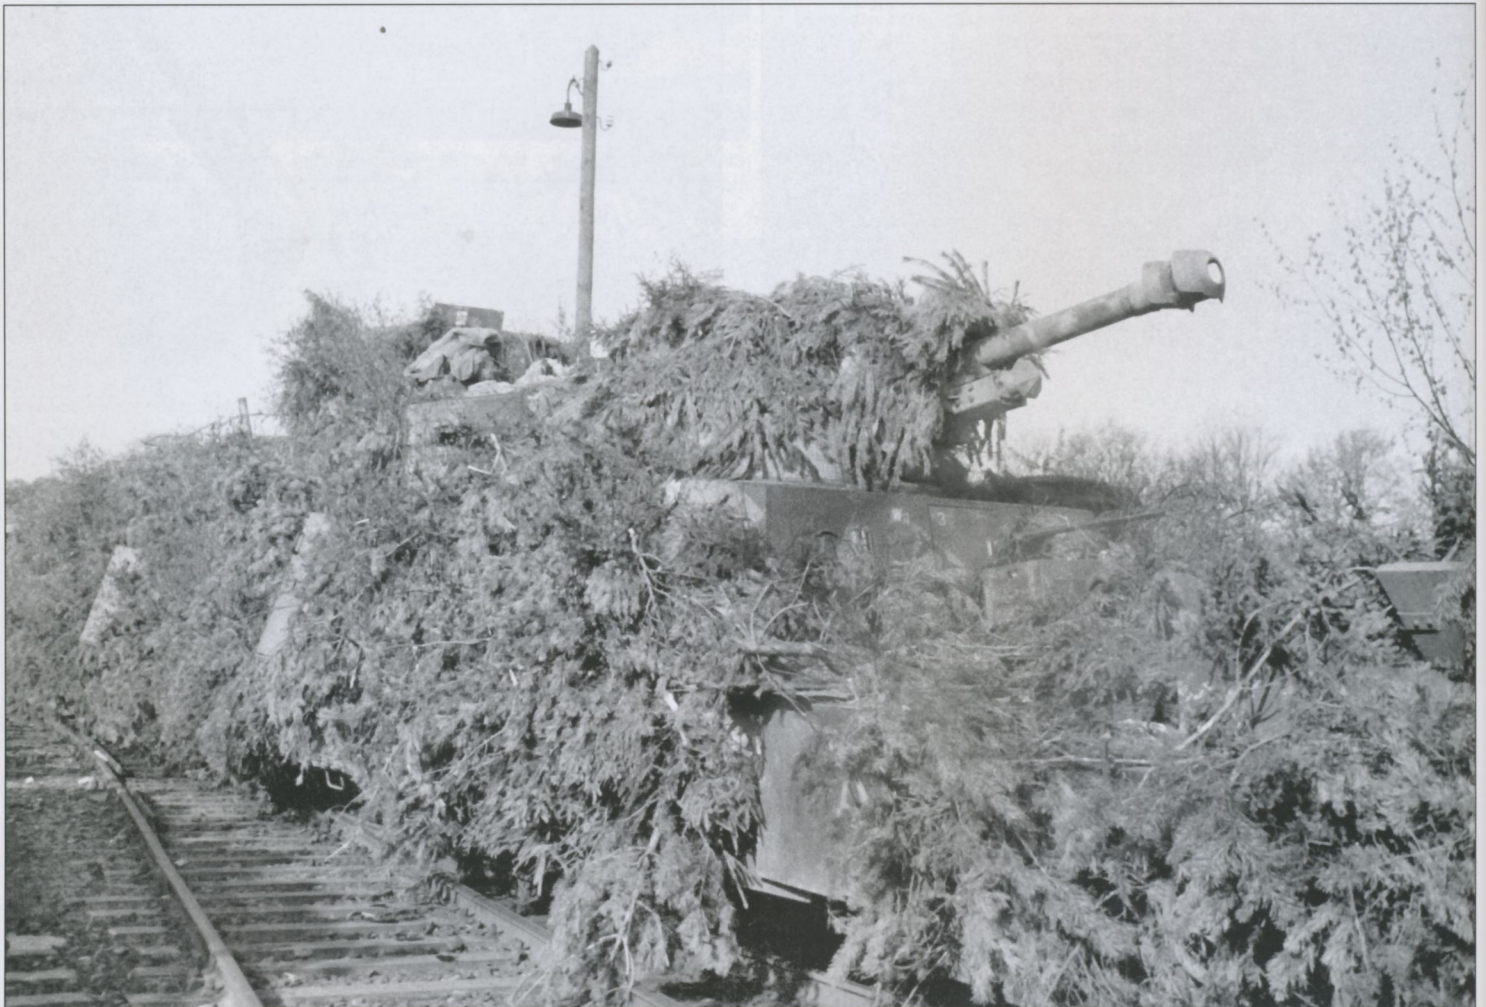
This armored train was captured by US forces near Hagenow, Germany in May 1945. The nearest flatcar carries a turreted 10.5cm leFH18 and behind it is a car with a 2cm FlaK 38 mounting. These trains were not commonly used on the Western Front, and this may be a train that had retreated from the Eastern Front where they were widely used in anti-partisan warfare.

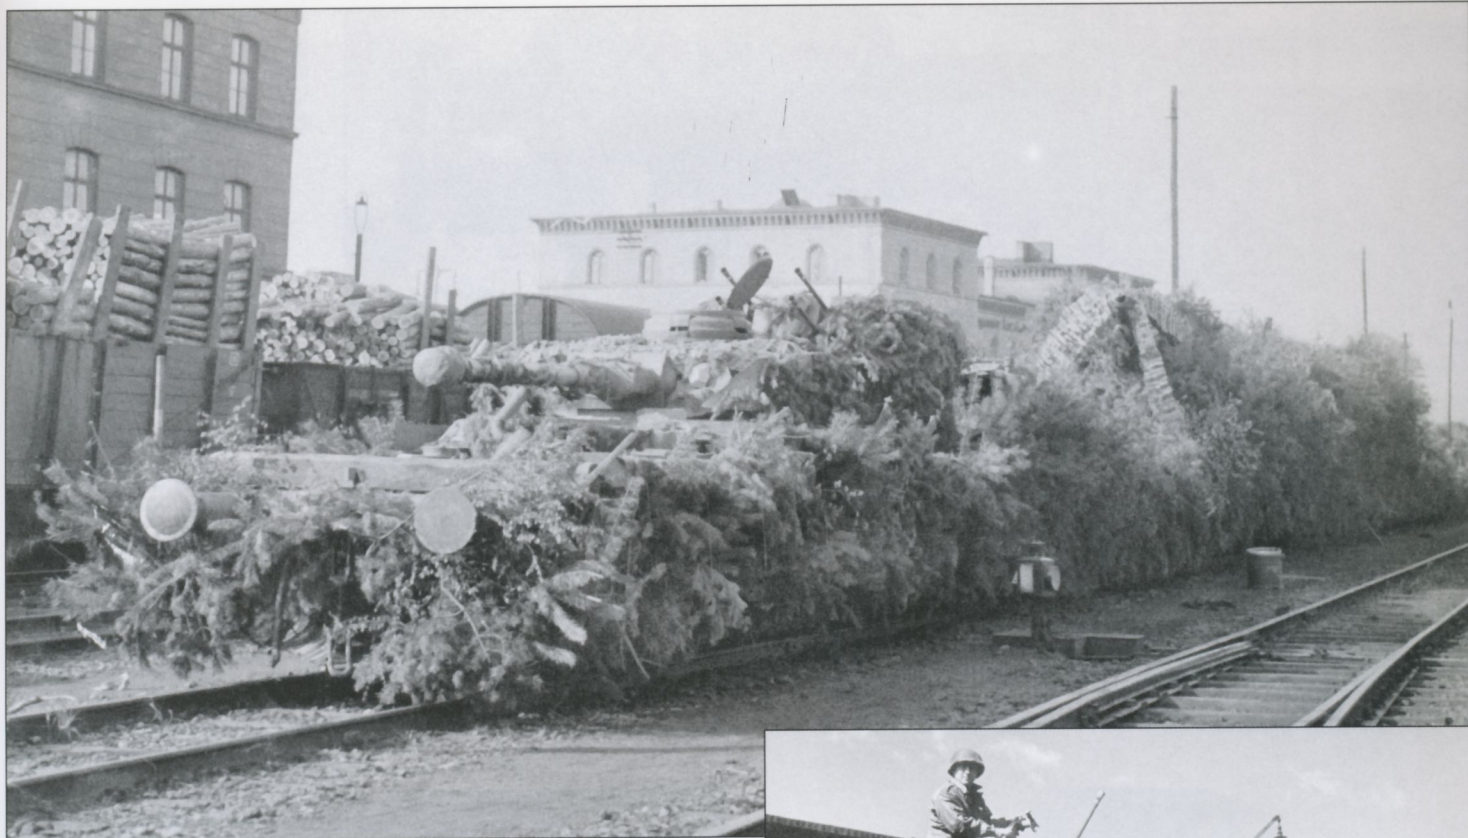
This is another flatcar on the same train with a second 10.5cm howitzer. The entire train is heavily draped in foliage to camouflage the train against its main nemesis- enemy air attack.

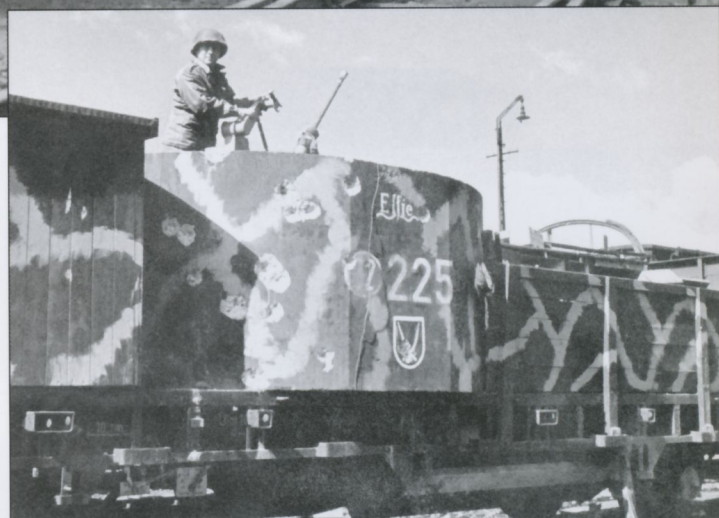
This shows the other end of the armored train armed with a flat-car mounting a Pz.Kpfw.IV turret.

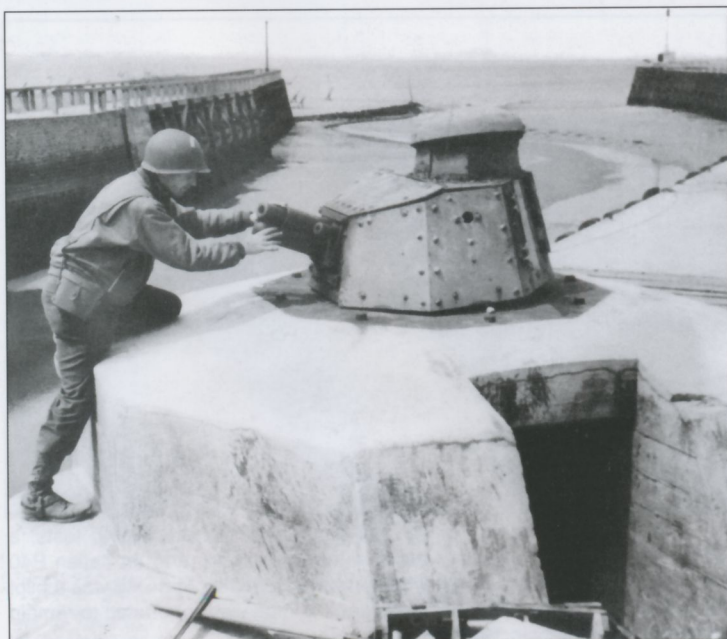
A GI looks over a 2cm flak cannon mounted in a concrete parapet for train defense on a train captured in Germany in April 1945. These types of protected mounts were used on armored trains as well as on regular transport trains for self-defense against Allied fighter-bombers.

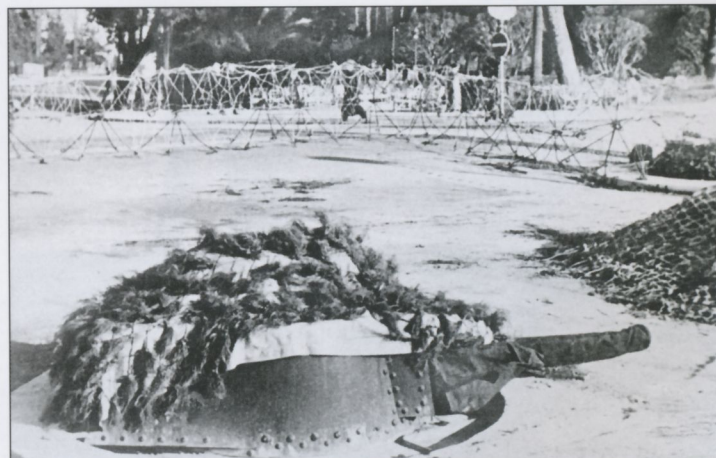
The obsolete Pz.Kpfw.38(t) turret was also widely used for coastal defense like this example near the coast in Marseilles.

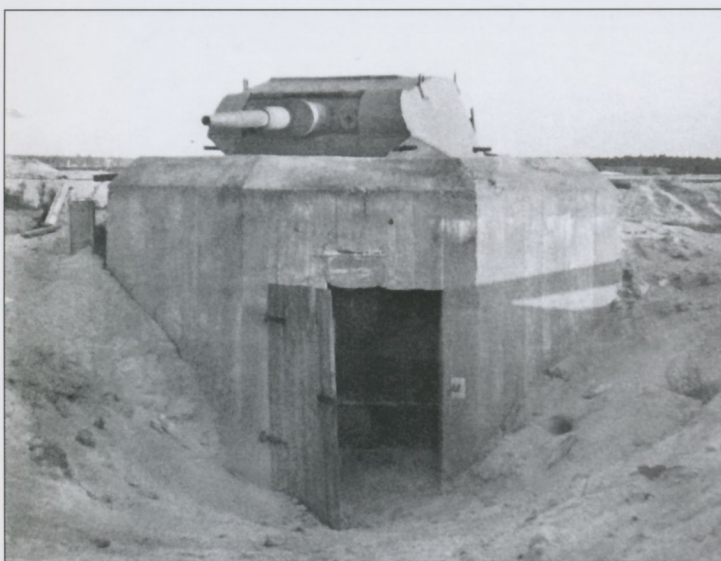
The Rheinmetall proving ground was one of the main test centers for *panzerstellung*, and this is an example of a Pz.Kpfw.38(t) *panzerstellung*.

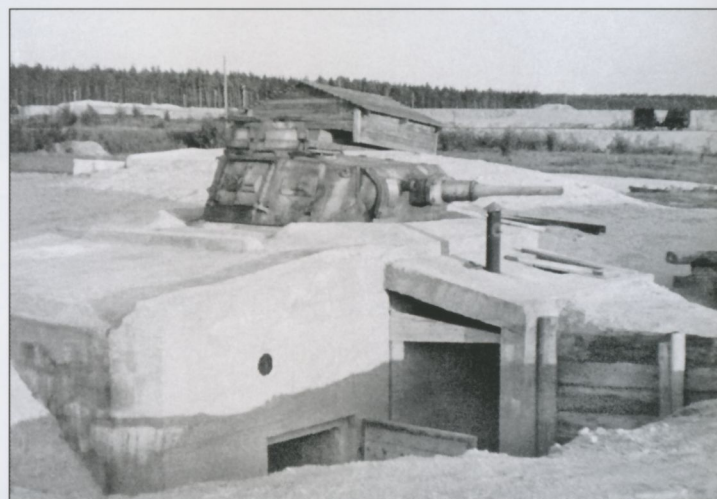
An example of a Pz.Kpfw.III *panzerstellung* at Hillersleben showing the rear armored access door.

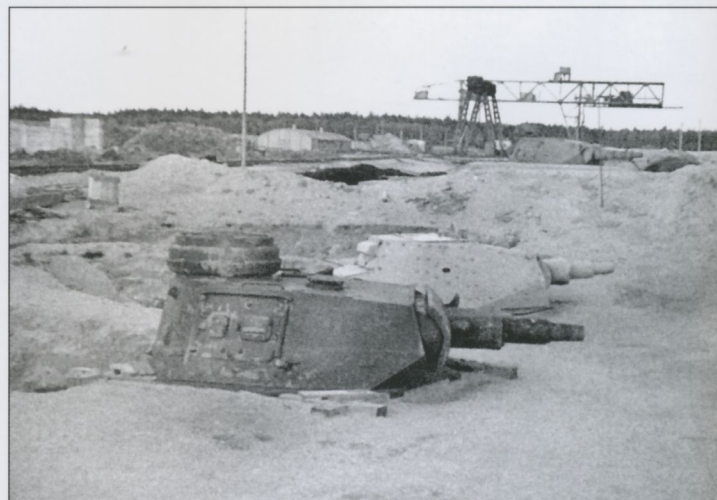
A Panther turret being tested with a *panzerstellung* at Hillersleben. This was presumably taken from an actual tank judging from the use of zimmerit.
