Panzerspähwagen 'Puma' (Sd.Kfz. 234/2) 5 cm KwK 39/1 L/60

# Panzerspähwagen in Action

Created by Uwe Feist  
Captions by Mike Dario

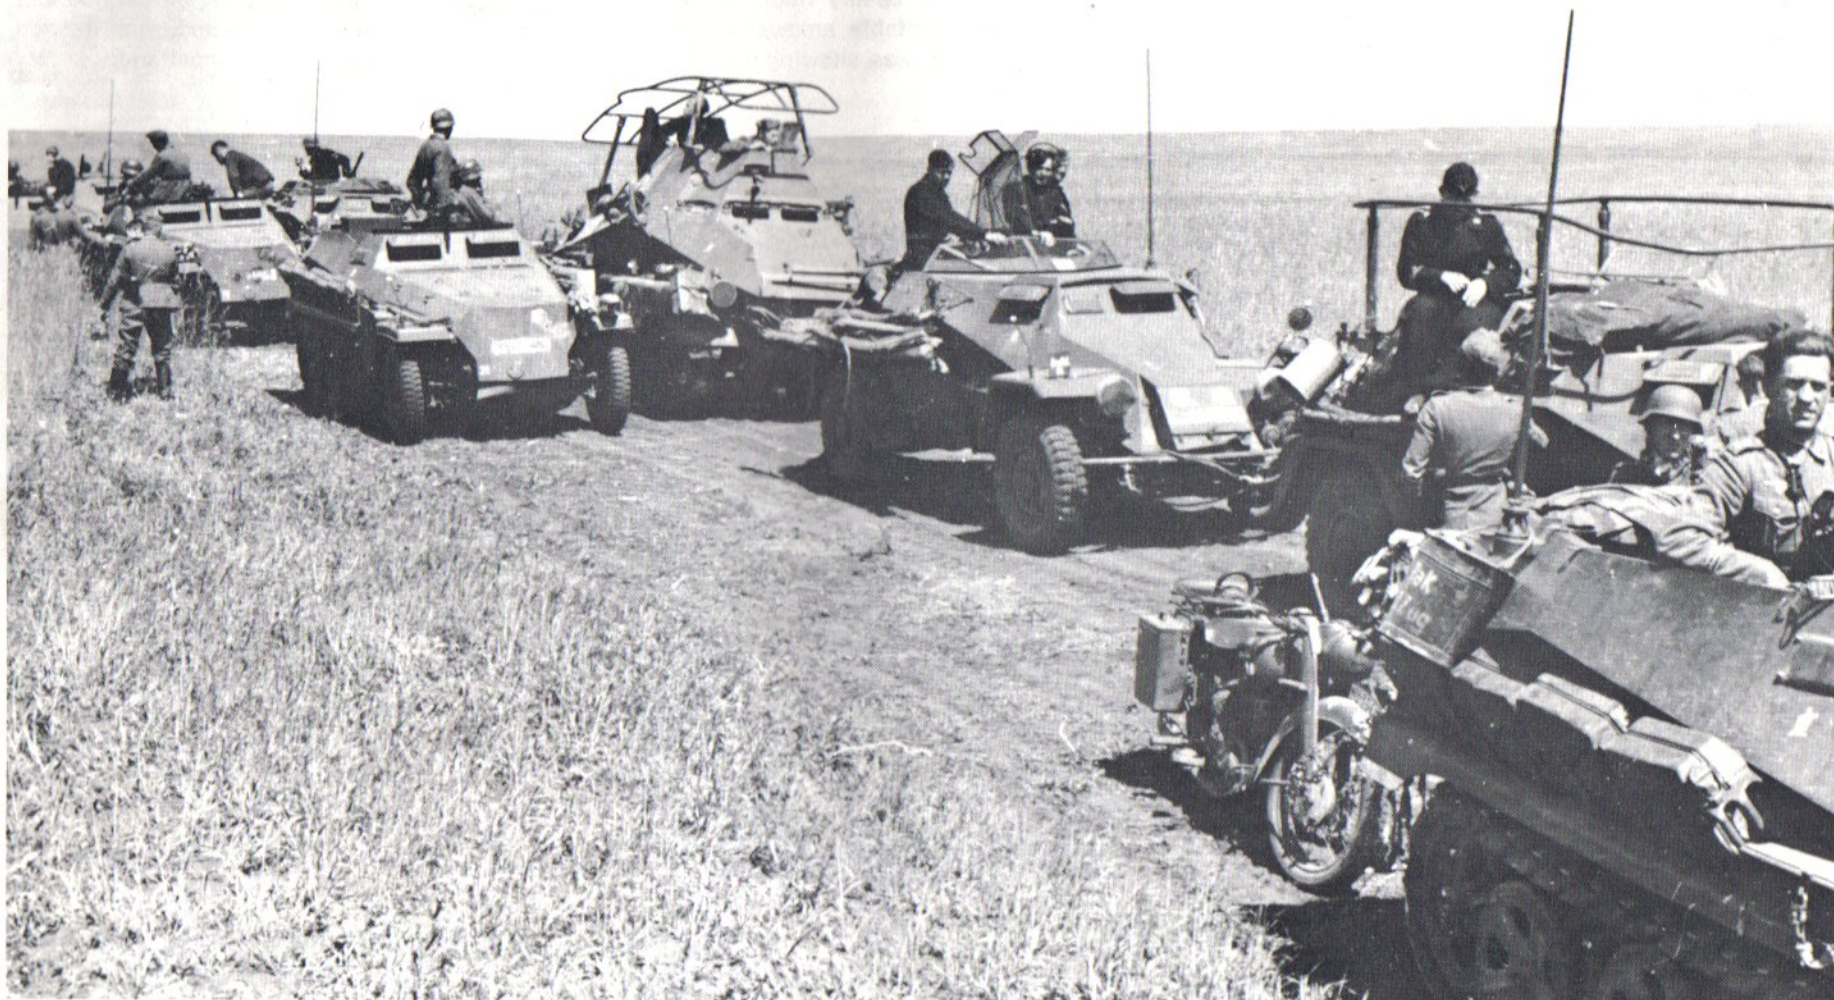
BLITZKRIEG! An armored reconnaissance column of the **Grossdeutschland Division** pauses during the campaign in the East. Visible in this photo are six separate types of vehicles: five **Sd.Kfz. 250 halftracks**, one **DKW motorcycle**, an **Sd.Kfz. 223 light armored communications car**, two **Sd.Kfz. 261 light communications cars** (with whip antennas) and an **Sd.Kfz. 263 heavy armored communications car**.

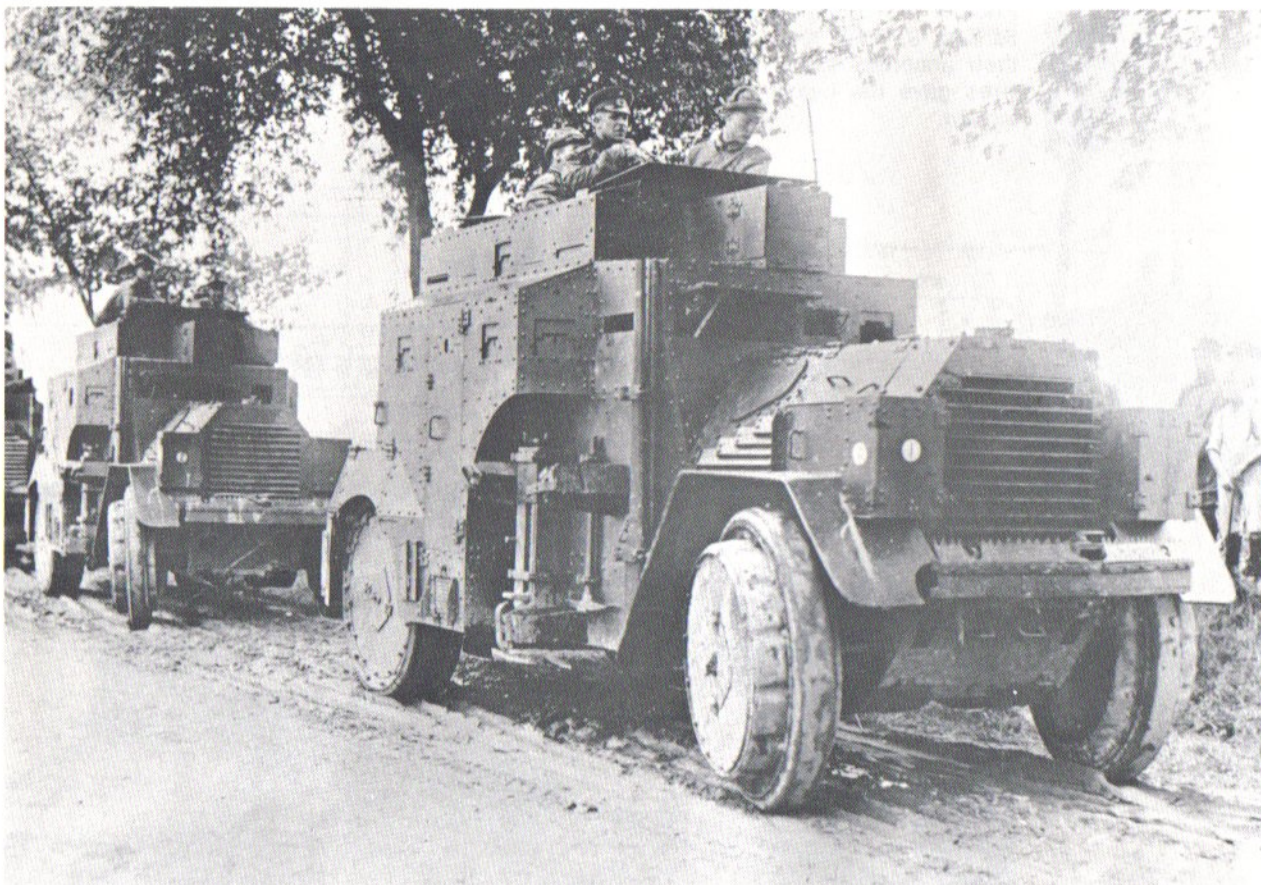
A Krupp-Daimler armored car participating in the **Reichswehr** autumn maneuvers of 1930 in East Prussia. Although the vehicle is armed with only one machine gun, there were no less than fifteen separate firing ports around the vehicle through which the machine gun could be fired.

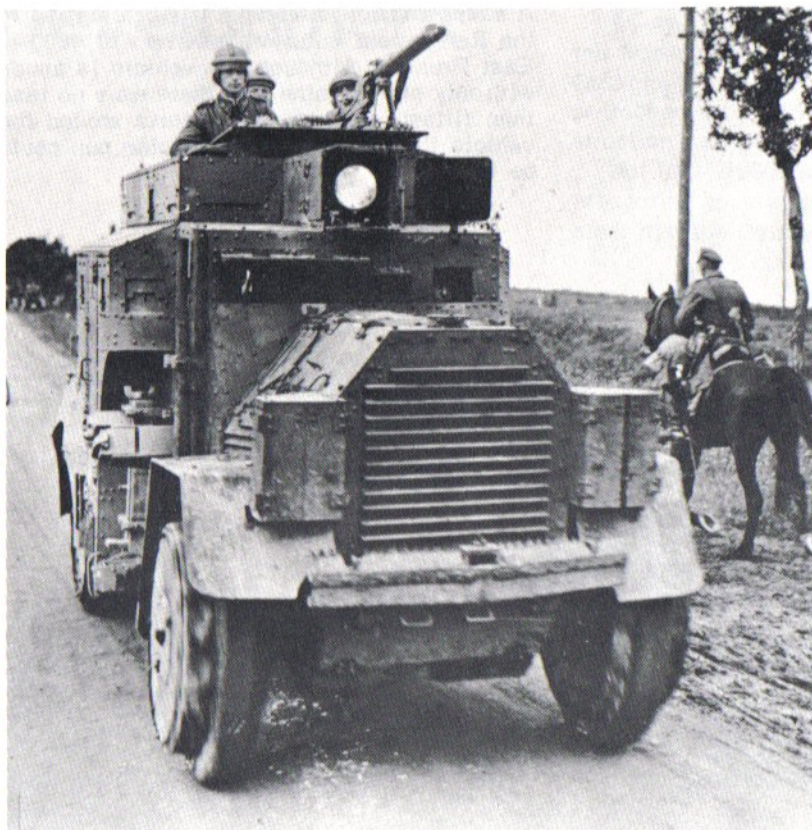
Another view of the big **Krupp-Daimler** armored car, designated by the **Reichswehr** as **Sd.Kfz. 3**. This shot provides a good view of the searchlight and the headlights in their armored boxes. The extensions, or grouzers, on either side of the solid rubber tires gave the heavy vehicle a bit more buoyancy when moving over soft or muddy terrain.

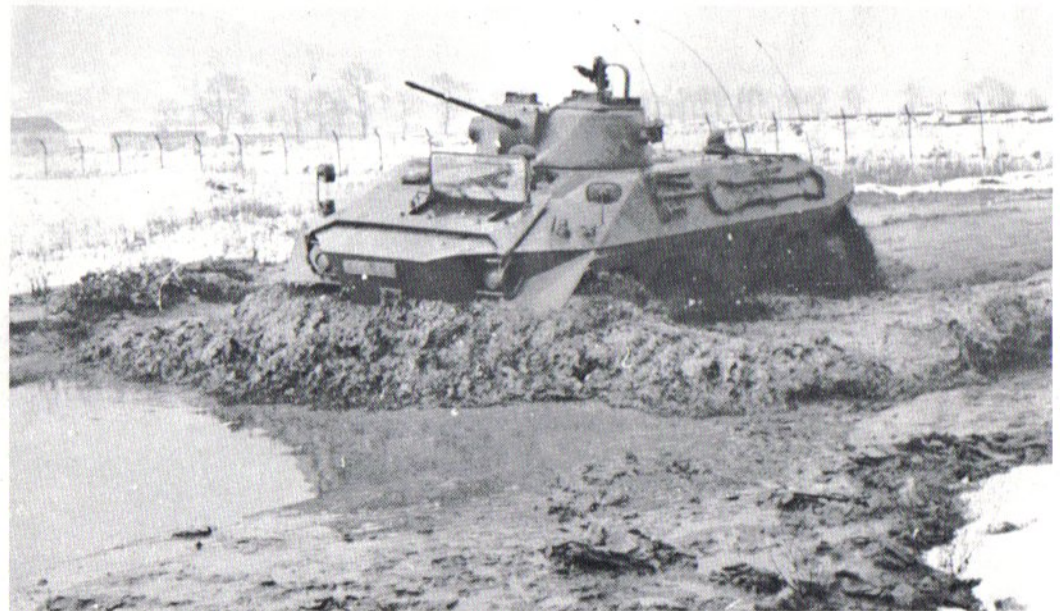
How the times have changed. An example of the West German **Bundeswehr's** newest armored car. This 8-wheeled vehicle features 8 x 8 drive, all wheel steering and independent coil suspension for each of its eight wheels.

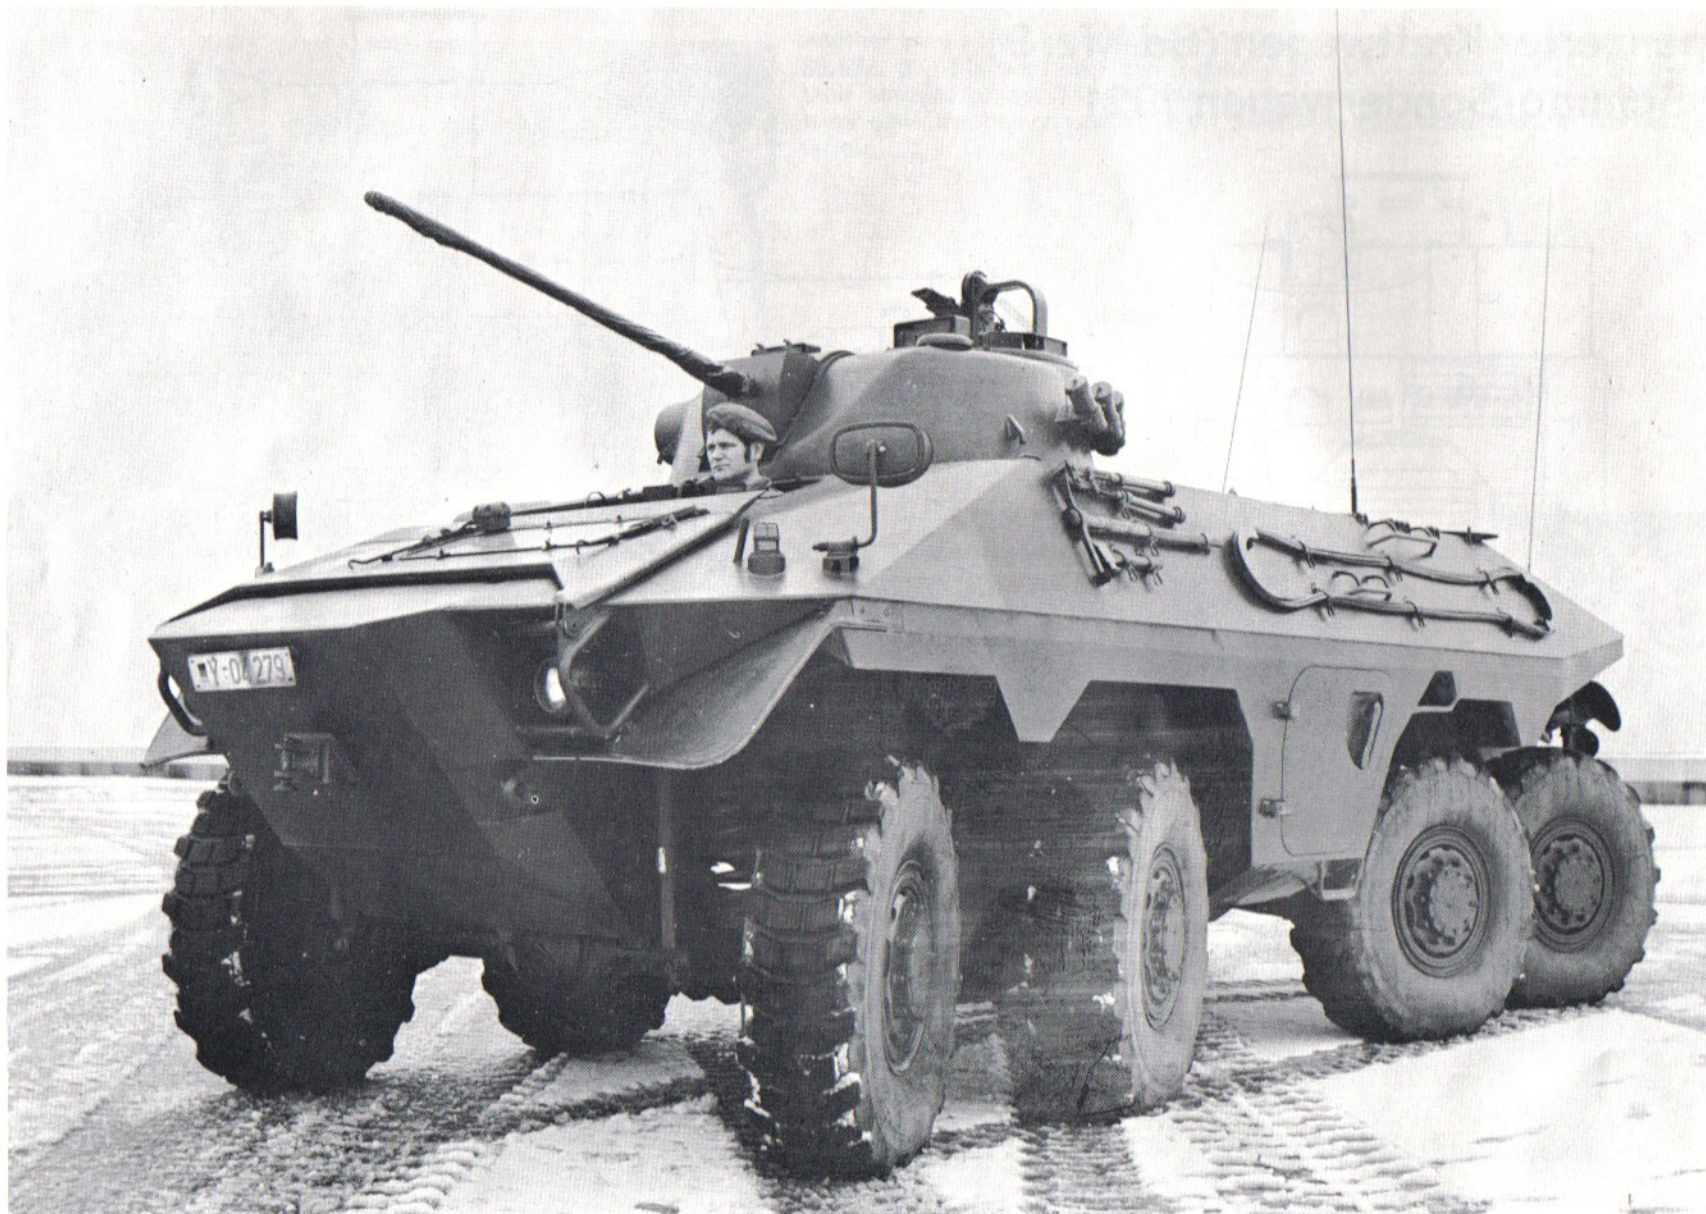
West Germany's 8-wheeled armored car on trials. The vehicle is built by **Daimler-Benz** and is powered by a V-12 300 horsepower engine. She is armed

with a single **Hispano-Mauser** 20mm cannon in the turret and an MG 1 (ex MG 42) can be mounted on the turret top for anti-aircraft defense.

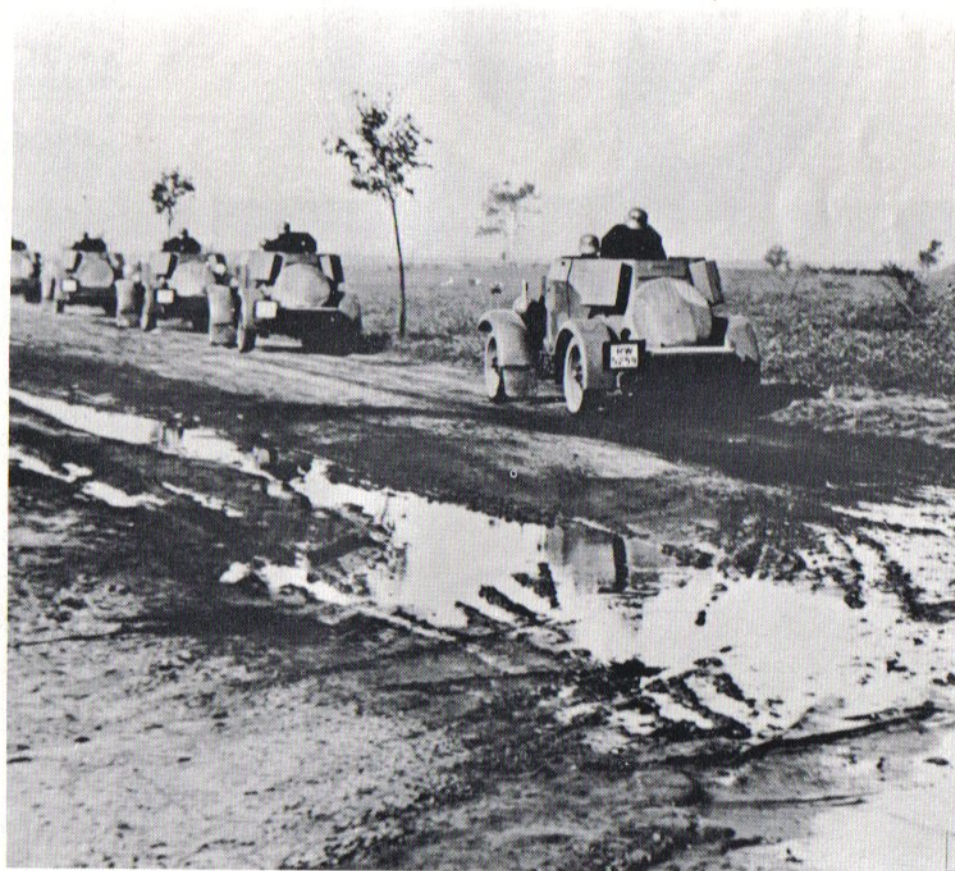
(Right) A column of armored cars bearing the white 'G' of General Guderian's armored corps passes through an abandoned village. The car in the foreground is an **Sd.Kfz. 221**, identified by the single upraised armored visor for the driver. The armored car to the right is one of the three-axled armored cars, an **Sd.Kfz. 232 (6 Rad)** heavy armored communications vehicle with a 2cm gun.

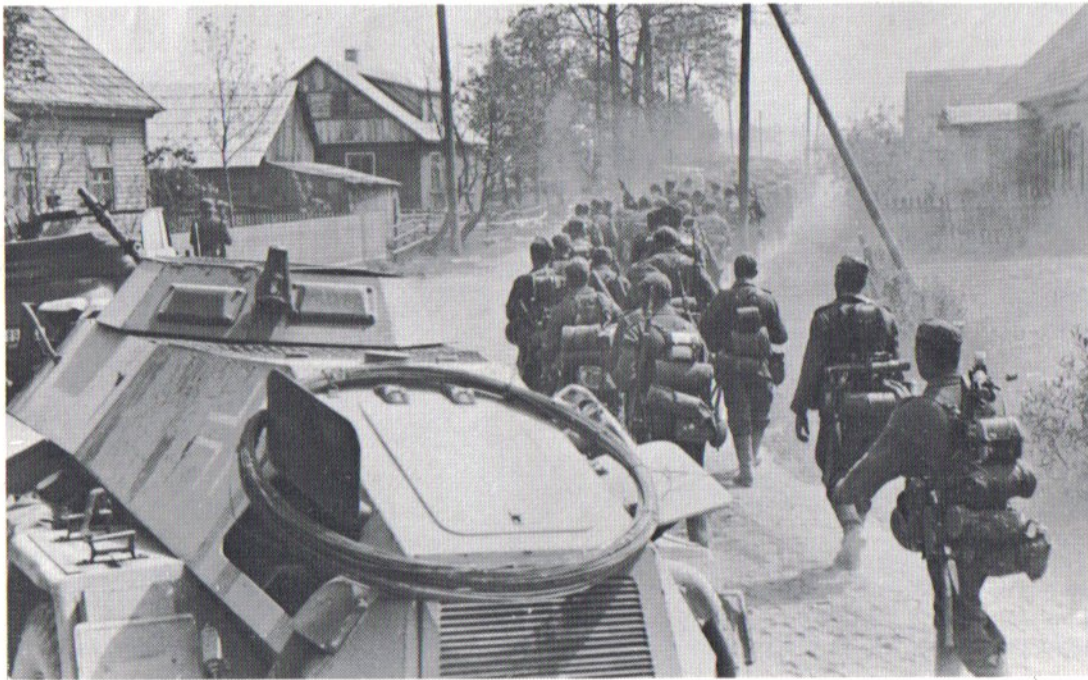
As a column of infantry marches by, this **Sd.Kfz. 221** armored car provides automatic weapon coverage with its MG 34. The **Sd.Kfz. 221** was the first armored car to be developed on the standard medium car chassis of 1937. Note the sloping rear deck of the car, showing the rectangular engine access plate. This is one of the most important distinguishing features between the **Sd.Kfz. 221** and the later **222** and **223** models.

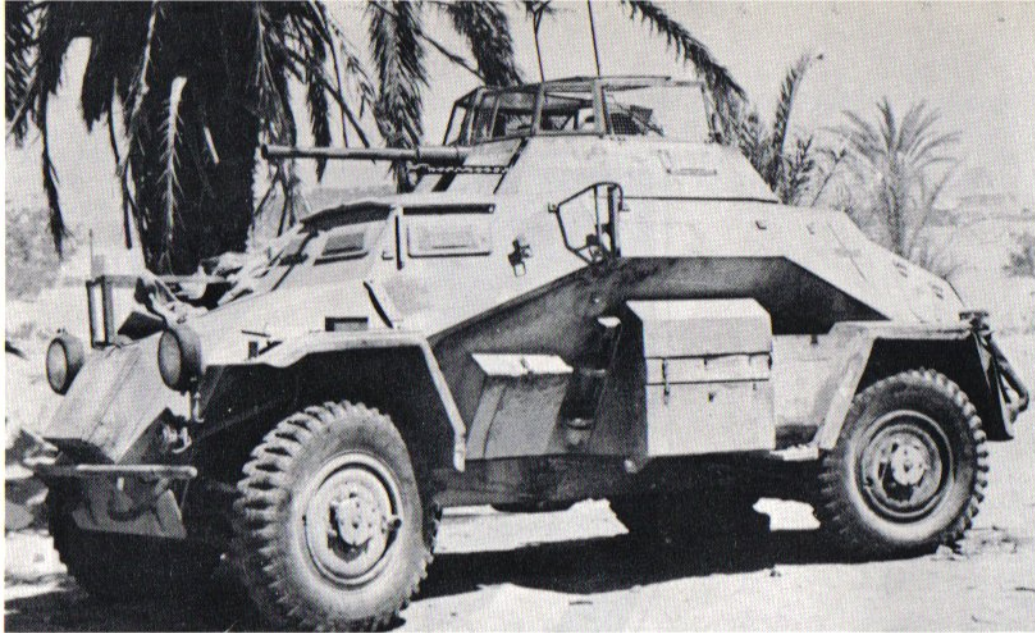
A nice view of an **Sd.Kfz. 222** armored car parked next to an oasis during the North African campaign of 1940-1942. The major distinguishing characteristic of this vehicle is its 2cm rapid firing gun and the MG34 machine gun adjacent to it. The vehicle can be further distinguished from the earlier **Sd.Kfz. 221** by the obvious 'step' on the rear decking.

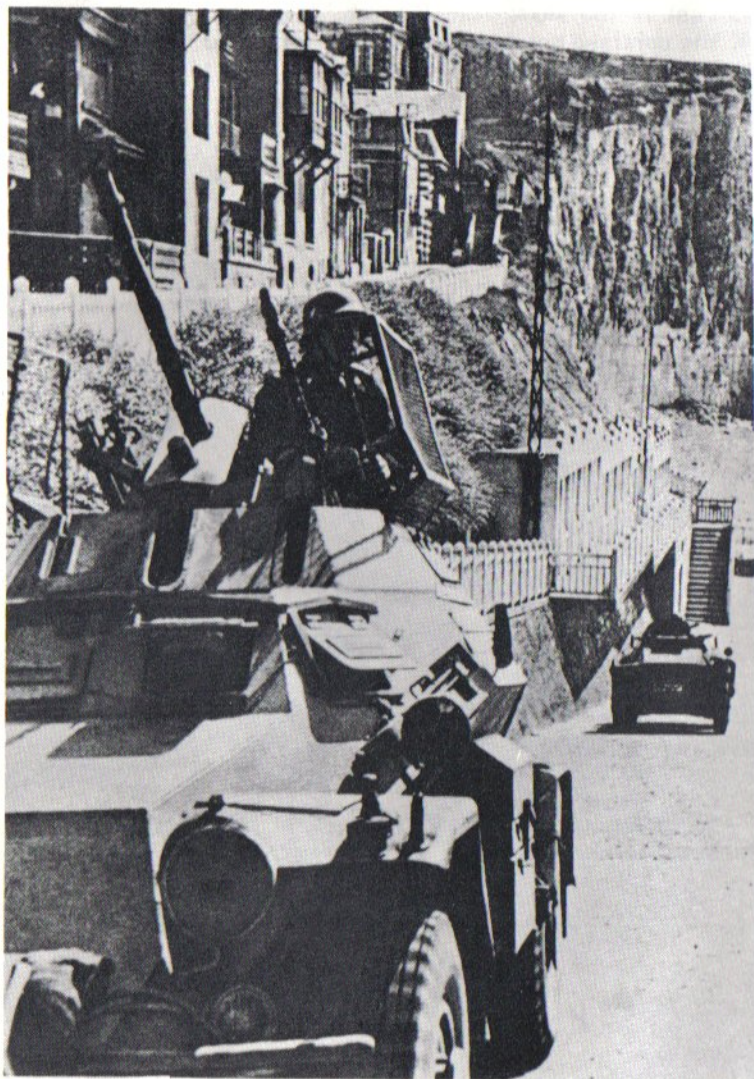
With its main armament raised for anti-aircraft defense, this **Sd.Kfz. 222 armored car** patrols the streets of a Belgian town adjacent to one of Belgium's larger canals, during the 1940 lowlands campaign.

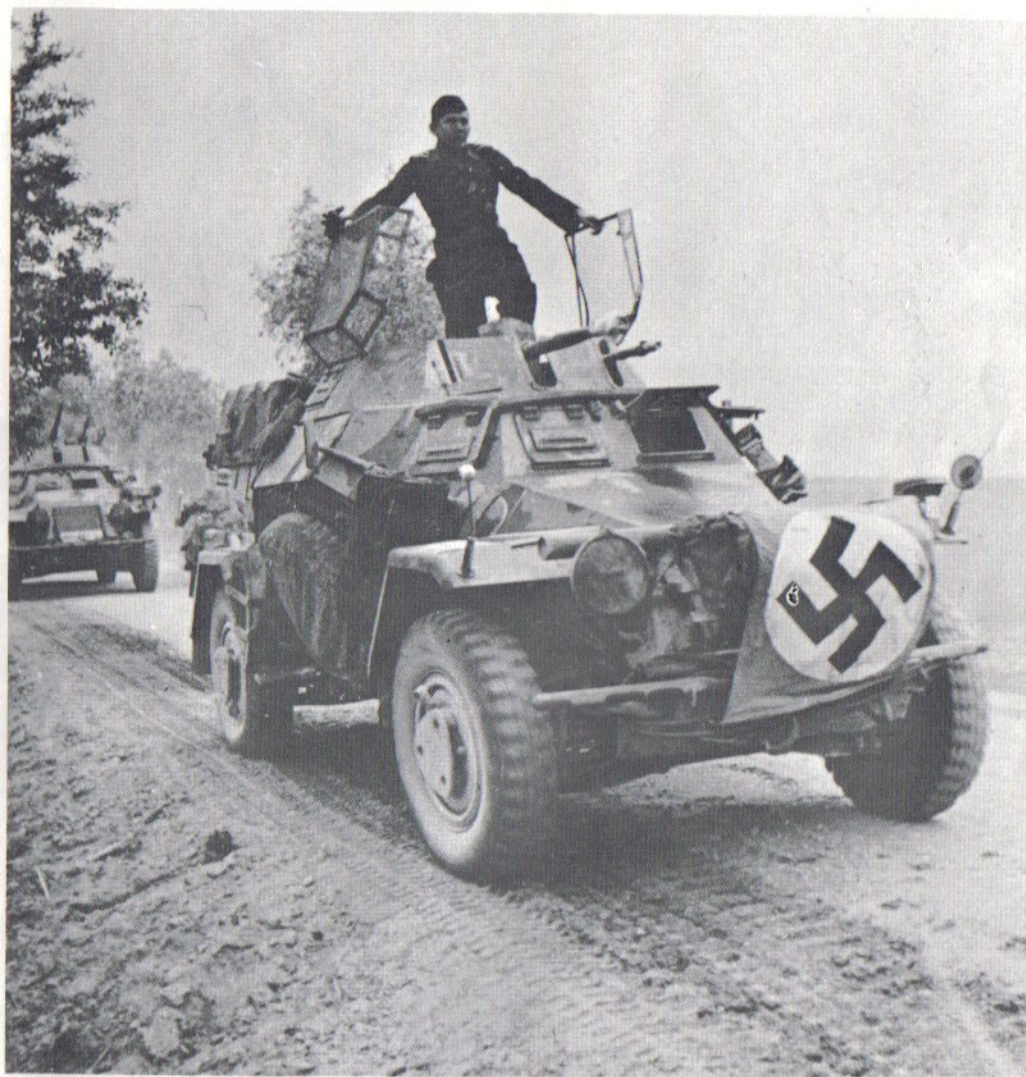
A column of **Sd.Kfz. 222's** moves into an assembly area on the Southern Front in Russia, 1941. The front vehicle is camouflaged with the standard grey base paint and a tan over-painting to break up its image. The large flag on the front of the vehicle served as a recognition marker to low flying German aircraft and was most normally displayed on the hood of the vehicle.

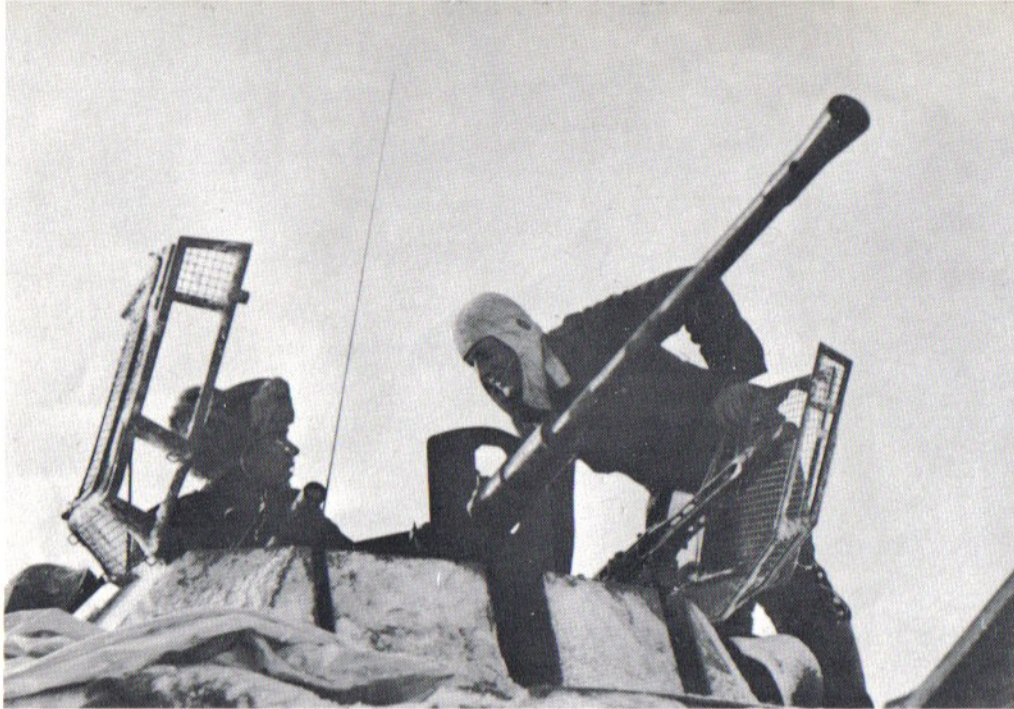
Perimeter watch from the turret of an **Sd.Kfz. 222**, January, 1943. Of interest is the MG42 machine gun, instead of its sister, the MG34. The upraised screens on the turret protected the vehicle and crew from grenades or mines thrown into the open turret.

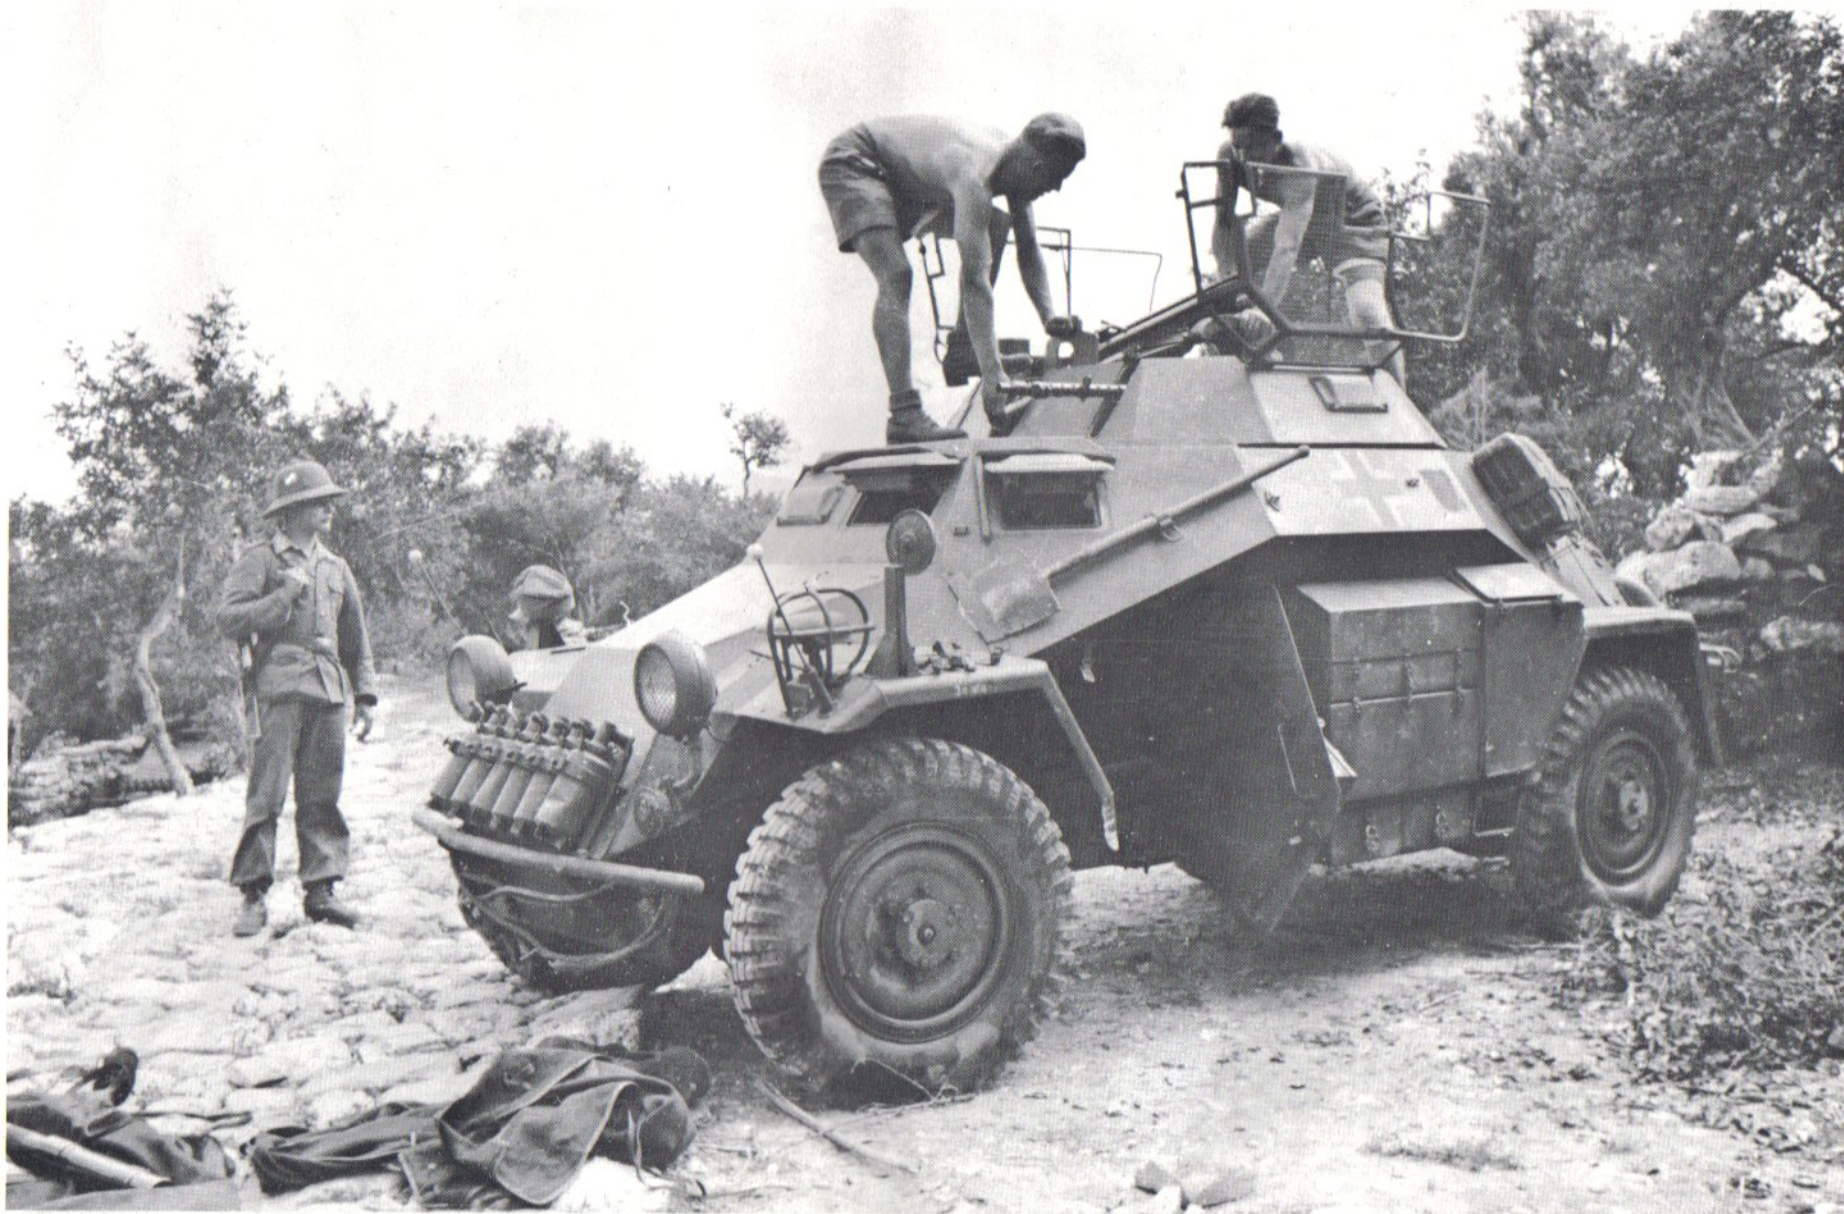
Here, the crew of an Sd.Kfz. 222 is in the process of removing the breech and visible on the tarpaulin on the ground at the left of the photo is the barrel recoil mechanism of their 20mm main armament, in order to clean it.

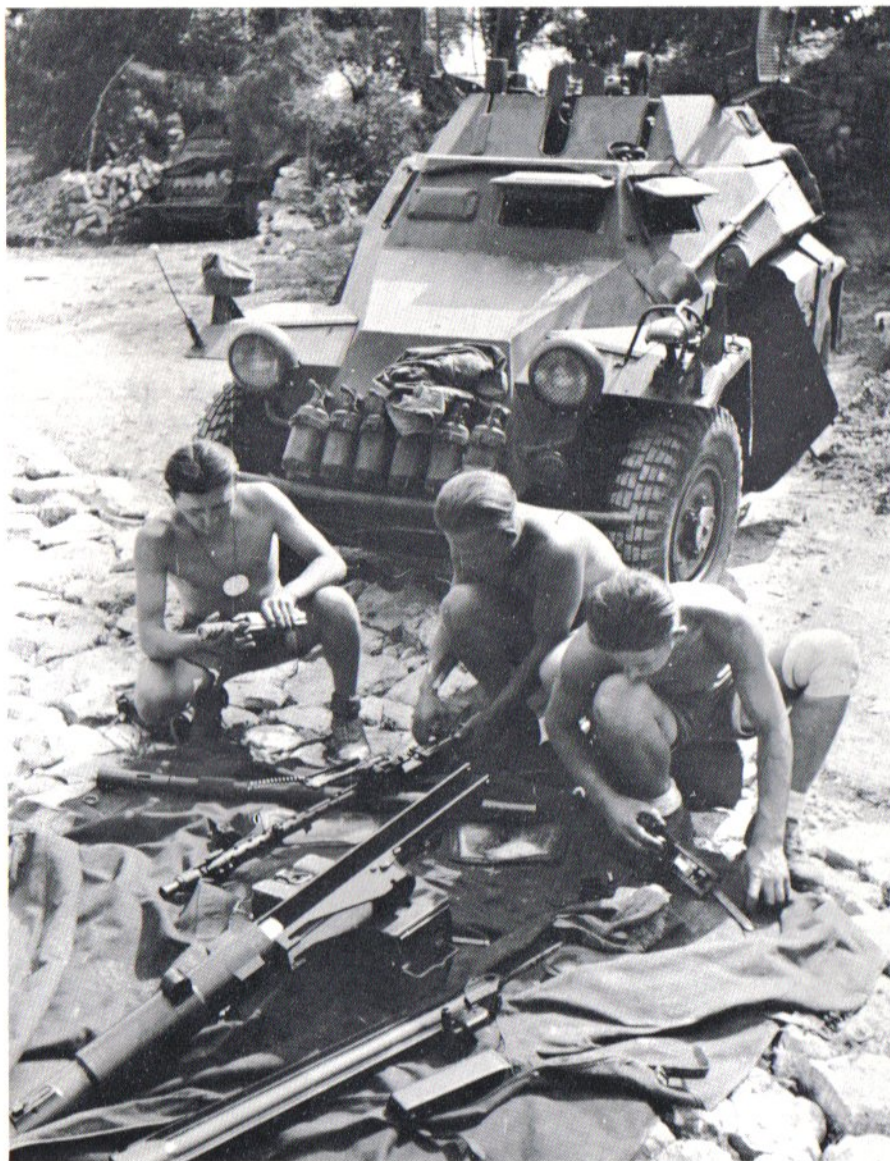
With both the 20mm and the MG 34 out of the vehicle, the three crew members go about wiping them clean of desert sand and cordite residue. Note the six smoke candles attached to the front armor plate of their vehicle in the background.

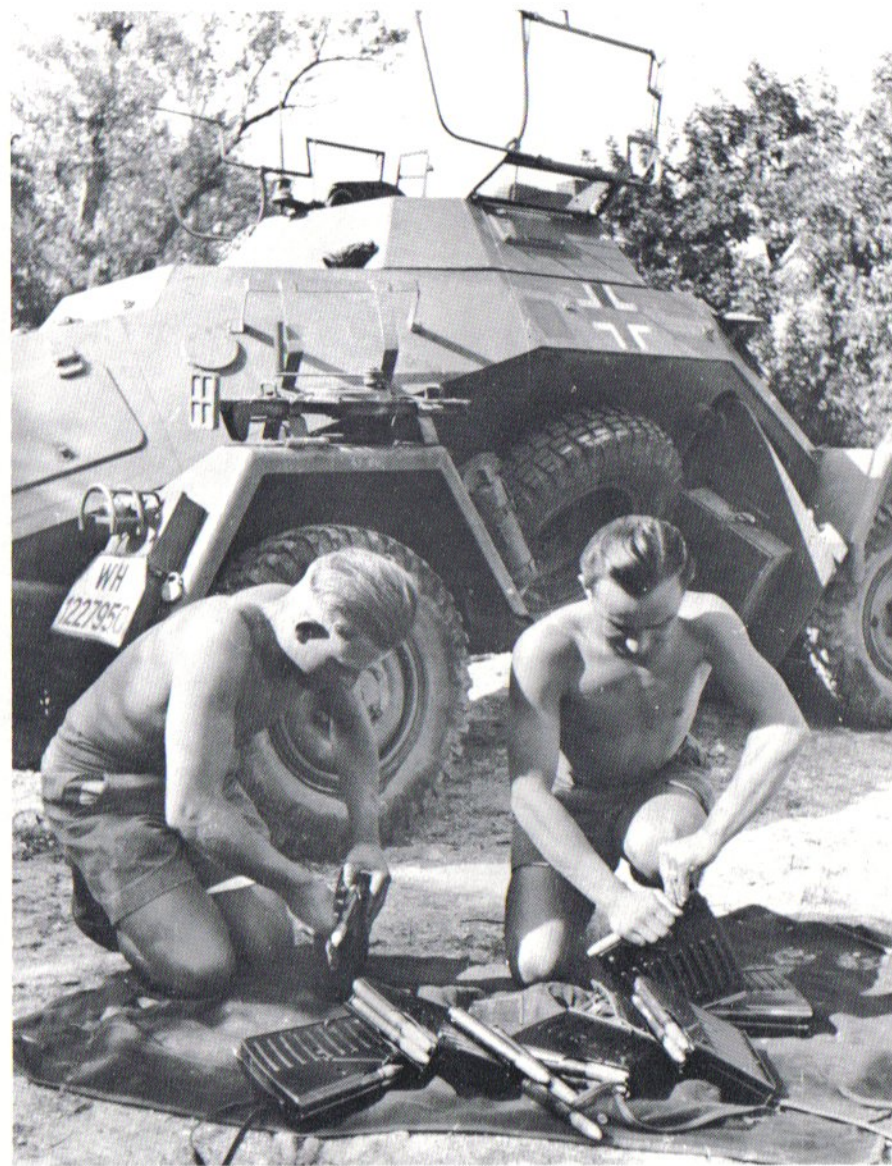
After the armored car's armament has been thoroughly cleaned, two of the crew members begin to prepare the 20mm ammunition magazines which held 10 to 12 20mm projectiles each. Stowage space for 20 magazines was provided in each of these vehicles

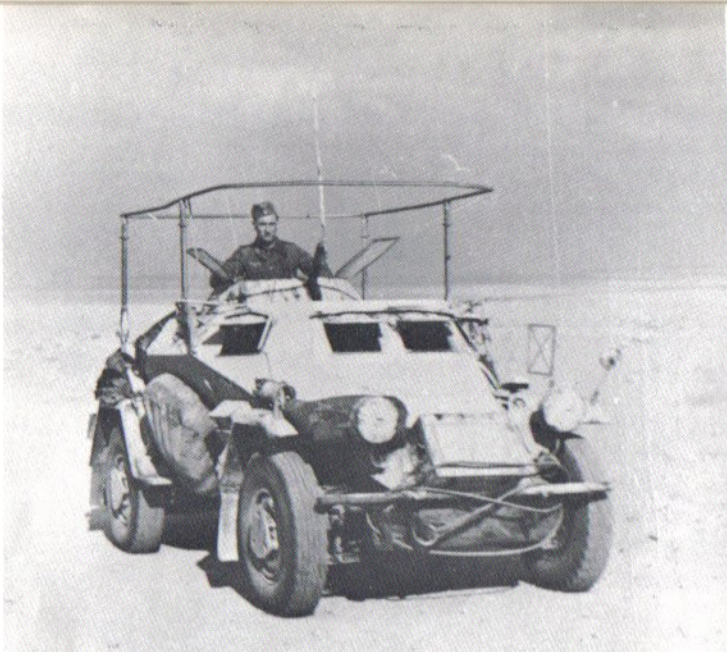
On the move! An **Sd.Kfz. 223** loaded up for combat moves across the desert wasteland with both the whip antenna and the frame antenna upright. These little vehicles with their four-wheel drive and four-wheel steering were extremely maneuverable, but highly complicated and hard to maintain.

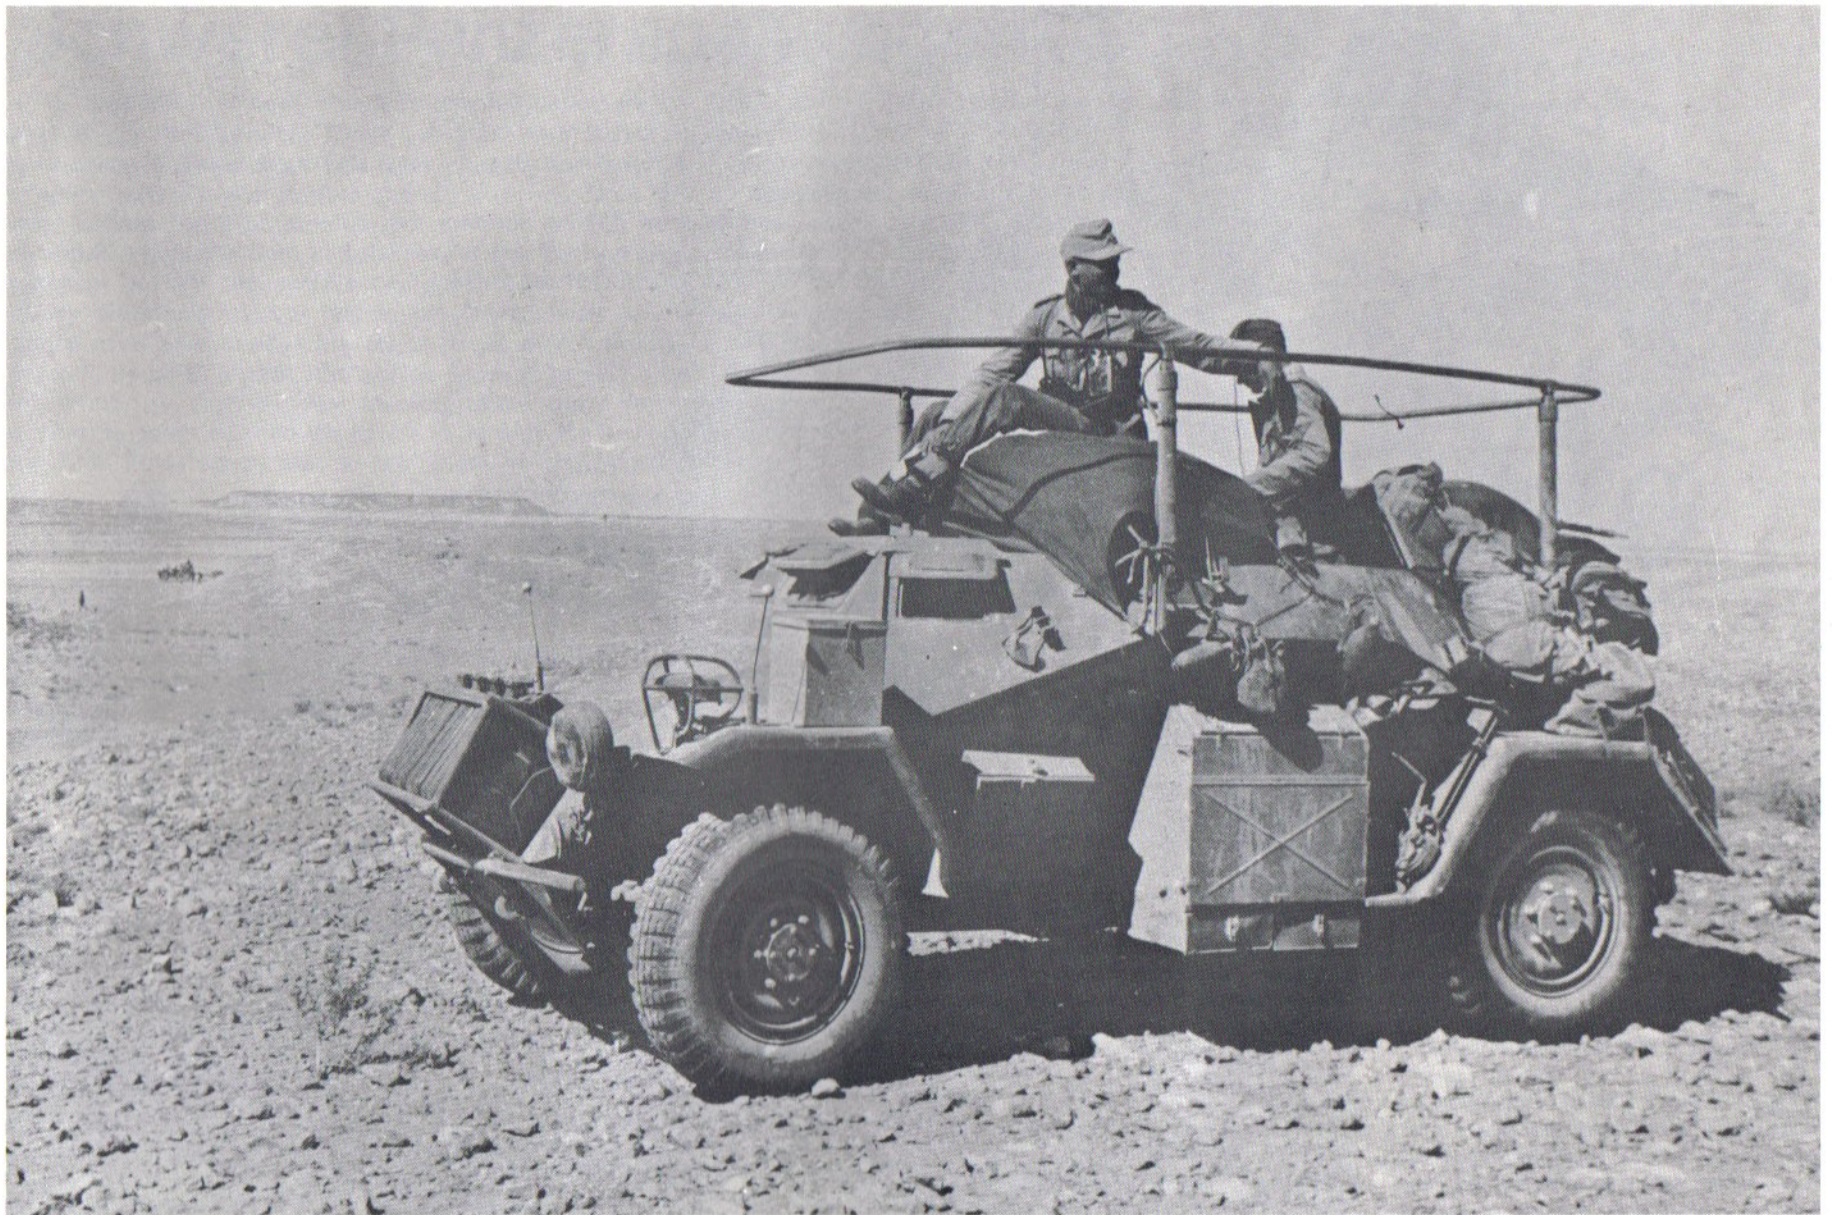
All set for a long range reconnaissance patrol, this **Sd.Kfz. 223** features all of the crew's personal gear strapped to the rear decking and at least twenty gallons of spare gasoline in the jerricans on the special rack attached to the front of the vehicle.

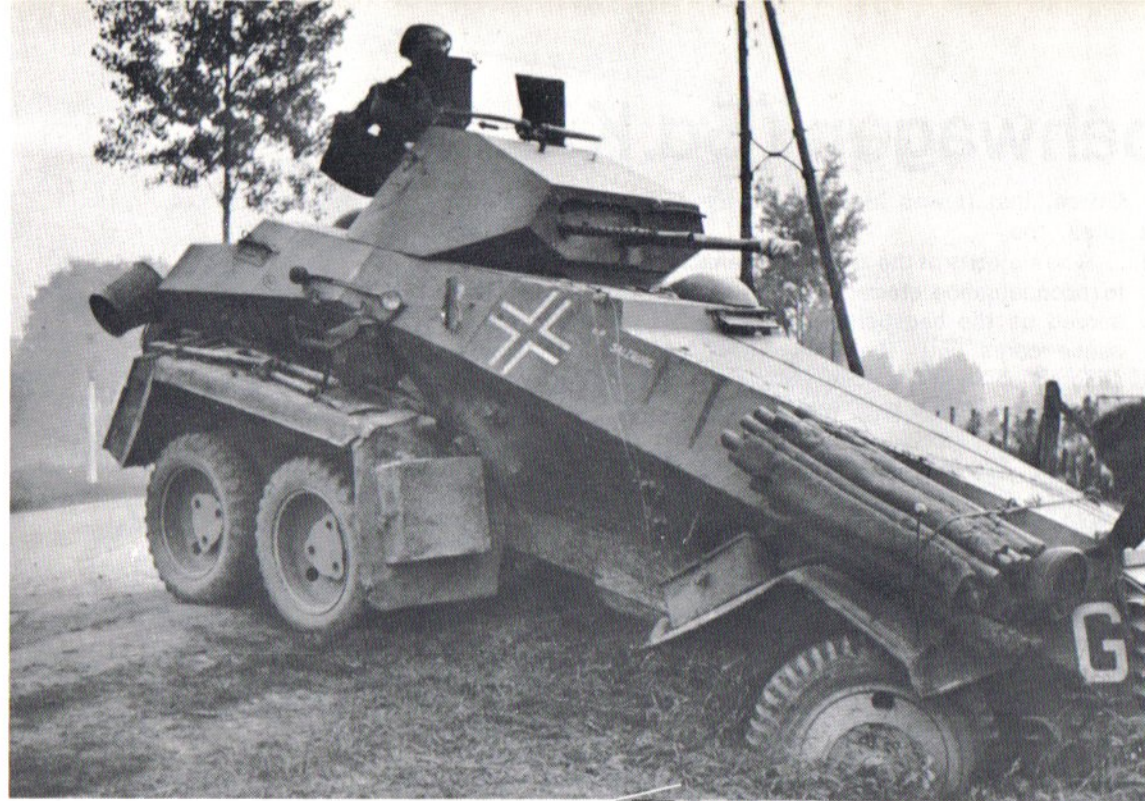
In this photo, one can see just what kind of cross-country capability these three-axled armored cars possessed, weighing over five tons and powered by a 68 horsepower engine. The vehicle is stuck fast in the ditch beside the road, but cannot extricate itself under its own power.

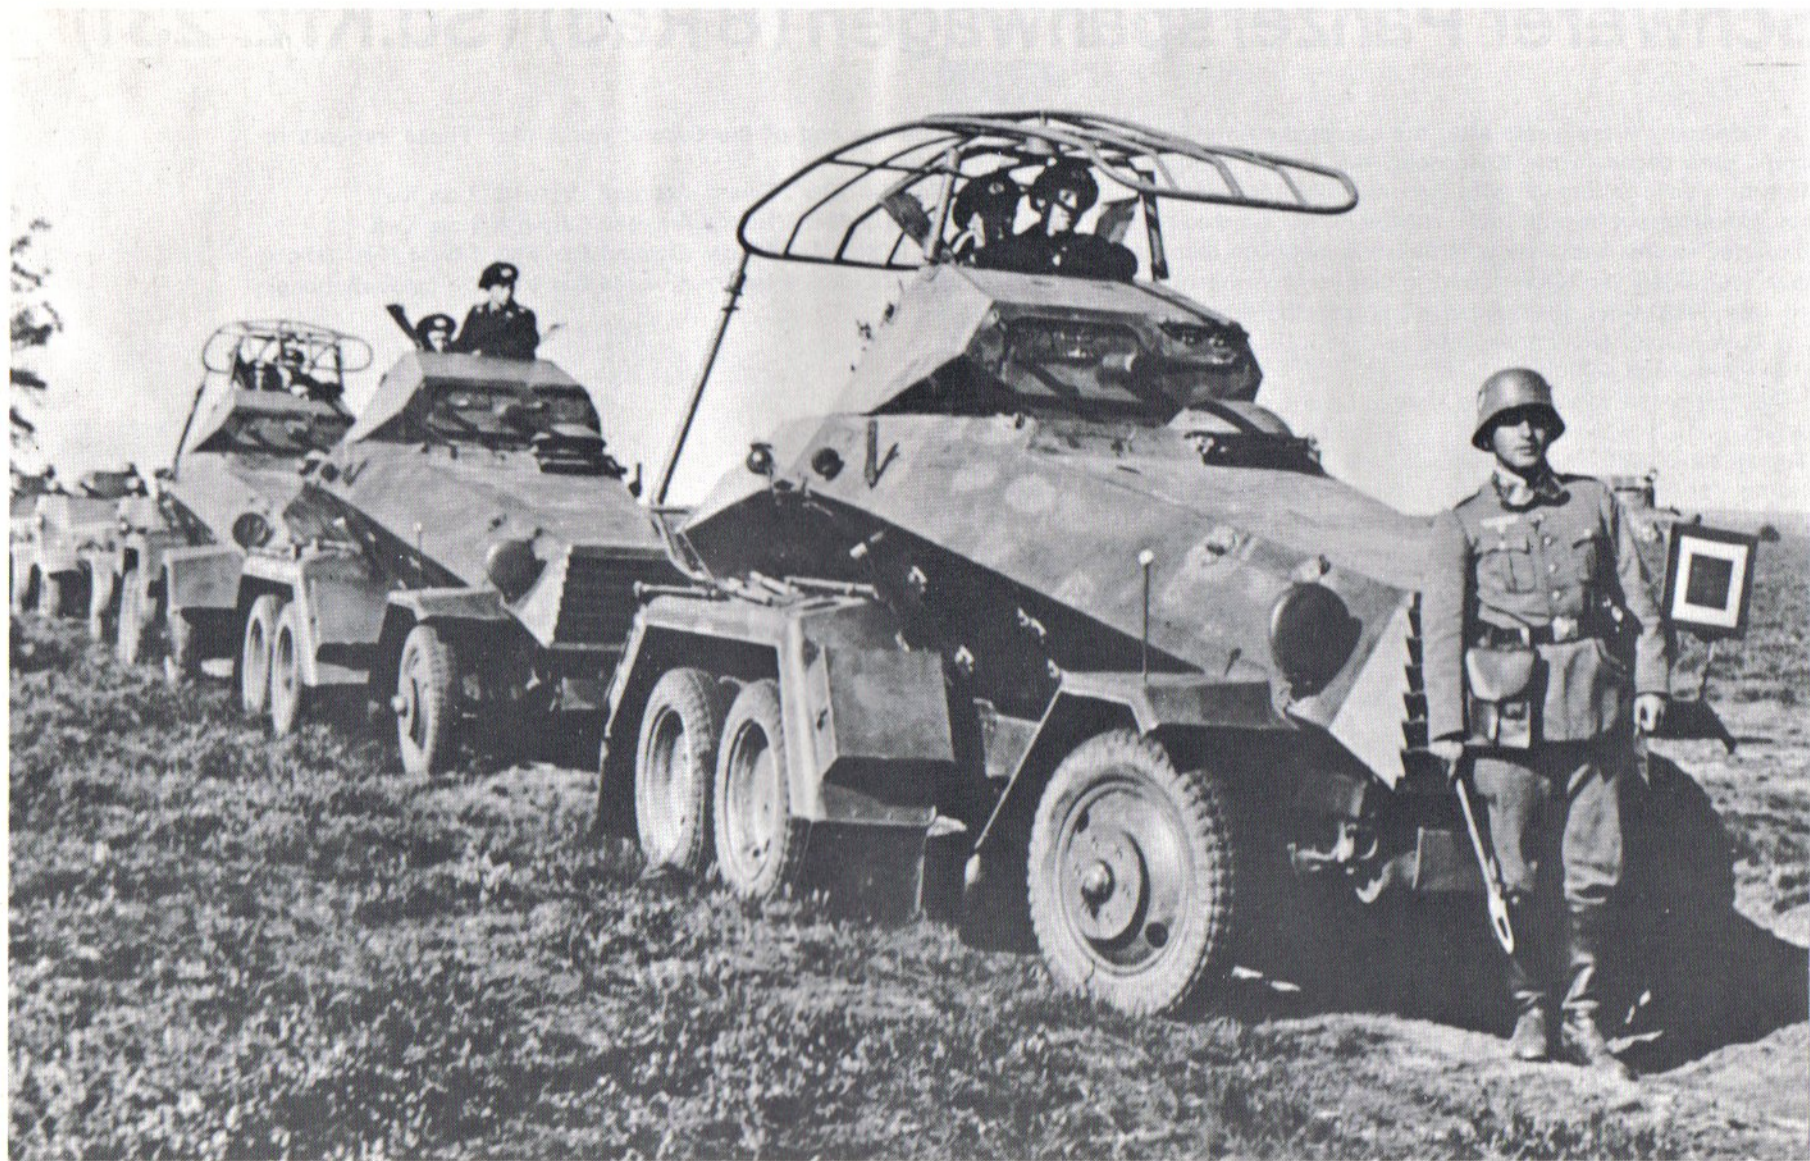
This is a rare photo indeed, in that all three types of the three-axled armored cars are shown together. The front vehicle is the **Sd.Kfz. 232 heavy armored communications car**, followed by the **Sd.Kfz. 231 heavy armored car**. The third vehicle in the line is the **Sd.Kfz. 263 armored communications car**. The only

difference between the first and third vehicles was the rigid turret on the third car (Sd.Kfz. 263) which could not be rotated. Barely visible behind the **Sd.Kfz. 263** is a **Kfz. 13 machine-gun carrier**, one of Germany's early armored cars.
