Panzerspähwagen 'Puma' (Sd.Kfz. 234/2) 5 cm KwK 39/1 L/60

# Panzerspähwagen in Action

Created by Uwe Feist  
Captions by Mike Dario

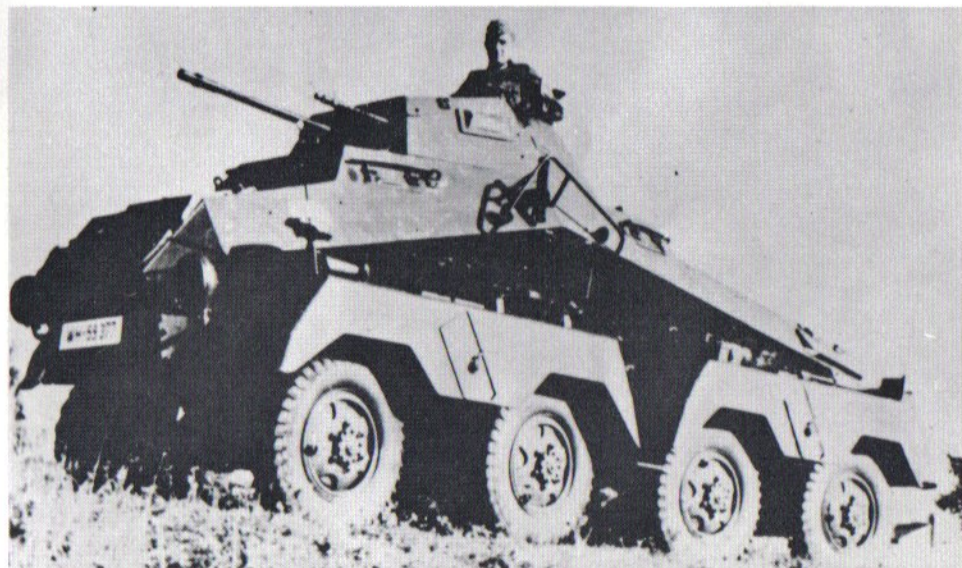
A heavy armored car on the move. These 8-wheeled vehicles had the best cross-country mobility of any of the **Wehrmacht's** wheeled vehicles, despite their weight of near nine tons. The vehicle's biggest disadvantage was its extremely high silhouette.

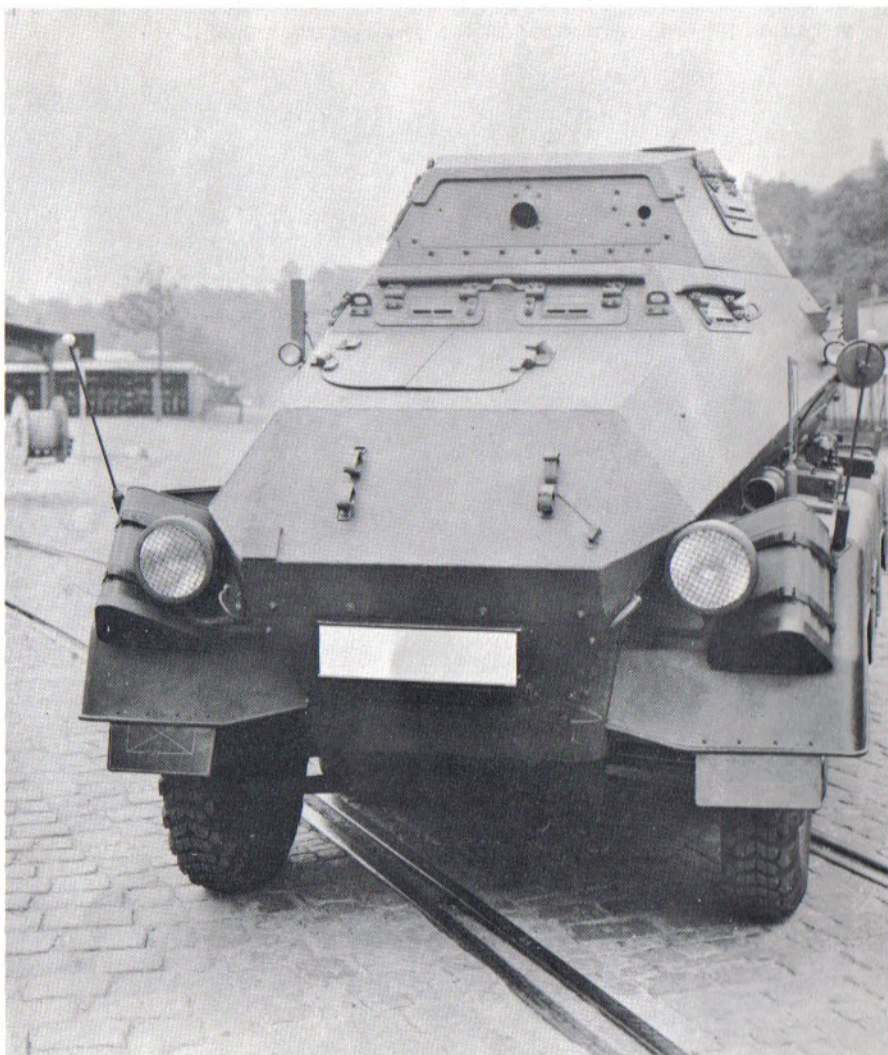
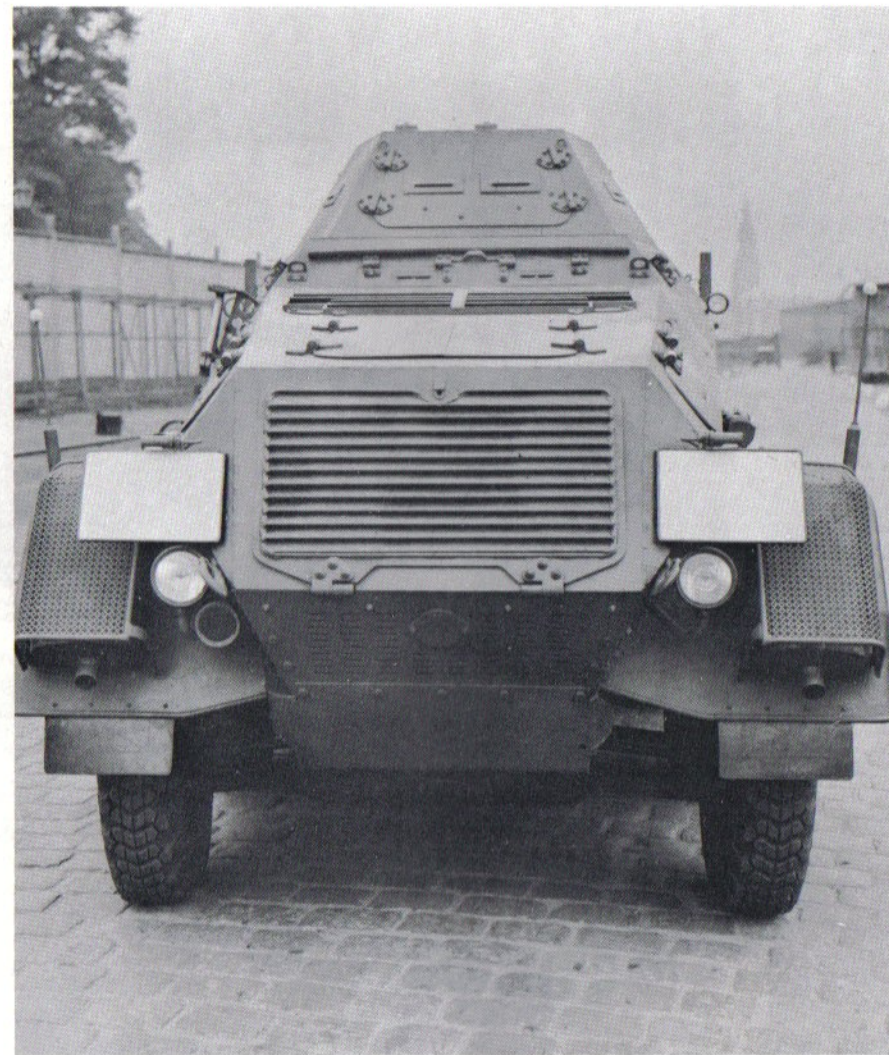
An excellent photograph of a brand-new **Sd.Kfz. 231** heavy armored car ('**Waffenwagen**') just wheeled out of the **Deutsche Werke** factory in Kiel. Armament for this vehicle and other equipment was not installed until the vehicles were inspected and accepted by a **Wehrmacht** or **Waffen-SS** Ordnance Reception Unit.

A rear view of the factory-fresh **Sd.Kfz. 231**, showing to advantage the alternate set of headlamps just below the license plate holders (still blank) and the rear driver's vision slits just above the air intake grille on the rear top decking.

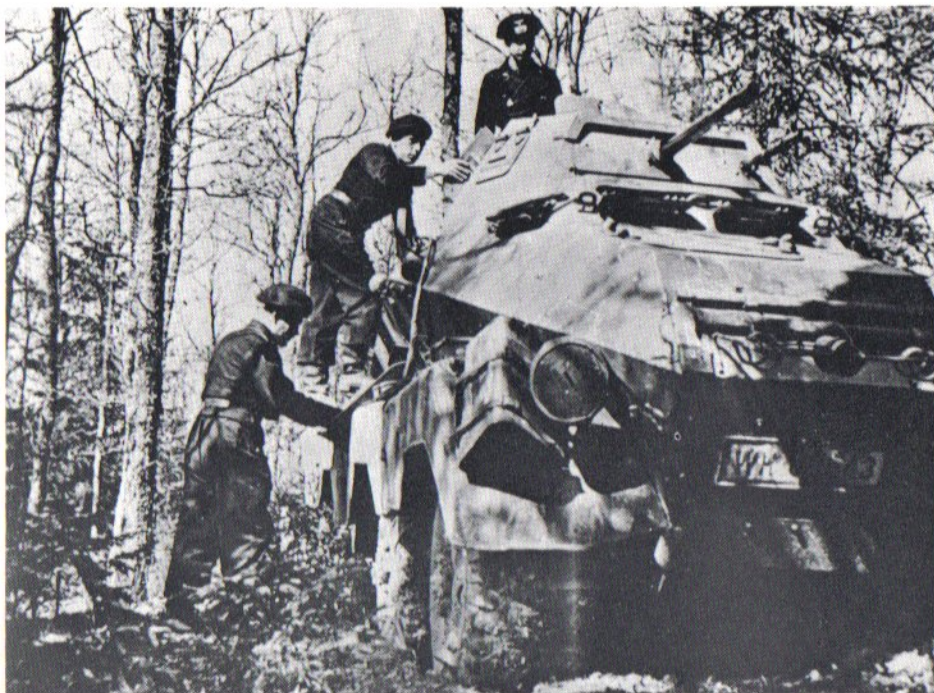
A Wehrmacht armored car crew gets ready to man their Sd.Kfz. 231 'Waffenwagen' during the French campaign of 1940. The crew members are wearing the standard black uniform of the Panzer corps. Note the open visors on the front and sides of the driving compartment.

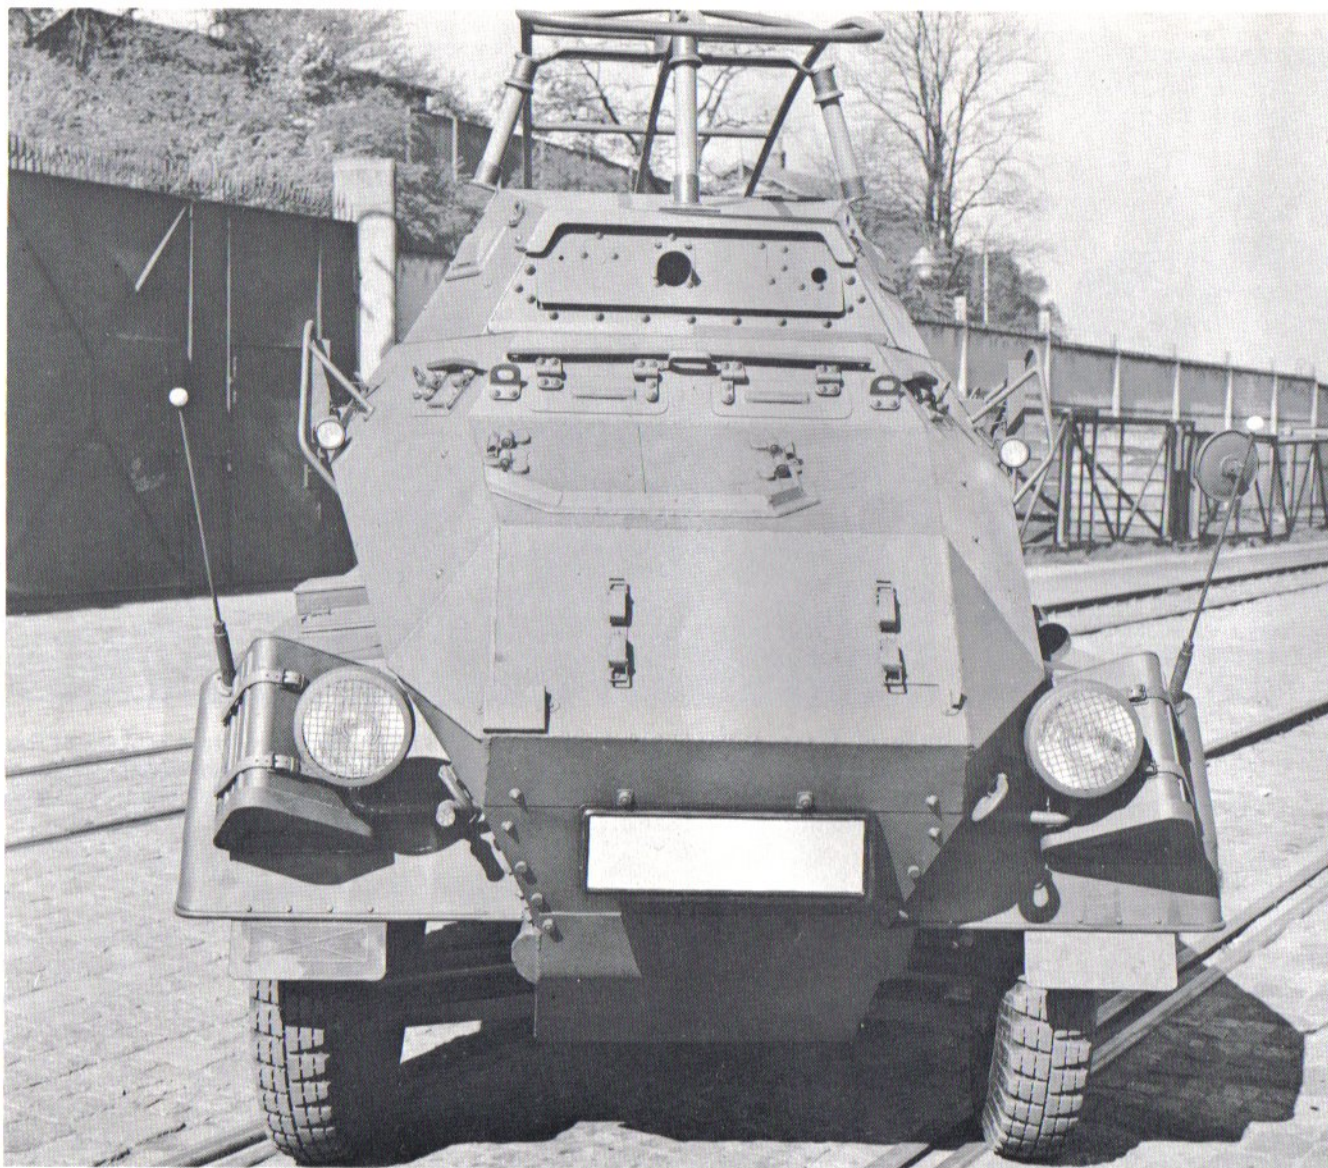
At the **Deutsche Werke** factory in Kiel, a brand-new **Sd.Kfz. 232** waits adjacent to the factory's railroad spur until a train can pick it up for delivery to a **Wehrmacht** inspection unit. During peak production of these vehicles, the **Deutsche Werke** factory could turn out up to twenty of these vehicles a day. More could have been produced, but no third, or 'graveyard' shift was worked.

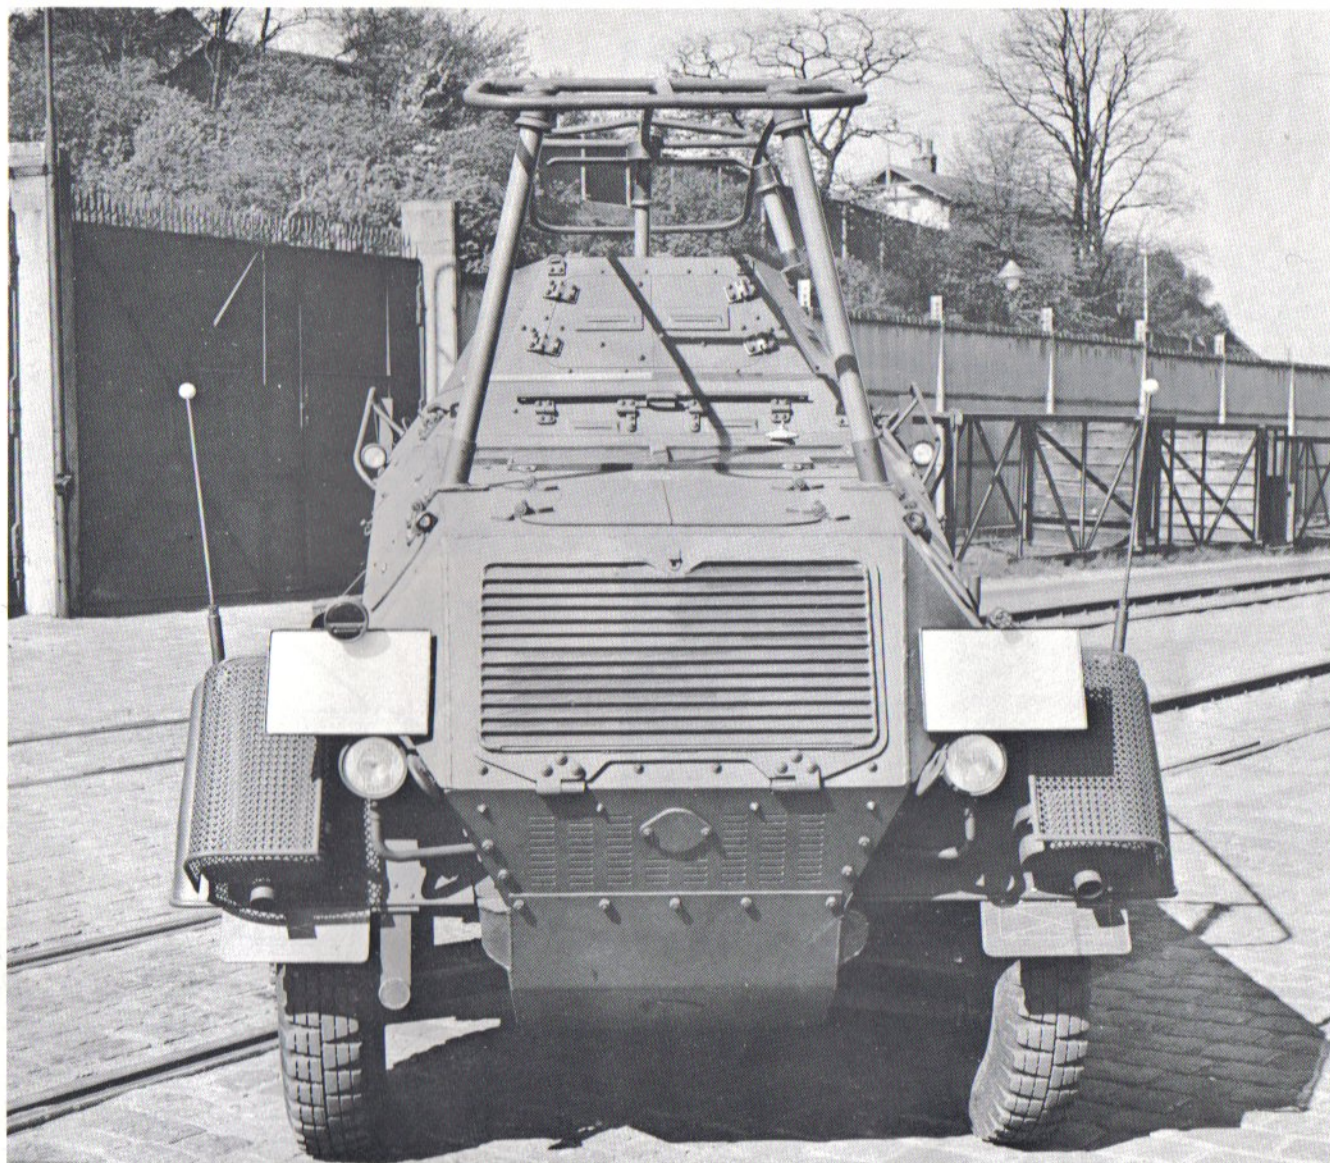
The **Sd.Kfz. 232** here differed only from its brother, the **Sd.Kfz. 231** by the inclusion of the built-on frame antenna and additional radioequipment. The rods on the fenders with the small white balls at their tops signified the widest part of the vehicle. They enabled the driver to judge distance between obstacles and determine if the vehicle could fit between them.

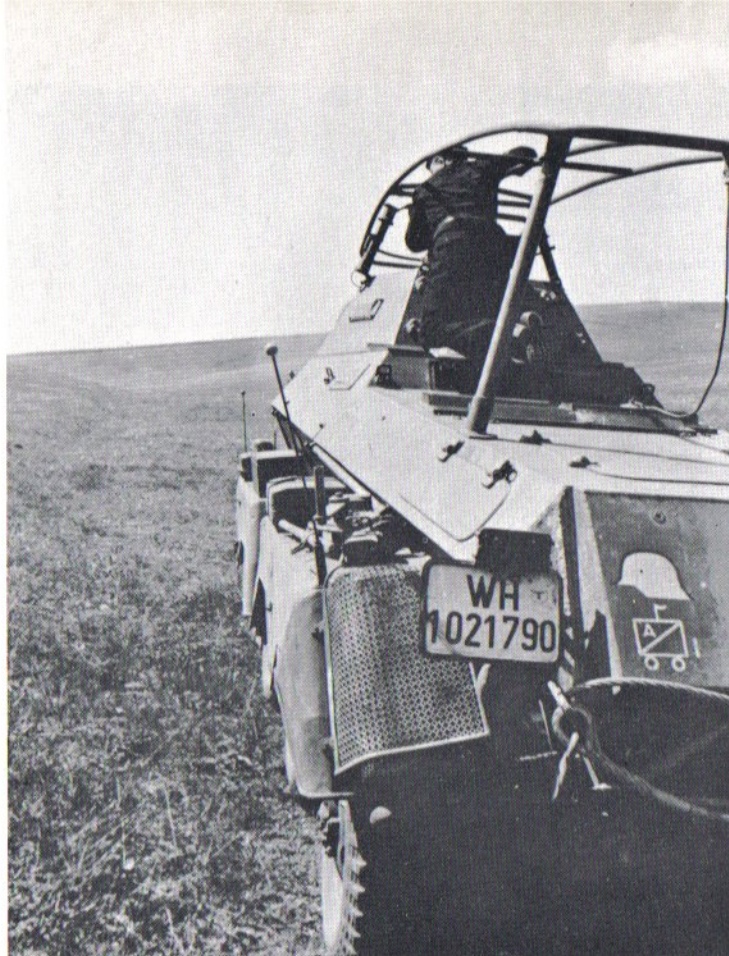
(Above) The commander of this **Sd.Kfz. 232** belonging to a reconnaissance unit of the '**Grossdeutschland**' Division issues sighting instructions to his gunner inside the turret of the vehicle. The large antenna was quite an impediment in many cases.

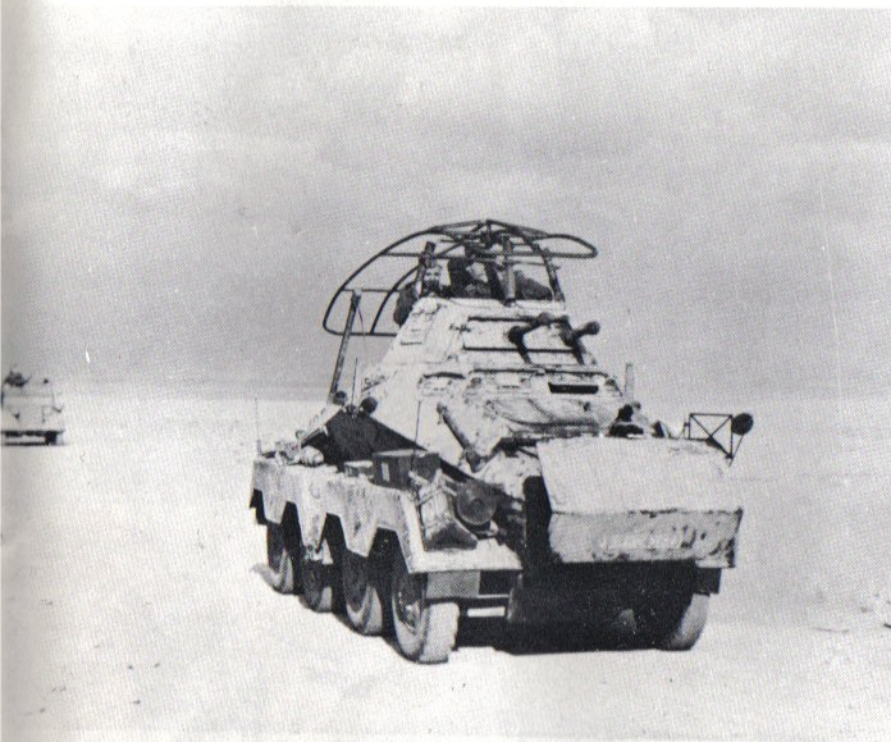
Leading a reconnaissance patrol, this heavy armored communications car features the additional frontal armor plating and a rather worn-looking desert camouflage paint job. Both the 2 cm gun and the coaxial machine gun are covered with canvas to prevent sand from fouling the weapons.

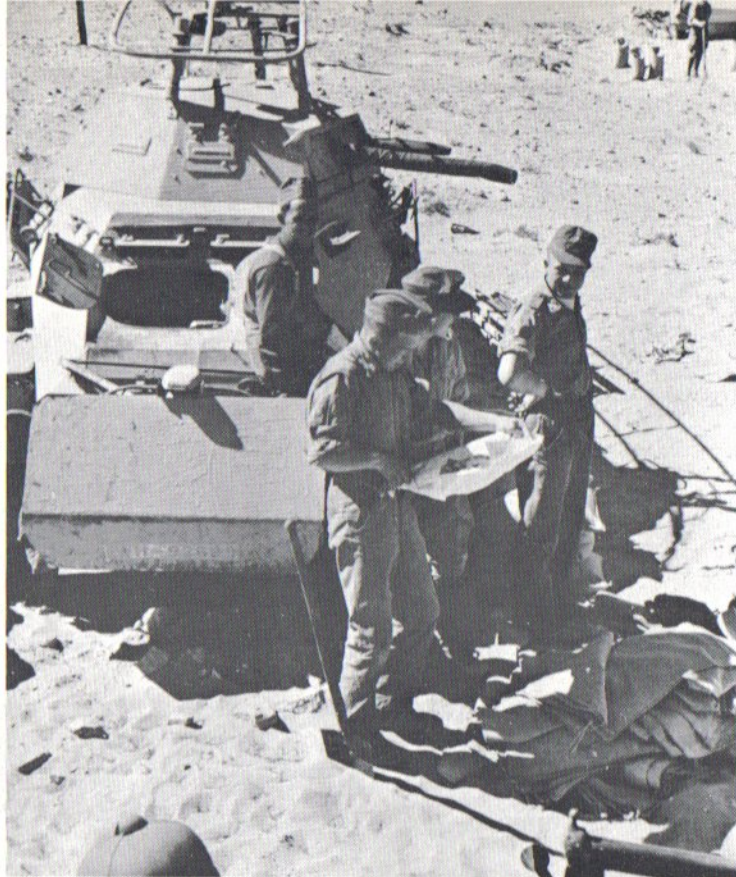
A nice view of the turret and armament of an **Sd.Kfz. 232** heavy armored communications car. Note how the forward part of the large frame antenna was supported by the three uprights which connected together in the middle so that the turret could rotate without harming the antenna.

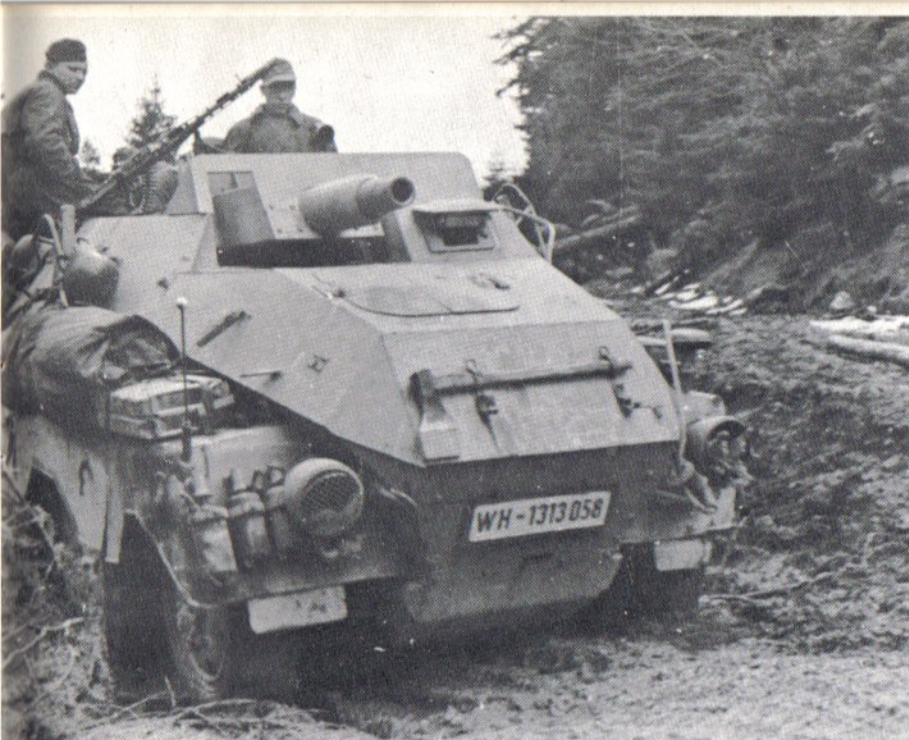
(Left) On the defensive. This **Sd.Kfz. 233** heavy armored car backs down into a dugout position to prepare for a defensive stand. Although the headlamps are still in place on the fenders of the vehicle, they are only shells; the insides having been either removed or damaged and not repaired.

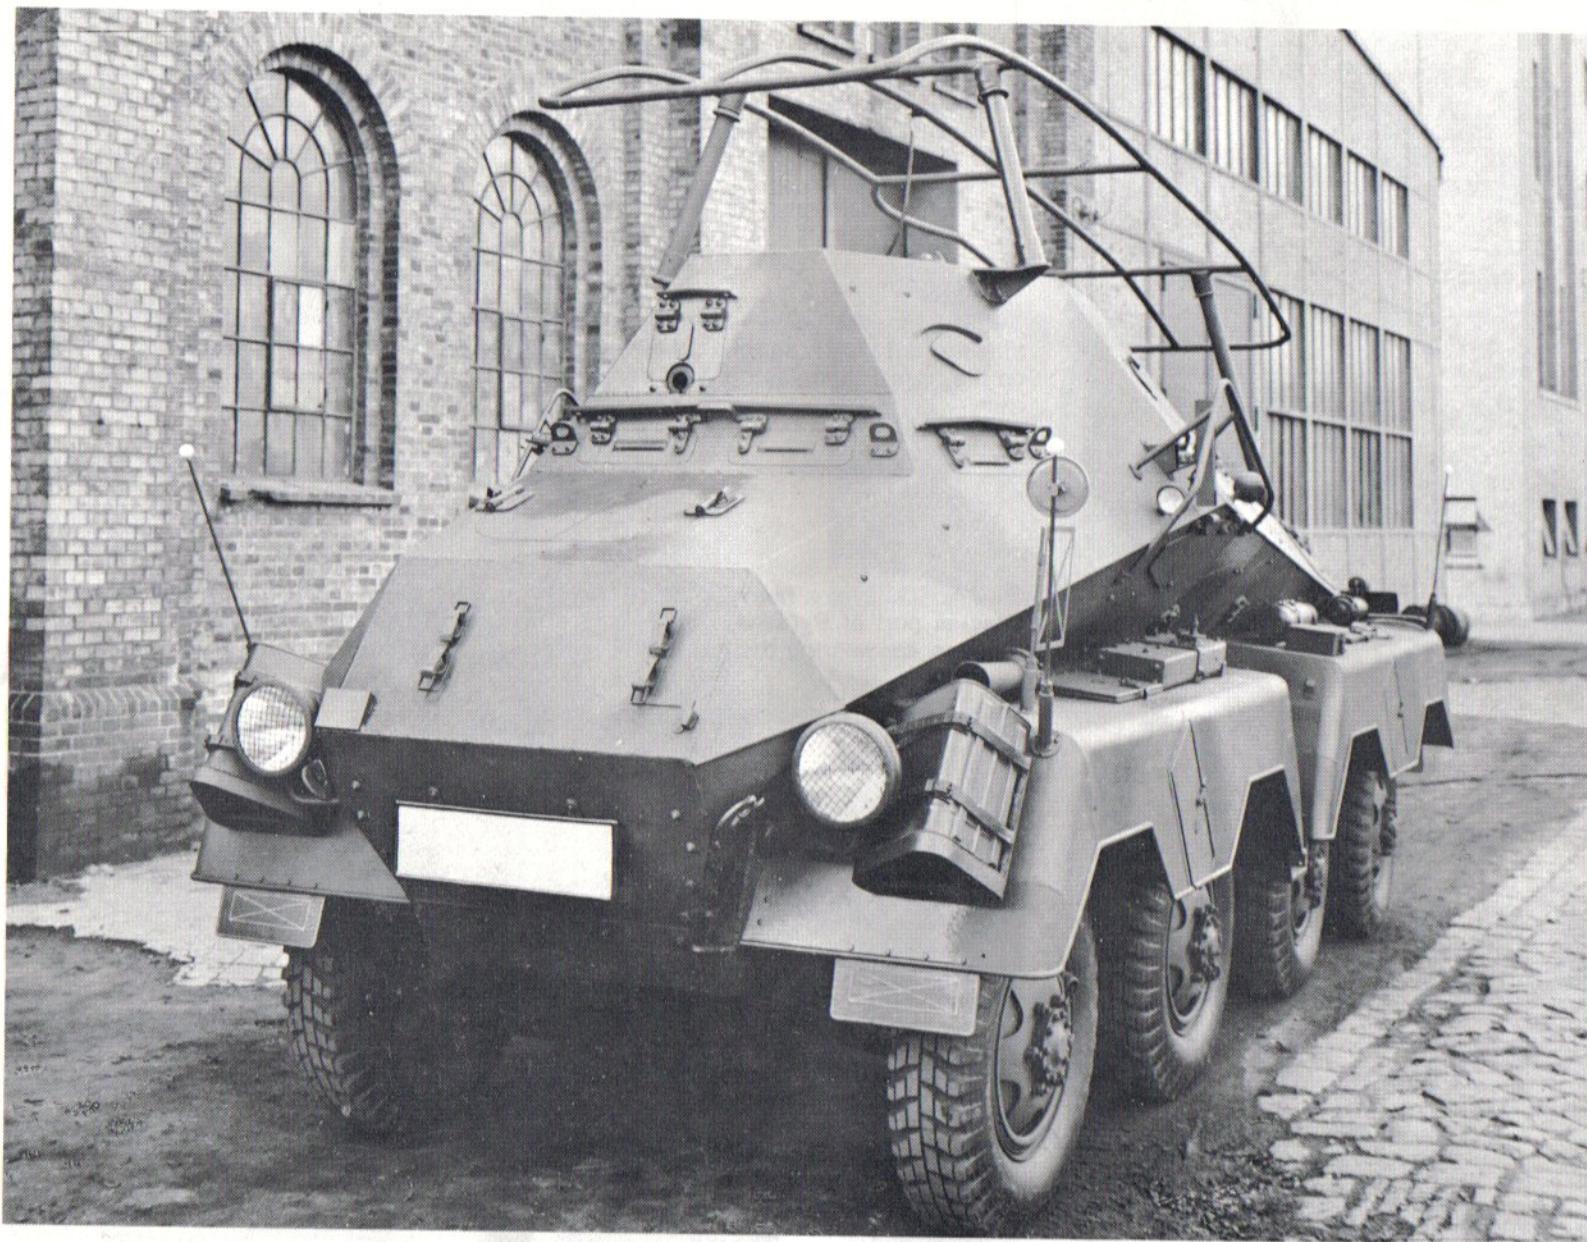
A heavy communications vehicle, Sd.Kfz. 263. Although built along the same lines as its brothers, the Sd.Kfz. 231 and 232, this vehicle had no turret. The superstructure was simply raised in order to accommodate the additional radio equipment necessary for command communications functions.

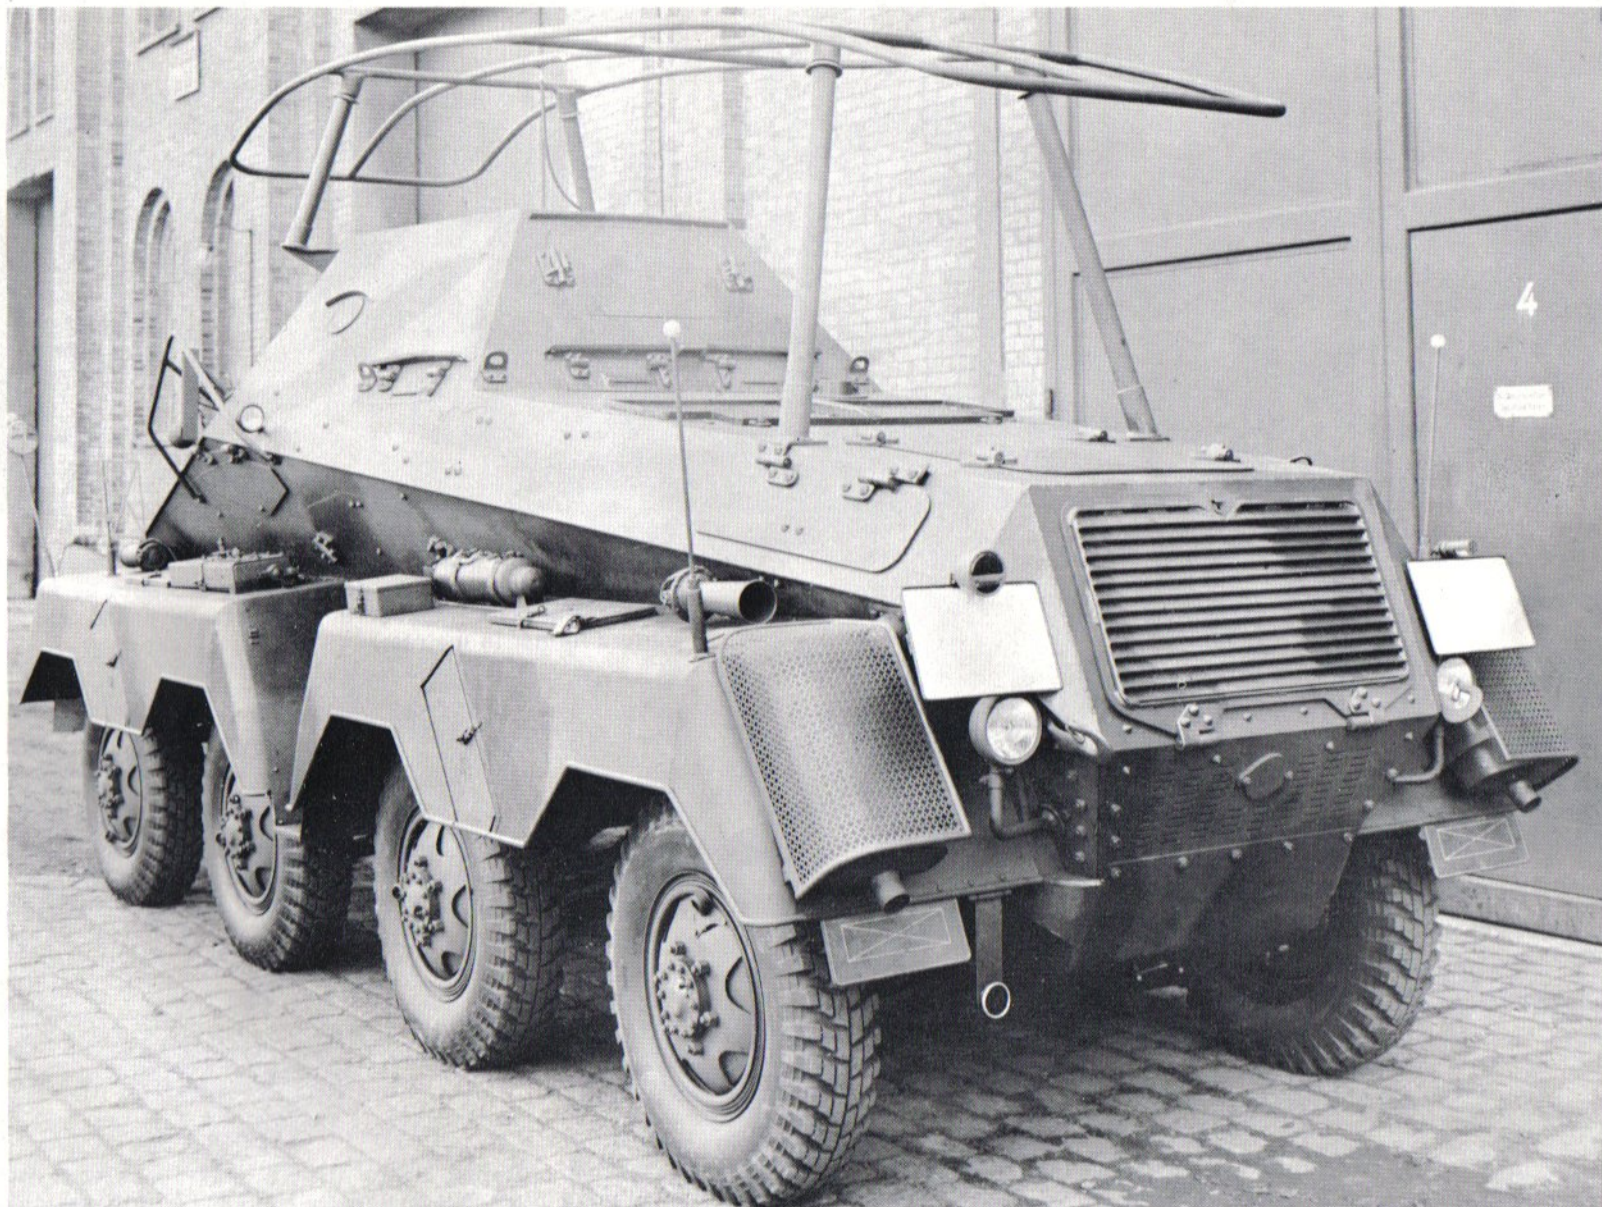
A very nice three-quarter rear view of the newly constructed **Sd.Kfz. 263**. This particular vehicle has been camouflaged with a two-toned sand yellow and light brown shadow scheme. A close look will reveal round pistol ports on the sides of the superstructure, two air horns; one facing forward and the other aft.

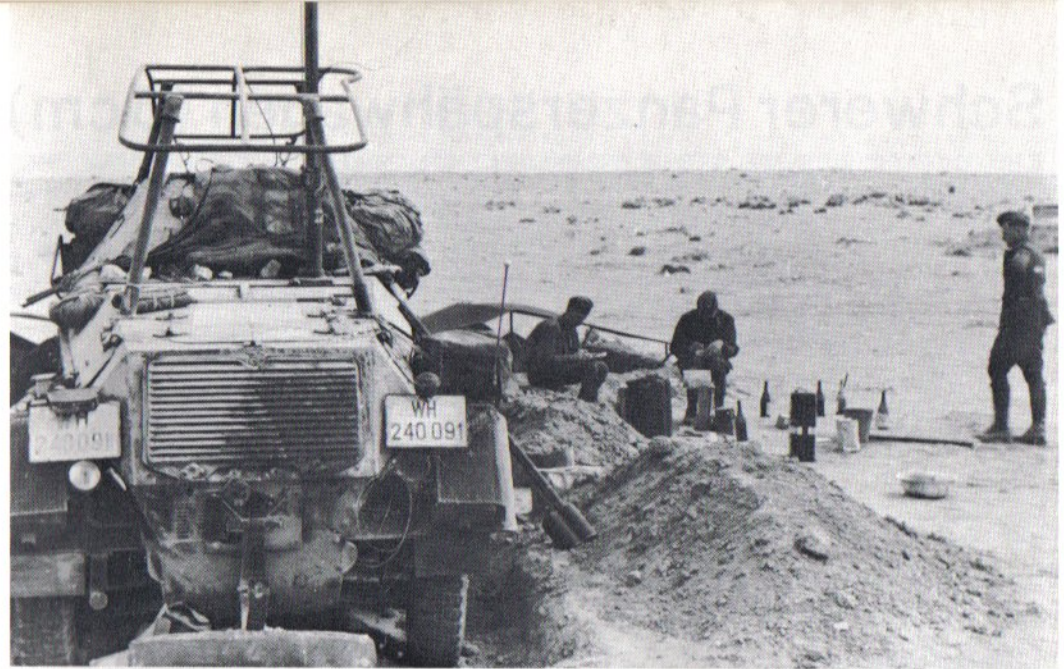
The members of the crew are swabbing down the rear decking of their vehicle with gasoline, concentrating on all areas around the intake grilles and the radiator in order to remove the sand and grit that has accumulated there over the past several days so that it will not be sucked inside the engine compartment and possibly foul the engine, once it is started up.

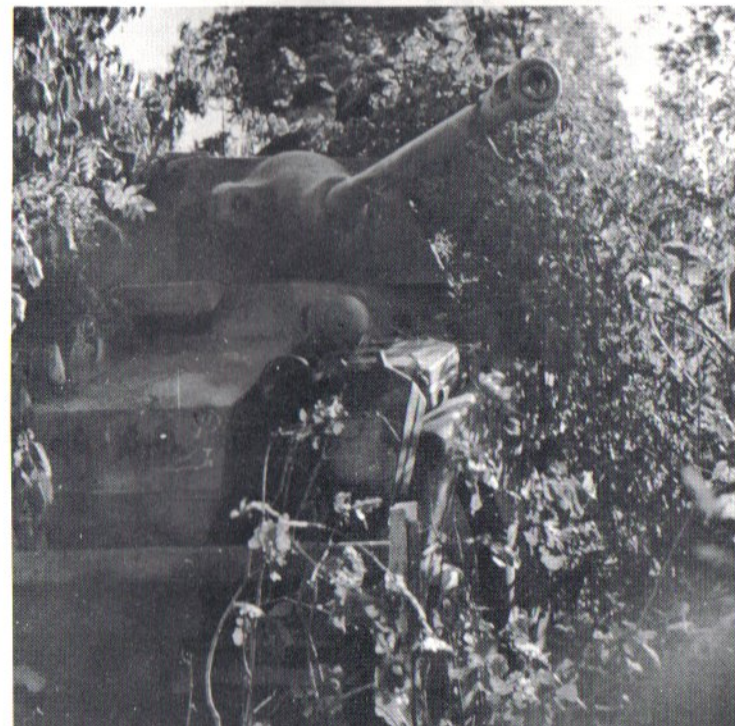
A crew member on radio watch peers out of the turret of this **Sd.Kfz. 234/2**. The barrel and muzzle brake of the 5 cm gun had to be kept clear of brush and leaves not only so that the gunner could get a good, clear shot at his target, but also because the additional brush on the gun tube might foul it if the turret were rotated toward a new target.

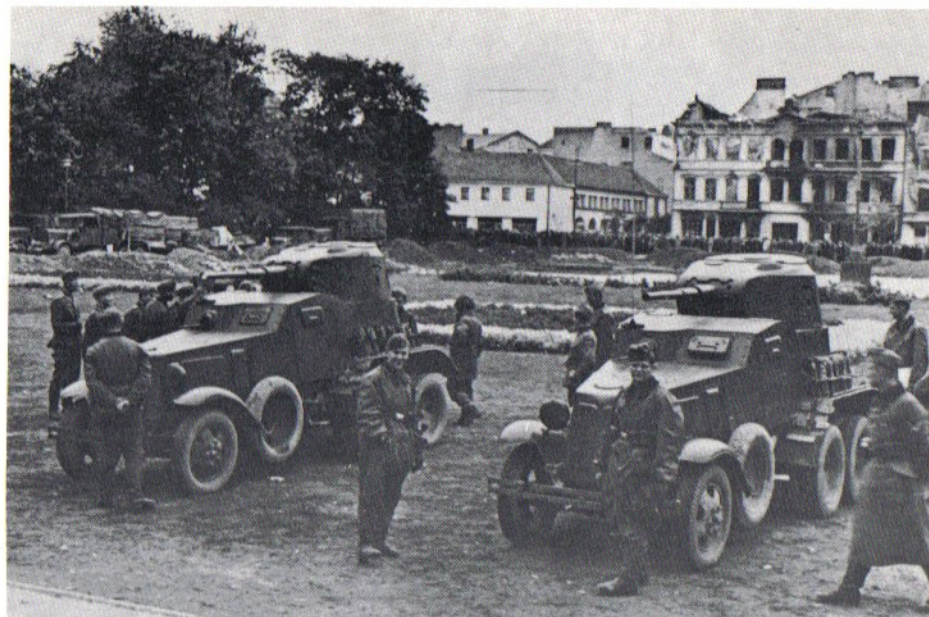
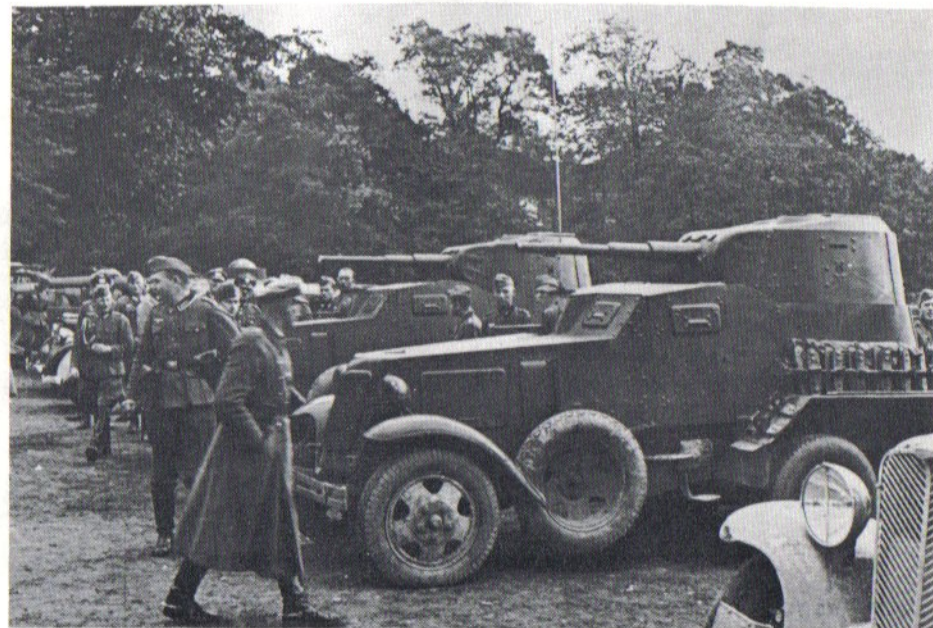
(Right) A side view of the captured Soviet **BA-10 armored cars**. These vehicles were built on the standard **Ford 6 x 4 truck** chassis and featured removable tracks for the rear tires to aid in traction over bad terrain. The tracks are visible on the rear fenders of the vehicle in their stored position.
