Missing aircraft, Boeing 777, 9M-MRO, 8 March 2014

**Identification of two items of debris
recovered from beaches in Mozambique**

ATSB Technical Examination Report

AE-2014-054

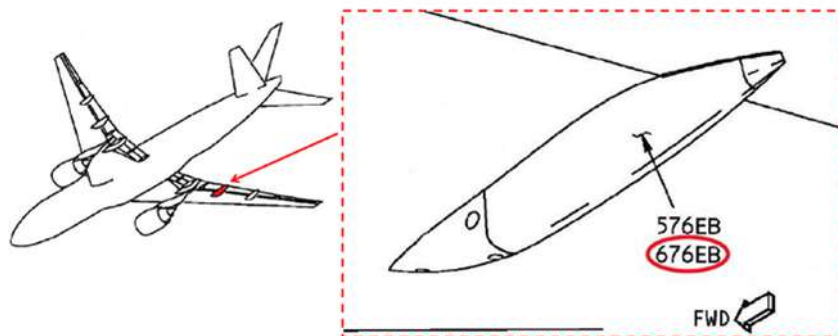
Figure 1: Location of flap track fairing panel No. 676EB

The first part was initially identified from a number stencilled on the part (676EB), as a segment from a Boeing 777 flap track fairing (Fairing No. 7) from the right wing (Figure 1). All measurable dimensions, materials, construction and other identifiable features conformed to the applicable Boeing drawings for the identified fairing.

- Part No. 1 was a flap track fairing segment, almost certainly from the Malaysia Airlines Boeing 777 aircraft, registered 9M-MRO.
- Part No. 2 was a horizontal stabiliser panel segment, almost certainly from the Malaysia Airlines Boeing 777 aircraft, registered 9M-MRO.

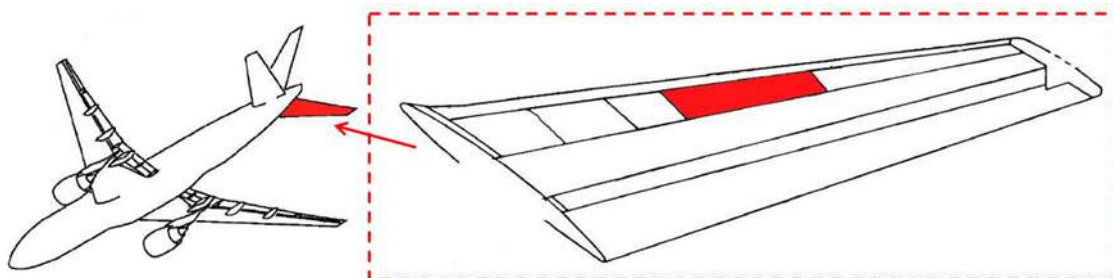
Figure 3: Location of horizontal stabiliser panel No. 3 upper

The second part was primarily identified from images showing the materials, construction and “NO STEP” stencil, as a segment of a Boeing 777 RH horizontal stabilizer panel (Figure 3). All measurable dimensions, materials, construction and other identifiable features conformed to the Boeing drawings for the stabiliser panel.
